NATIONAL TRANSPORTATION SAFETY BOARD
Vehicle Recorder Division

Specialist's Factual Report By Kyle Garner

Location: Fort Worth, Texas
Date: February 11, 2021
Vehicle: Multiple
Operator: Multiple
NTSB Number: HWY21FH005

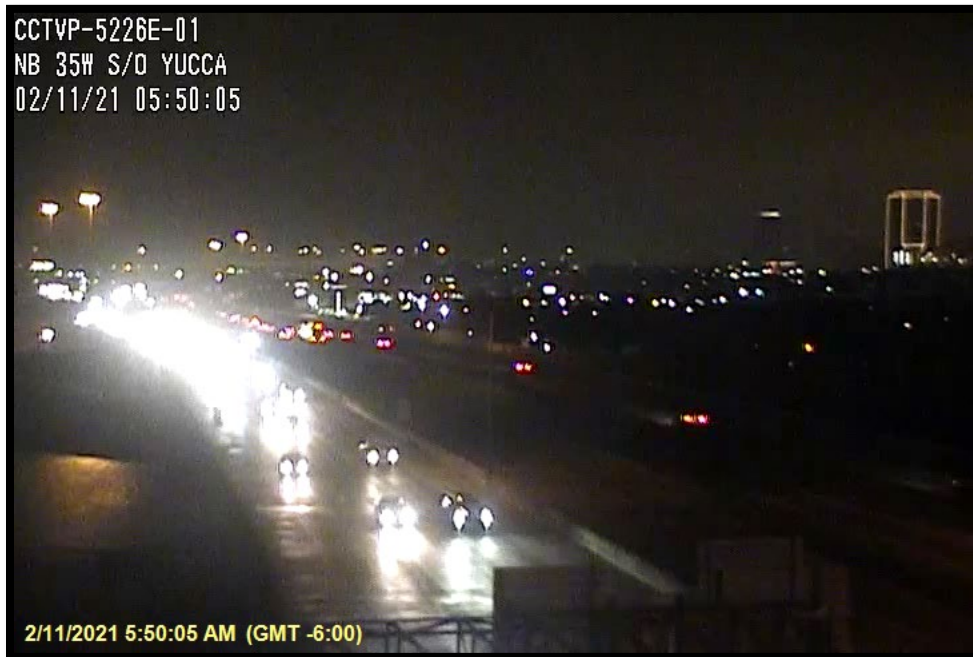
Figure 1. View of camera 1 - facing south.

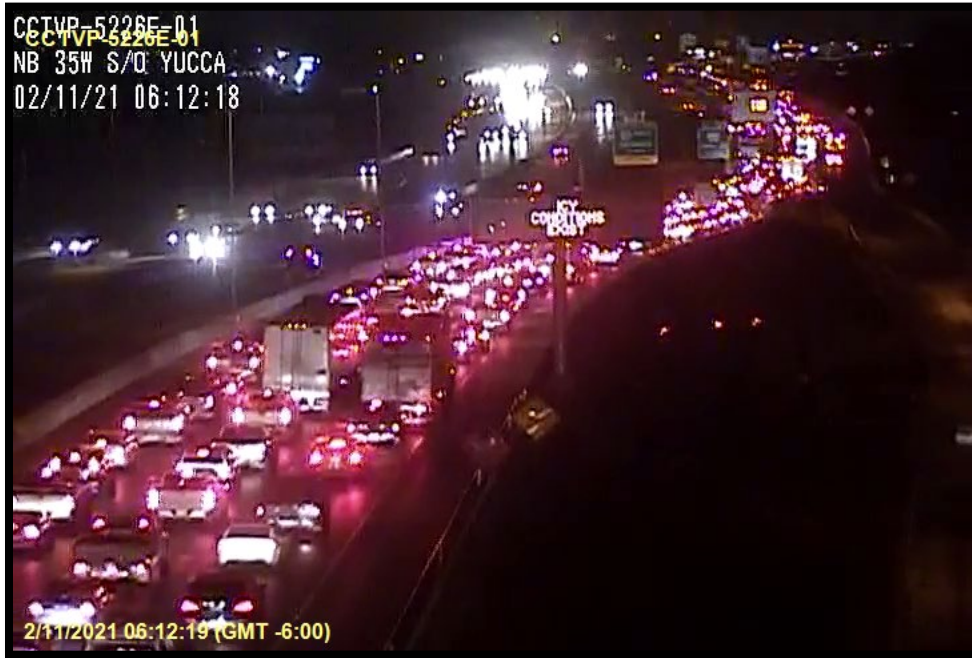
Figure 2. View of camera 1 - facing north.

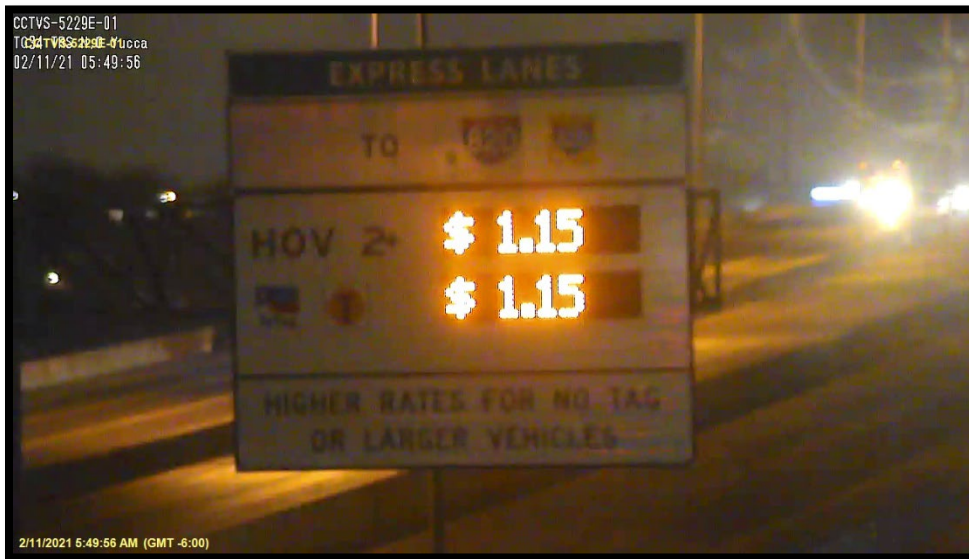
Figure 3. View of camera 2 for the duration of recording - facing north.

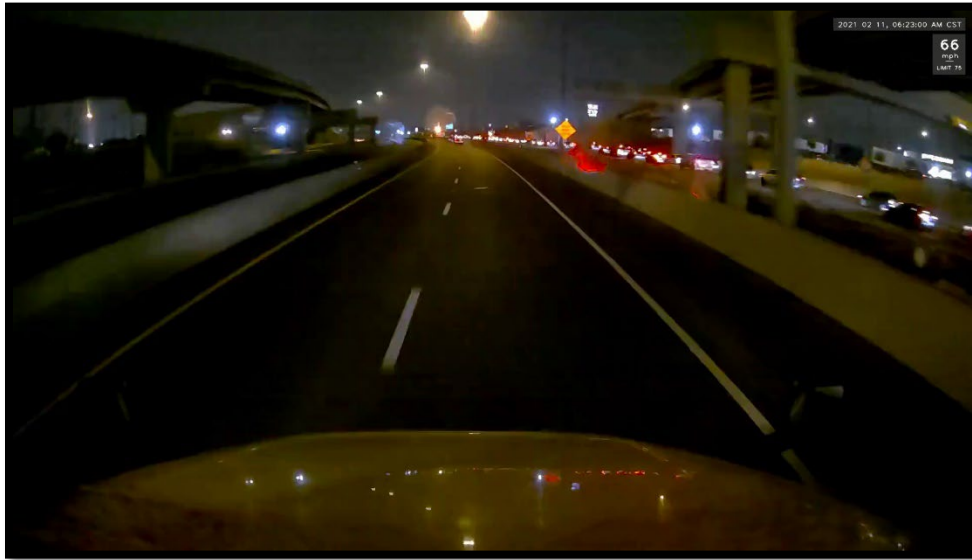
Figure 5. View of combination vehicle's camera – beginning of video 1.
