NATIONAL TRANSPORTATION SAFETY BOARD

INVESTIGATOR'S FACTUAL REPORT OF INVESTIGATION FOR AIRCRAFT SYSTEMS AND POWERPLANTS

A. **ACCIDENT:** DCA17MA022

AIRCRAFT: McDonnell Douglas/Boeing DC-10-10F, N370FE

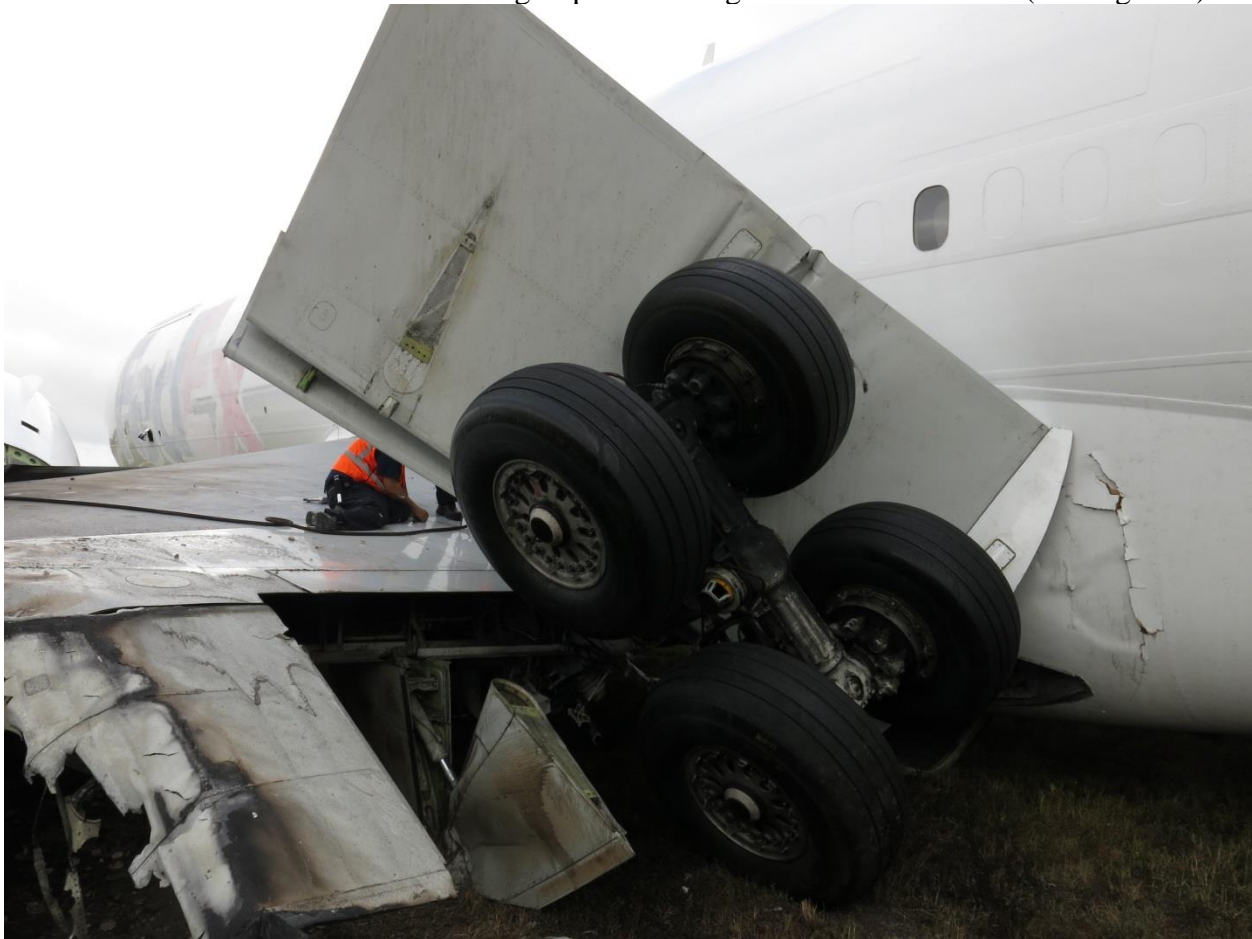
The left main landing gear shock strut (oleo) was broken and folded aft. The leading tires were oriented downward and the inboard wing flap was resting on the inboard tires.¹ (See Figure 1)

Figure 1. The inboard left flap resting on the left main landing gear.

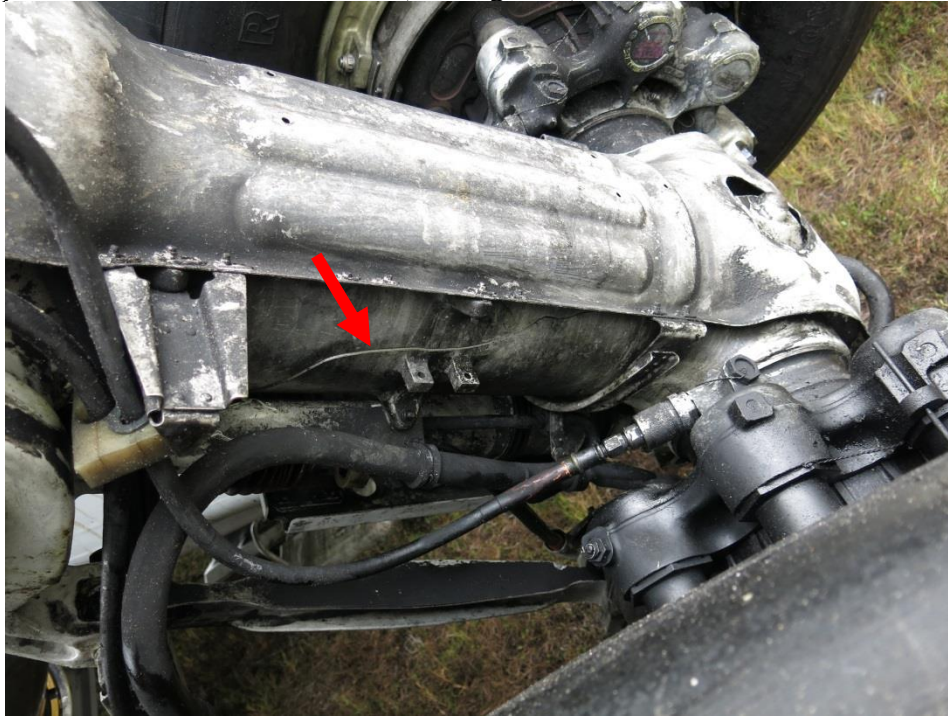
The outboard side of the left truck beam had a major crack ahead of the forward axle, on the outboard side. The broken end of the truck beam was between the tire resting on the ground and the bottom pivot of the vertical oleo strut. (See Figure 2)

Figure 2. Bottom of left truck beam, showing crack. (Arrow)

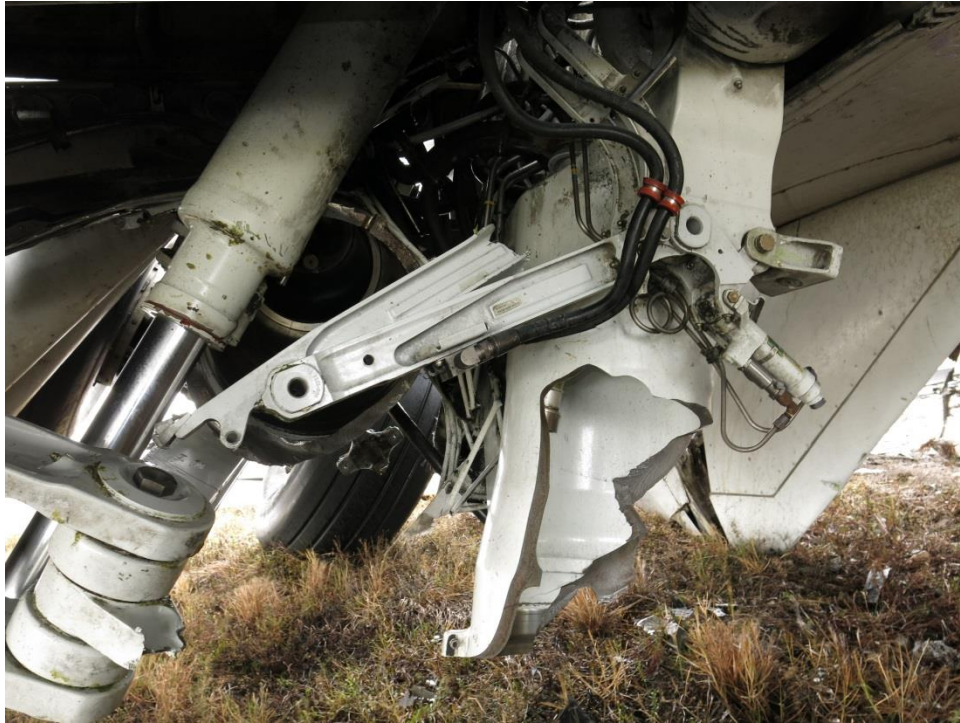
The down-lock, side braces, and the end of the retraction rod were found twisted and broken. (See Figure 3) The twisting and fractures were consistent with the break in the main landing gear cylinder which rotated aft. The broken end of the retraction rod did not visibly have fatigue striations.

Figure 3. Broken and twisted downlock assembly and attachment point for retraction actuator.

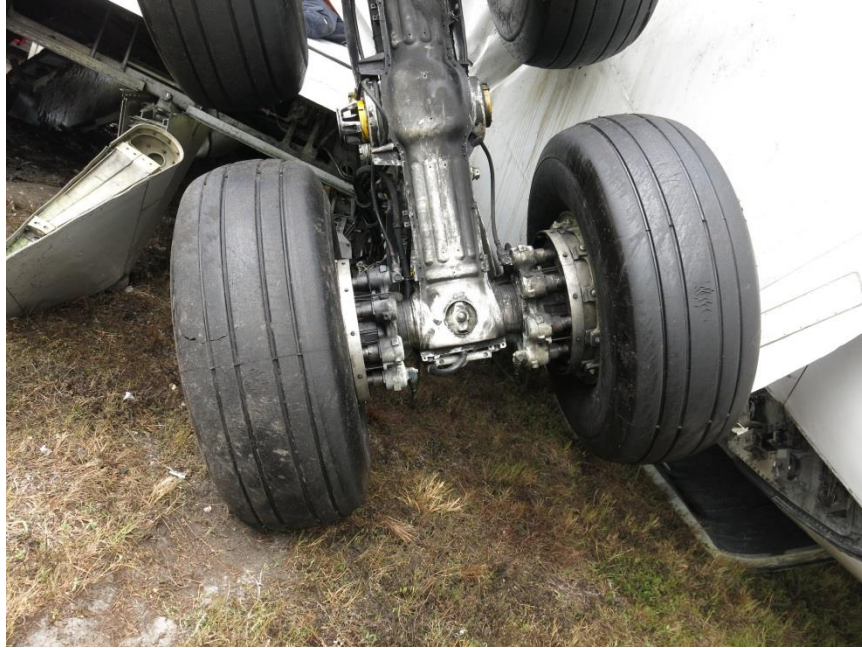
The tires were all generally in good condition, with minimal operational wear or damage. The tread grooves in each had substantial depth remaining, none of the tire treads had flat spots, and all tires remained pressurized. The outboard forward tire (No. 1) had more shoulder wear, which was consistent with the angle it had been displaced to by the broken landing gear strut; the wear was within serviceable limits. (See Figure 4) Tread damage related to the accident sequence was found, such as the left main gear inboard aft tire (No. 6) had a deep circumferential cut in the shoulder, near where the tire struck the most inboard flap track. (See Figure 5) The left nose wheel tire exhibited more wear than the right.

Figure 4. Tire wear, showing tires No. 1 and No. 2.

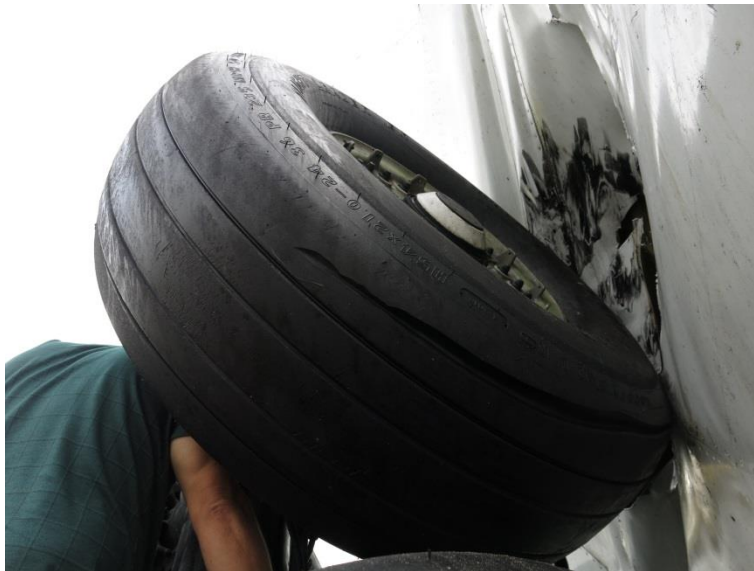
Figure 5. Circumferential cut in shoulder of tire No. 6.

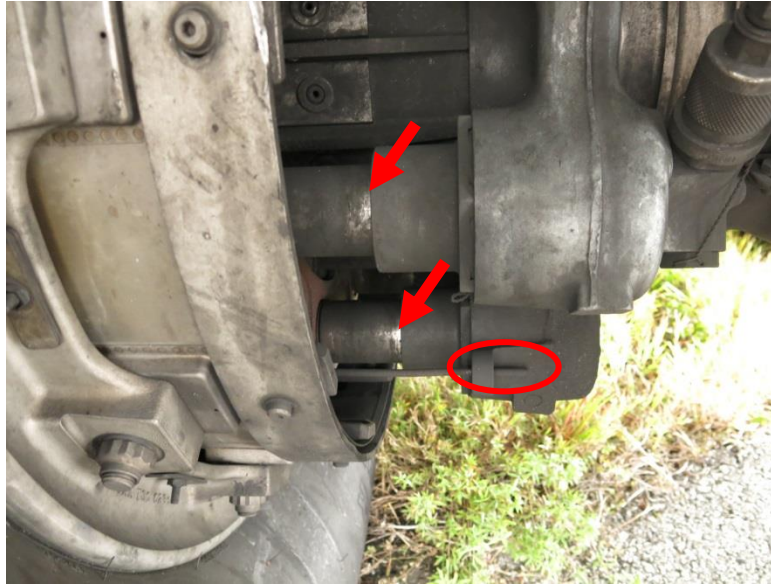
The hydraulic system had been too extensively breached to pressurize, consistent with breakage of the landing gear strut and the extensive fire damage. Without pressure, the state of the brake wear could not be accurately determined. The lengths of the brake wear pins and pistons were consistent with the airplane having available brake material at the end of the landing. (See Figure 6)

Figure 6. Example of brake wear pin (oval) and piston (arrows).

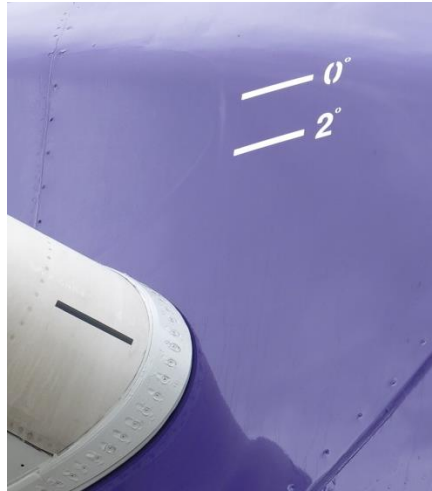
The horizontal stabilizer and elevators were undamaged. The stabilizer trim was leading edge down beyond the two markings painted on the fuselage and by visually estimating from those marks the trim was about 9-10 degrees airplane nose up. (See Figure 15)

Figure 15. Stabilizer trim markings on right side of fuselage.

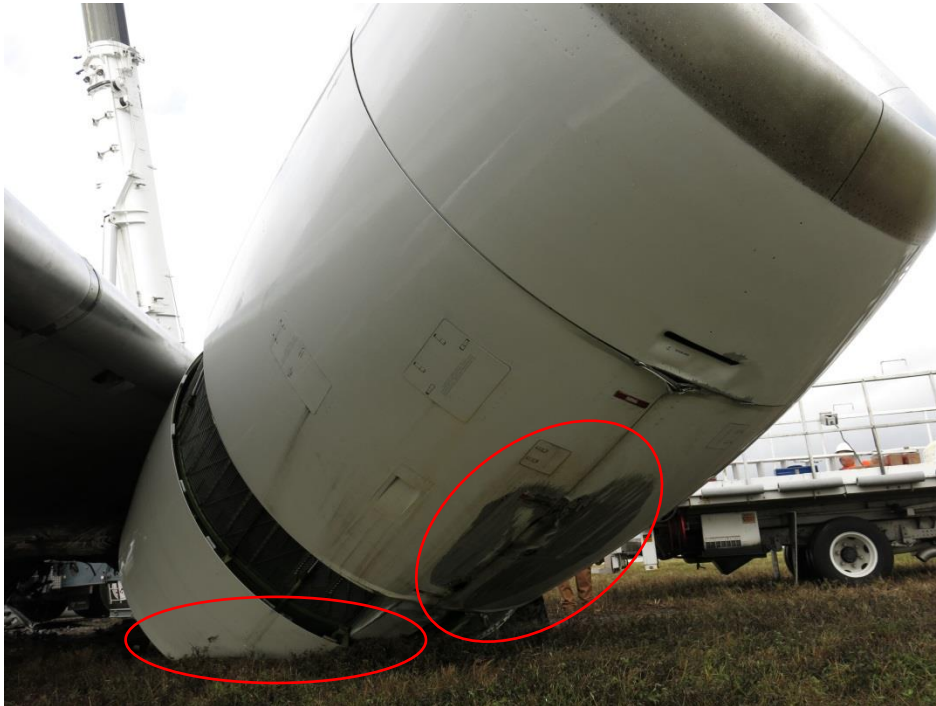
The bottom of the left engine had two large areas of scrapes. The forward scrape was along the bottom of the cowl doors, and the second scrape extended aft from the aft edge of the thrust reverser blocker vanes. A video of the landing showed that the left engine was initially supporting the airplane with the left engine inlet in normal relation to the fuselage when fire

began near the left wing tip. The skid marks at the bottoms of the cowling doors were consistent with this orientation. (See Figures 17, 19, and 20)

Figure 17. Two areas of scraping on the bottom of the left engine were found. (See ovals) Scrapes existed on bottom of engine cowling doors and a scraped crush line was along the aft edge.

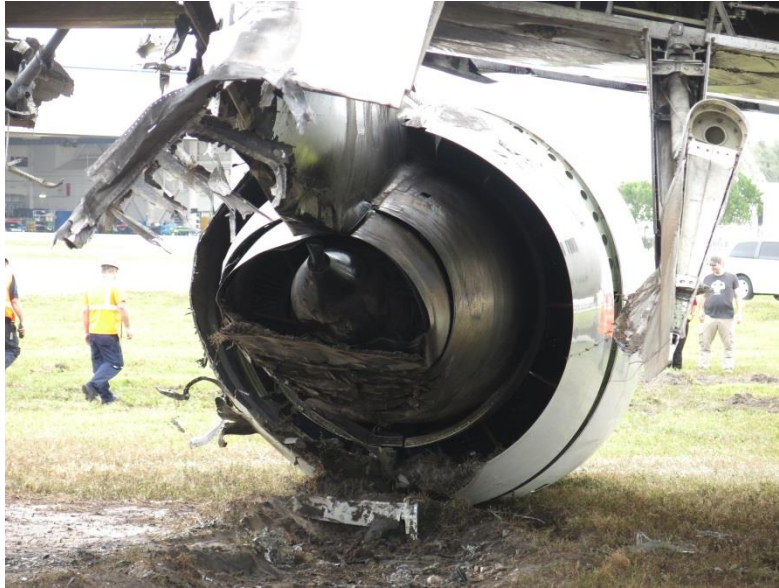
The left engine and pylon assembly was found oriented with the inlet upward and trailing end of the pylon near the ground. The aft pylon attach bracket had broken and the two pylon attach points at the forward wing spar were intact. A crush line existed from the aft edge of the thrust reverser vanes to what had been the centerline of the core exhaust. (See Figures 19 and 20)

Figure 19. Crush line of the left engine from rear.

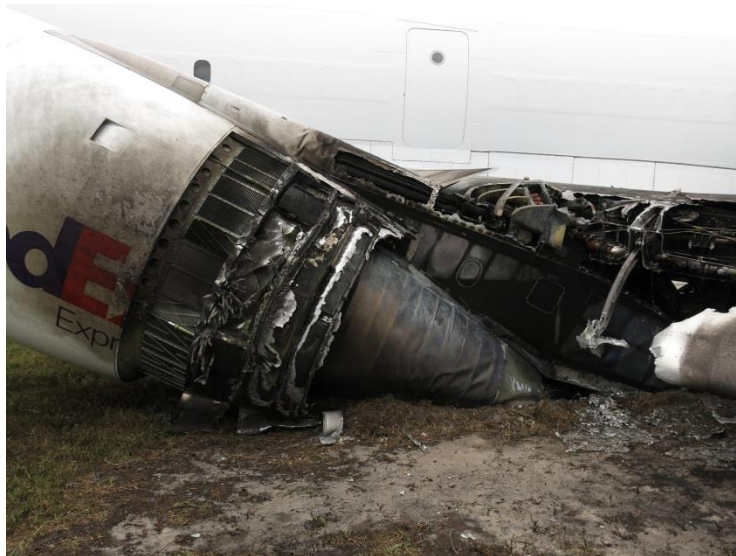
Figure 20. Left engine crush line from side and orientation as found. The thrust reverser translating cowl is open and the outboard extent of the fire is visible. The burned outboard side of the pylon is visible.

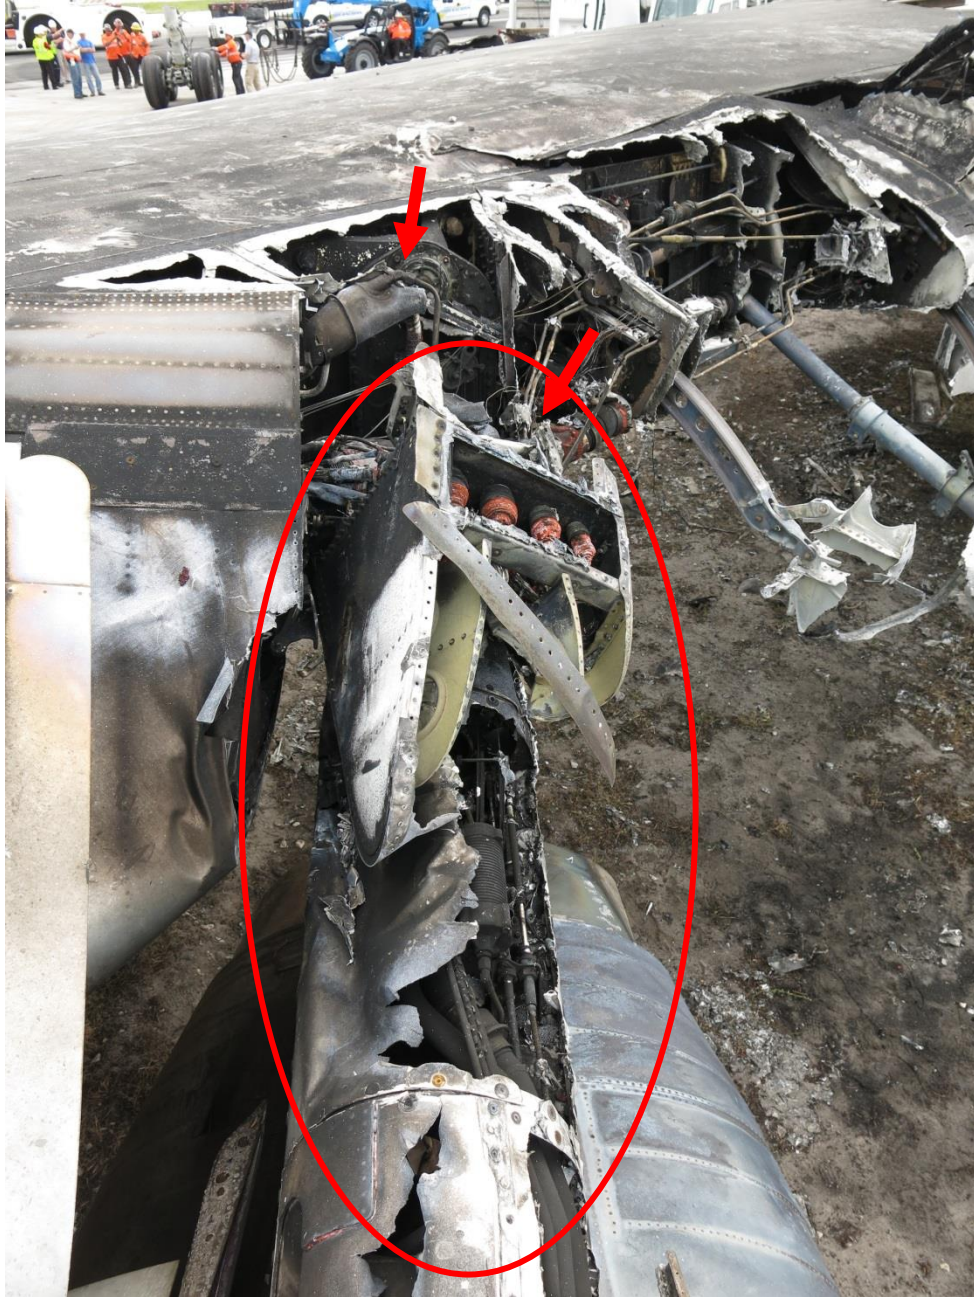
The left pylon fuel tube was found torn and partially consumed by fire. (See Figure 21) The firewall shutoff valve was found in the closed position.

Figure 21. This view is from above the left engine and looks aft, showing the left engine pylon (oval), top of the engine, and left wing leading edge. The arrows point to the torn and partially consumed ends of the pylon fuel tube.

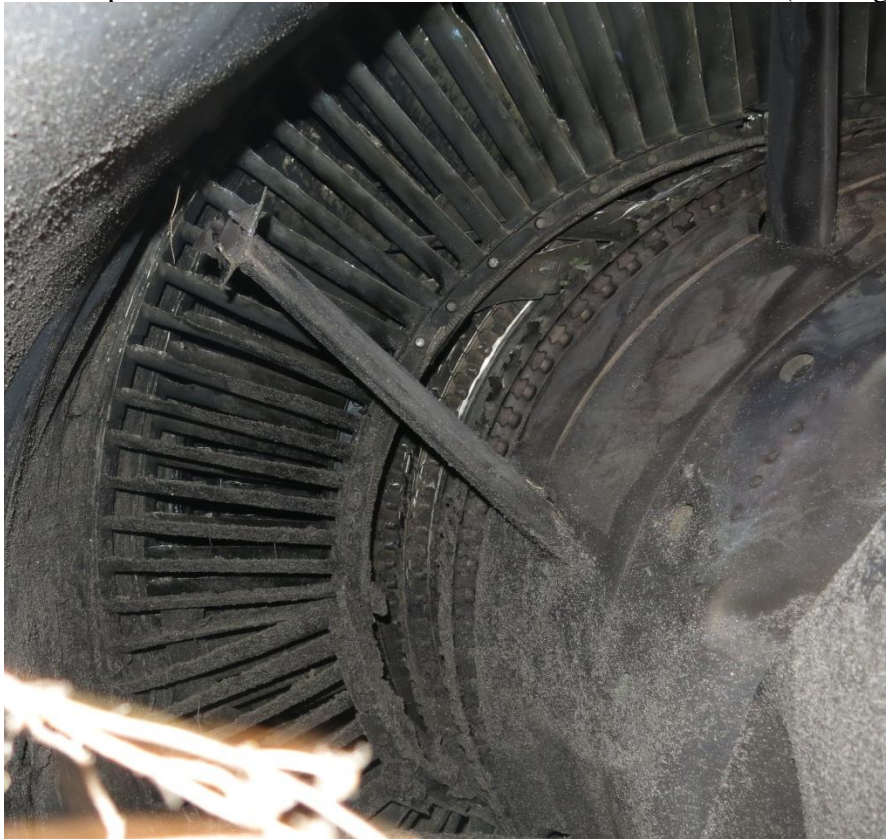
The complete turbine case had broken and been displaced about five inches up from the rest of the engine. Turbine blades were found scattered along the runway where the fire debris began and when viewing the turbine section from the exhaust, two complete rows of turbine blades were missing. Many of the root portions of the missing blades were in the discs. A third partial ring of blade sections which appeared to be exhaust vanes had dislodged from the mounted orientation; the lower portion of these blades were not in the exhaust case. (See Figure 22)

Figure 22. View into exhaust of left engine.

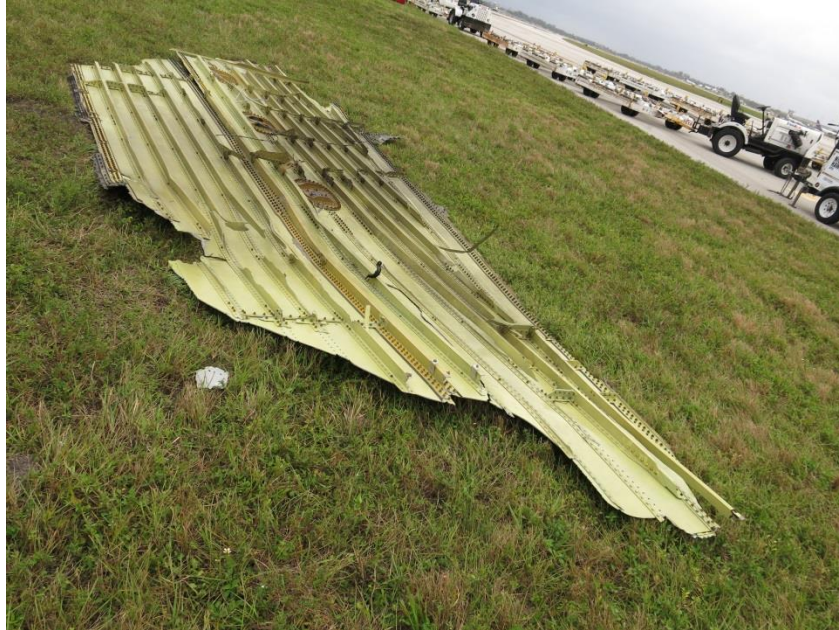
A portion of the top wing skin separated from the wing and landed outboard of the wing tip. Three fragments were found; one large and two small. The large panel was irregularly shaped and the outer dimensions were 25' 6" spanwise by 8' 11" chord-wise. (See Figure 23) The two small fragments were about 9 inches in the longest dimension, one of which was skin material and the other was the edge of a wing rib. (See Figure 24)

Figure 23. Panel of left wing top wing surface.

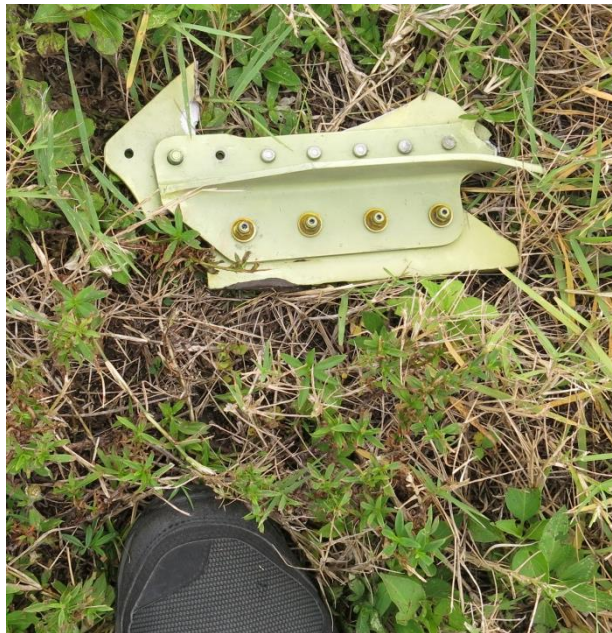
Figure 24. One of two small wing rib fragments, showing toe of boot for scale.

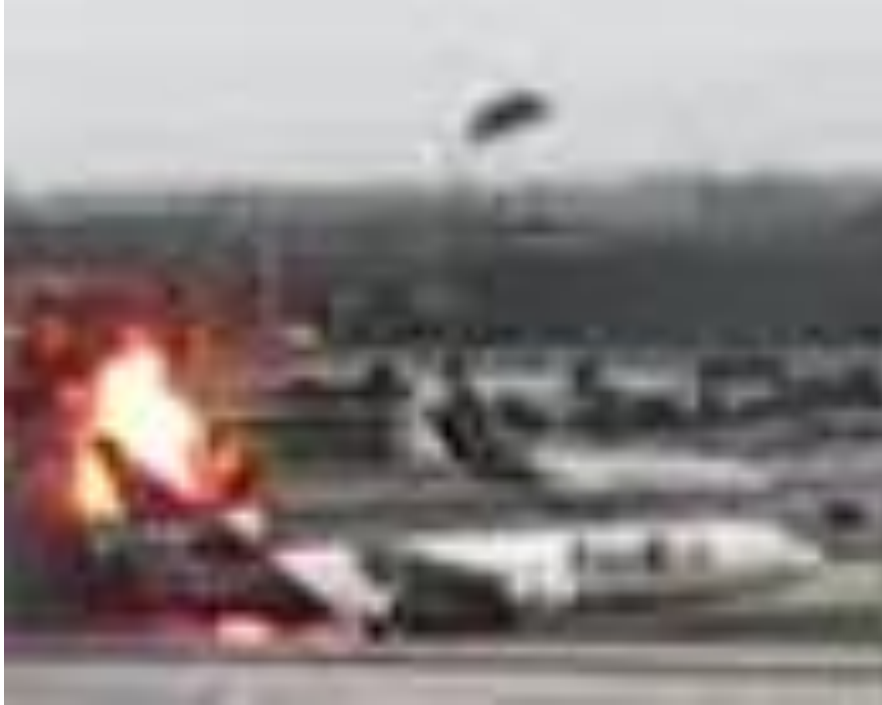
The large piece landed 44 feet outboard of the wingtip, and 54 feet forward of the leading edge of the tip. This was in line with the joint between the nose cowl and cowl doors, and 95 feet outboard of the (displaced) engine centerline. The small fragments landed almost directly behind the large piece with the aft-most straight outboard of the wing tip, with the aft-most 66 feet aft of the center of the large panel. Using the airplane tail as scale and utilizing still images from videos of the explosion, the upper skin panel reached a height of about 140-150 feet. (See Figure 25)

Figure 25. Exemplar still image taken from a video, showing the wing panel visible above MD-10 at peak of height after separating from the wing. For scale, airplane drawings indicate that the top of the tail is about 75 feet tall.

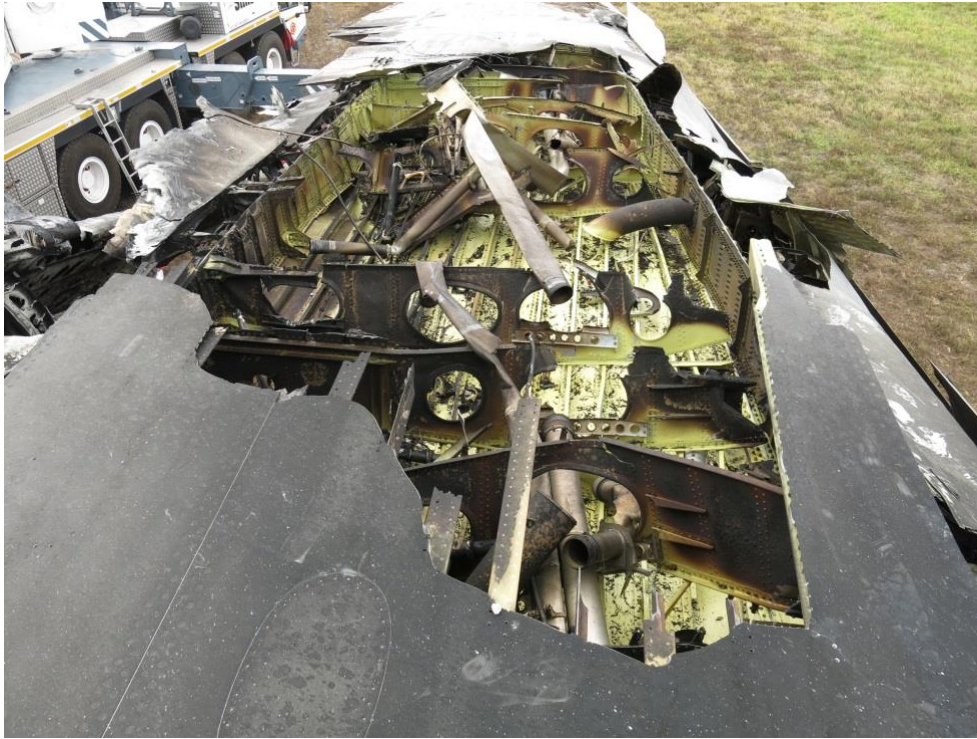
On the top surface of the wing, the inboard end of the hole was at about wing station XORS 433. This was directly ahead of the joint between the inboard aileron and outboard flap. (See Figures 26 and 27)

Figure 26. The extent of material missing from the top of the left wing is viewed from inboard to outboard. Buckled ribs and fragmented structure are visible.

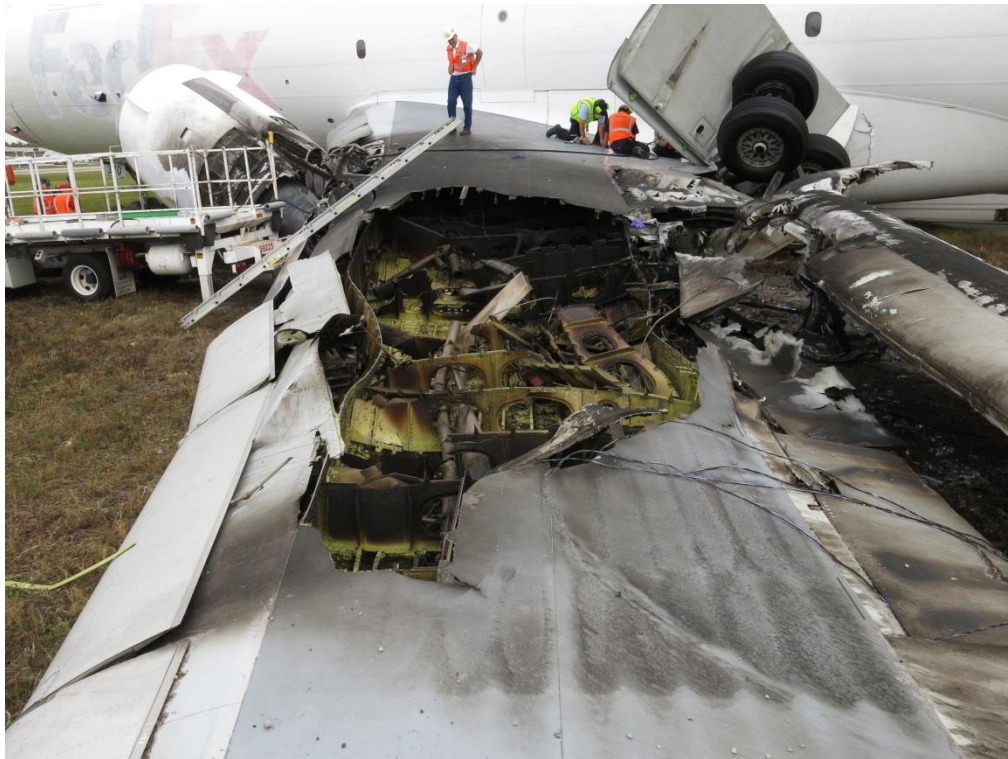
Figure 27. View of hole toward fuselage from outboard wing, showing a person for scale.

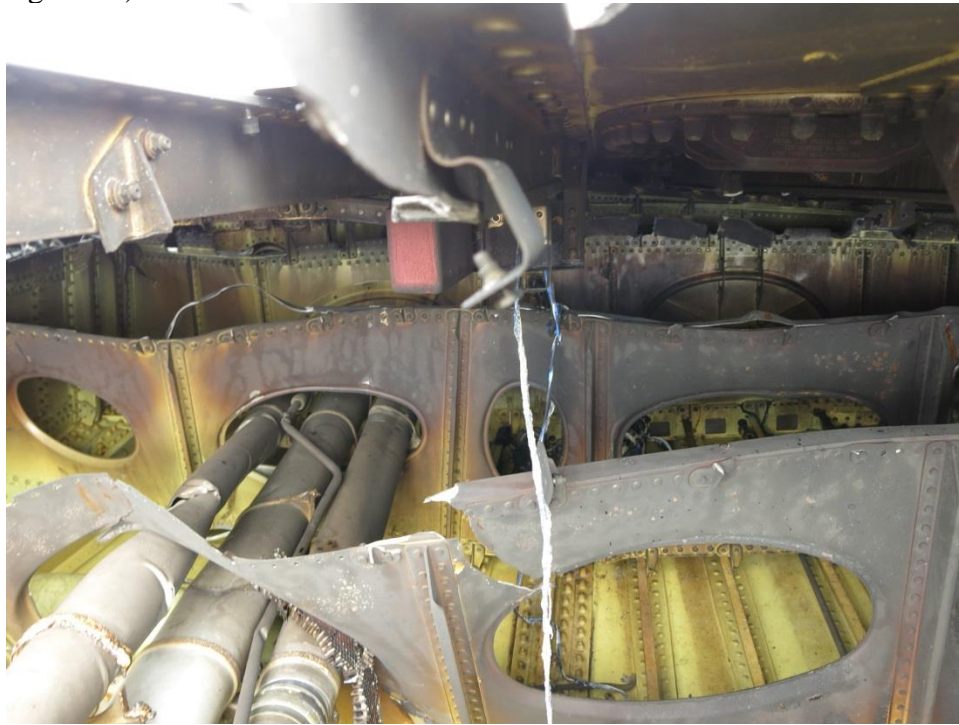
Looking down into the remaining structure and beneath the upper skin, inboard of the check bulkhead, the wing ribs had been displaced outboard. The fuel vent tubes in tank 1 had been

crushed flat. In the area of the fuel tank between the pylon and check bulkhead, the upper skin was displaced upward and lower skin displaced downward, with rows of fasteners missing from each. (See Figure 28)

Figure 28. View inboard from hole in left fuel tank, showing three ribs outboard displaced toward camera.

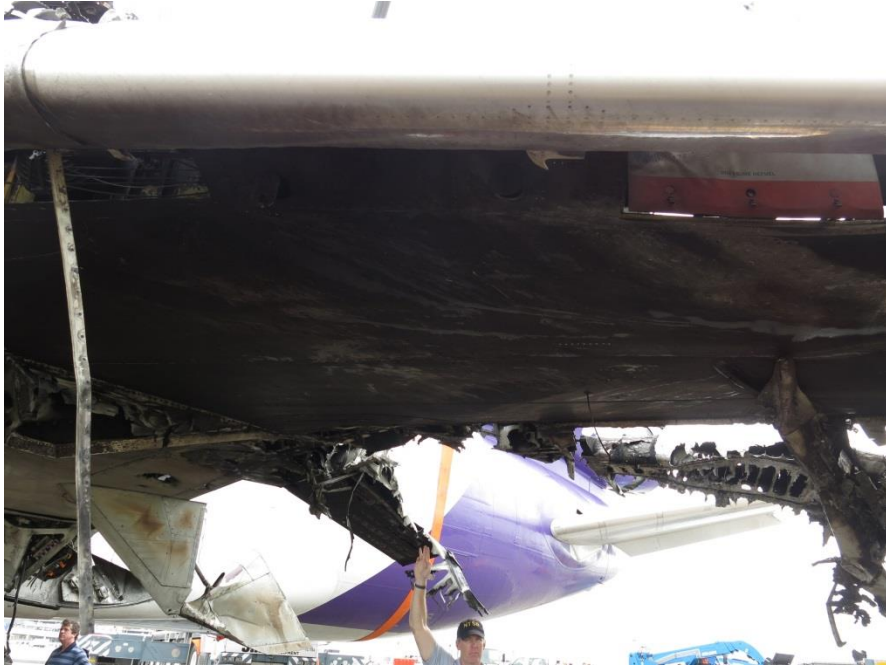
The most intense heat damage was on the wing spar, immediately outboard of the left pylon, at about XORB 299. In this area, the leading edge slat and wing leading edge were consumed beneath where the upper wing skin separated from the leading edge spar. Aft of this location, the upper wing skin was displaced upward and the lower skin displaced downward, rows of top and bottom surface fasteners were missing, and the flap pivot mount had been displaced from the bottom of the wing. (See Figure 29)

Figure 29. Downward bulge in lower wing skin visible above investigator's hand.

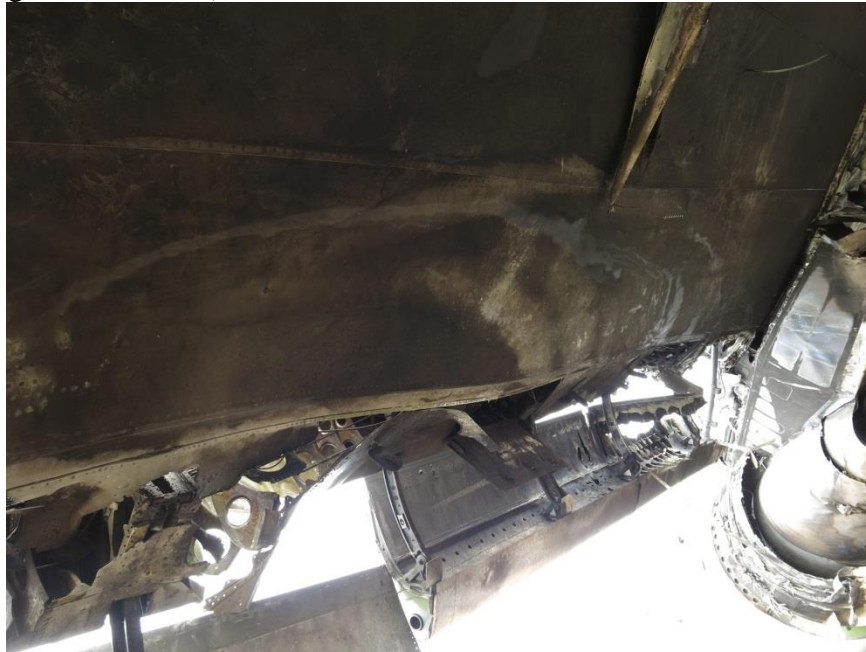
Other separations of the upper and lower wing skins from the leading and trailing edge spars were also seen. The lower wing skin split from the forward spar at the pressure fueling door panel. (See Figures 30 and 31)

Figure 29. Lower wing skin separated from forward spar. Note left engine for orientation.

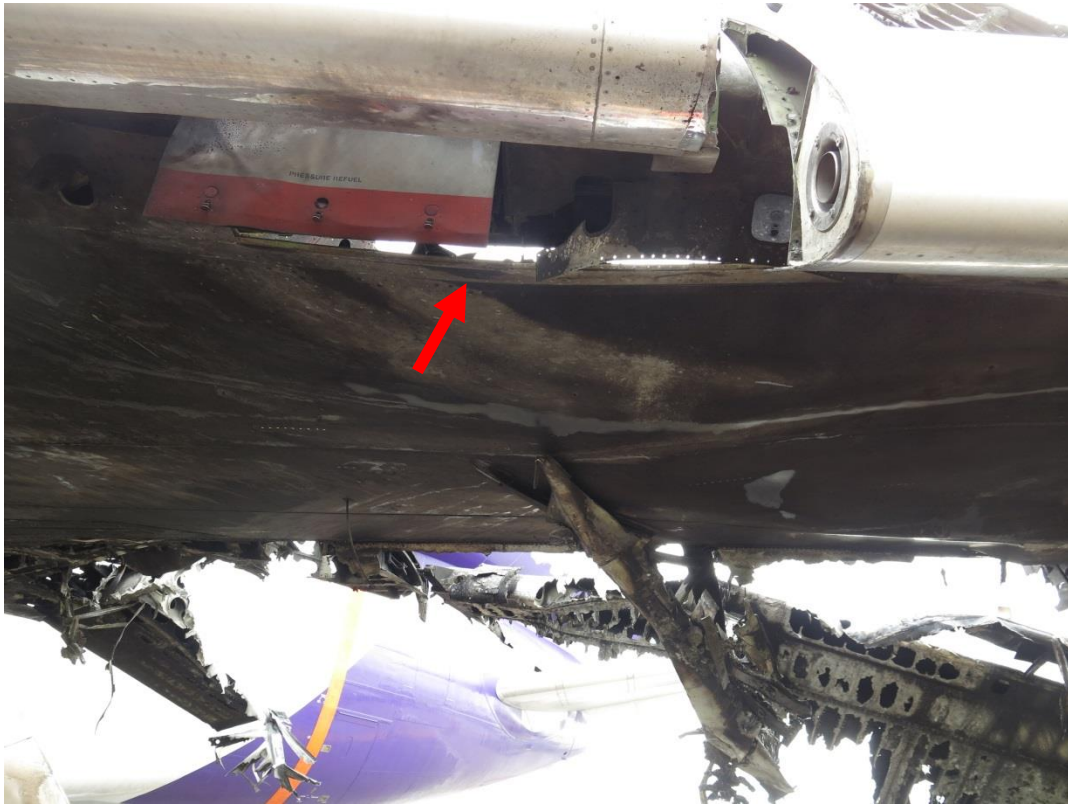
Figure 30. Split of lower wing from spar, immediately outboard of left pylon. Note downward bulge of lower wing skin to the right of the arrow.

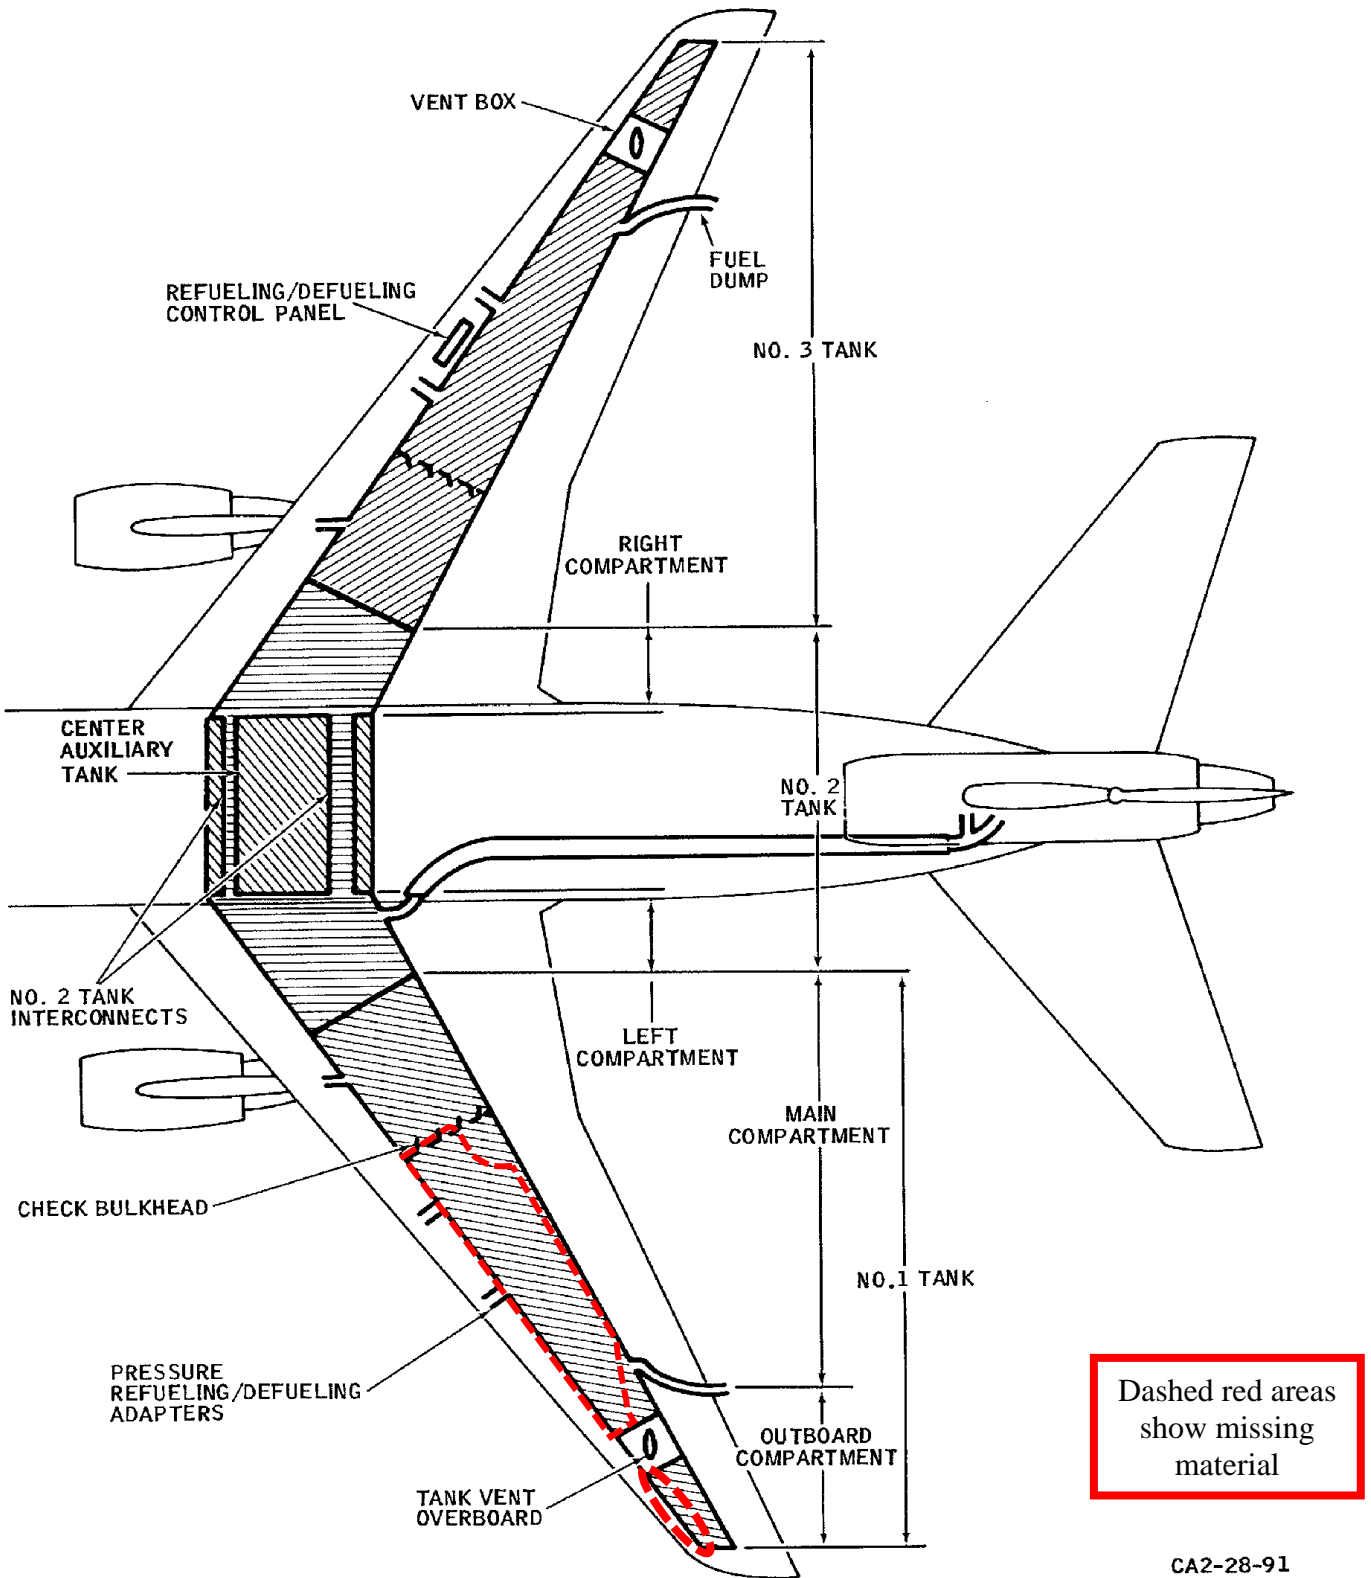
Figure 31. Missing wing material in relation to fuel tanks. Source illustration in Attachments.

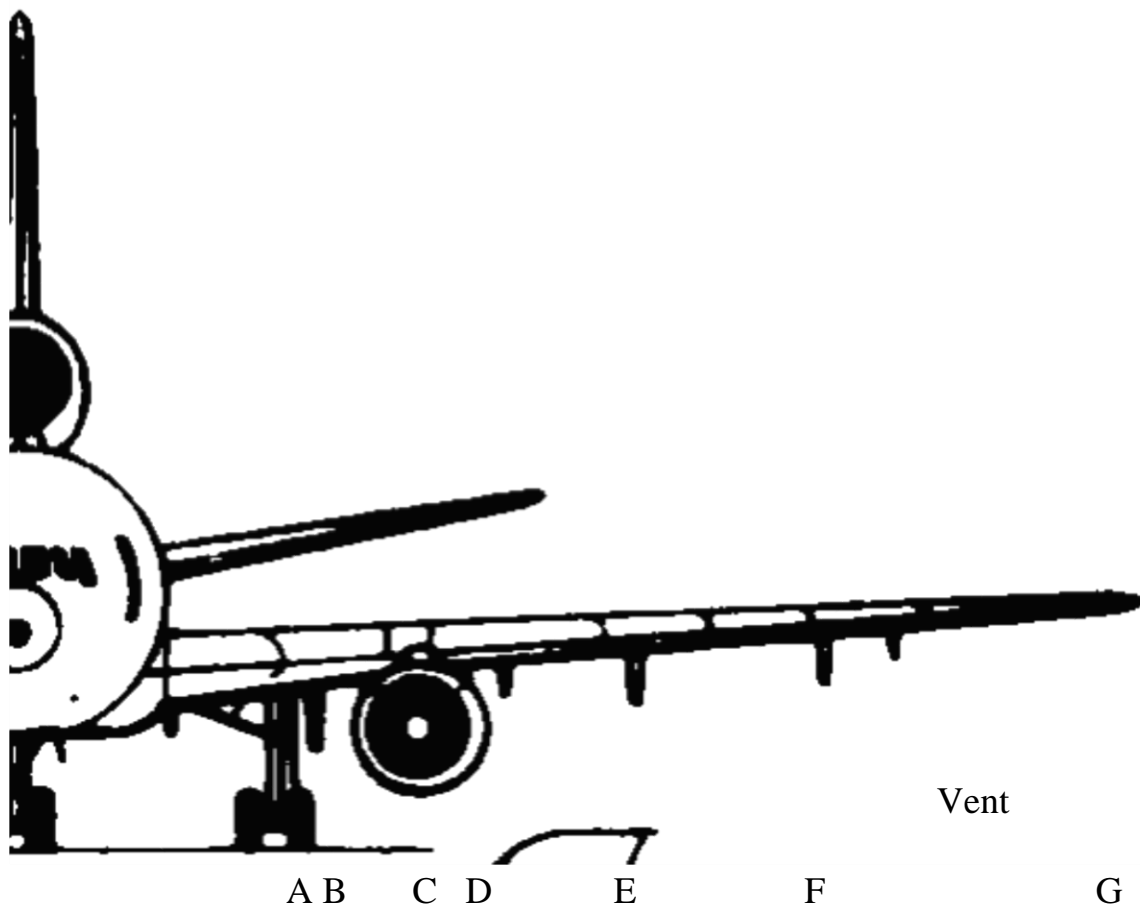
Videos from the landing correlated with soot and other damage on the runway to show that a line of fire existed near the wing tip before a second fire began at or near the left engine. The initial burn marks on the runway were at the spacing of the left wing vent, prior to where the wing tip contacted the ground. (See Figure 33)

Figure 33. Alignment of runway scrape marks with aircraft features, to relate fire damage.

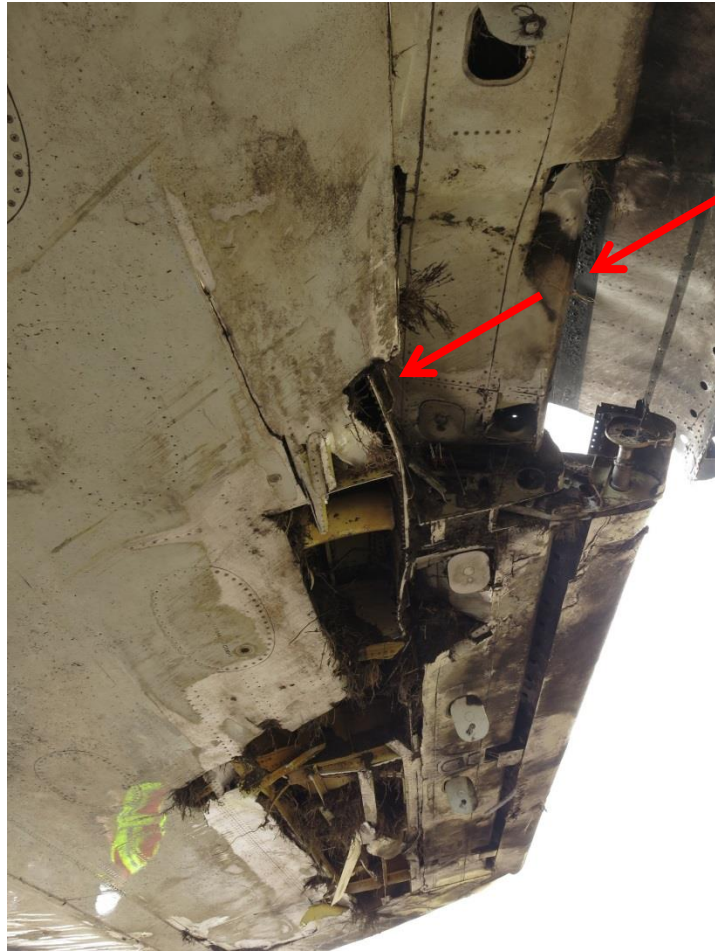
Two lines of burn marks were found along the runway, which correlated with the video. The outboard was at the span distance of the left wing vent, between F and G). Near where the tracks aligning with the bottom of the engine became suddenly more severe and turbine blades were found, the second line of fire began (C to outboard of D). When the line of travel was less than half the distance to the airplane resting place, the width of fire near the vent suddenly broadened to beyond the wing tip. Examination of the bottom wing skin gouges of about the width of runway lights and found that the bottom of the tank had opened ahead of the outboard left aileron and to the wing tip. This area is an outboard portion of the #1 fuel tank, which extends to inboard of the engine. (See Figure 34)

Figure 34. Bottom of left wing tip, showing gouges (arrows) and open bottom of fuel tank.
