INSPECTION REPORT

Inspector's Name Chavez, Stacy		Inspector's Signature			Inspector's ID No. [REDACTED]	Report No. 95	Date yy mm dd 2022 11 04						
Railroad/Company Name & Address PETROLEUM SERVICES RAILROAD 5025 Preston Ave Pasadena TX 77505				R/C R	Division SYSTEM	RR/Co. Representative (Receipt Acknowledged) Name Clifford Branin Title Director of Operations Email [REDACTED] Signature _____							
From: City BEAUMONT		Codes 0490	Destination City & County			Codes	From Latitude						
State TX		48	City BEAUMONT			0490	From Longitude						
County JEFFERSON		C245	County JEFFERSON			C245	To Latitude						
Mile Post: From		To	Inspection Point EXXON MOBIL LUBES PLANT				To Longitude						
Activity Code:	ACC												
Units:	1												
Sub Units:	1

PSCG employee fatality; October 28, 2022; FE-2022-15

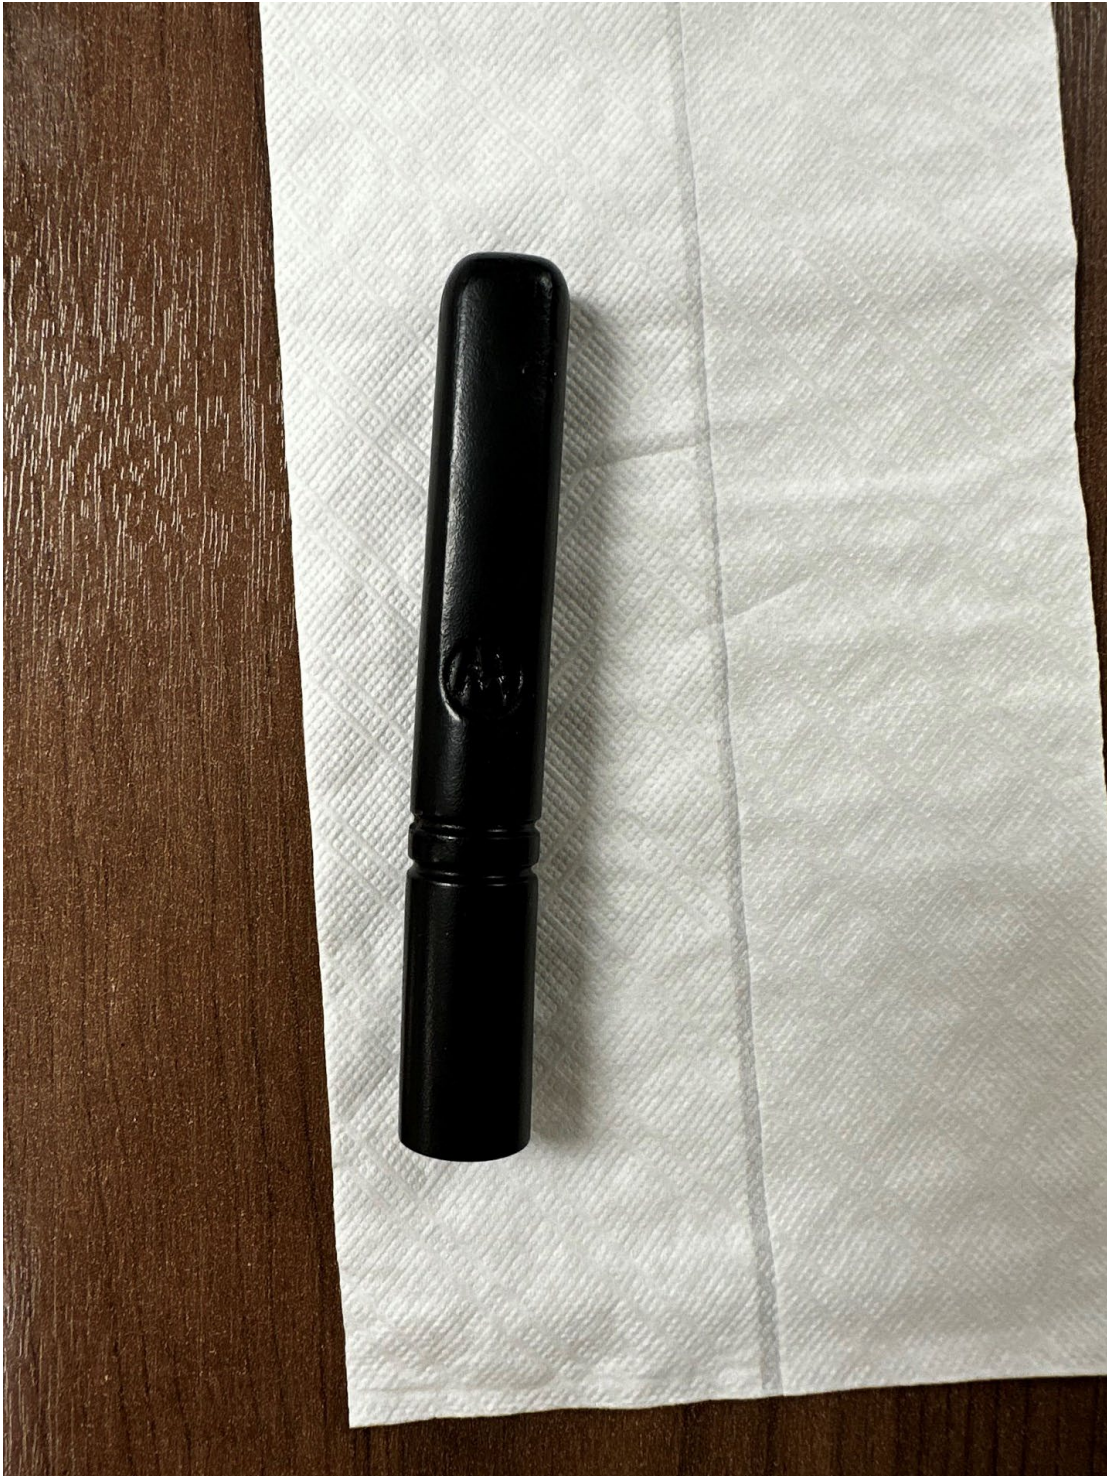
Antenna plastic cover

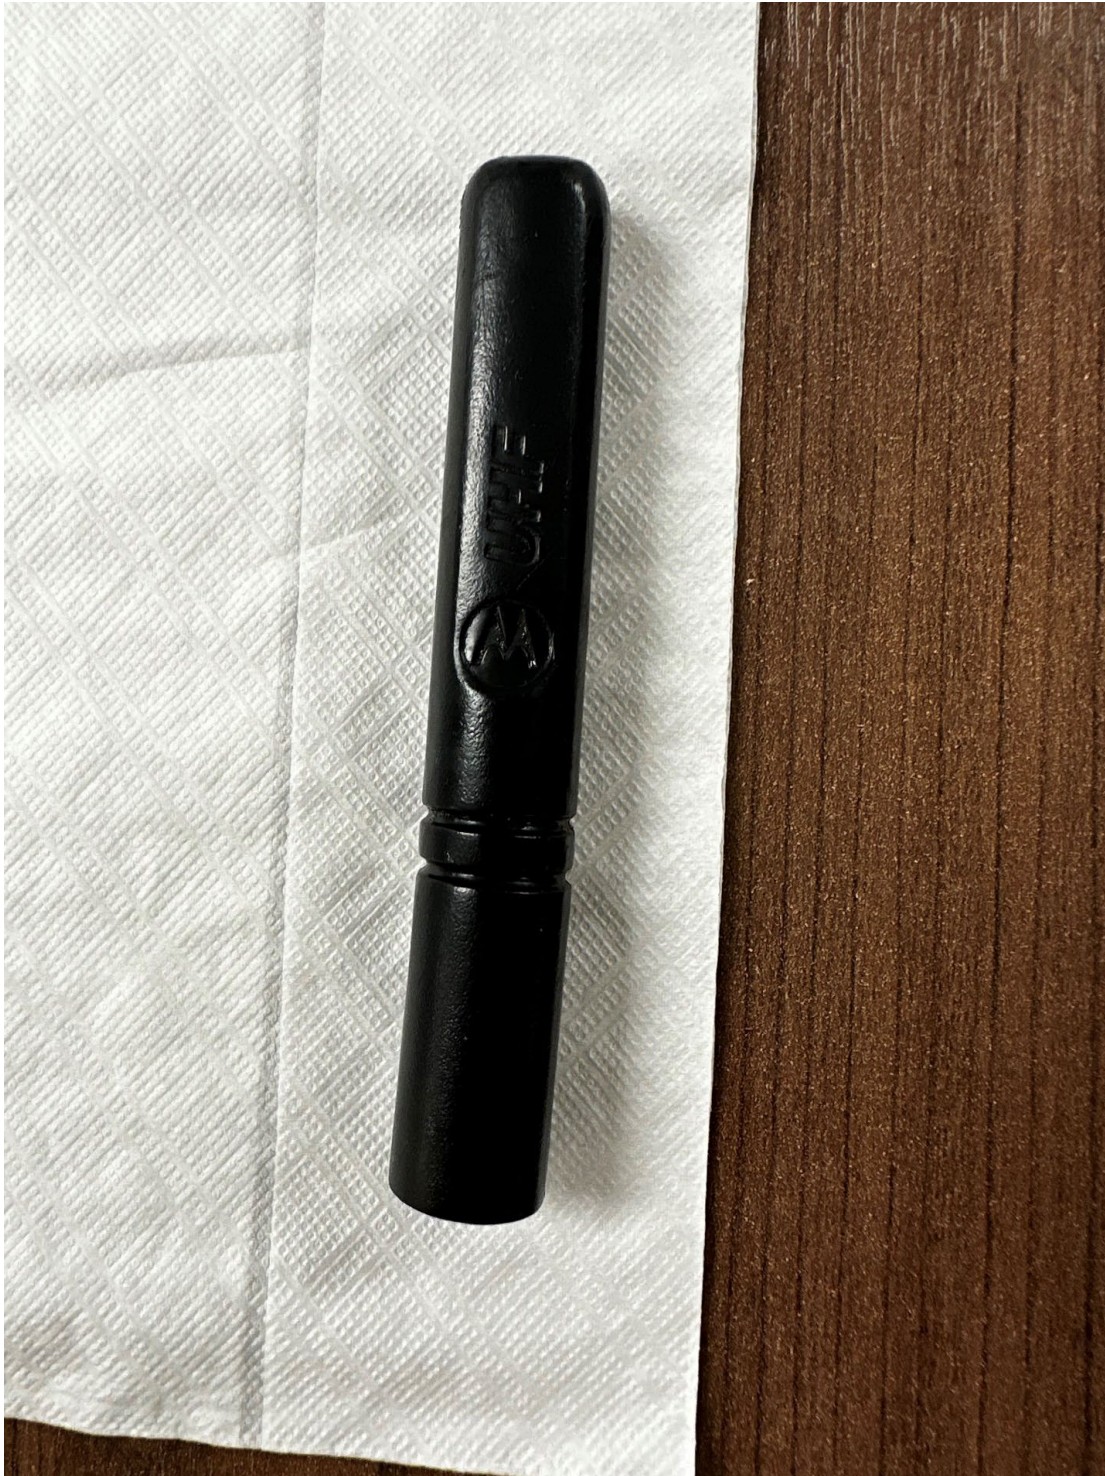
Antenna plastic cover

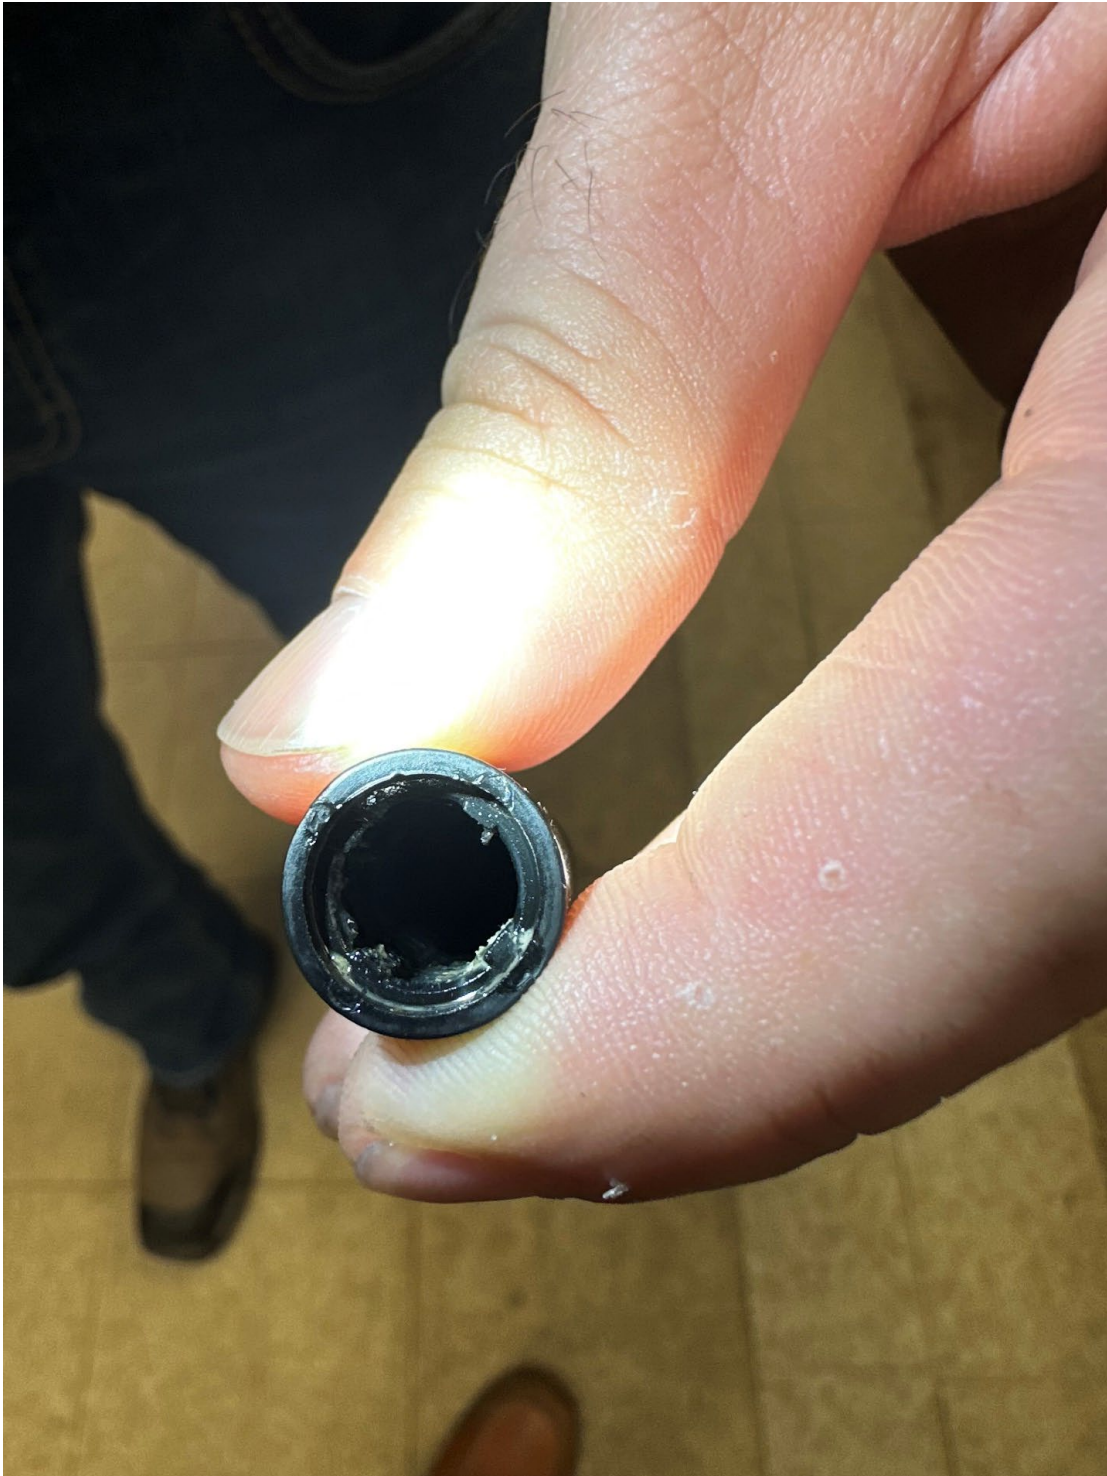
Antenna well of plastic cover

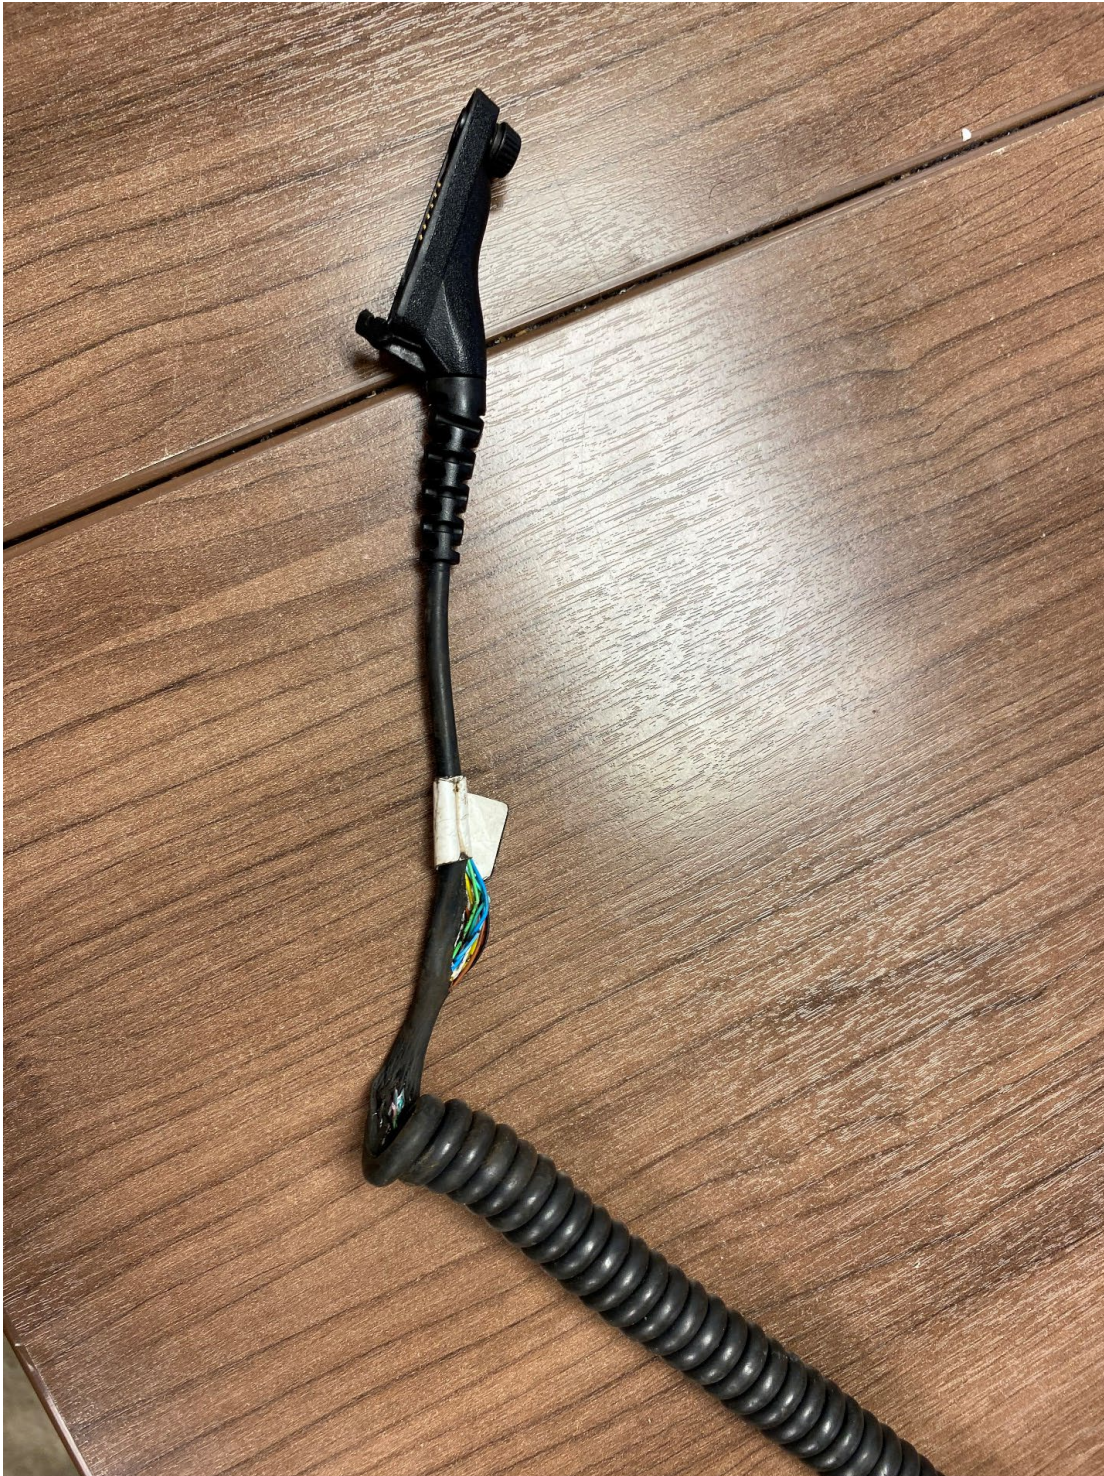
Item	Initials/Milepost	Equipment/Track #	Type/Kind	49 CFR/USC	Defect	Subrule	Speed	Class	Train #/Site	SNFR*	RCL**	# of Occ.***	Activity Code
2										N	N	0	
Description - [** Comment to Railroad/Company **] Two way radio microphone cable was severed at some point during incident and did not work during test. Internal radio antenna base was still threaded in the handheld radio with the copper coil intact but bent to the side. Antenna plastic cover was recovered in grate under rail car at Exxon Mobil Lubes plant (spot 1) location of deceased employee.													
Seal Applied			Seal Removed			Hazard Class			UN/NA ID				
Violation Recommended				<input type="checkbox"/> Yes <input checked="" type="checkbox"/> No		Latitude:				Longitude:			
Written Notification to FRA of Remedial Action is:				<input type="checkbox"/> Required <input checked="" type="checkbox"/> Optional		Railroad Action Code		Date(mm/dd/yyyy):		Comments on back?

Cables of microphone cord exposed not allowing for communication transmissions

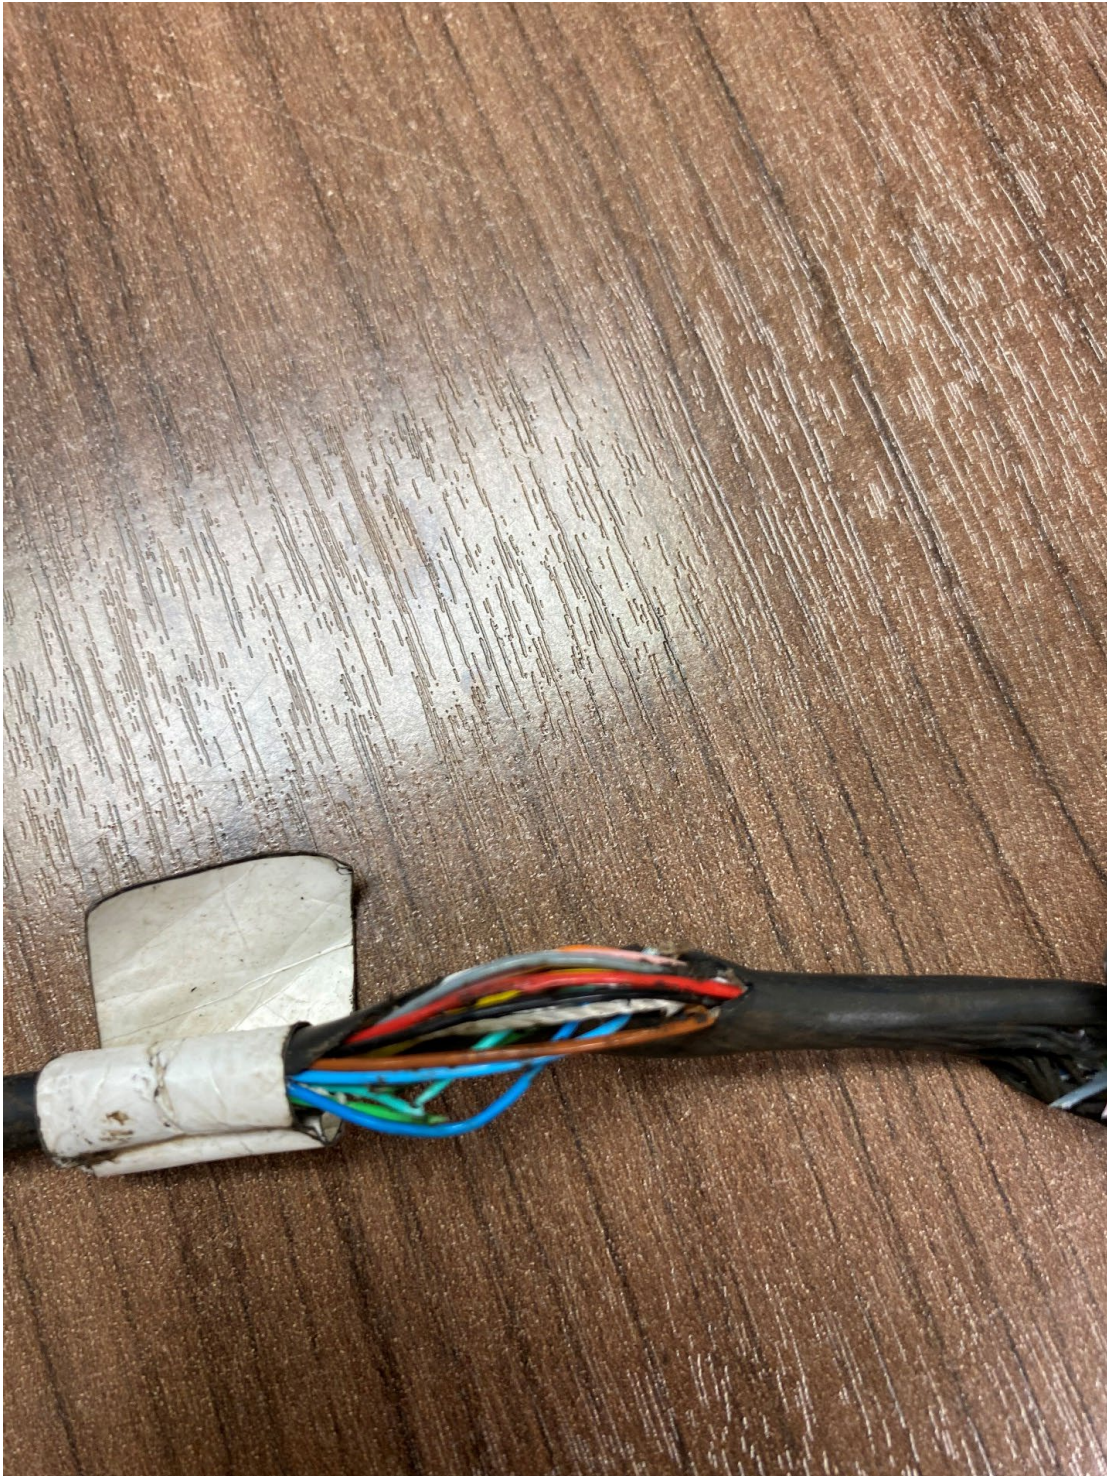
Severed cables of microphone cord

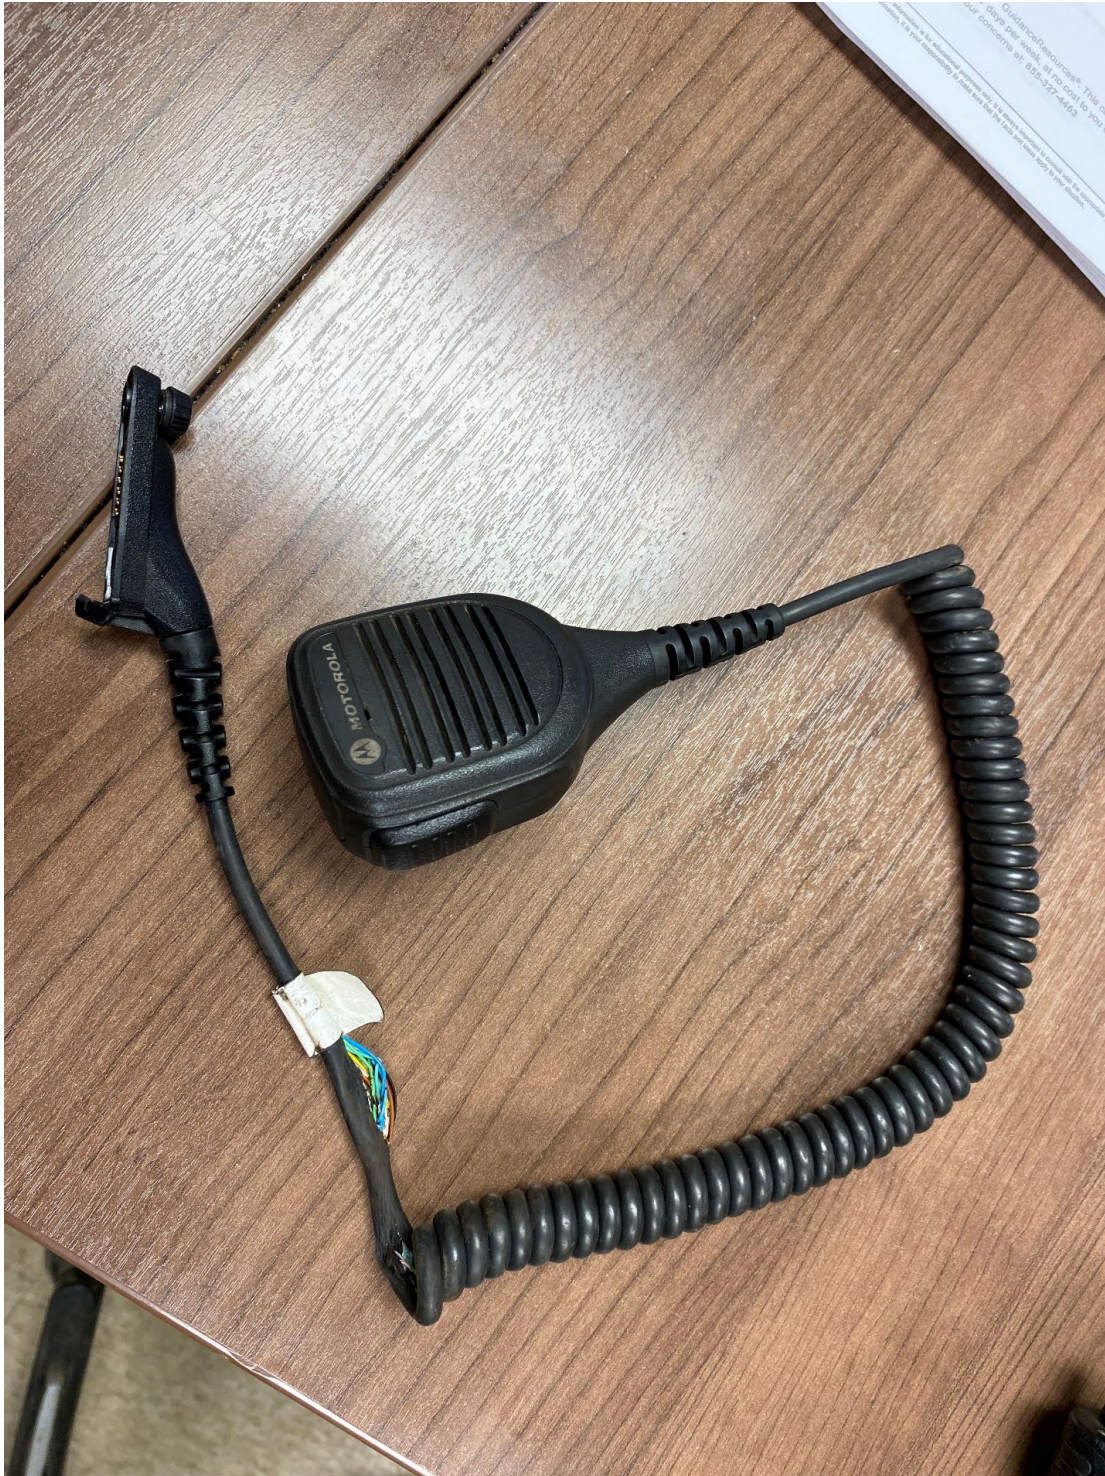
Microphone cord

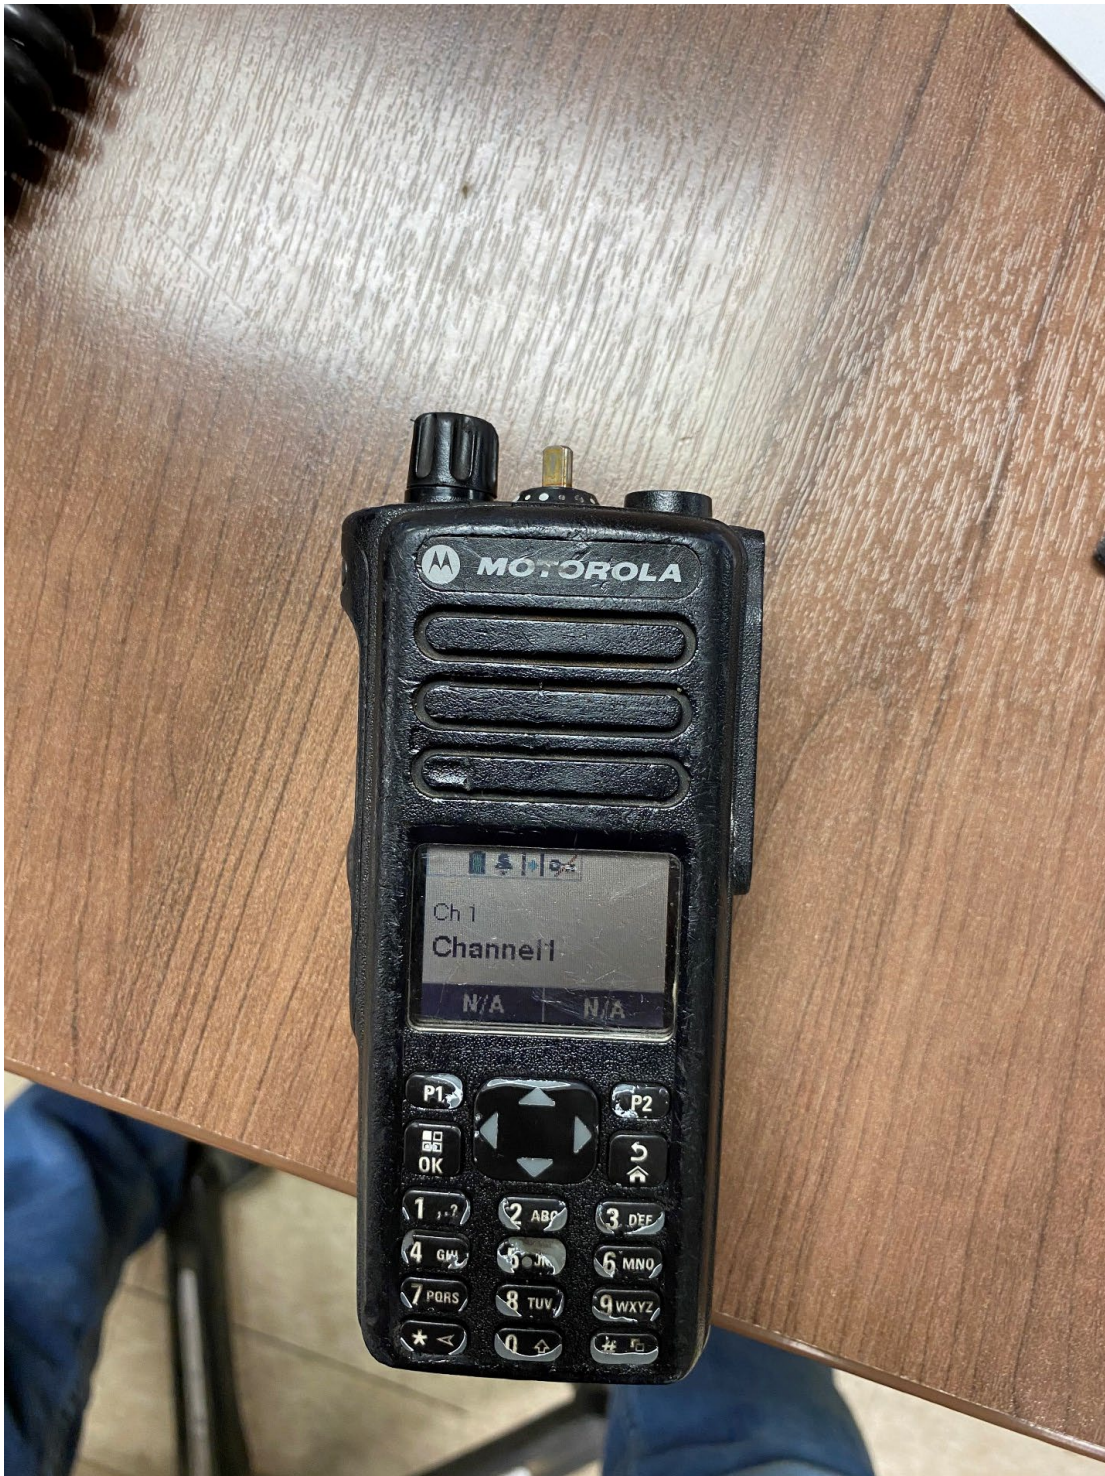
Radio screen display powered ON

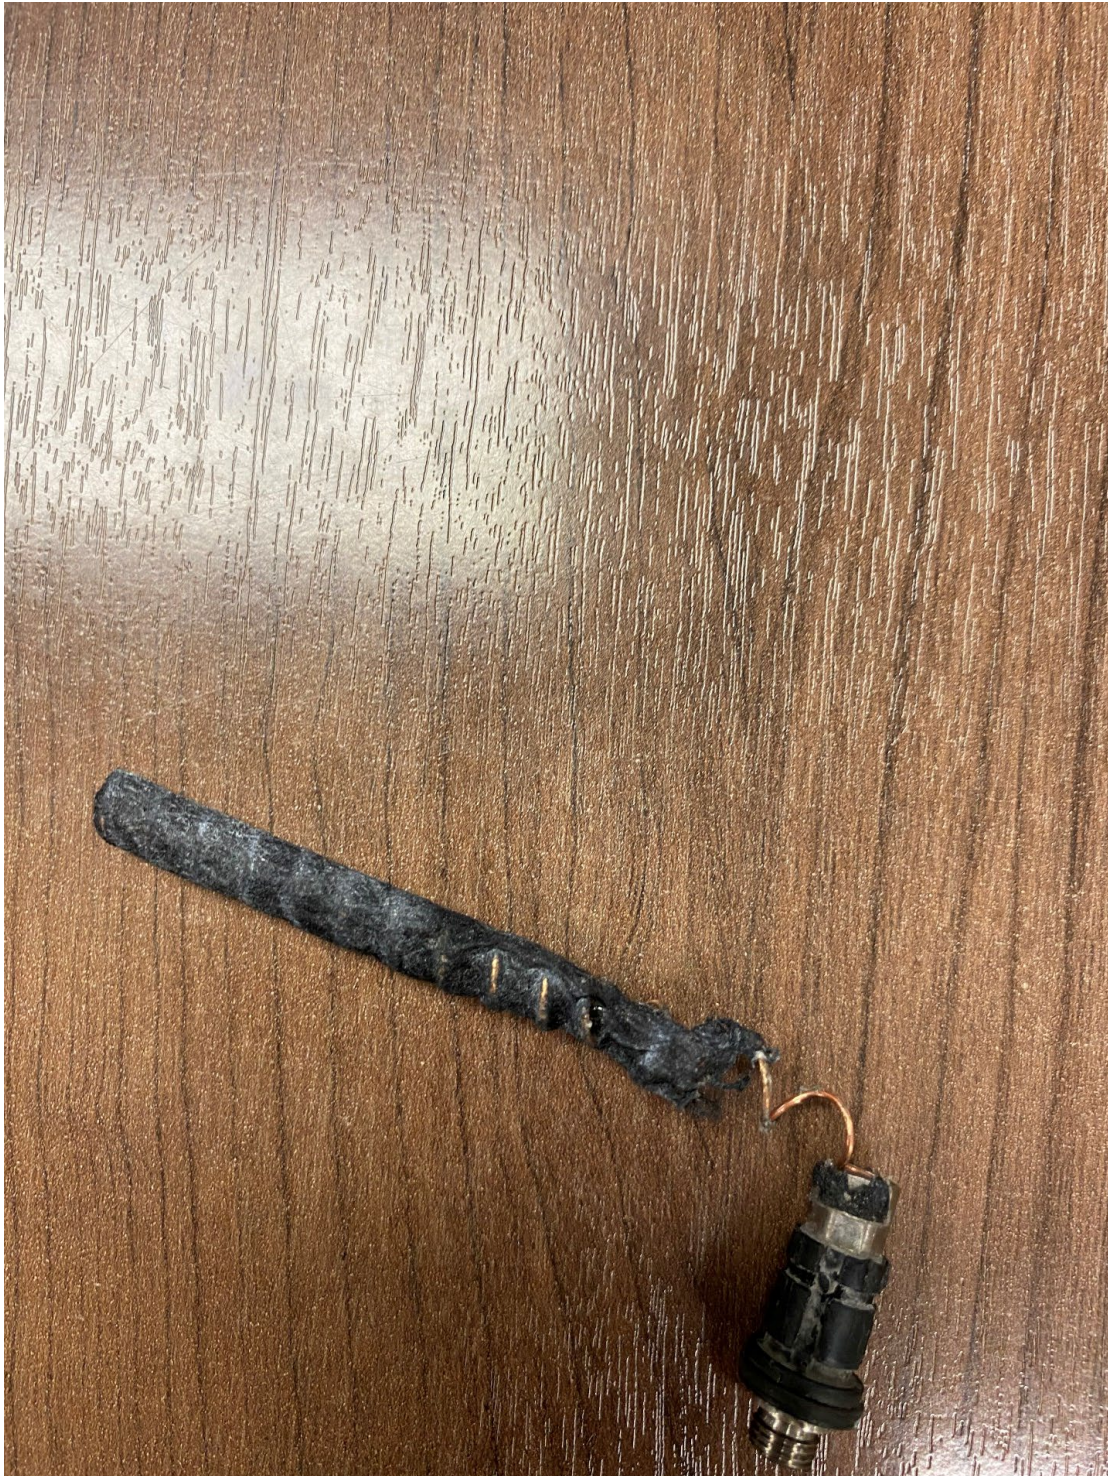
Antenna base with copper coil and wrap removed from handheld radio

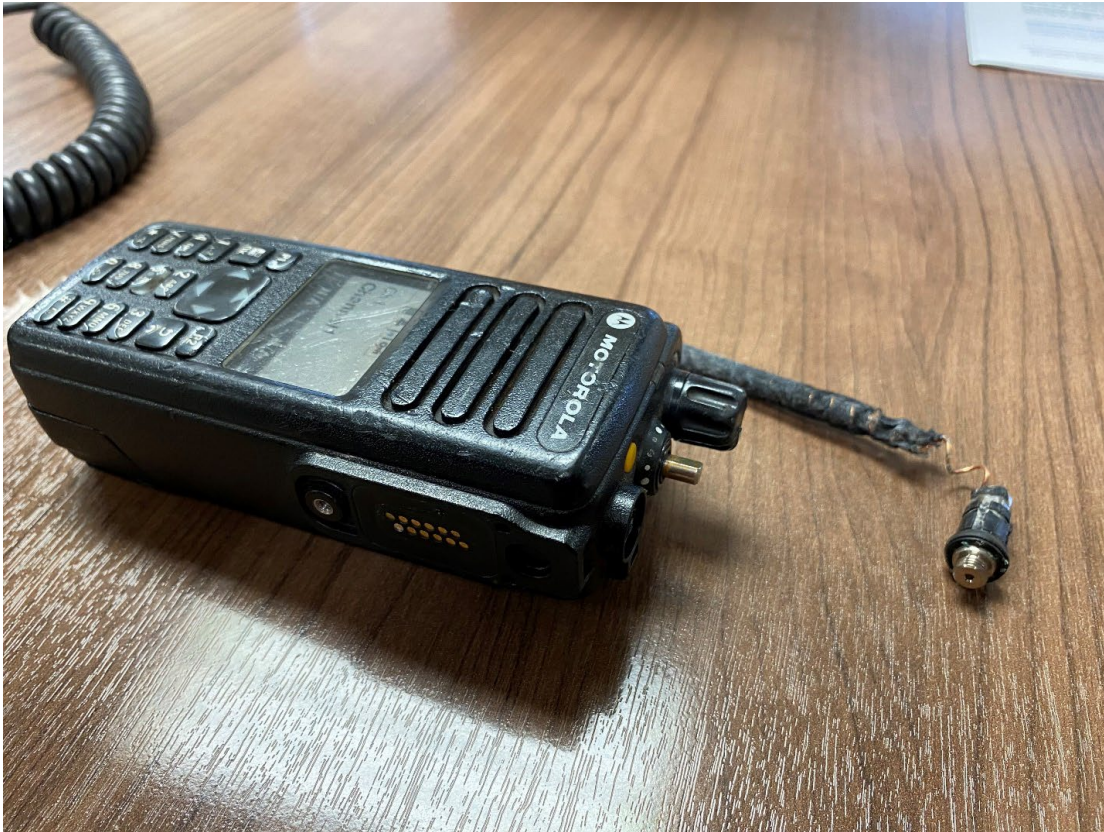
Radio view after unscrewing antenna base with copper coil attached

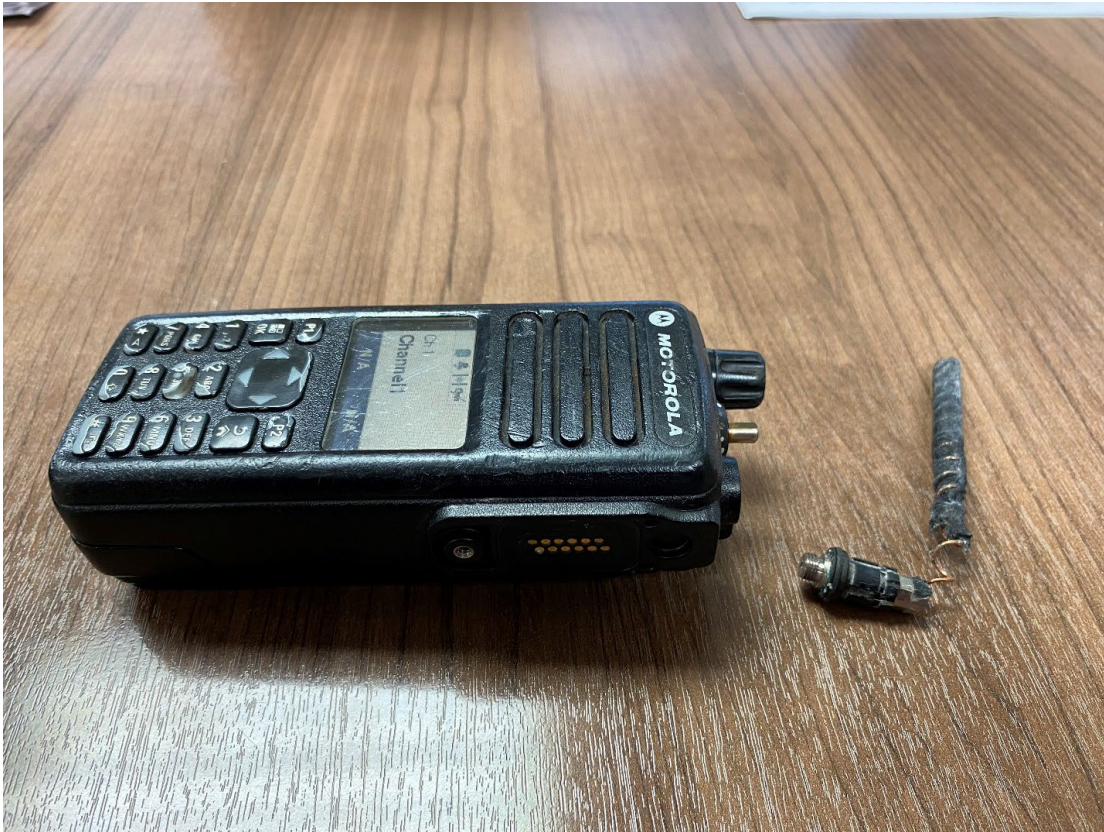
Radio and bent antenna
