Update Service Order at 3527 DURANGO DR , DALLAS , TX

2/22/18 Leak Survey Map

AEC-NTSB-000280

LEAK REPORT

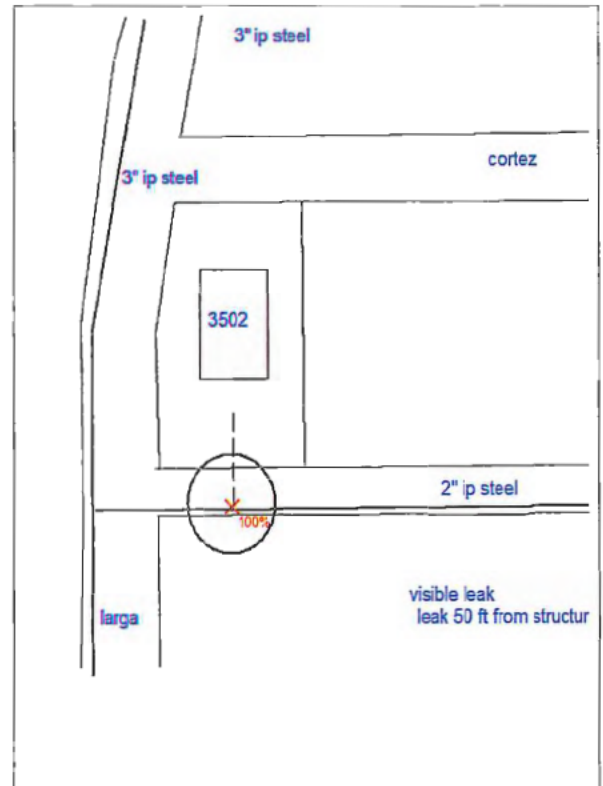
Leak Number: 578706

Conditions will not permit bar test

Surface Over Leak: Concrete

Leak Repaired On: Service	External Corrosion: None
Type: Compression Coupling	External Pits: None
Material: Coated Steel	External Coating: Good
Pipe squeezed: EFC:	Min Pit Depth:
Pipe Size: 1.00	Min Length of Pit:
Pressure: I.P. 1-60 PSIG	Internal Corrosion: No Inspect
Cause of Leak: Thread Leak	Technician: Macias, Jesus-MAS
Station Plus:

Compression Coupling information :	Manufacturer: Unknown
Model / Style: No	Type: screw
Soil Type: clay	Pullout: No Separated: No

Service Repair: Replaced Service Line
 O2 Level: Greater than or equal to 19.5%
 Permanent Repair Tech : Macias, Jesus-MAS

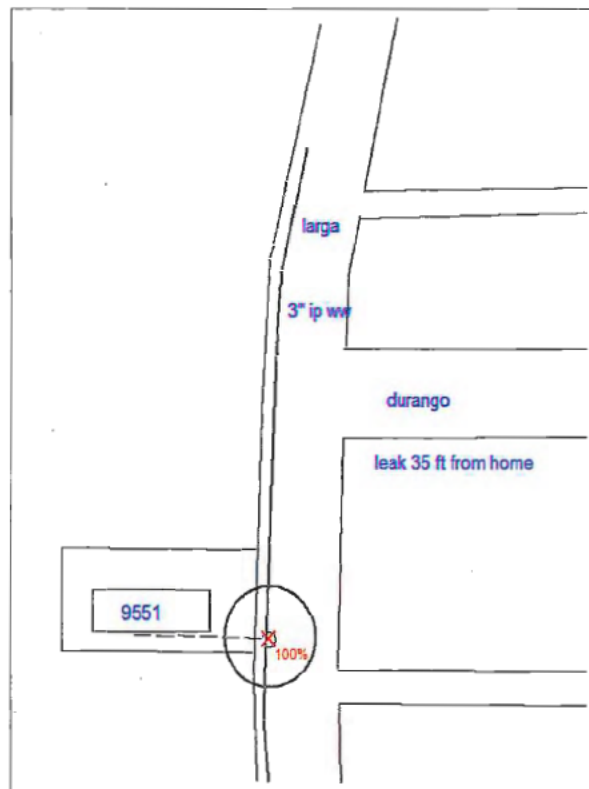
Leak Number: 578711

Conditions will not permit bar test

Surface Over Leak: Soil

Leak Repaired On: Service
 Type: Compression Coupling
 Material: Coated Steel
 Pipe squeezed: EFC:
 Pipe Size: 1.00
 Pressure: I.P. 1-60 PSIG
 Cause of Leak: Thread Leak
 Station Plus:

External Corrosion: None
 External Pits: None
 External Coating: Good
 Min Pit Depth:
 Min Length of Pit:
 Internal Corrosion: No Inspect
 Technician: Huerta, Angel-MAS

Service Repair: Replaced Service Line
 O2 Level: Greater than or equal to 19.5%
 Permanent Repair Tech : Huerta, Angel-MAS

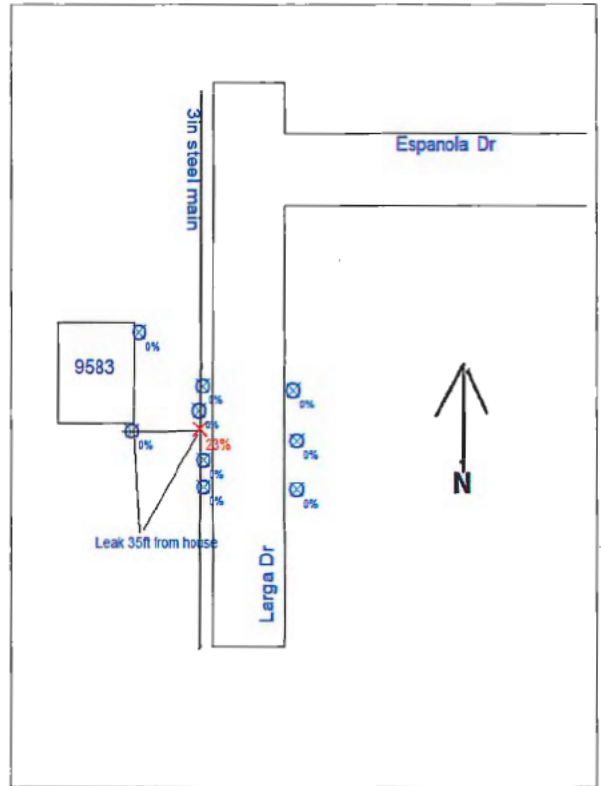
Leak Number : 578709

Surface Over Leak: Soil

Leak Repaired On: Service
Type: Compression Coupling
Material: Coated Steel
Pipe squeezed: EFC:
Pipe Size: 1.00
Pressure: I.P. 1-60 PSIG
Cause of Leak: Thread Leak
Station Plus:

Service Repair: Retired Service at Main
O2 Level: Greater than or equal to 19.5%
Permanent Repair Tech : Lewis, Roderick

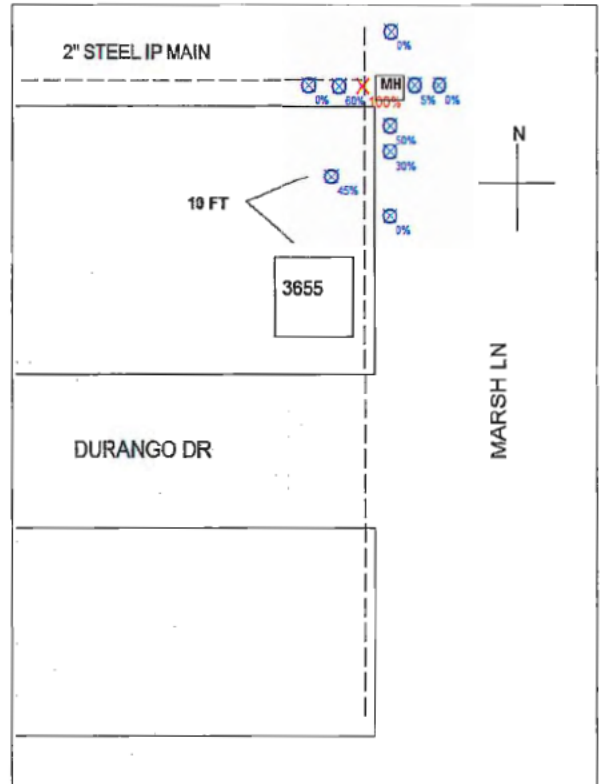
Leak Number: 578718
 Town: Dallas
 Address: 3655 DURANGO DR
 Date Found: 2/22/2018
 Technician: Cruz, Juan
 Probable Source: Main
 Gas Detected: Soil
 CGI Test: 100
 Meter #: 08K790521

LIO #: _____
 Grade: 1
 Time Graded: 8:30 pm
 Assistance Requested: 8:35 pm
 Assistance Arrived: 8:50 pm
 Condition Eliminated: 2:46 AM

Surface Over Leak: Concrete
 Surface Over Main: Concrete
 Probable Pipe Type: Coated Steel

Leak Repaired On: Main
 Type: Joint
 Material: Coated Steel
 Pipe squeezed: EFC:
 Pipe Size: 2.00
 Pressure: I.P. 1-60 PSIG
 Cause of Leak: Ground Movement
 Station Plus:

External Corrosion: None
 External Pits: None
 External Coating: Fair
 Min Pit Depth:
 Min Length of Pit:
 Internal Corrosion: No Inspect
 Technician: Lopez, Roberto-CAN

Main Repair: Welded Split Sleeve
 O2 Level: Greater than or equal to 19.5%
 Permanent Repair Tech : Cobb, Glenn-CAN

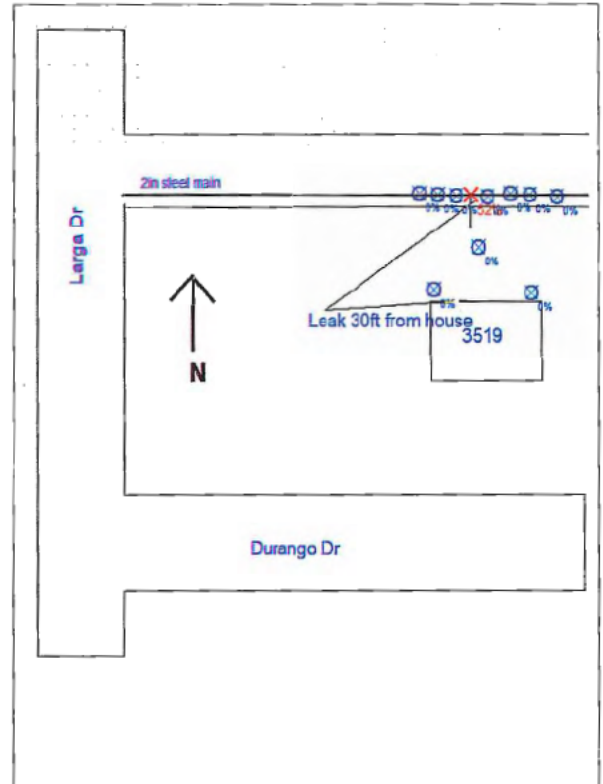
Leak Number: 578697

Town: Dallas
Address: 3519 Durango Dr
Date Found: 2/22/2018
Technician: Wallis, Josh
Probable Source: Service
Gas Detected: Soil
CGI Test: 52
Meter #:

Surface Over Leak: Soil
Surface Over Main: Soil
Probable Pipe Type: Coated Steel
Temporary Repair Type:

Leak Repaired On: Service
Type: Pipe
Material: Coated Steel
Pipe squeezed: EFC
Pipe Size: 1.00
Pressure: I.P. 1-60 PSIG
Cause of Leak: Thread Leak
Station Plus:

Service Repair: Replaced Service Line
O2 Level: Greater than or equal to 19.5%
Permanent Repair Tech : Rodriguez, Ricky
