NATIONAL TRANSPORTATION SAFETY BOARD

Airframe and Engine Exam

WPR20LA130

Location: Mesa, AZ.
Date: April 24, 2020
Aircraft: N3276T, Bell, UH-1H
NTSB Investigator-in-Charge: Samantha Link

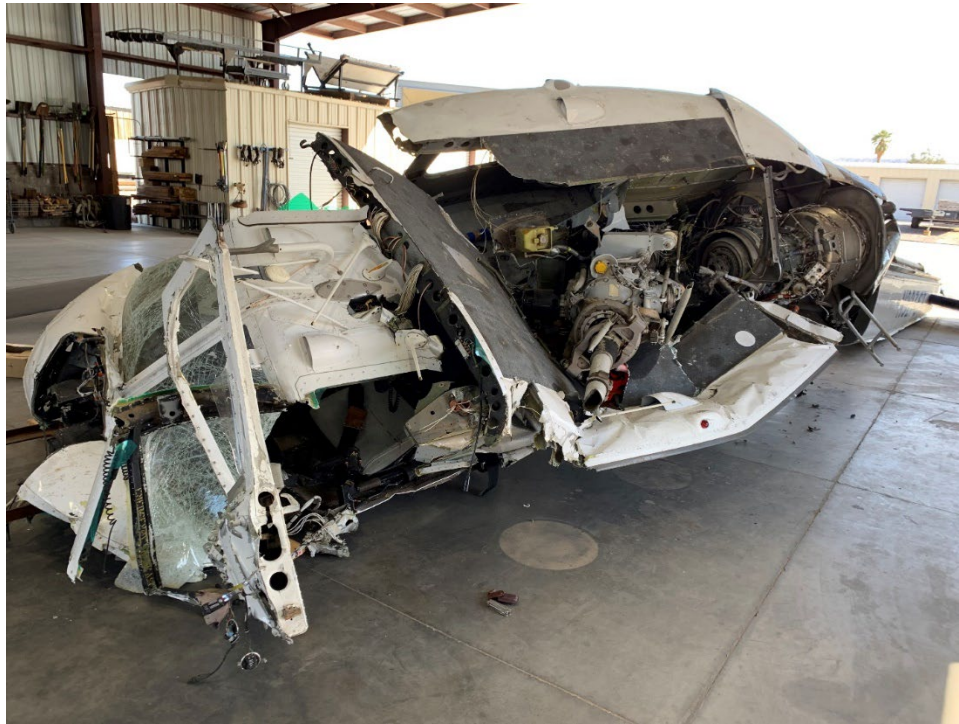
- Extensive crush damage was observed on the lower left side of the helicopter, with the most severe damage concentrated at the left-pilot's station.
- The helicopter was at rest in about a 45° left angle.

Photo 1. N276T front left view.

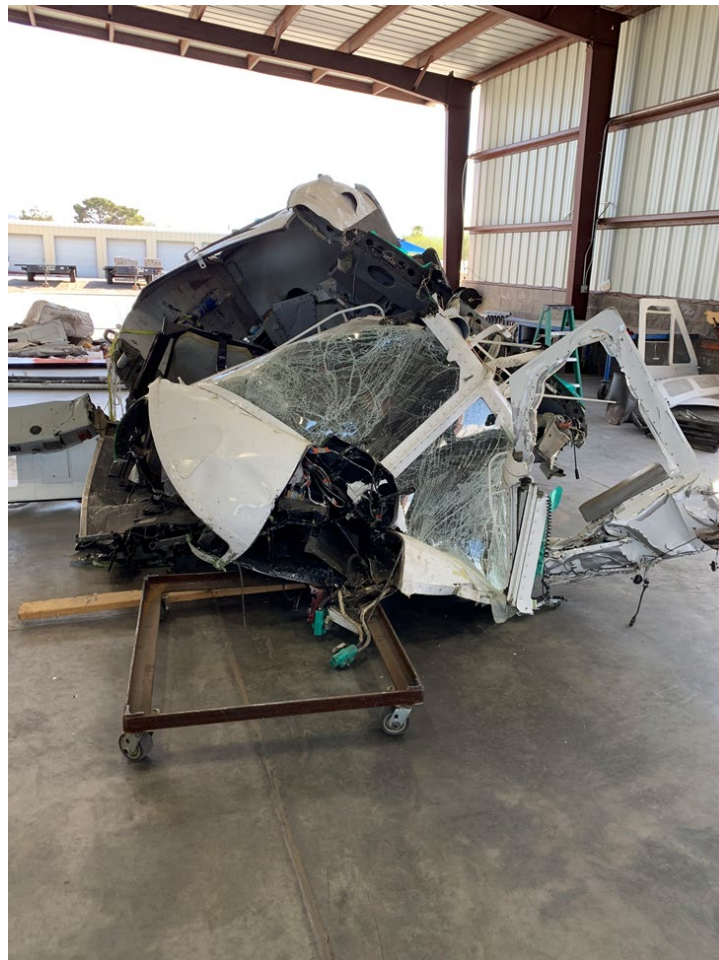
Photo 2. Front view.

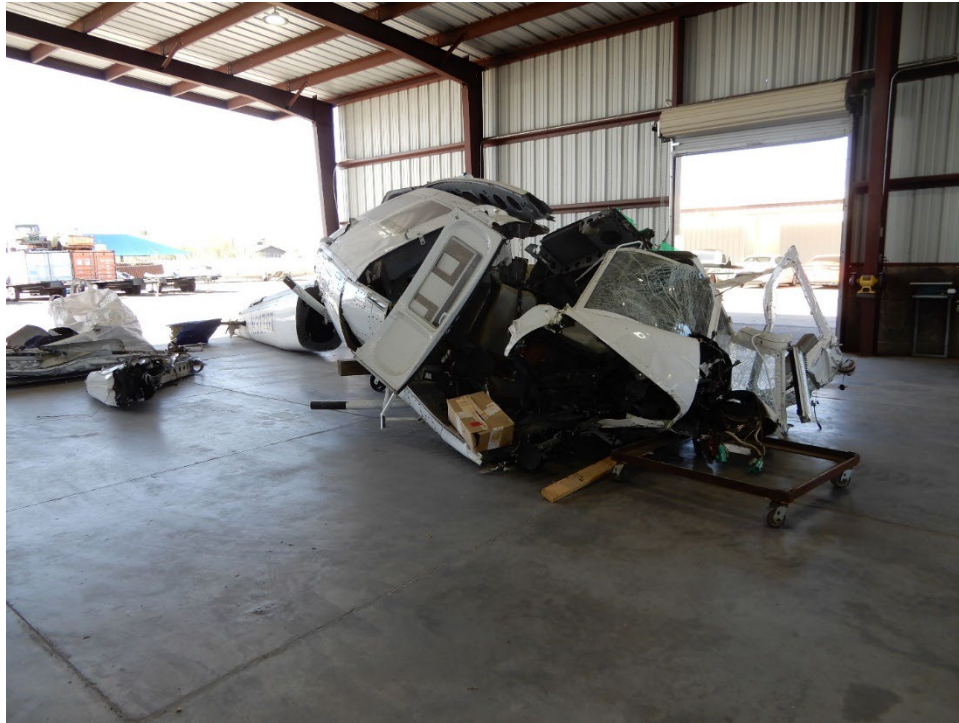
Photo 3. N3276T Front right view.

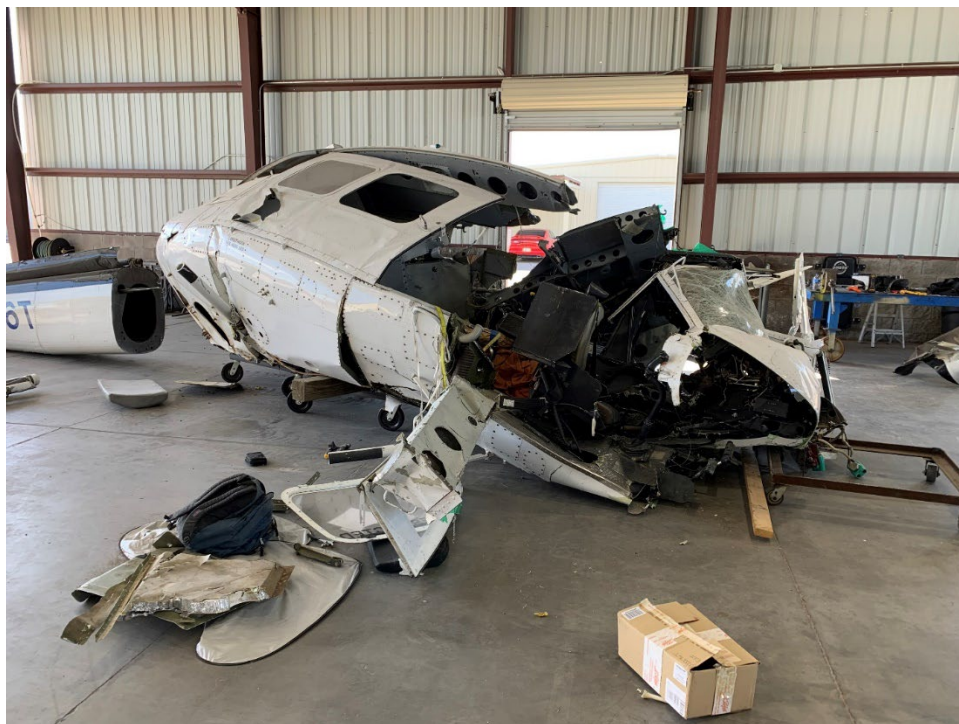
Figure 4. N3276T Right-side view.

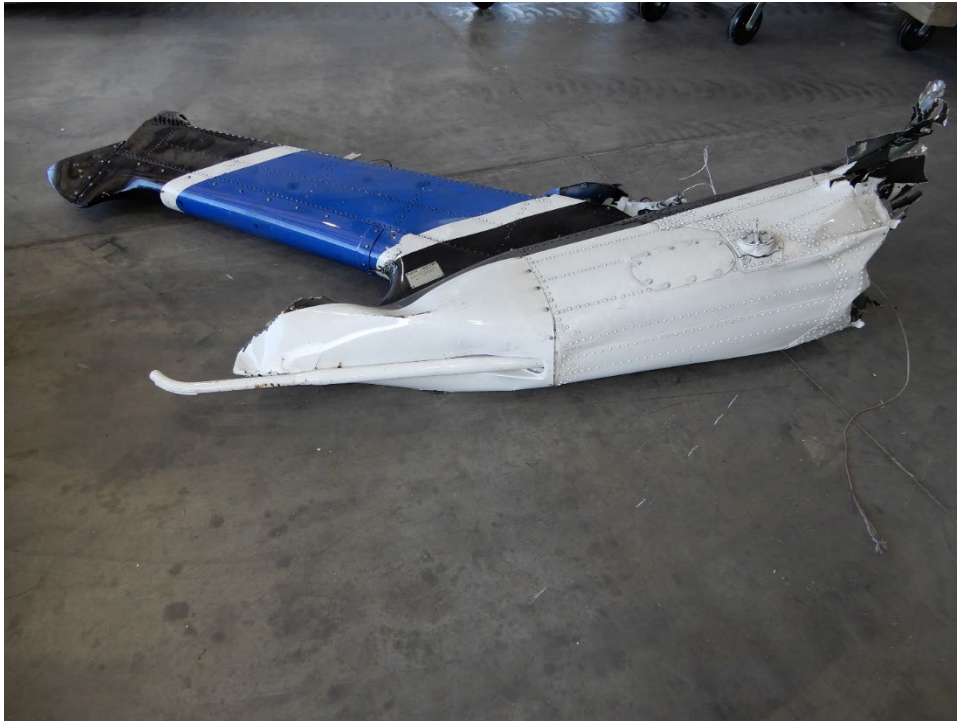
- The 90° gearbox and tail rotor assembly were not present for this examination. (The Federal Aviation Administration removed them during an initial examination and shipped them to the NTSB materials laboratory.) The top of the vertical stabilizer was present and retained one of the 90° gearbox mounting bolts. The other mounting bolts had also been previously sent to the NTSB Materials Laboratory.

Photo 6. Vertical stabilizer without the 90° gearbox or tail rotor assembly.

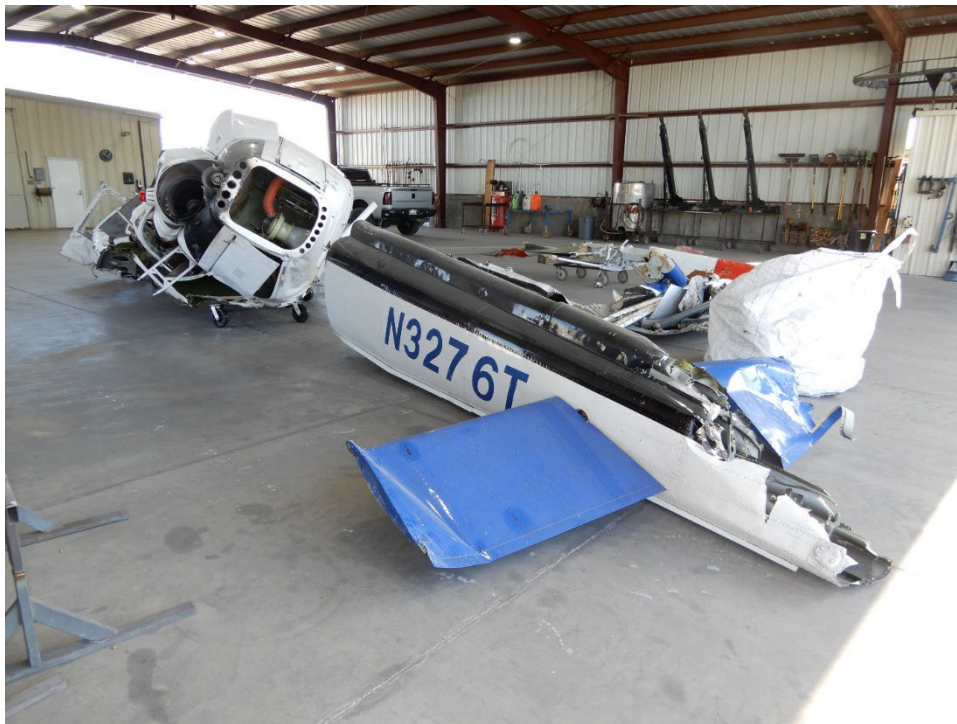
- The tailboom displayed minor damage from the mounting surface back to the area just in front of the synchronized elevators.
- The tailboom displayed a major fracture and separation just aft of the synchronized elevators.

- The tail boom stinger was remained attached to the tailboom and was bent upwards to the tail cone.
- Sheet metal at the tailboom area just aft of the synchronized elevators was bent inwards on the left side of the tailboom and outward at the right side of the tail boom, consistent with main rotor blade contact in a clockwise direction.

Photo 5. Tailboom left-side view.

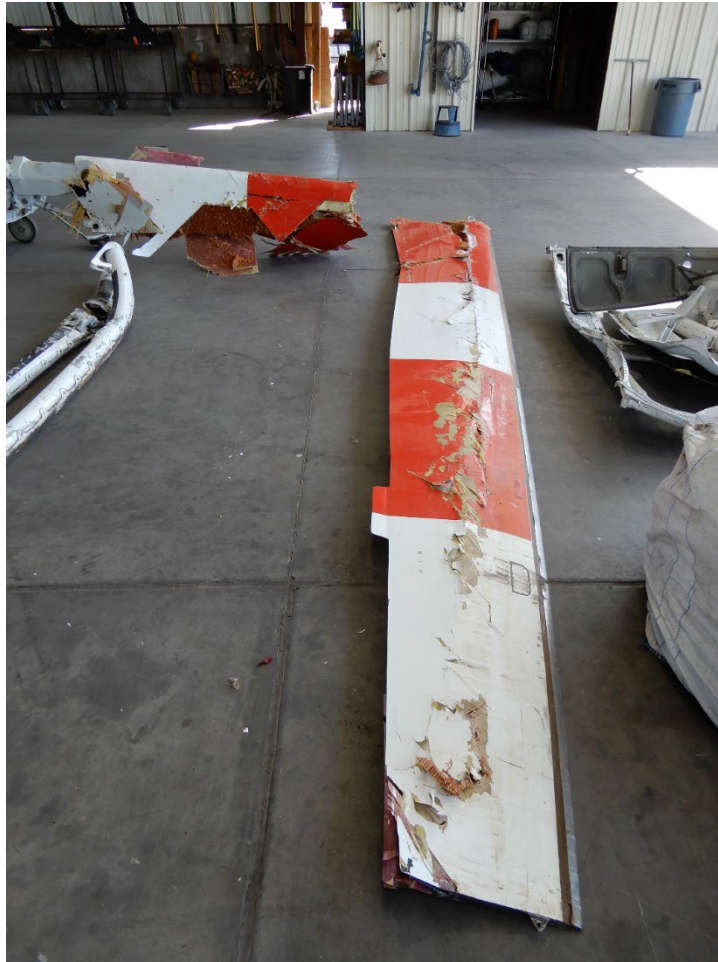
The white blade separated from the main rotor system about 5 ft from the blade grip. The composite blade was heavily fractured spanwise from the root to the fracture and separation point. The remaining blade portion displayed major span-wise fractures running from the fracture at the root end to the tip. The tip remained attached to the blade. The entire leading edge was coated with dirt, consistent with a distinguishable ground gouge at the accident site.

Photo 7. The white main rotor blade, top view.

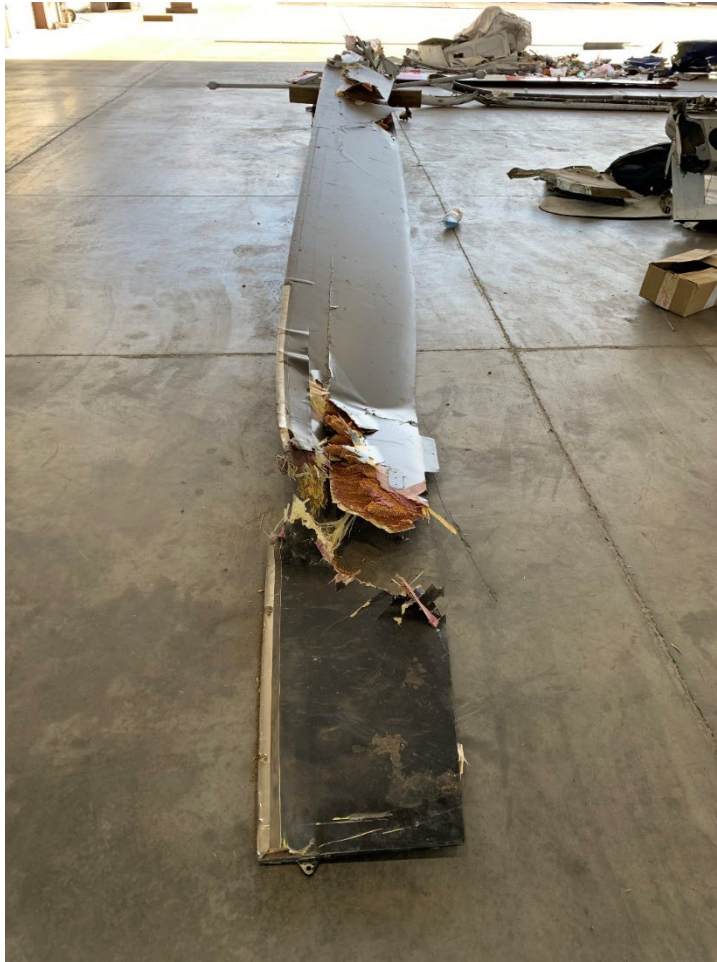
The Red blade displayed a fracture and separation at about 26 inches from the tip. There were multiple deep gouges at the stainless-steel leading edge, and multiple scrapes running along the span of the blade. A large span-wise fracture ran from the root of the blade in between the blade grip and the drag brace and outboard for about 4 ft. The blade remained attached to the hub at the blade grip and drag brace.

Photo 8. The red main rotor blade, underside view.
