National Transportation Safety Board

Group Chairman's Factual Report

Engineering Group

Conception

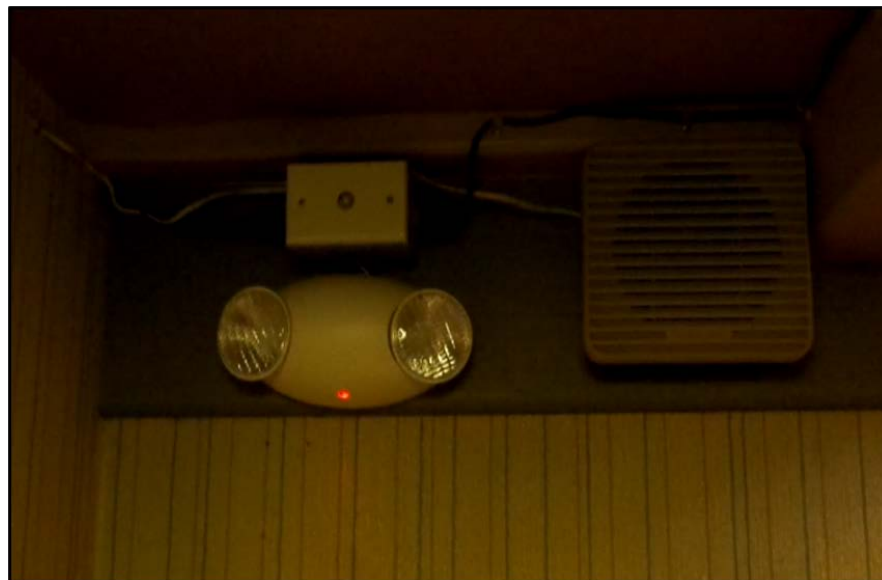
12 The *Conception* had emergency lighting in the bunk room. It was located at the base of
13 the main stairs going up to the galley/salon, and was designed to automatically activate in the event
14 of the loss of the vessel's service supply power and provide minimal lighting for crew and
15 passengers to maneuver through the space. The emergency lighting was powered from the ship's
16 service 120-volt A/C system, and if this source was lost, batteries internal to the unit would supply
17 power for lighting.

18
19 **Figure 3. Bunkroom emergency lighting on board the similar vessel *Vision*. The lighting was of the**
20 **same make and in a similar location as was on board the *Conception*. Also note the public address**
21 **system speaker to the right of the lights.**

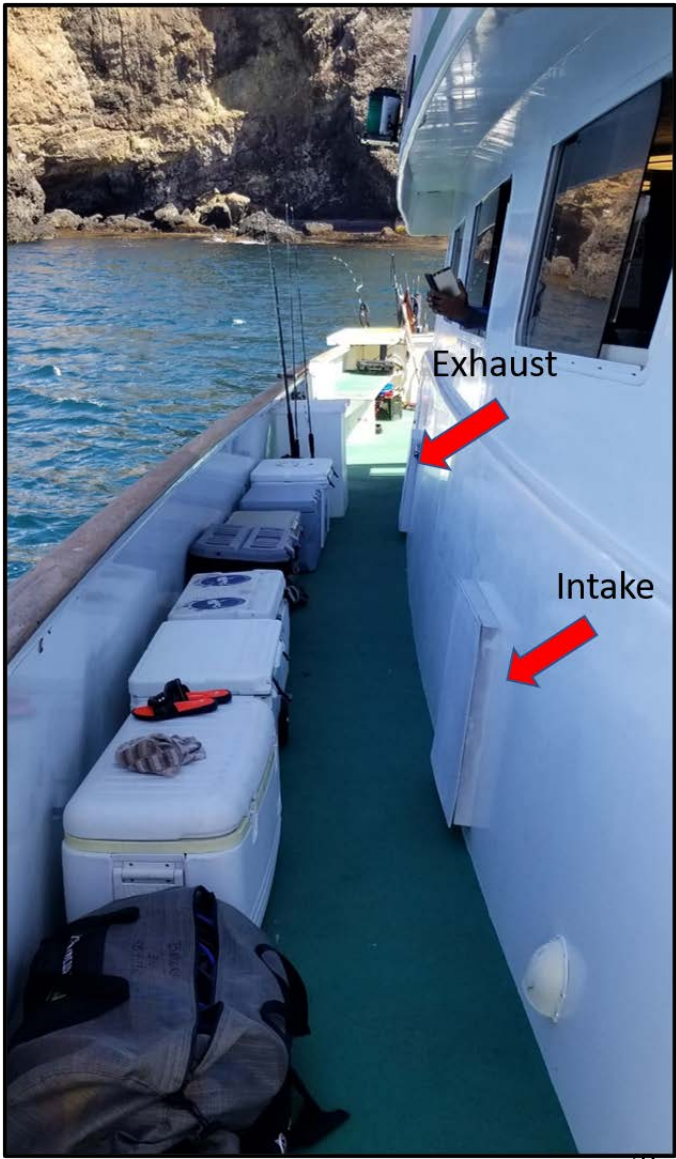
Figure 5. The starboard-side main deck of *Conception*, looking aft from forward of the galley. The red arrows indicate the location of the bunkroom ventilation intake and exhaust ducts. Also note the sliding windows. (Source: R. White).

The bunkroom regularly utilized a combination of circulation fans, as well as an air conditioning unit. The supply fan, located at the forward end of the space, drew air through ducting that originated 12 inches above the main deck. The ducting attached to air plenum boxes that were about 6–10 inches off the main deck. These boxes were located on both the port and starboard sides, just below the forwardmost side galley windows. Two exhaust fans, one located on each side of the aft area of the bunkroom, expelled air from the space to the main deck. The ducting for these fans, led to identical plenum boxes, which were located aft of the intake plenum boxes.

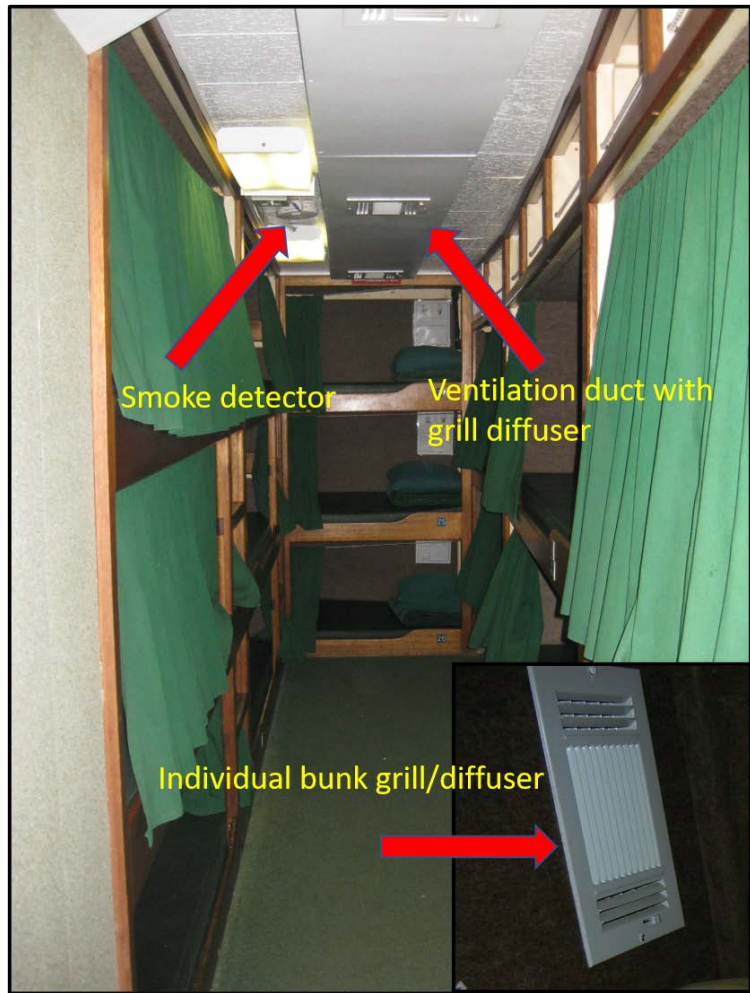
The primary means of cooling and ventilation for the bunkroom was an air conditioning unit. The unit was located under the bunkroom deck boards just port of midship and underneath bunks 30U, 31M, and 32L (see the survival factors report for a layout of the bunkroom) in the vessel’s bilge area. The direct expansion package unit

Figure 6. Port side of the *Conception's* bunk room looking aft, with inset of grill/diffuser (Source: Ryan, Inset: Landis).

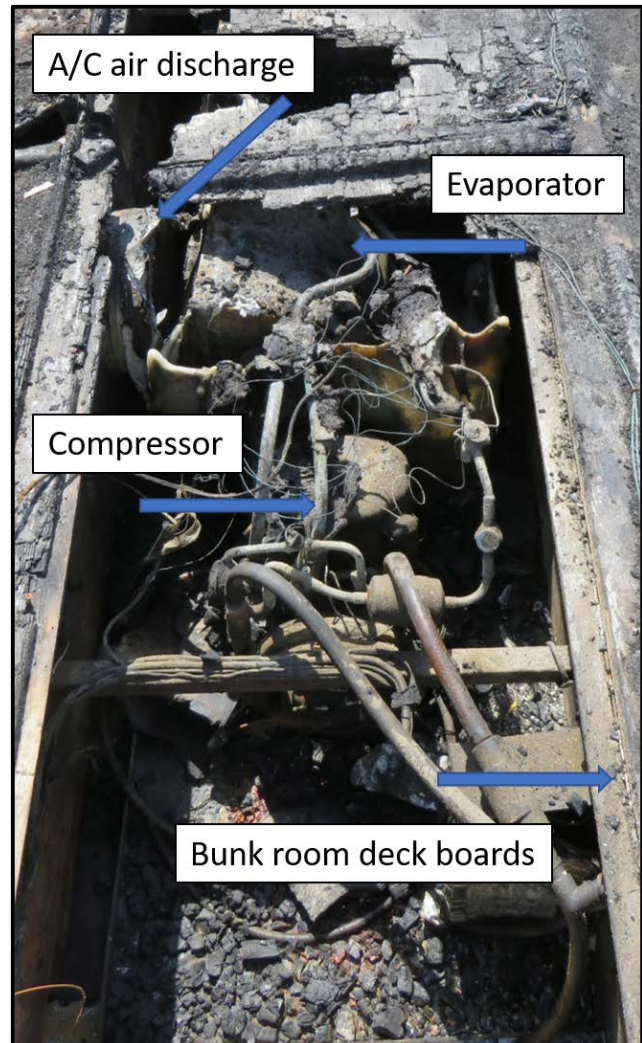
1 by investigators. There were no signs of
2 mechanical failure to the components of the
3 unit. The air conditioning system was not
4 connected to the vessel's emergency power.
5 None of the surviving crewmembers turned off
6 the air conditioning system at the time the fire
7 was discovered. The unit would have operated
8 until the *Conception's* main power was lost
9 (although there was no means to confirm that
10 this occurred).

Figure 7. Post-accident photo of bunk room air conditioning unit located in vessel's bilge area.
