National Transportation Safety Board

RRD23FR015

TRACK

Group Chair's Factual Report

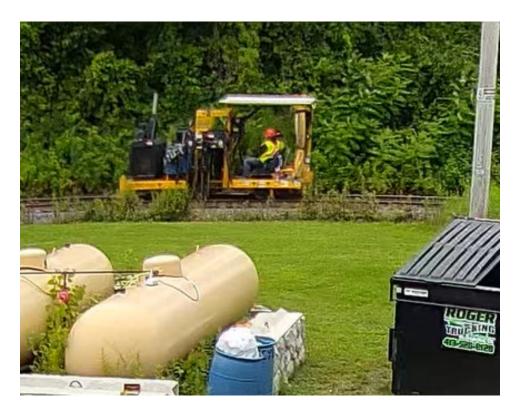
Figure 1: Cropped still frame from surveillance video.

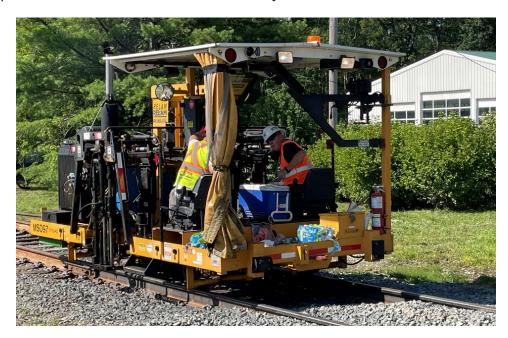
Investigators noted the machine was not equipped active safety systems such as back up cameras/sensors or a collision avoidance system that would warn, alert, or assist the operator to avoid or reduce the severity of imminent collisions.

Figure 2: The tie drilling machine MS097.

Investigators performed an evaluation of the mechanical condition of the striking machine; machine number MS097. The evaluation included determining the machines compliance with federal regulations related to roadway maintenance machines outlined in CFR Part 214 Subpart D and the general mechanical condition of the brakes and other systems. With regards to compliance with FRA roadway maintenance machine regulations, investigators noted the 360-degree intermittent warning light was not visible to an observer standing in front of the machine.

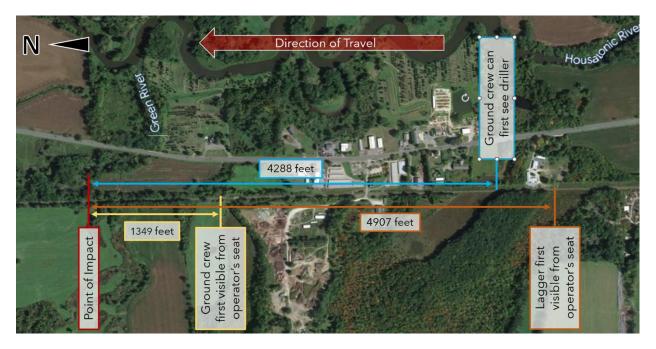
- It was possible for the investigator in the operator's seat of the driller to first see the stationary lagger parked north of the point of impact when the machine was about 4,907 feet away from the point of impact.
- It was possible for the investigator in the operator's seat of the driller to first see the team members on the ground at the point of impact when it was about 1,349 feet away from the workers.

Figure 3 is a representation of the results of the sight distance evaluation displayed over aerial imagery of the accident site. Aerial imagery provided by Google Maps.

Figure 3: Sight distance observation results.

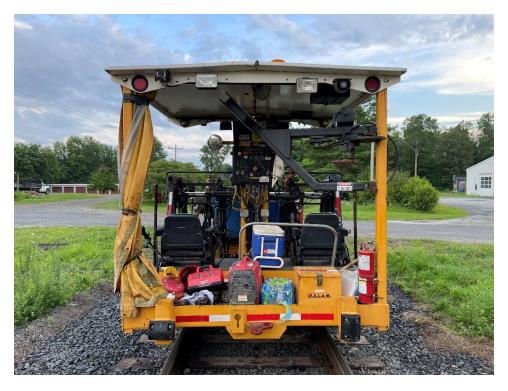
Figure 5: Photograph of Driller MS0097 from the rear. (Provided by FRA).

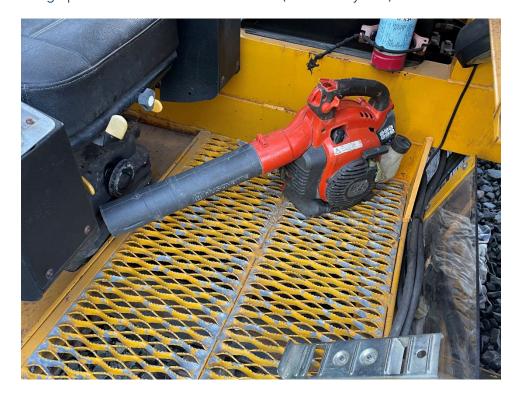
6.67	Red plastic piece found under rock on tie plate right (east) rail gage side. (Presumed from blower)		
17.58	Leaf blower air filter in gage.		
20.08	Red plastic piece found in gage that matches leaf blower.

Figure 6: Photograph of the leaf blower used by Employee 1 at the time of the accident. (Provided by FRA).

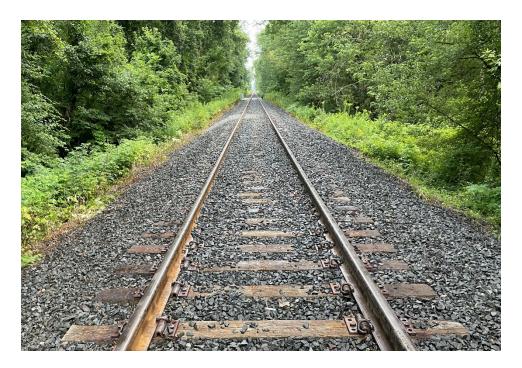
Figure 7: Photograph of the accident location, looking south from near the point of impact. (Provided by FRA).

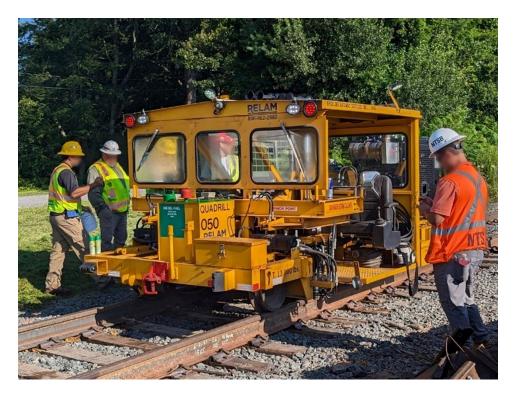
Figure 8: Photograph of the Lagger while being examined by investigators.

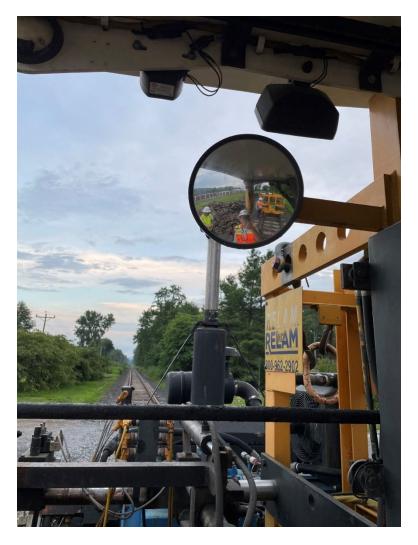
Figure 9: Photograph of typical view in mirror from the operator's seat of the Driller. (Provided by FRA).

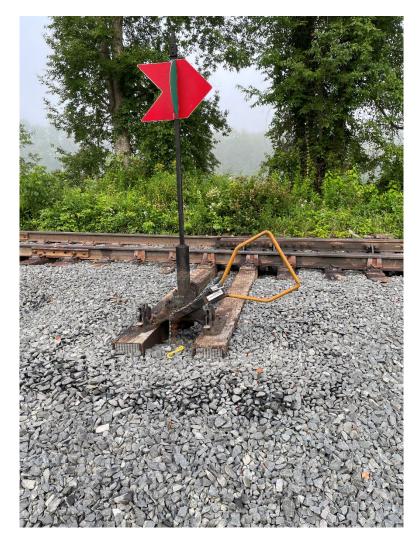
Figure 10: Photograph of the switch at Lanes taken August 6, 2024. (Provided by FRA).
