## NATIONAL TRANSPORTATION SAFETY BOARD

Investigator in Charge Factual Report

# Sinking of Fishing Vessel *Emmy Rose*

DCA21FM007

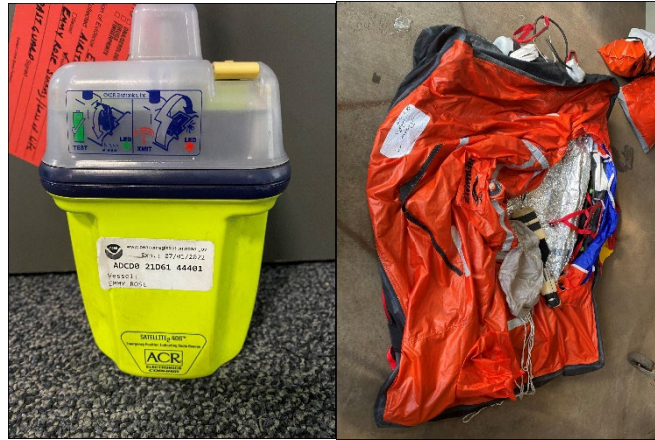
- 3
- 4 **Figure 6.** Recovered *Emmy Rose* EPIRB (*left*) and liferaft (*right*). (Source: Coast Guard)

4 Investigators inspected the EPIRB and liferaft, which were recovered by SAR  
5 crews, and determined that both pieces of equipment had functioned properly and  
6 had been deployed hydrostatically, meaning that no crewmember manually  
7 deployed either device.

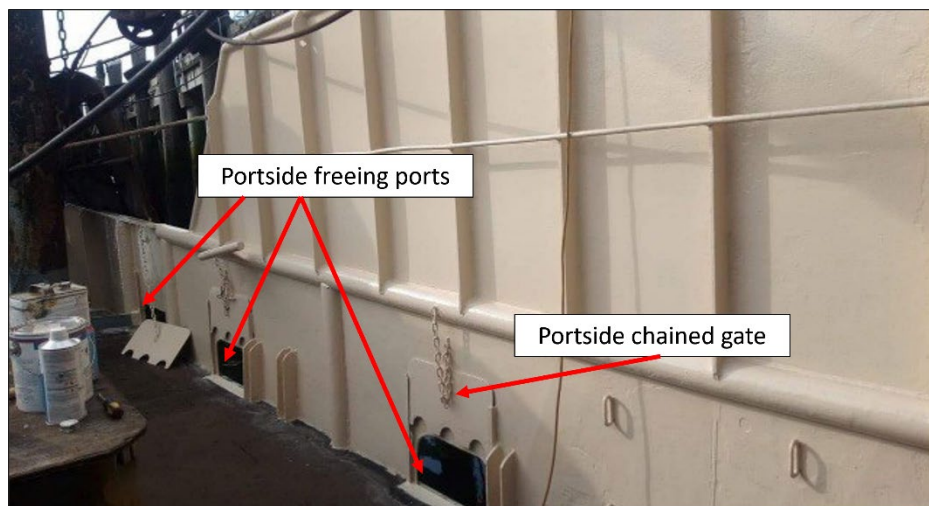
1           The aft portion of the working deck was surrounded by 36.5-inch-high steel  
2 bulwarks. On each side of the vessel, the bulwarks were fitted with five freeing ports,  
3 each measuring 10 inches by 20 inches. Each freeing port had a chained gate with  
4 three half-circle cutouts to allow water to drain in the closed position.<sup>5</sup> There were two  
5 freeing ports in the forward portion of the vessel, one on each side below the  
6 wheelhouse doors.

7  
8 **Figure 11.** Freeing ports on portside bulwarks. (Source: Boat Aaron & Melissa, Inc)

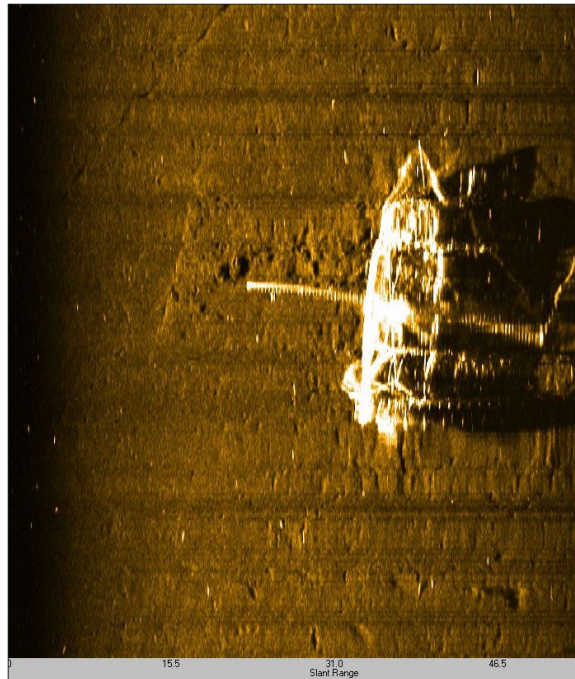
9 The side scan survey report stated that the *Emmy Rose* was found to be “sitting  
10 upright on the seafloor with the bow oriented at 135° (southeast direction) and both  
11 outriggers fully deployed.” The side scan images did not detect any debris field on the  
12 seafloor near to the sunken vessel. Additionally, the report stated that there was “no  
13 visible damage to *Emmy Rose* evident as the mast, wire rigging, and superstructure  
14 features all appeared to be intact. The ladders on both port and starboard outriggers  
15 were visible in the sonar imagery.” Sonar images indicated that both paravanes were  
16 deployed from the outriggers. Based on interpretation of imagery, MIND Technologies

1 engineers believed that about 203 feet of cable had been deployed from the port  
2 outrigger, and the paravane was this distance ahead of the vessel. The position of both  
3 paravanes leading forward of the vessel indicated that “the stern sunk to the seafloor  
4 before the bow at least just prior to the vessel making contact with the seafloor.”

6 **Figure 21.** Side scan sonar image of *Emmy Rose* from 246 feet above at 600 kHz. (Source:  
7 MIND Technologies)

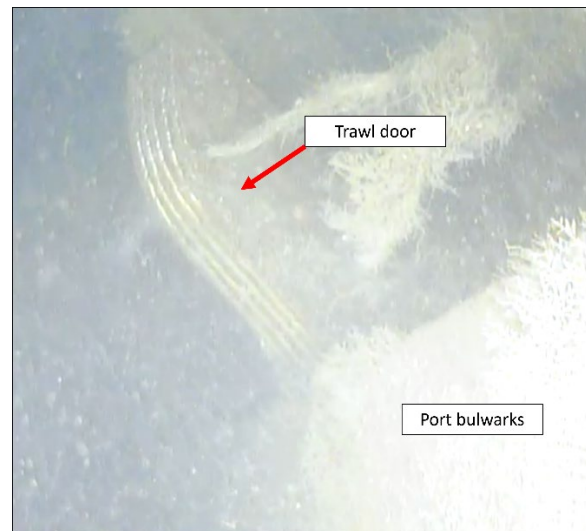
1 an inspection of the vessel's rudder and propeller. The two fishing nets were found  
2 stowed on the net reels and covered the storm gates, preventing the ROV from  
3 assessing the position of the gates. On the port side of the vessel aft working deck, the  
4 trawl door was found to be out of position from the typical stowage position above the  
5 bulwarks, perpendicular to the length of the vessel, and its leading edge extending  
6 over the bulwarks. The starboard trawl door was stowed inside the bulwarks. It is  
7 unknown if the portside trawl door was intentionally set on the rails for maintenance or  
8 for docking operations.

10 **Figure 23.** ROV image of portside trawl door. (Source: WHOI)

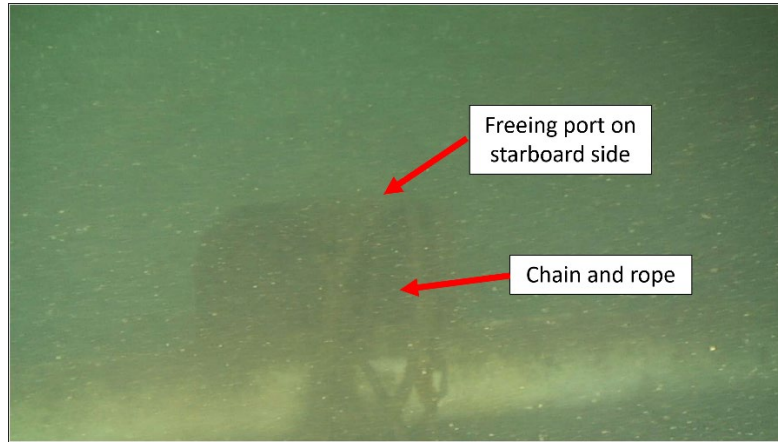
11 The ROV inspected the condition of the freeing ports on either side of the *Emmy*  
12 *Rose*. On the port side of the vessel, the aftermost freeing port was open. The next  
13 freeing port forward was closed. The next freeing port forward was partially open and  
14 had its plate hanging through the port. On the starboard side, the two aftermost  
15 freeing ports were closed. The next two freeing ports forward were open, and both

- 1 had chain and rope hanging out of the ports. The starboard freeing port under the
- 2 wheelhouse was open.

4 **Figure 24.** ROV image of freeing port on the starboard side with chain and rope hanging out.

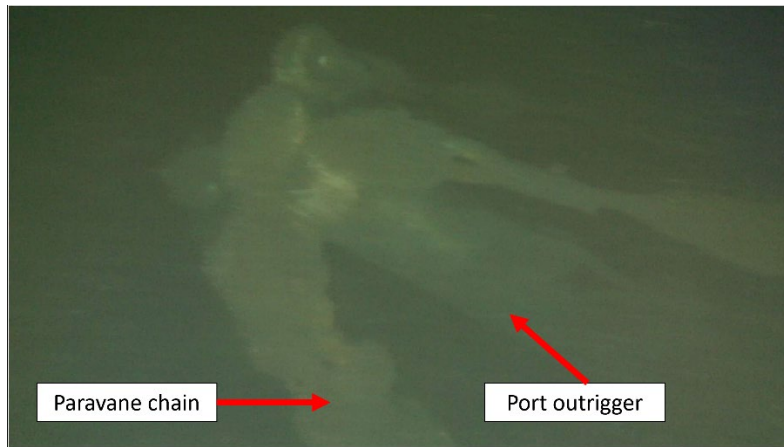
8 Due to the findings from the side scan sonar report, an inspection was completed  
9 on the portside outrigger; the port outrigger and associated rigging were all identified  
10 and appeared to be free of damage. The chain for the port paravane led down to the  
11 sea floor. A line or cable leading forward off the top of the outrigger was not observed.

2 **Figure 25.** ROV image of port outrigger. (Source: WHOI)
