NATIONAL TRANSPORTATION SAFETY BOARD

SYSTEMS GROUP CHAIRMAN'S FACTUAL REPORT

DCA20LA013

Location: Chicago, IL USA
Date: November 11, 2019
Time: 07:42 CST
Aircraft: Embraer EMB 145 LR, N619AE
Airline: Envoy Air Inc.

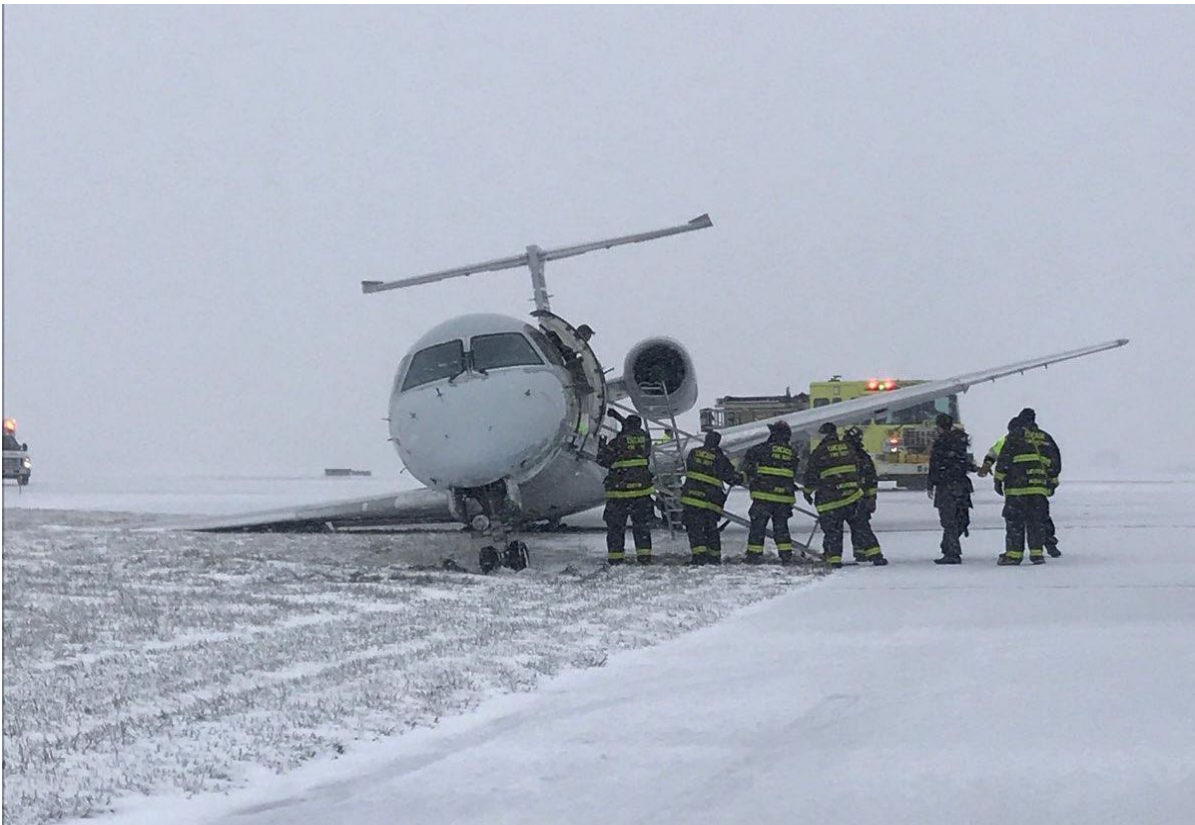
Figure 1: Aircraft Resting Position Following Runway Departure (Courtesy of Envoy)

The right main landing gear collapsed and damaged the landing gear itself, the upper wing skin, and Rib 4 between Spar II and Spar III. Rib 4 is considered primary structure by Embraer and was fractured. Minor damage to the wing where the wing contacted the ground was also observed. The No. 2 main gear tire had a slash mark that stretched across 4 of the 5 treads. The airport reported that two taxiway lights were damaged during the excursion.

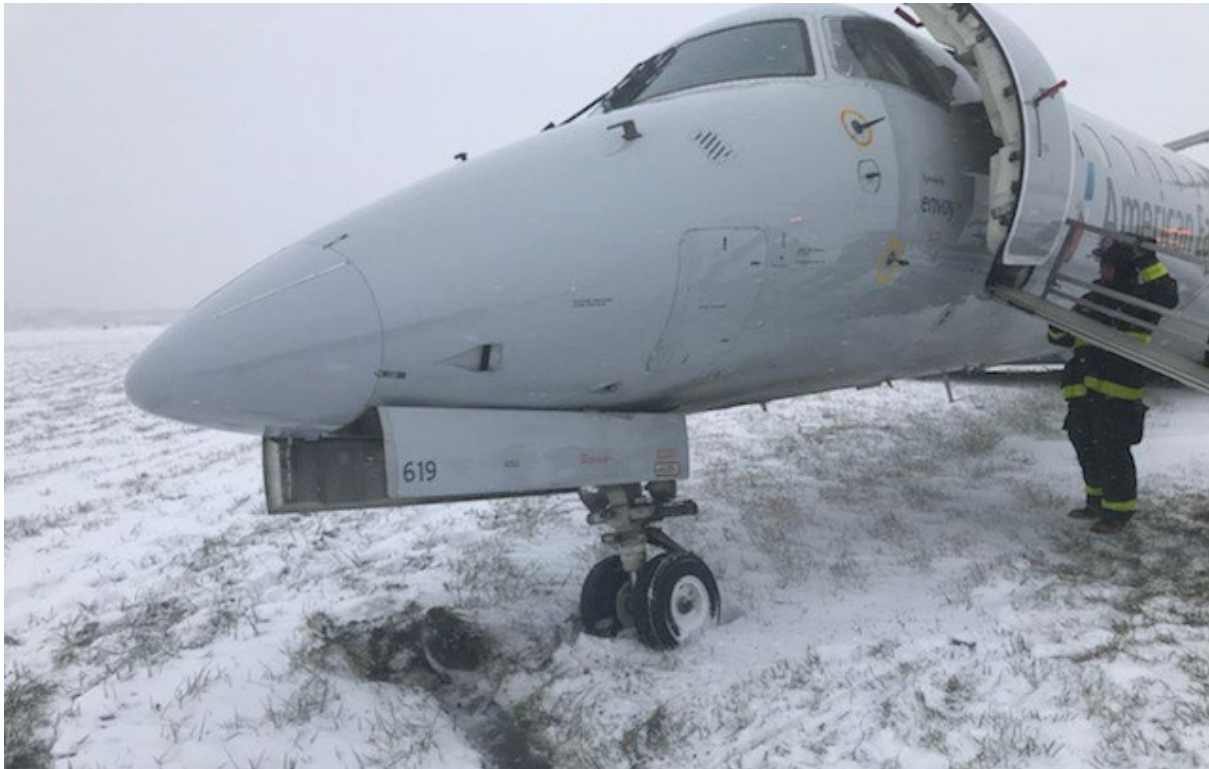
Figure 3: Nose Landing Gear Following Runway Departure

The nose wheel strut was deflated prior to all nose wheel steering checks being accomplished. Prior to deflation, the strut measured 40 psi when the strut was fully extended. With strut compressed the strut height was found to be approximately 6 inches.

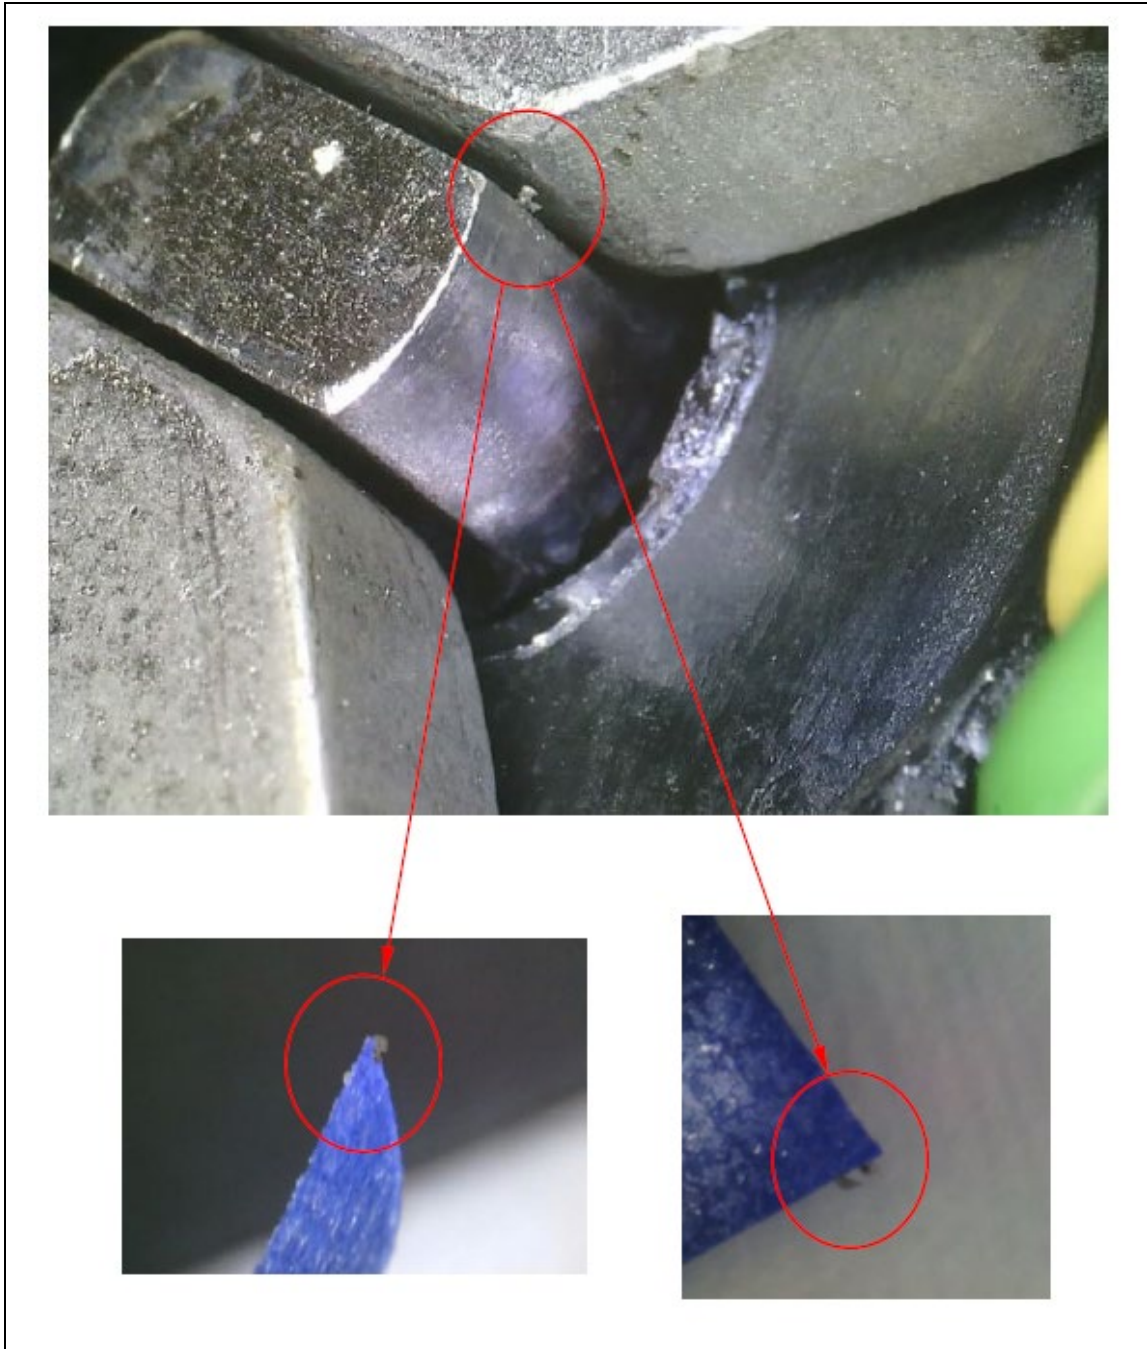
The torque motor cover was removed and a small spec of foreign object debris (FOD) was found adhered to the armature near the top of the air gap in the right (C2) side (see Figure 4). The FOD was removed using adhesive tape and was submitted to the NTSB materials lab for identification. EDS spectra and fracture morphology revealed the FOD was consistent with an organic material such as an amorphous polymer. The source for the FOD was not identified. The plots for pressure gain, flow gain, and internal leakage were rerun following the removal of this FOD. An additional test (not required by the ATP), labeled as a "noise test", was also rerun that compares the differential pressure versus time. The pressure gain plot and the noise test plot values changed as shown in Figures 5-8. According to Woodward HRT, the pressure gain, null balance, and hysteresis observed in both the before and after FOD pressure gain plots is acceptable and passed the as-new ATP requirements. Embraer further stated that any effects of the observed pressure gain plot shift along the x-axis could be nulled out at the aircraft level by adjustment of the feedback potentiometer. Woodward HRT stated the noise plots created both before and after the FOD removal were acceptable for a properly functioning unit.

Figure 4: FOD Found on Armature

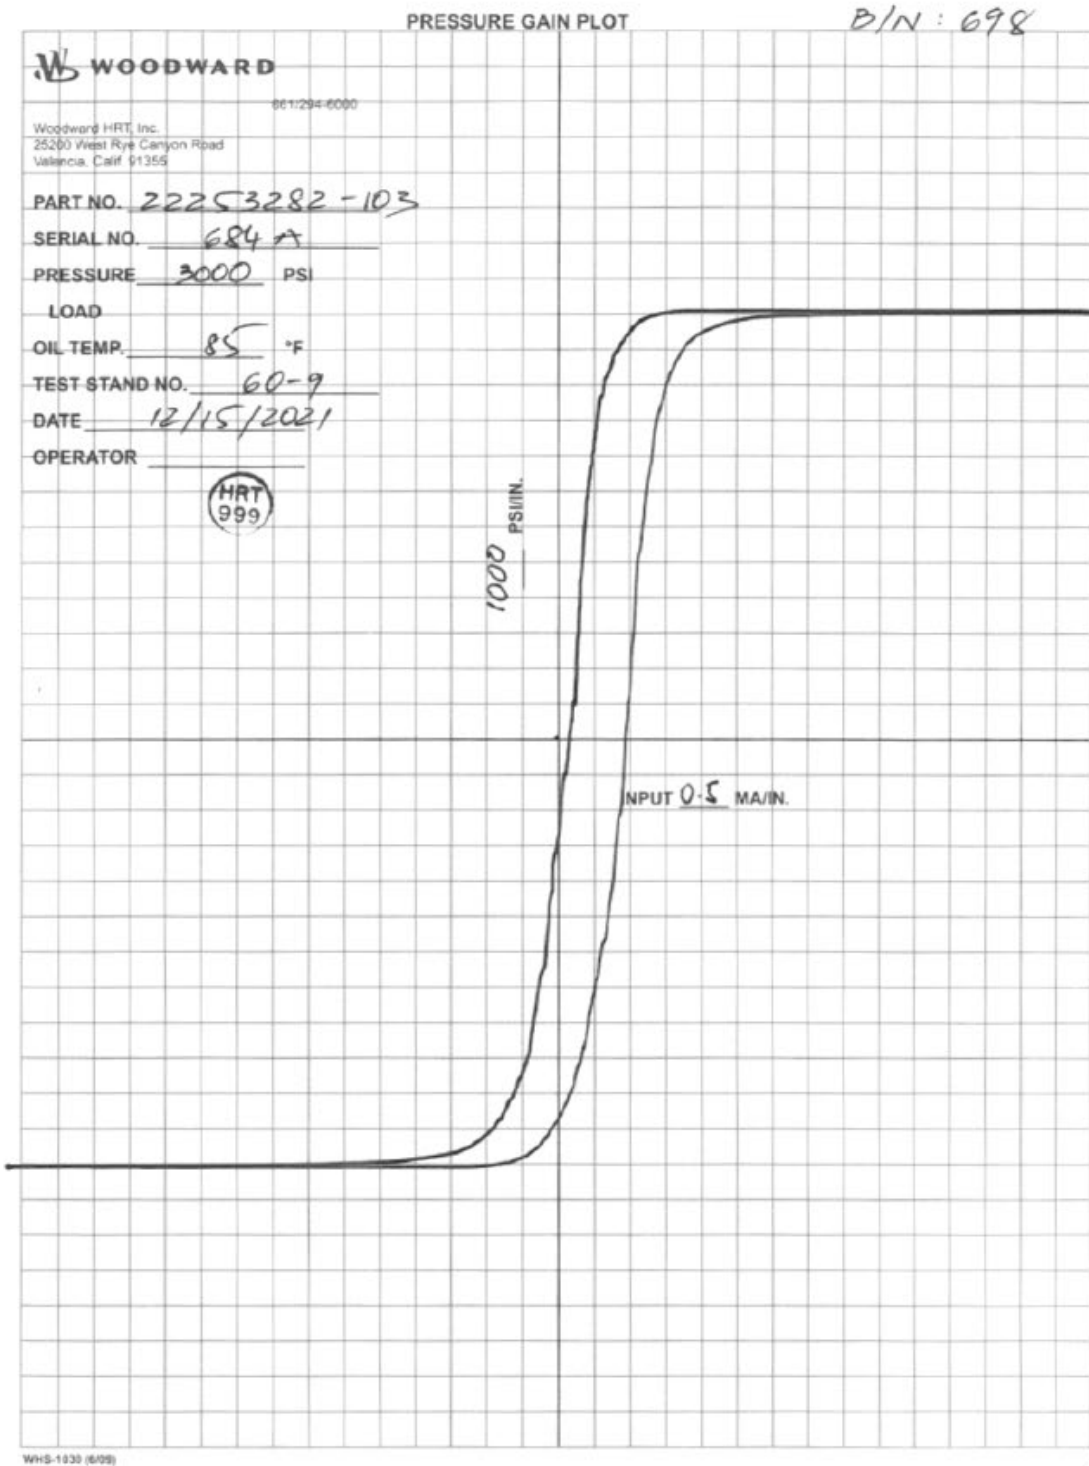
Figure 5: Pressure Gain Plot Before FOD Removal (Courtesy of Woodward HRT)
Figure 3 - Pressure Gain Plot with ATP scale (0.5 mA inch)

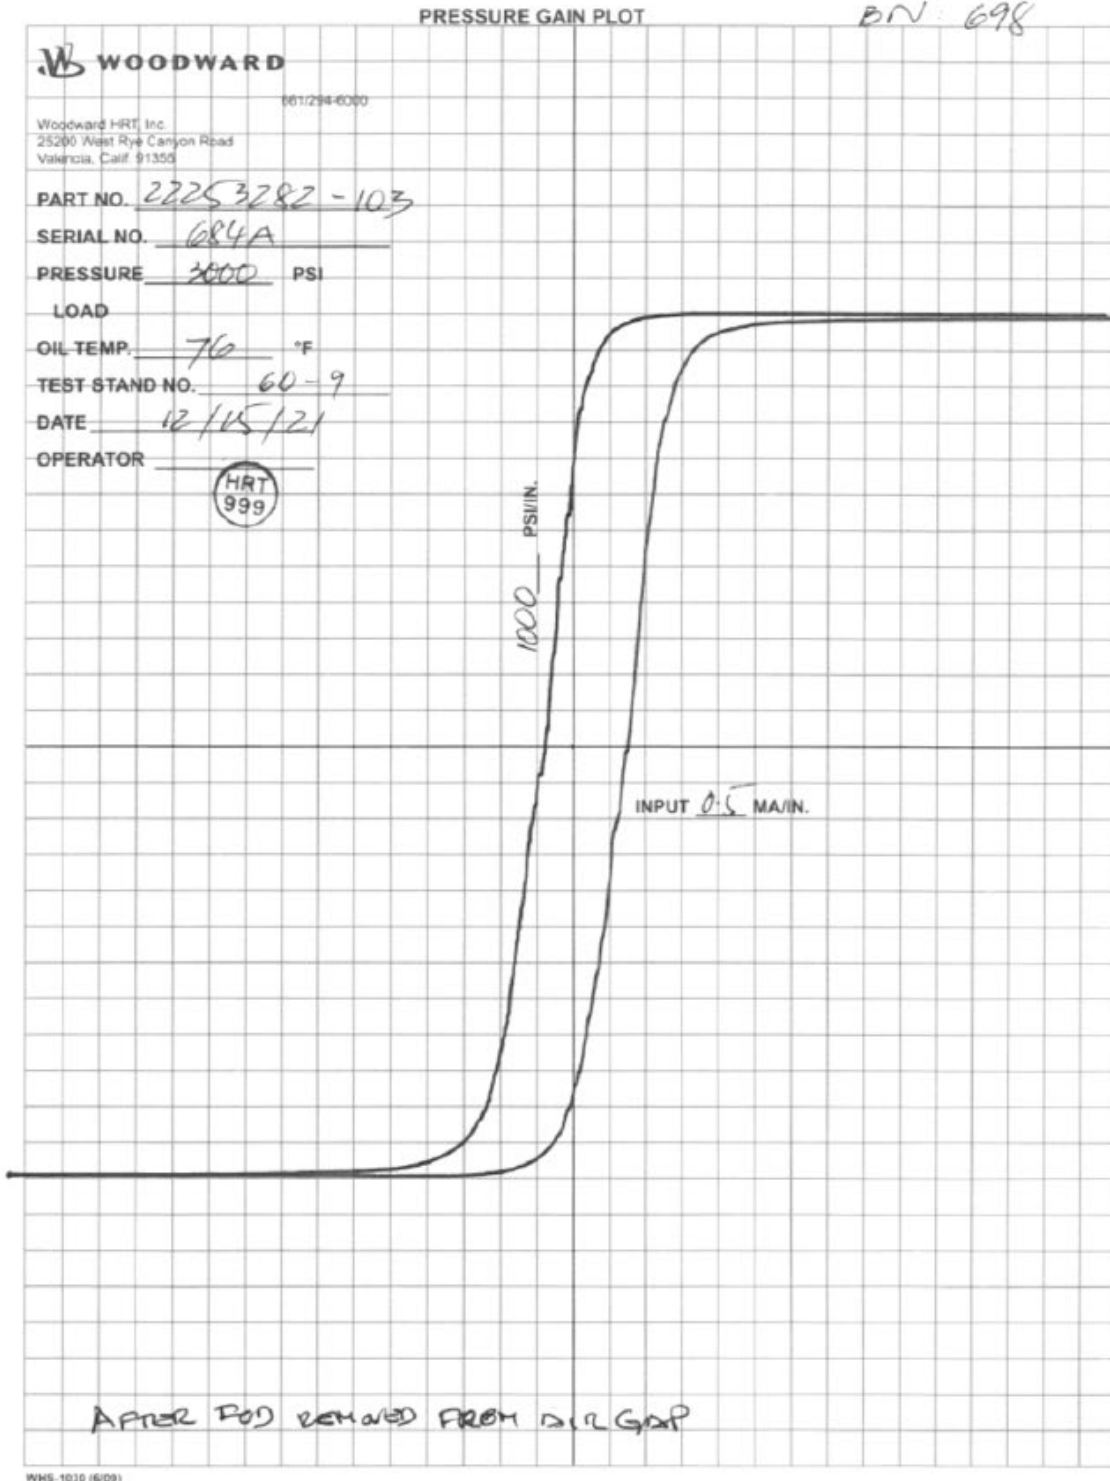
Figure 6: Pressure Gain Plot After FOD Removal (Courtesy of Woodward HRT)

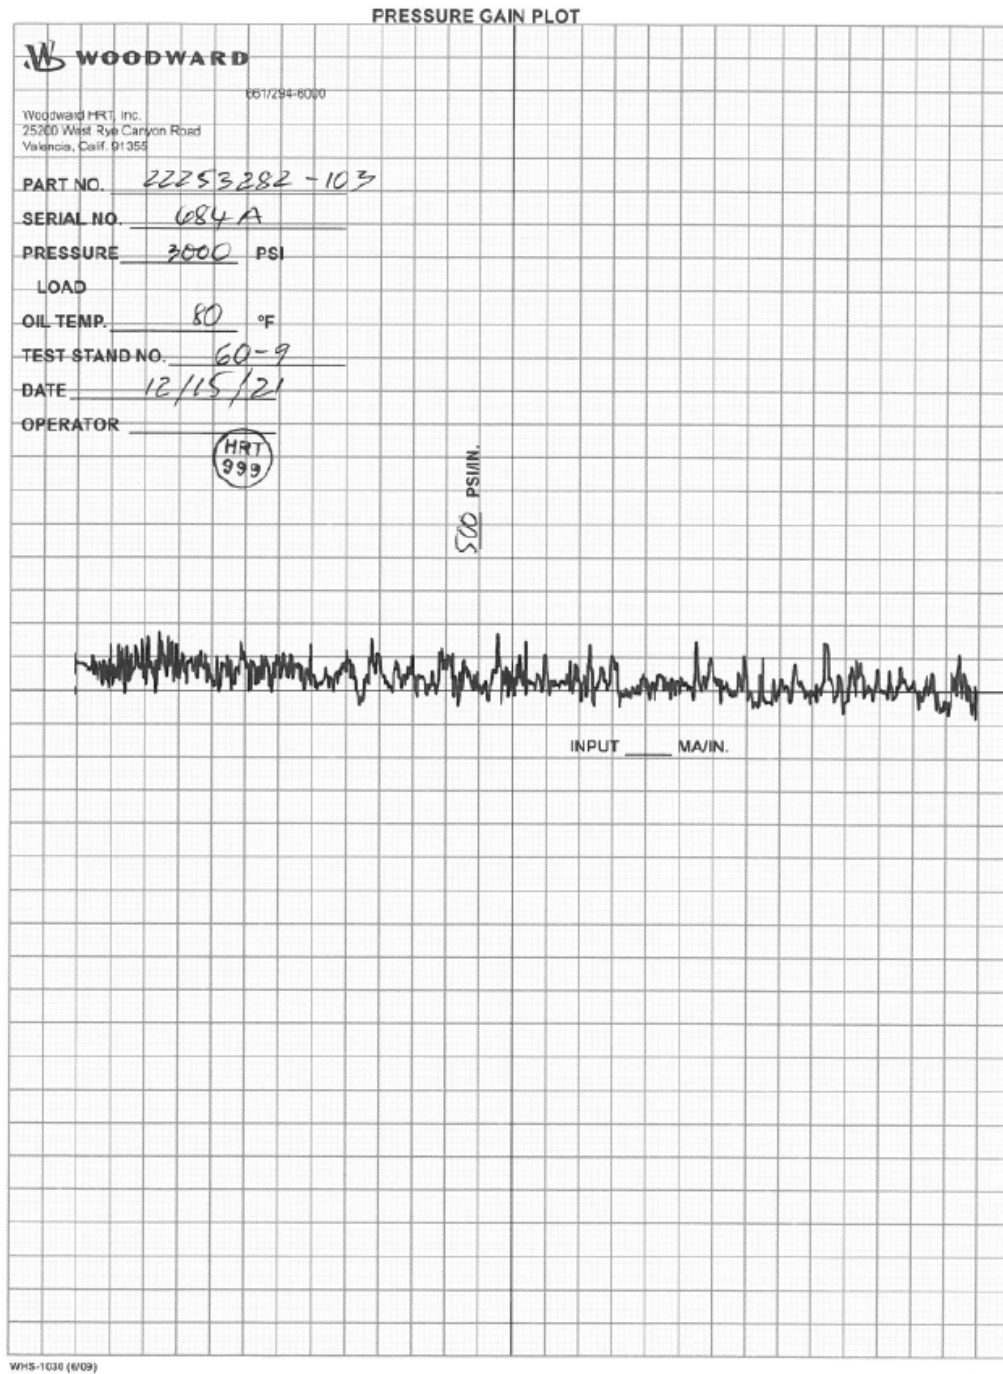
Figure 7: Noise Plot Before FOD Removal (Courtesy of Woodward HRT)

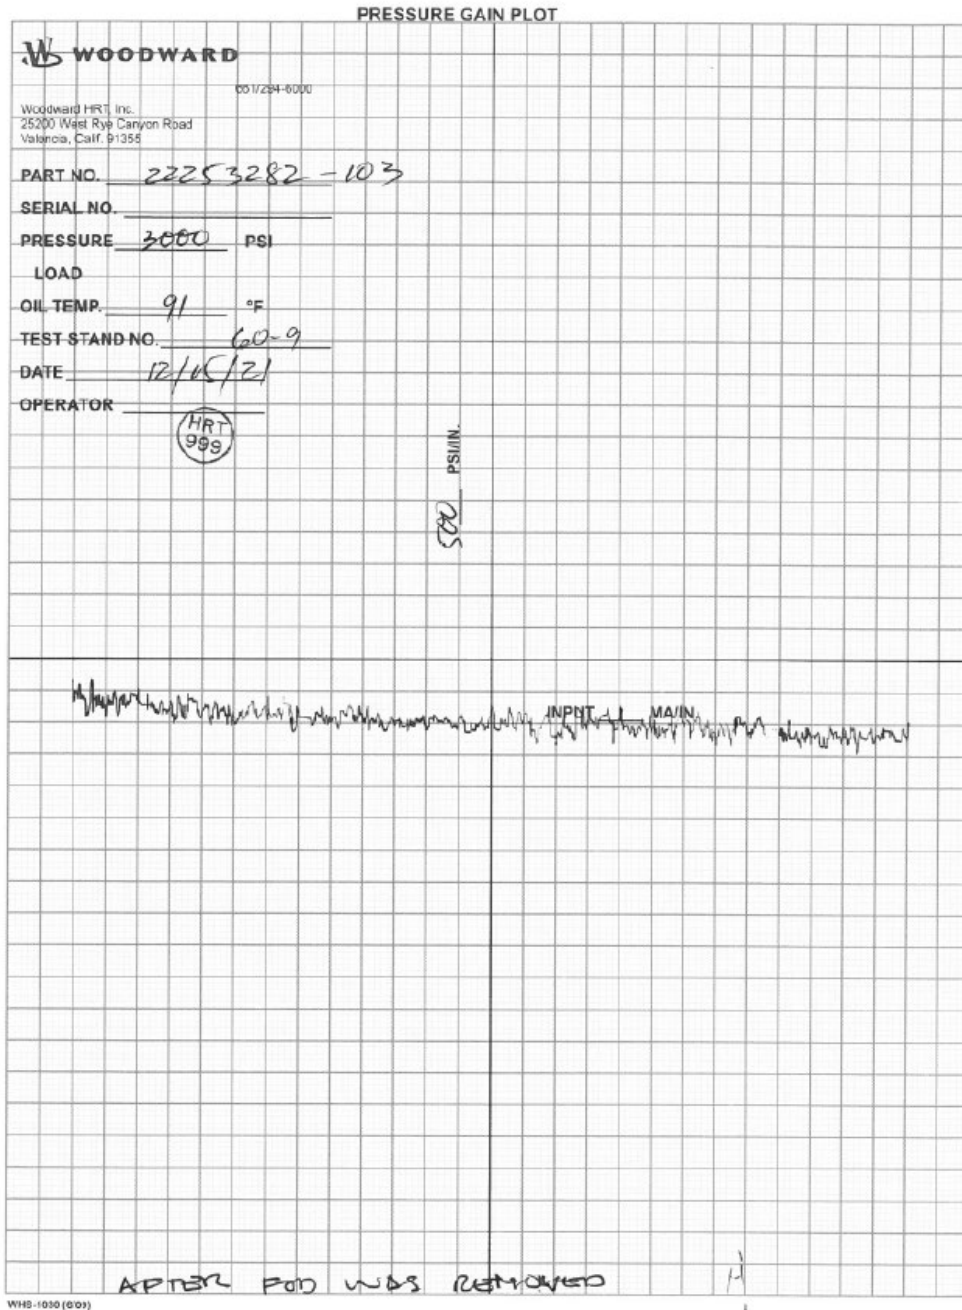
Figure 8: Noise Plot After FOD Removal (Courtesy of Woodward HRT)

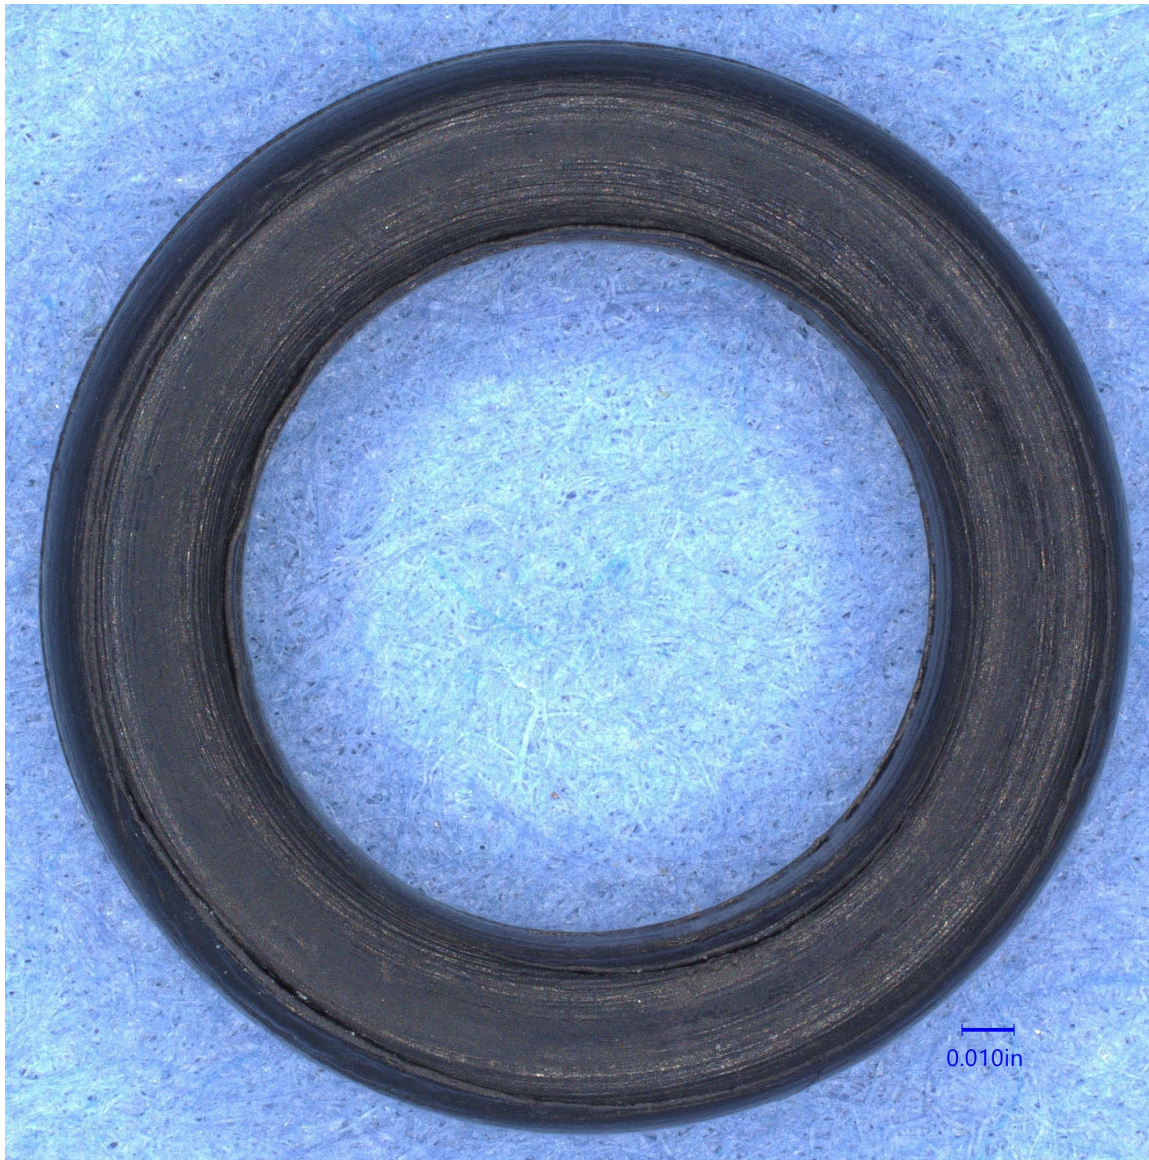
Further disassembly of the unit revealed that the C1 and C2 filter seals (O-rings) were beginning to split on both the inner and outer diameters in the circumferential direction (see Figure 9). Examination of the seals under 40X magnification revealed that that while gaps in the seal material were observed due to the splitting, no material loss of the seal was identified.

Figure 9: Example of Circumferential Splitting on Inner and Outer Diameter of the C1 Seal

Due to the unavailability of required tooling, the critical dimensions for the filter bore and the filter orifice plugs as specified in Woodward HRT document DV1719 were measured at a later date under the witness of the FAA. All measured dimensions except for the “A” filter orifice plug inboard land diameter were found to be within the document requirements. The “A” filter orifice plug inboard land diameter measured 0.2078 inch, while the requirement was 0.2088-0.2093 inch. An undersized plug land will increase the gap between the land and the filter bore. Per the manufacturer, as this gap increases, so does the tendency of the corresponding orifice

filter seal to extrude. DV1719 is an inspection document authorized by Embraer Service Bulletin 145-32-0099 (current revision 03, dated April 8, 2005) to address premature deterioration of O-ring seals within the EHSV. The document requires the inspection of dimensions related to the filter bore diameter, the distance from the edge of the housing to the edge of the k-cut edge break, and the orifice plug land diameters. An “A” suffix is applied to the end of valve serial numbers that have been screened and meet the requirements of DV1719. The accident EHSV serial number was stamped with the “A” suffix.
