**FACTUAL REPORT OF INVESTIGATION
SPORT UTILITY VEHICLE CENTERLINE CROSSOVER COLLISION
WITH PICKUP TRUCK ON STATE ROUTE 33**

HWY21FH003

**NATIONAL TRANSPORTATION SAFETY BOARD
OFFICE OF HIGHWAY SAFETY
WASHINGTON, D.C.**

FACTUAL REPORT OF INVESTIGATION

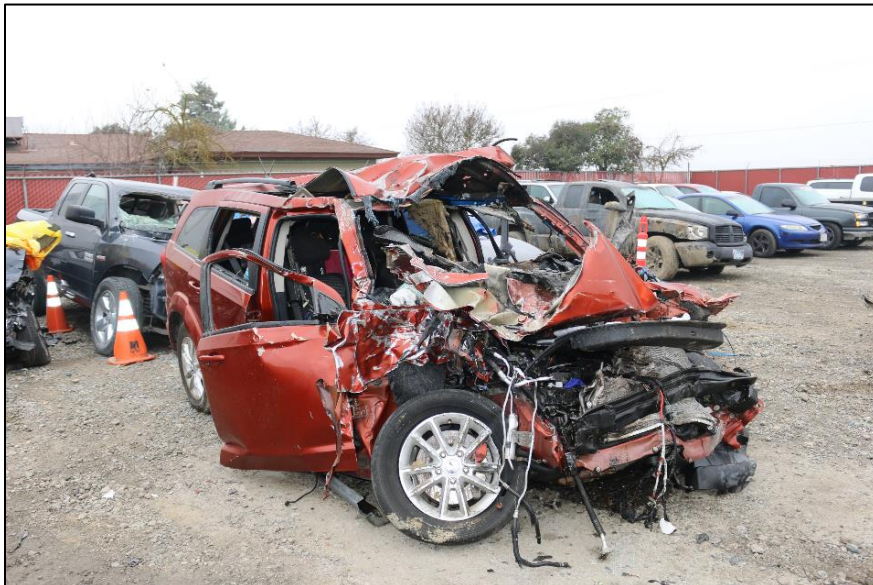
The 2013 Dodge Journey SUV had a Vehicle Identification Number (VIN) 3C4PDCBG0DTXXXXXX.⁵ The SUV was impounded by the CHP for evidence and stored at Eppler’s Towing and Transport storage yard, 5748 Avenue 7 ½, Firebaugh, California. A basic description of the vehicle damage is provided here, and more detailed information is provided in the Technical Reconstruction Group Chairman’s Factual Report, available in the crash docket. The right front (passenger side) was pushed rearward to the front firewall. The right front wheel and tire assembly was twisted left toward the engine compartment. The front bumper was bent inward and upward and displaced rearward with other engine components. Both front roof support structures (“A” pillars) were bent down and inwards toward the passenger compartment. The front roofline was bent rearward and upwards. See figures 1 and 2 for a depiction of the damage.

Figure 1. Damage to the front and right side of the SUV.

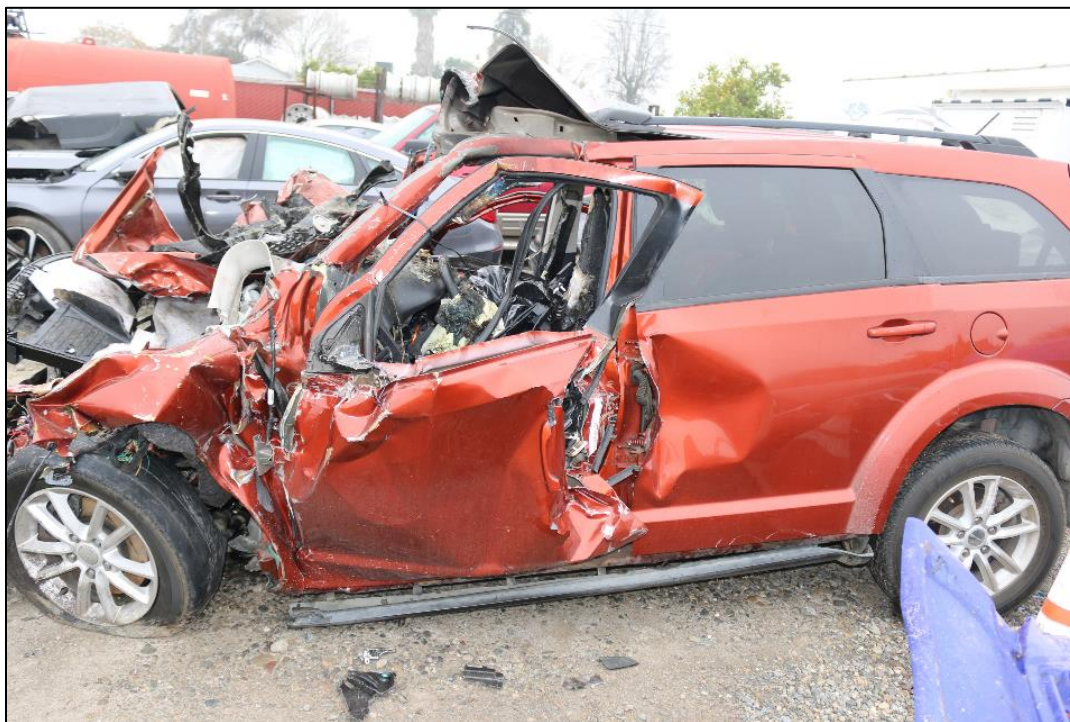
Figure 2. Damage to the left side of the SUV.

CHP investigators performed an inspection of the SUV and functional check of the steering, suspension, braking, and electrical systems, as well as the wheels and tires. The examination revealed no evidence of preexisting defects.

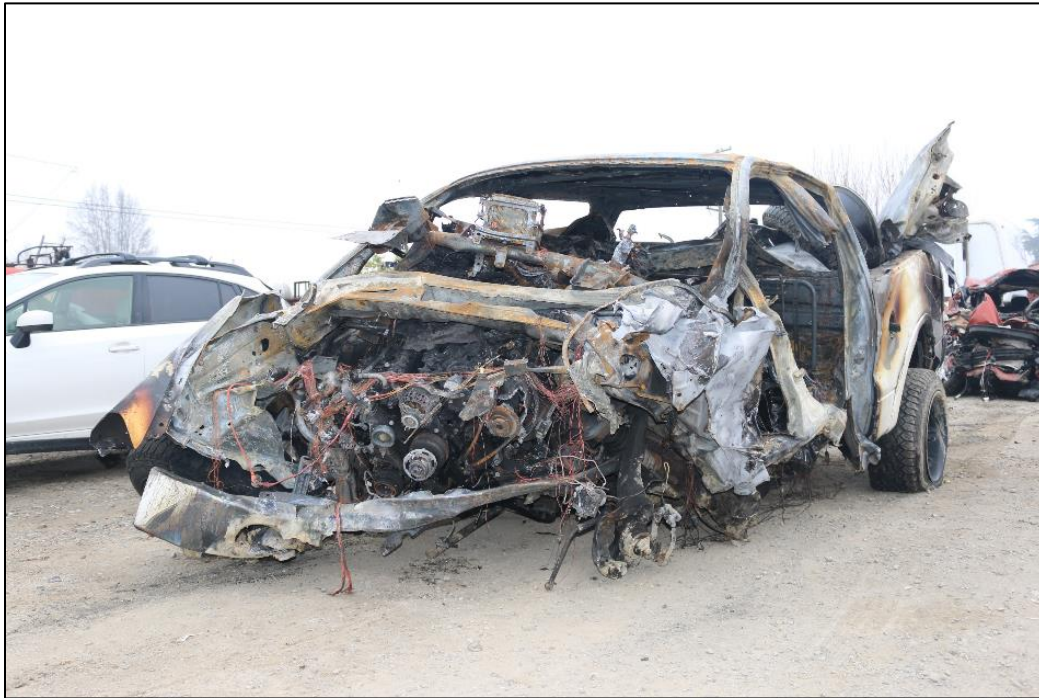
The truck was completely burned during the postcrash fire. The front bumper was bent and twisted rearward into the engine compartment area. The engine displacement caused the passenger compartment floor pan to deform upwards. The left front tire and wheel was torn from the truck during the collision sequence and the left fender was peeled rearward toward the engine compartment firewall. The right fender was buckled outward from the truck. The right front wheel was turned left with the bottom of the wheel bent upwards and inwards beneath the vehicle. The left side of the firewall and support for the "A" pillar was compressed rearward. The left side rocker panel was buckled and pushed upwards. The truck bed was displaced from the frame and

the distance between the wheel well and tire was increased. See figures 3 and 4 for a depiction of the damage.

Figure 3. Damage to the front and left side of the truck.

The truck was inspected to ascertain the source of the fire. The vehicle motor was intruding into the front passenger compartment. The entire undercarriage displayed evidence of fire damage. The fuel intake was consumed by fire and only remnants of the fuel tank remained.⁸ Most of the fire damage was near the engine and front passenger compartment with a directional fire pattern from front to rear.⁹ One witness who stopped at the crash scene immediately after the crash, reported the fire starting near the front of the truck and spreading rearward.¹⁰ He added that the fire appeared to originate from a severed line in the truck's engine compartment. Another witness who attempted to extricate passengers from the truck said the fire originated near the bottom of the truck's firewall and spread rearward, quickly consuming the interior occupant compartment.

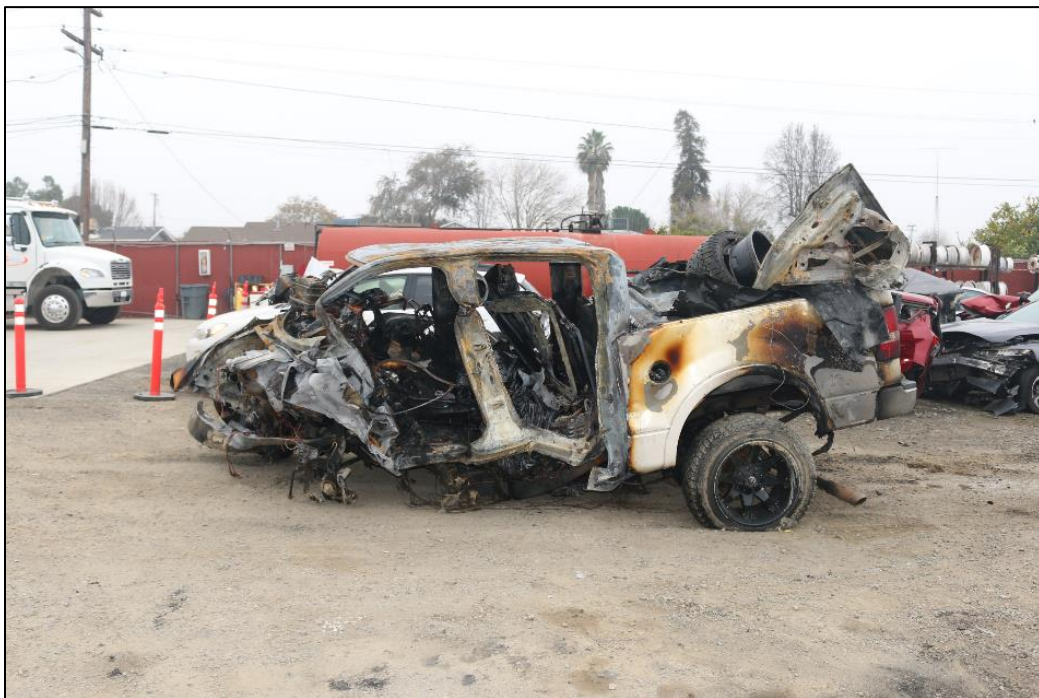
Figure 4. Damage to the left side of the truck.
