1 **National Transportation Safety Board**

12  
13  
14 **Survival Factors Group**  
15

16  
17  
18  
19 **Conception**

20  
21 **DCA19MM047**  
22

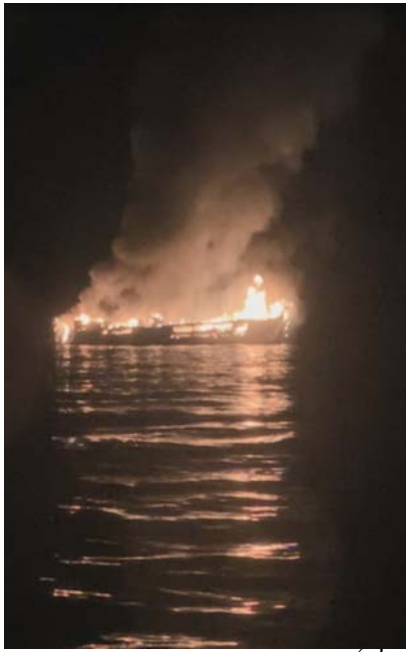
**Figure 5: *Conception* as seen on arrival by *Boat 15*. (Source: VCFD)**

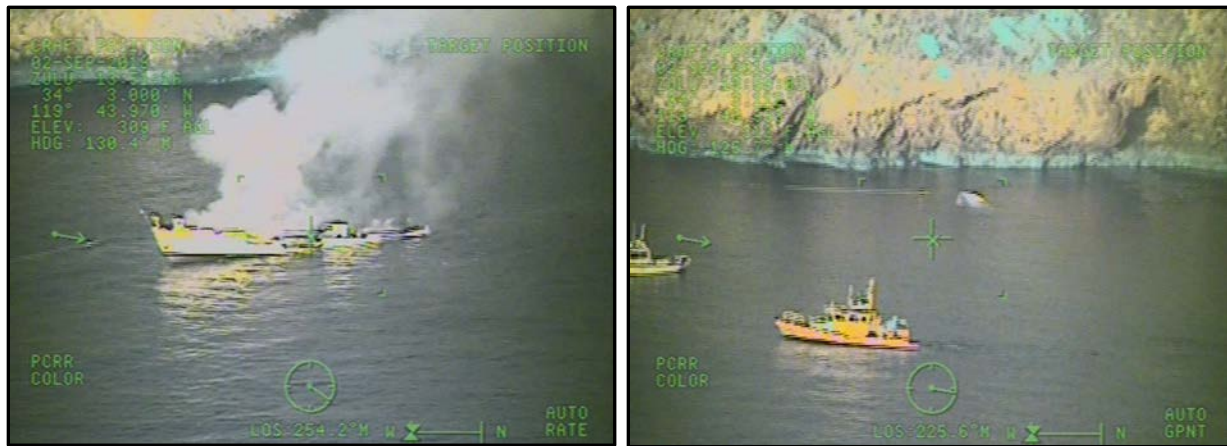
1            *Boat 15*, with Engine Company 54 embarked, arrived on scene, followed by *Boat 3*, and  
2 commenced fire suppression efforts, first with fire monitors and then with handlines. The  
3 *Retriever II* arrived on scene at 0502 and shortly after began towing the burning wreck away from  
4 the shallow water with a grappling hook to a location where the fire boats could better reach it.  
5 The fire was first reported extinguished at 0508 but re-flashed several times in the area of the fuel  
6 tanks and on the bow. Burned out through-hull penetrations eventually submerged, where the main  
7 engine exhausts had been, and the vessel sank stern first in position 34° 02.9' N 119° 44.3' W at  
8 0654, approximately 20 yards from shore, in 61 feet of water. First responders were not able to  
9 safely board the vessel before it sank. Underwater recovery divers later found the wreckage, lying

11  
12 **Figure 6: *Conception* as seen from CG 6014 at 0651 (left) and at 0659 after sinking (right). (Source:**  
13 **Coast Guard)**

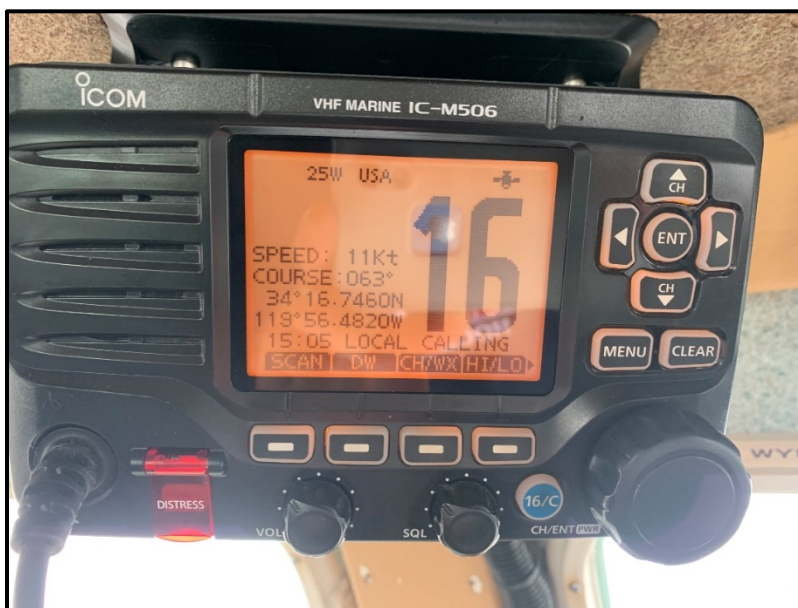
**Figure 9: Conception's VHF radio located overhead in the wheelhouse. The VHF-DSC distress button in the lower left is color-coded red. (Source: B. Priddin)**

communications by voice, by pushing and holding the red distress button on the front panel of the radio for three seconds, a VHF-DSC call would communicate the nature of the distress (default to undesignated distress, if the user did not input this) and the latest position of the vessel, and would have continued to transmit distress messages every 3.5 to 4.5 seconds until the call was acknowledged. Due to the nature of the criminal investigation, investigators were not permitted to interview the captain to determine if he initiated a VHF-DSC distress call. The Coast Guard, however, did not receive a VHF-DSC distress call from the *Conception*, nor did any other vessels contacted by investigators.

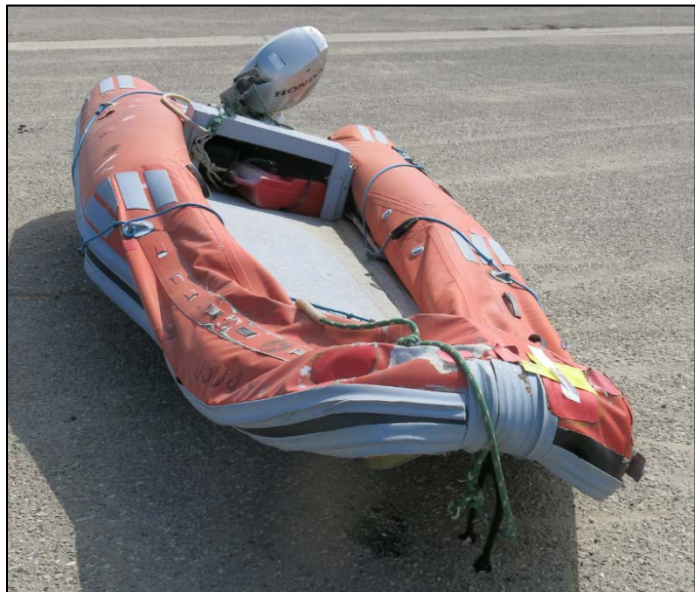
4 **Skiff:** The *Conception's* skiff was  
 5 a 16-foot Caribe rigid-hull inflatable  
 6 equipped with a 40-hp Honda 4-stroke  
 7 outboard engine and was primarily used  
 8 to support diving operations, but also for  
 9 the retrieval of persons overboard. The  
 10 skiff was also the designated rescue boat  
 11 per 46 *CFR* Part 180.10-35 (Old T) and  
 12 180.210 (New T). It was stowed at the  
 13 stern and was launched via a  
 14 hydraulically powered launch platform,  
 15 which required the vessel's main  
 16 electrical power to lower the platform.

Figure 10: Postaccident photo of the skiff from the *Conception*. Note the cut line at the bow

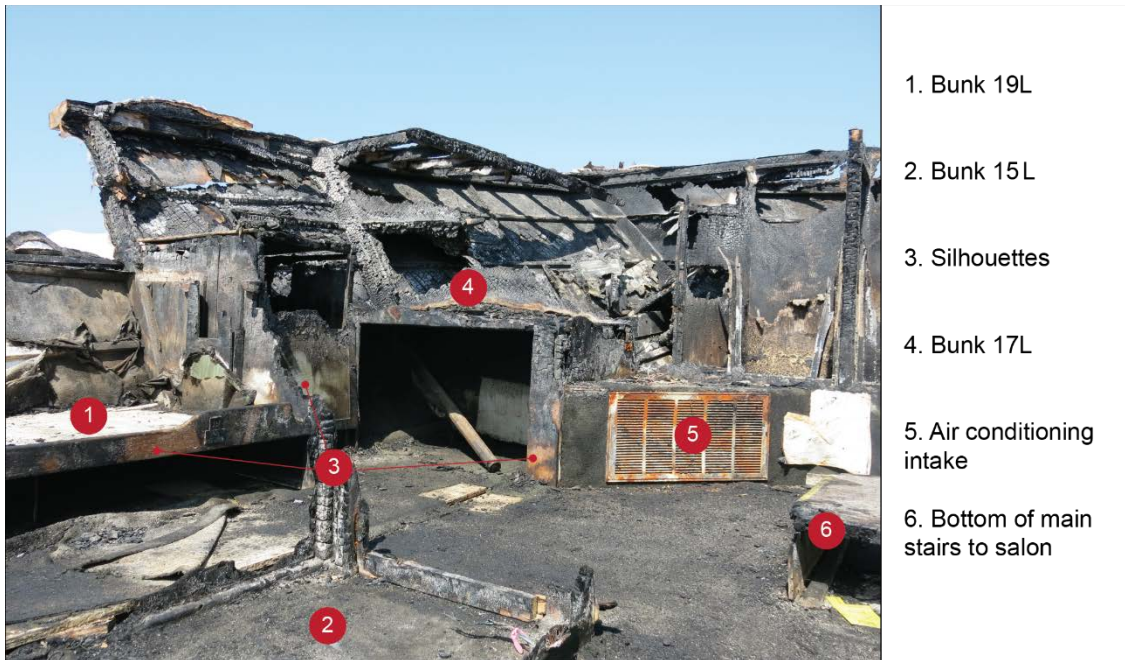
11           Upon examination of the wreckage, investigators found silhouette evidence markings  
12 consistent with the outline of persons or objects of non-uniform shape (e.g. duffel bags) in the  
13 bunk room at the bottom of the main stairs leading to the salon, on the port side forward outboard  
14 lower double bunk and adjacent vertical and horizontal bunk frames at bunks 17L and 19L. The  
15 mattresses and personal effects from 17L and 19L were also mostly unburned. The mattress for  
16 19L had an observable silhouette and traces of human tissue on it, as did the air conditioning intake  
17 louver at the bottom of the main stairs. Personnel effects, including paper documents, recovered  
18 from the crewmember assigned to bunk 17L were almost entirely unburned.

- 1. Bunk 19L
- 2. Bunk 15L
- 3. Silhouettes
- 4. Bunk 17L
- 5. Air conditioning intake
- 6. Bottom of main stairs to salon

1  
2 **Figure 12: Postaccident photo of the bunkroom looking from the starboard aisle forward and to**  
3 **port.**

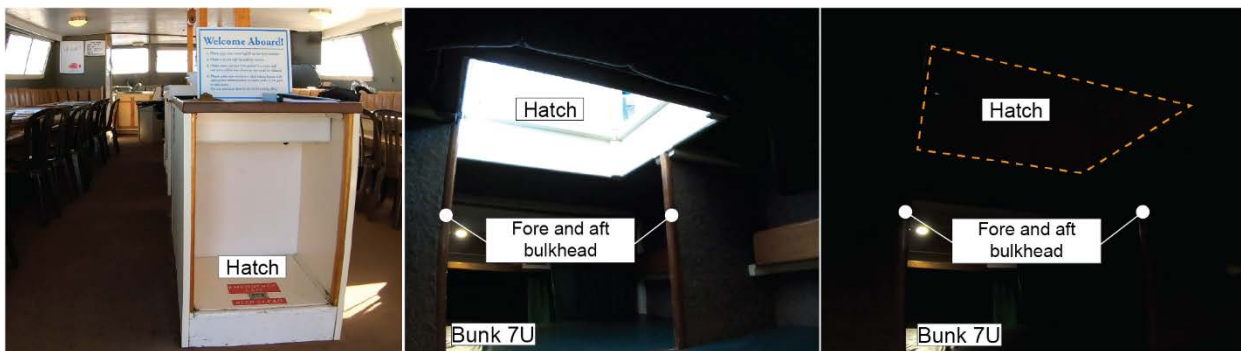
An escape hatch was installed on the centerline at the aft end of the bunk room that led to the aft end of the salon and was original to the vessel. In all available historic documentation and inspection history of the *Conception*, no discrepancies or modifications were found related to the emergency escape hatch. The hatch was accessible from either aisle by climbing a wooden ladder, located in the corner where the aftermost middle and aft athwartship tiers of bunks were, through a privacy curtain (if not opened) onto the top bunk, crawling to the centerline over bedding and personal effects, and pushing the plywood escape hatch out of the way. The escaping passenger

17  
18 **Figure 13: The *Conception* berthing area escape hatch from above in the salon (left) and from the**  
19 **port side, below deck with the hatch open (middle), and with the hatch closed (right). (Source: Ralph**  
20 **A. Clevenger photography and video)**

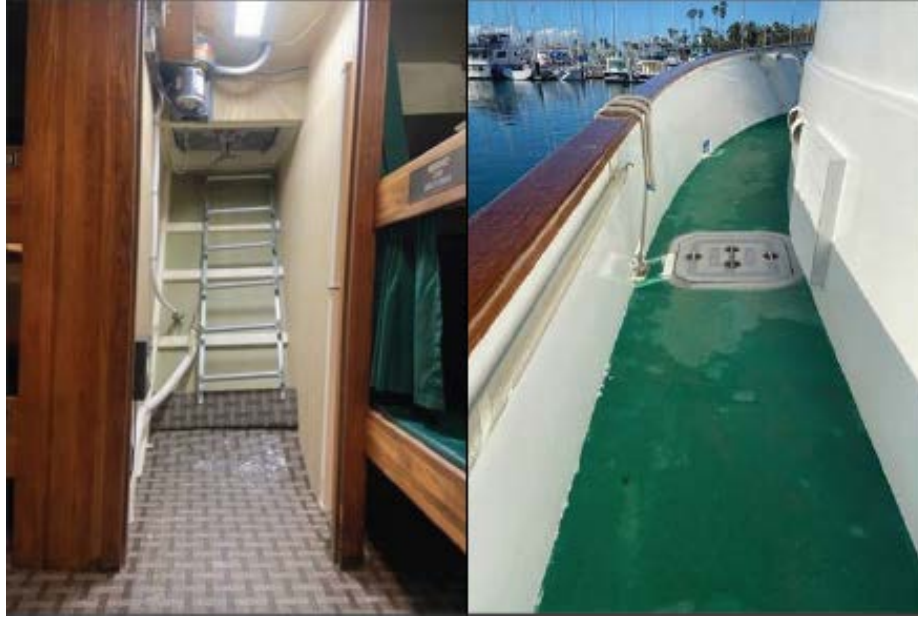
22 After the fire on the *Conception*, Truth Aquatics modified the bunkroom egress on the  
23 similar vessel *Vision*. A closet near the port forward end of the space was converted to a  
24 passageway and ladders added, leading to watertight hatches, flush with the main deck exterior  
25 outside of the galley, both port and starboard.

1  
2 **Figure 16: Modifications made to the *Vision*, after the accident on the *Conception*. Left: Ladders at**  
3 **the forward end on each side of the bunkroom lead directly to the weather deck. Right: Flush**  
4 **mounted watertight hatches were installed in the deck, outboard of the galley. (Source: Truth**  
5 **Aquatics)**

6 Because the Coast Guard considered this to be a major modification as per regulations, the  
7 emergency escapes fell under New T regulations, even though the *Vision* was considered an  
8 existing vessel. New T regulations are more specific regarding emergency exit pathways, and as  
9 such the owner of the *Vision* was required to submit the plans to the Coast Guard for approval  
10 which, at the time of publication of this report, were still under review and have yet to be approved  
11 by the OCMI.
