1 **National Transportation Safety Board**

6
7
8
9
10 Group Chairman's Factual Report
11
12

13
14 **Nautical Operations Group**
15

16
17
18
19 *Höegh Xiamen*

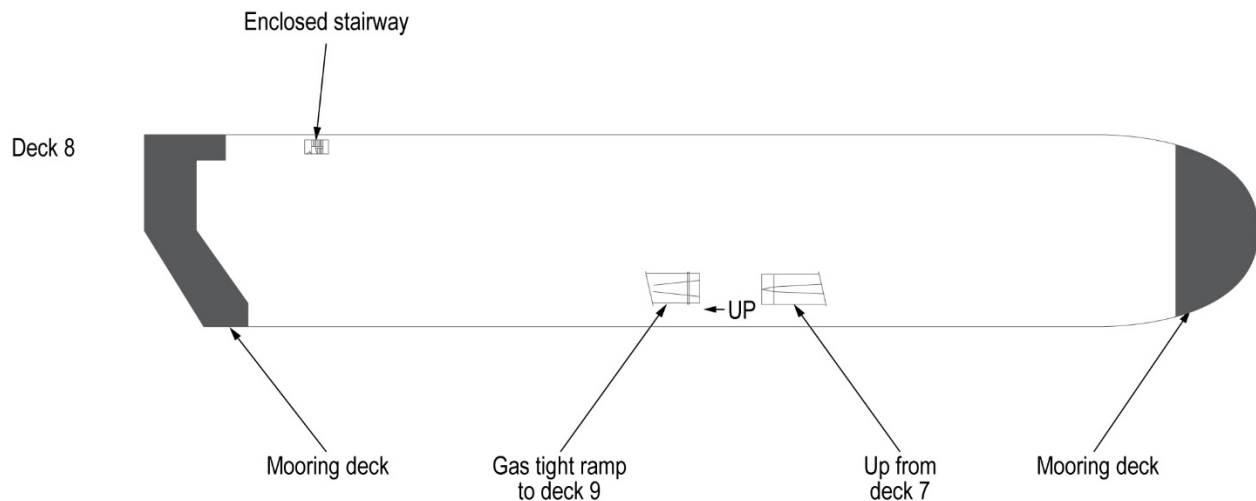
2 Aboard the vehicle carrier, the OS reported back to the mate that there was fire on Decks
3 7 and 8 and that there was no lighting on Deck 8. The chief engineer also reported heavy smoke
4 and no lighting on Deck 8, but also checked Deck 7 where he could see a small fire on Deck 8
5 above with flaming fuel dripping to Deck 7, starboard side aft. The mate then ordered the fire
6 team, once mustered by the general alarm, to investigate. They, too, were forced to retreat due to
7 heavy smoke under pressure on Deck 8.

9 **Figure 4. Höegh Xiamen arrangement of Deck 8 (Source: Höegh)**

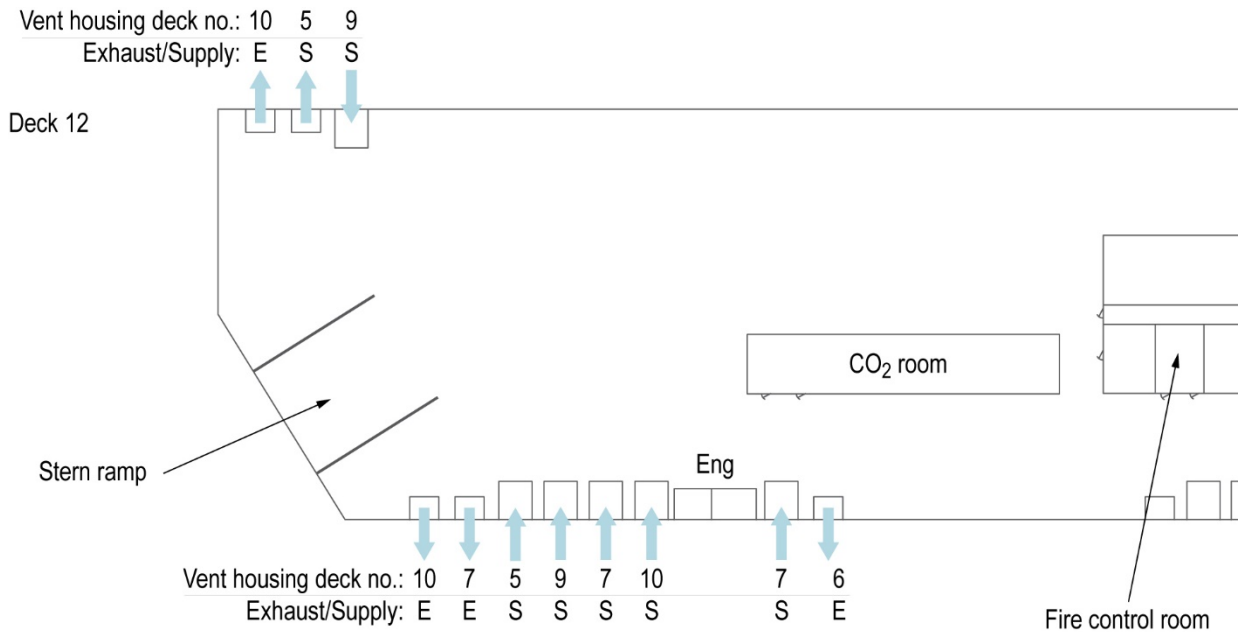
10 About this time, the mate saw smoke from additional ventilation trunks. He
11 recommended to the master using the fixed CO₂ system and mustered the whole crew. The
12 captain also had the mate close all the manual dampers on the top deck, in addition to the
13 remotely controlled ones.

Figure 5. Arrangement of ventilation trunks on Deck 12, starboard aft.

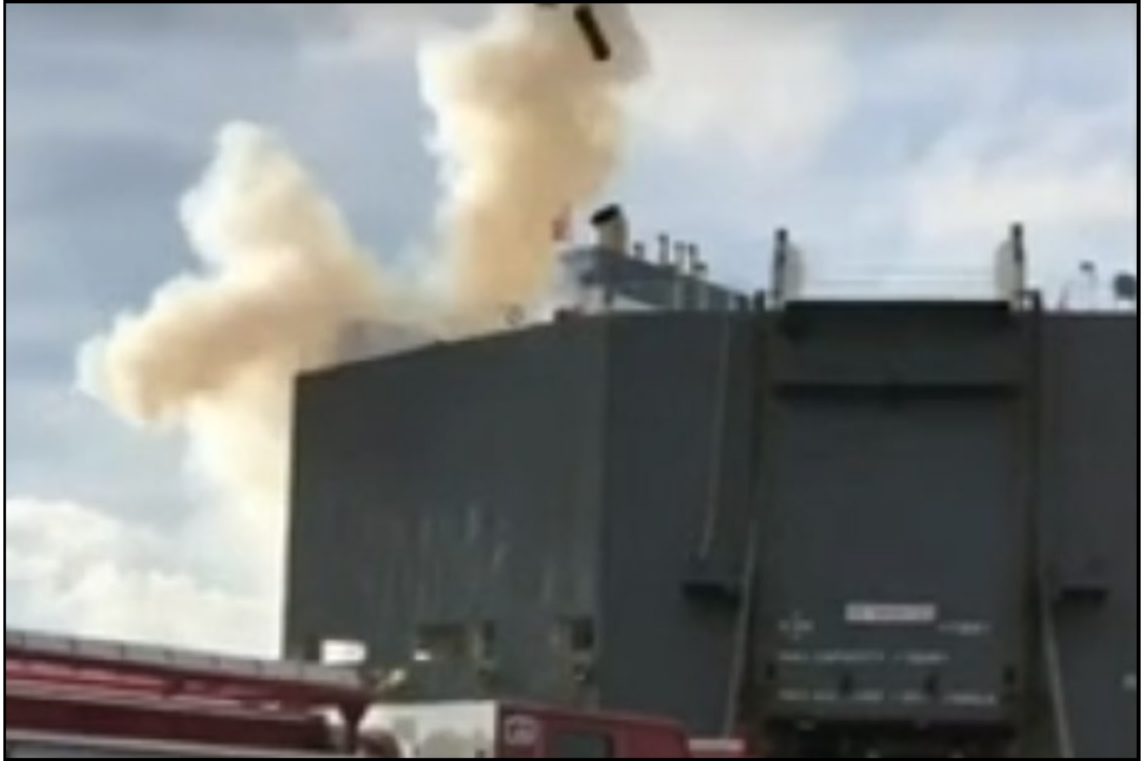
7 Firefighters reported finding doors closed in the port aft stairway to each deck, except the
8 upper deck, Deck 12. There was no pressure behind the doors when they accessed Decks 7 and 8,
9 and they started suppression using their own hose lines and equipment. About 1846, a ladder
10 company working on the upper deck was ordered to start opening ventilation to evacuate smoke
11 and improve visibility on the fire decks. They reported smoke flowed freely from the starboard
12 aft ventilation trunks after opening the housing doors. Upon opening the door to the exhaust
13 trunk for Deck 9 though they heard a rush of air and the ventilation housing exploded, throwing
14 debris in the air. Firefighters staged in the port aft stairway and on Deck 5 described two
15 explosions with intense heat and a “roaring sound of rushing air”. Eight firefighters were
16 burned, five of them seriously. Another developed heat exhaustion. Those firefighters working on

1
2 **Figure 6 – Overpressurization of Deck 9 ventilation exhaust trunk (Source: WJXT)**
