National Transportation Safety Board

WPR23FA007

FIELD NOTES SUMMARY

On October 4, 2022, about 1238 Pacific daylight time, a Cornford Mustang II airplane, N887QR, was substantially damaged when it was involved in an accident near Jamul, California. The pilot sustained fatal injuries. The airplane was operated as a Title 14 Code of Federal Regulations Part 91 personal flight.

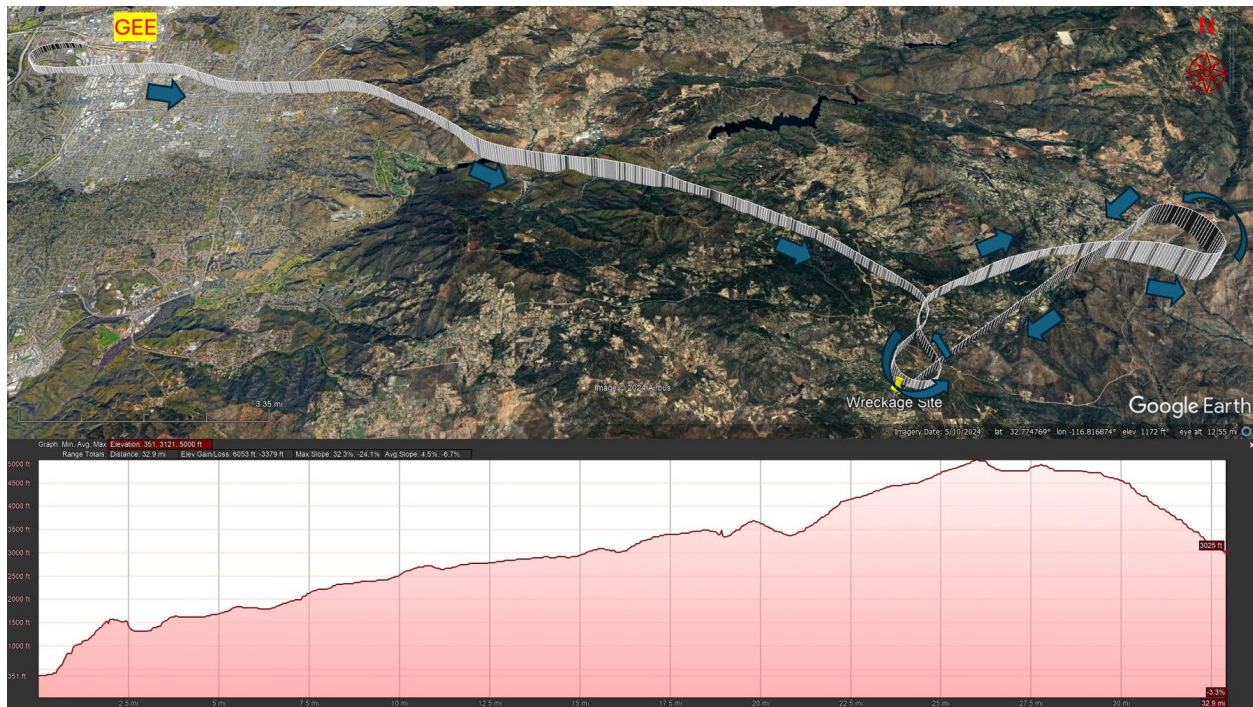
Figure 1. View of plotted ADS-B data in relation to wreckage site

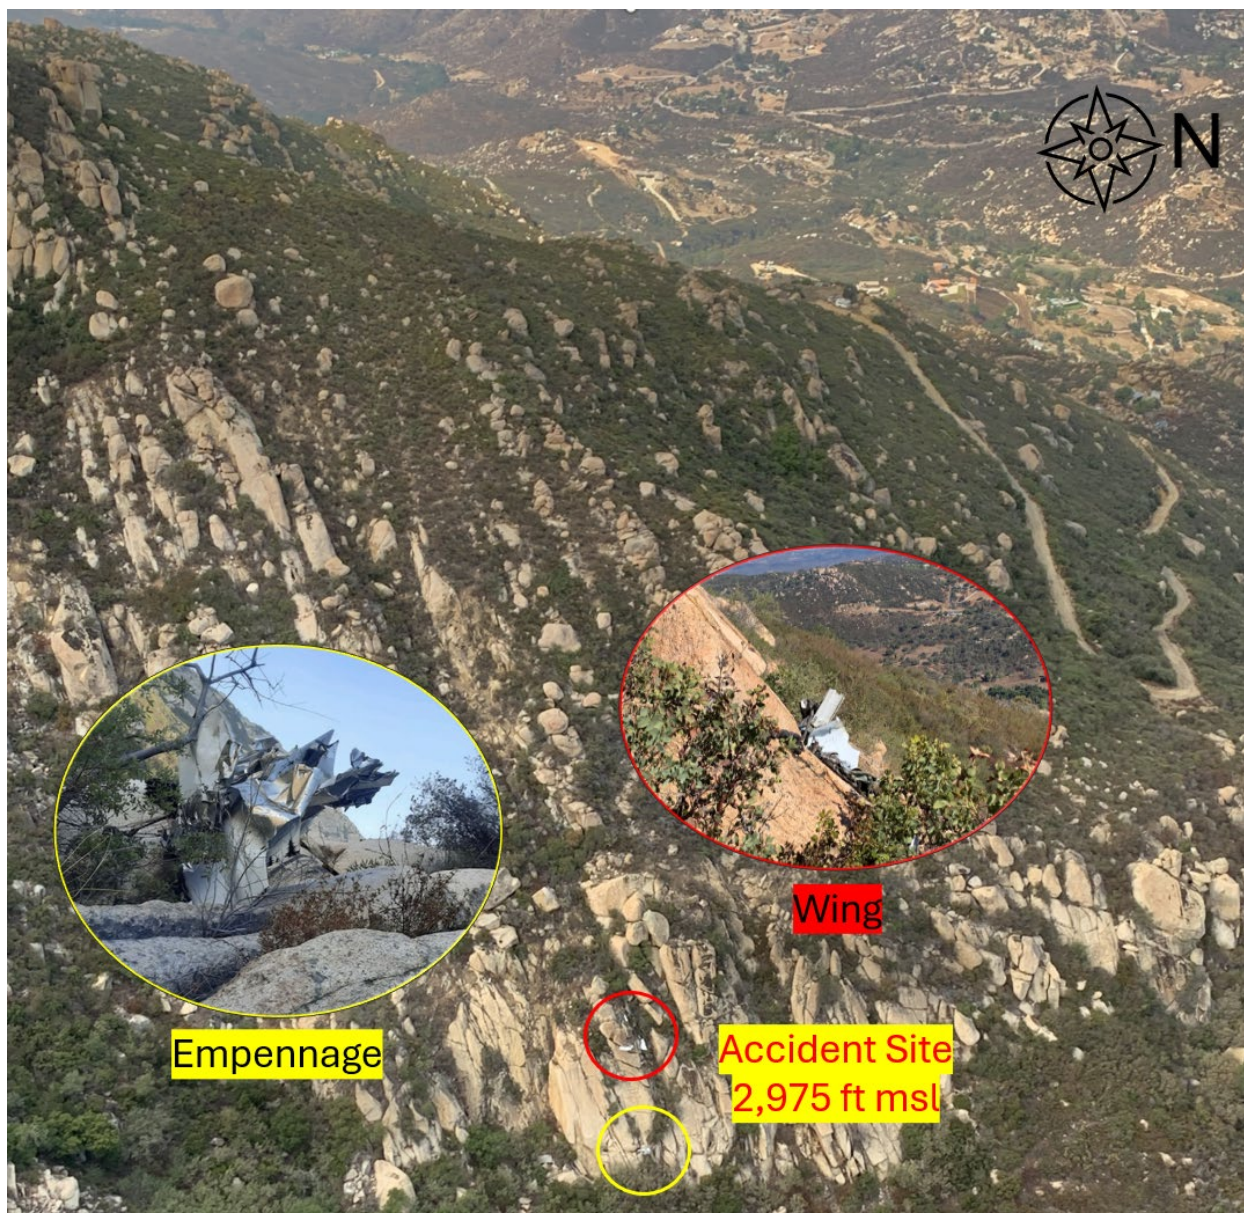
The airplane impacted sparsely vegetated, rocky and steep mountainous terrain at an elevation of about 2,975 ft msl. Due to the terrain's accessibility, the recovery and subsequent examination of the airplane and engine could not be completed. Various components and parts that could not be identified were located while attempting to access the accident site.

Figure 2. View of mountain side depicting location of accident airplane

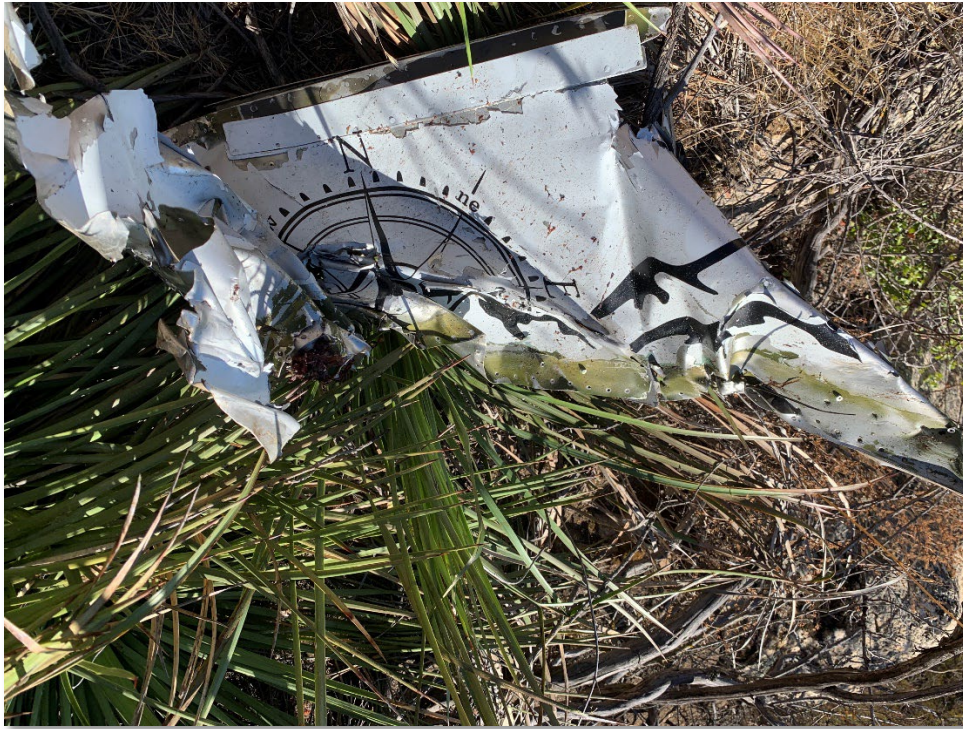
Figure 4. View of section of fuselage

A section matching the paint/sticker scheme from the exemplar picture of the airplane was found about 35 ft southwest from the wing/cockpit.

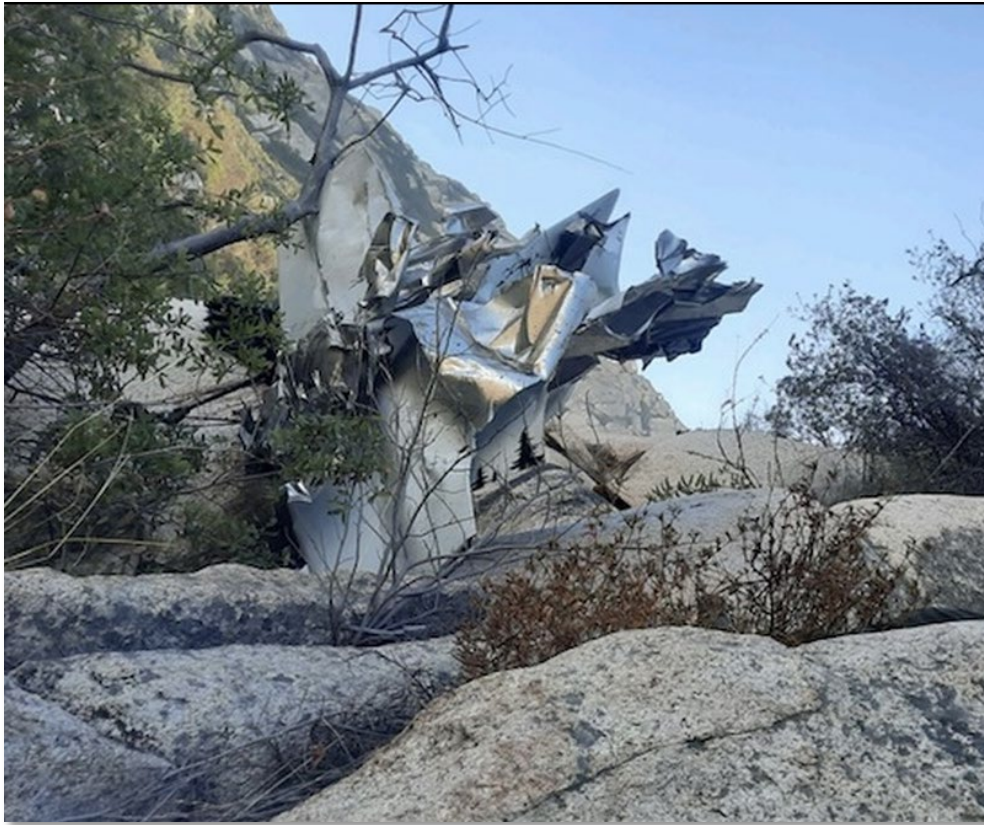
Figure 5. View of empennage that came to rest on boulders

The empennage came to rest about 55 feet east and down the rockface from the cockpit/wings.

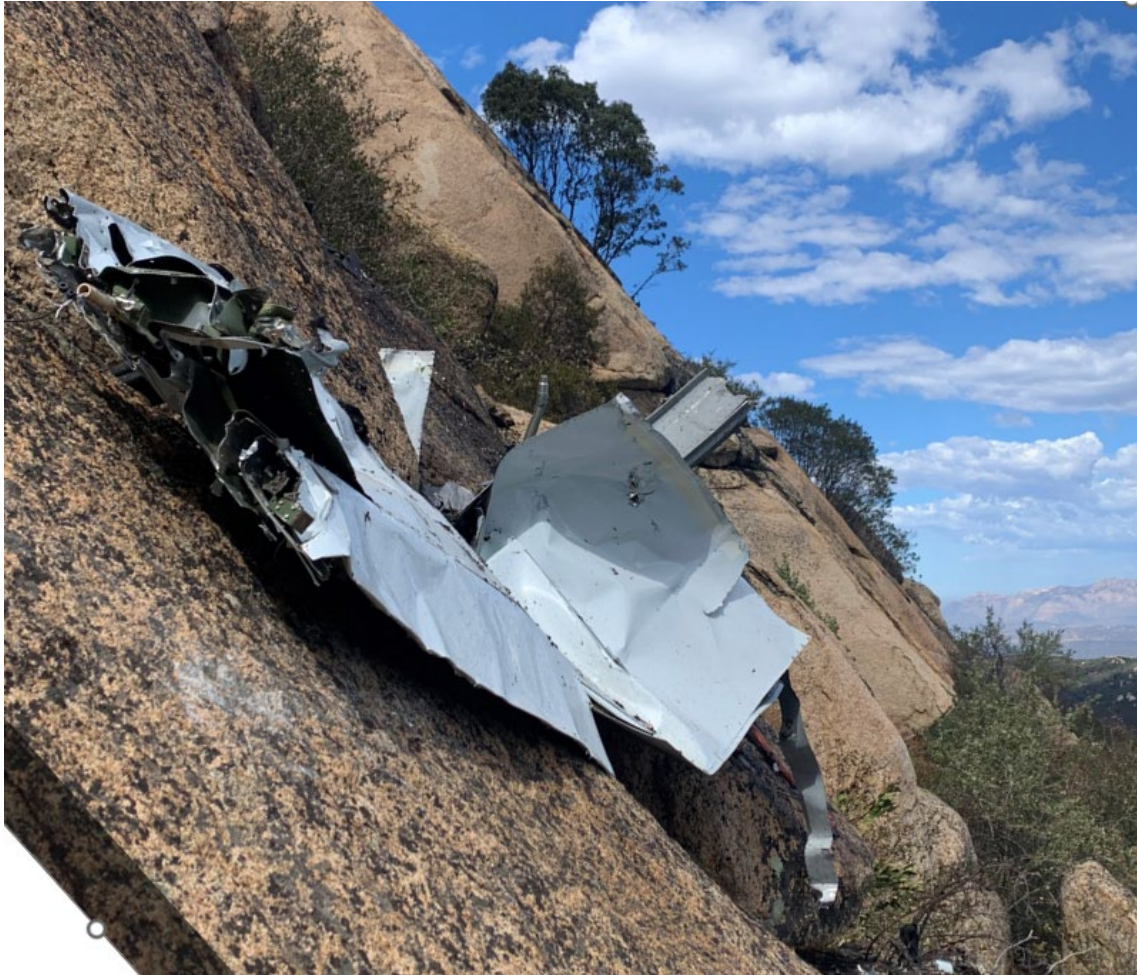
Figure 6. View of damaged wing section that came to rest on rockface

A section of the wing was found on about a 45°-50° rockface in mountainous terrain. Accessibility was not feasible due to safety concerns.

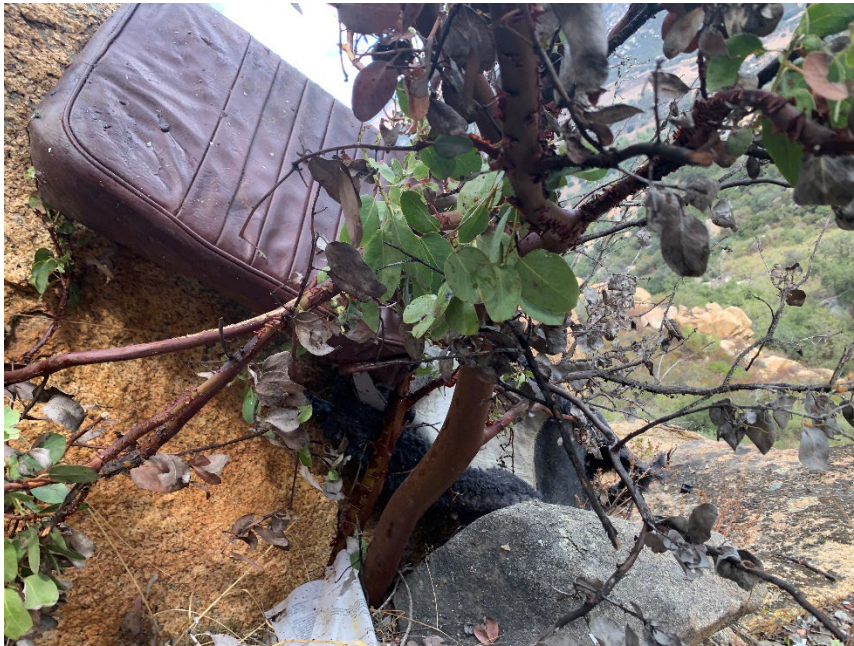
Figure 7. View of seat cushion stuck in vegetation

A seat cushion was located within vegetation on the rockface.
