NATIONAL TRANSPORTATION SAFETY BOARD
Office of Aviation Safety

ACCIDENT/ENGINE EXAM FIELD NOTES

A. ACCIDENT WPR22FA215

Location: Buckeye, Arizona
Date: June 18, 2022
Time: 0654 mountain standard time (MST)
Operator: Daniel Keen, Owner
Aircraft: Beech E-35
Registration: N-13AR

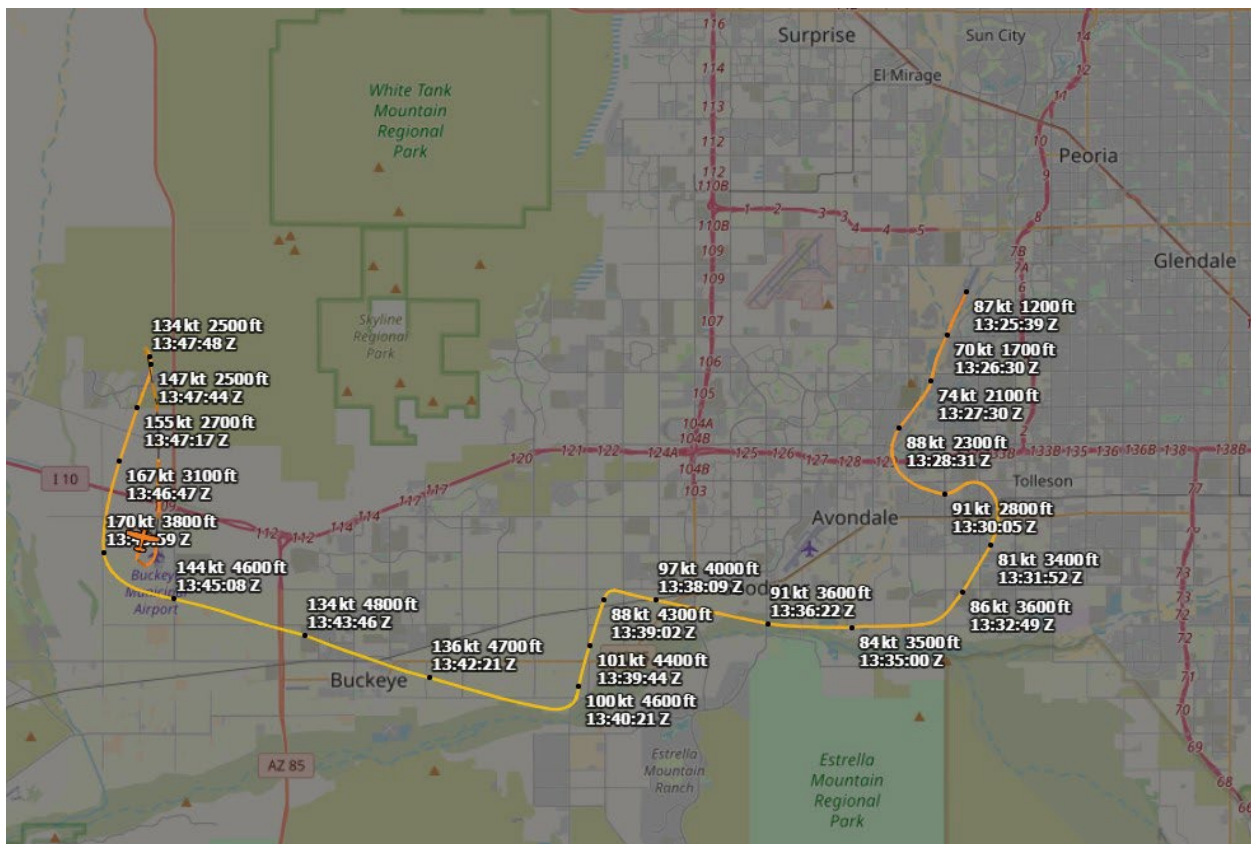
Figure 1 – ADS-B Flight Track

Automatic Display Surveillance – Broadcast (ADS-B) data indicates that the accident airplane departed runway 19 at Glendale Municipal Airport (GEU), Glendale, AZ about 0625. After departure the airplane made a left turn out to the east briefly, then back right to a SE heading before turning right again and traveling west-northwest, making one jog to the southeast briefly then back to a west-northwest heading. At about 0645, the airplane passed south of the Buckeye Municipal Airport (BKK), then turned right to a northerly heading. When the airplane was about 5 miles north-northwest of BKK, it made a descending 270° turn to the left, then turned right and traveled southbound consistent with a straight in approach to runway 17 at BKK. The aircraft track and altitudes were consistent with a low approach before the airplane made a right turn about midpoint of runway 17 and continued to a downwind heading. The flight track then angled to the northeast before it indicated an increase in the right turn until track data was lost at about 0654, near the reported wreckage location northwest of the approach end of runway 17 (figures 1-3).

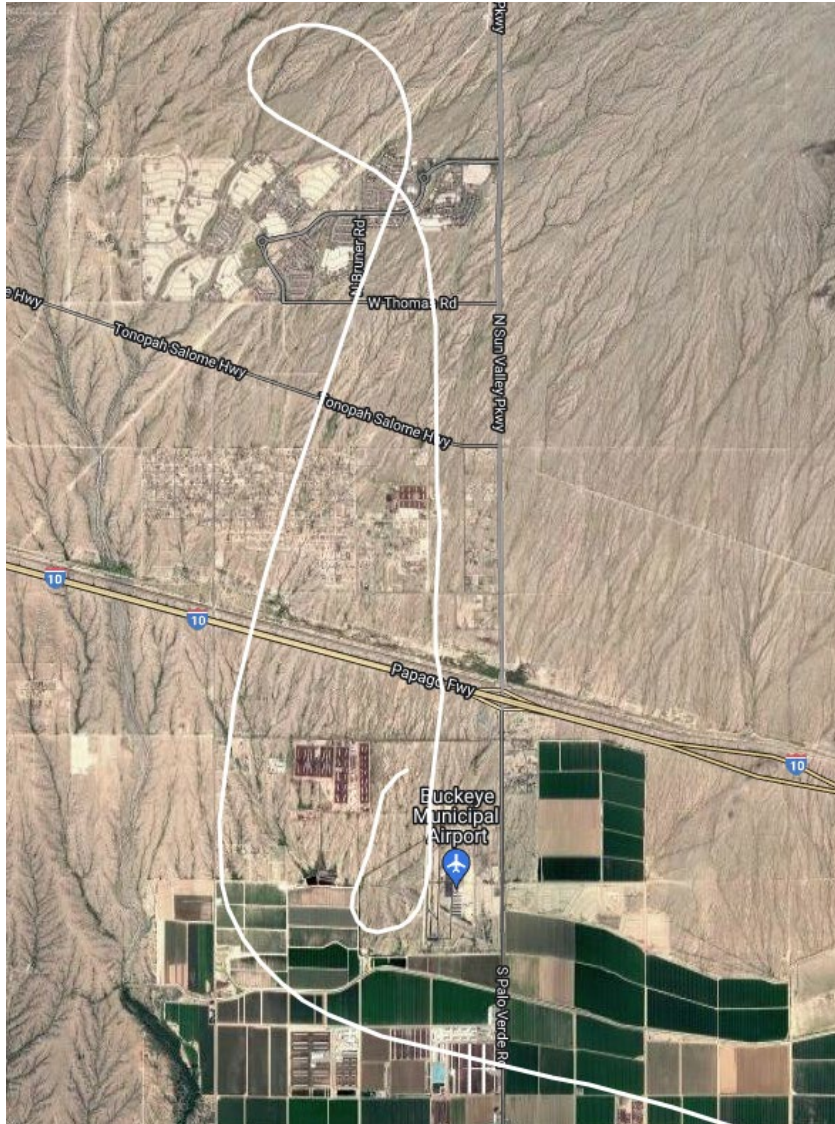
Figure 2 – Flight Path (VirTower Generated)

Note: The airport (BKK) was equipped with a VirTower airport operations tracking system. Airport personnel provided the image in figure 1 showing the accident airplane's flight path. Personnel were unable to provide the source data for flight path depicted in the image.

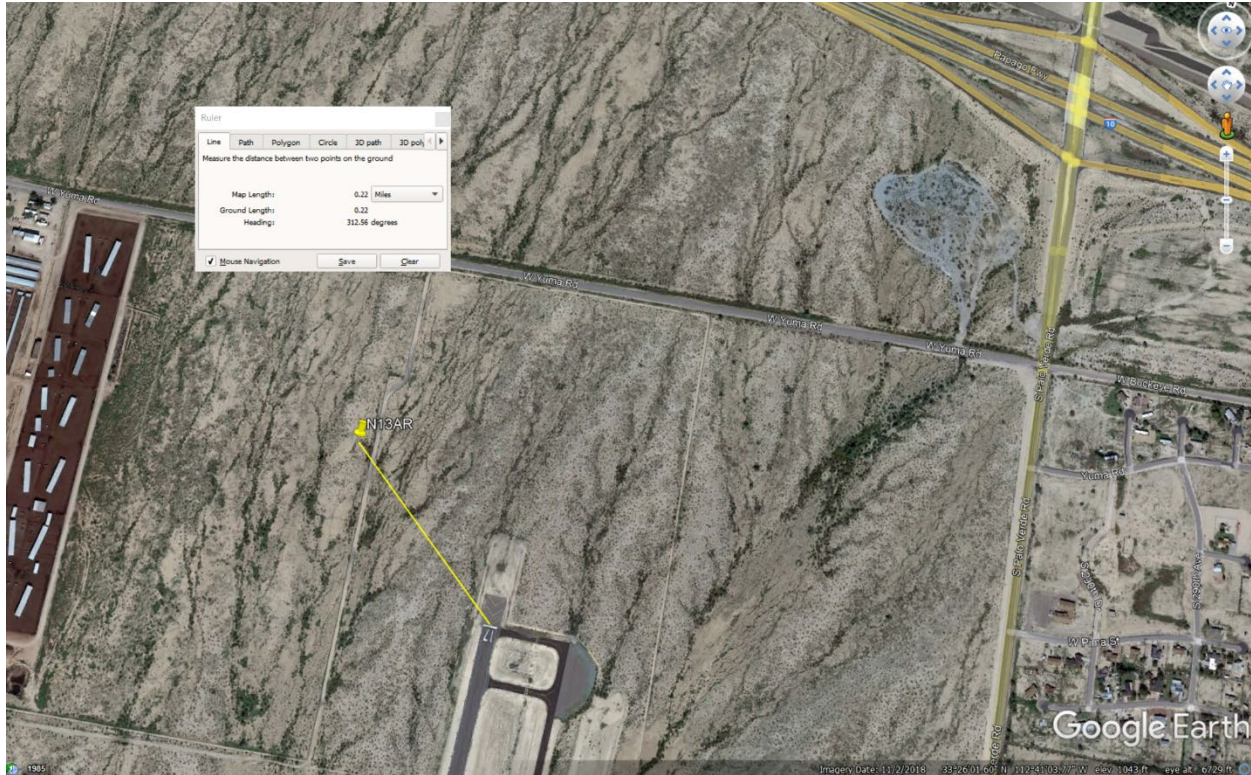
Figure 3 – Accident location

The airplane impacted flat, sparsely vegetated desert terrain bearing 313° and .22 miles from the approach end of runway 17 (figure 3). The aircraft impacted left wing first followed by the engine. A propeller cut mark was observed in the dirt near the engine impact crater. The aircraft then came to rest nose down on a heading of 158° . A post impact fire consumed a majority of the fuselage. The outboard 1/3 of the left wing along with a majority of the left aileron separated during the impact sequence. Both wing leading edges exhibited aft crushing damage with the left wing being crushed further aft.

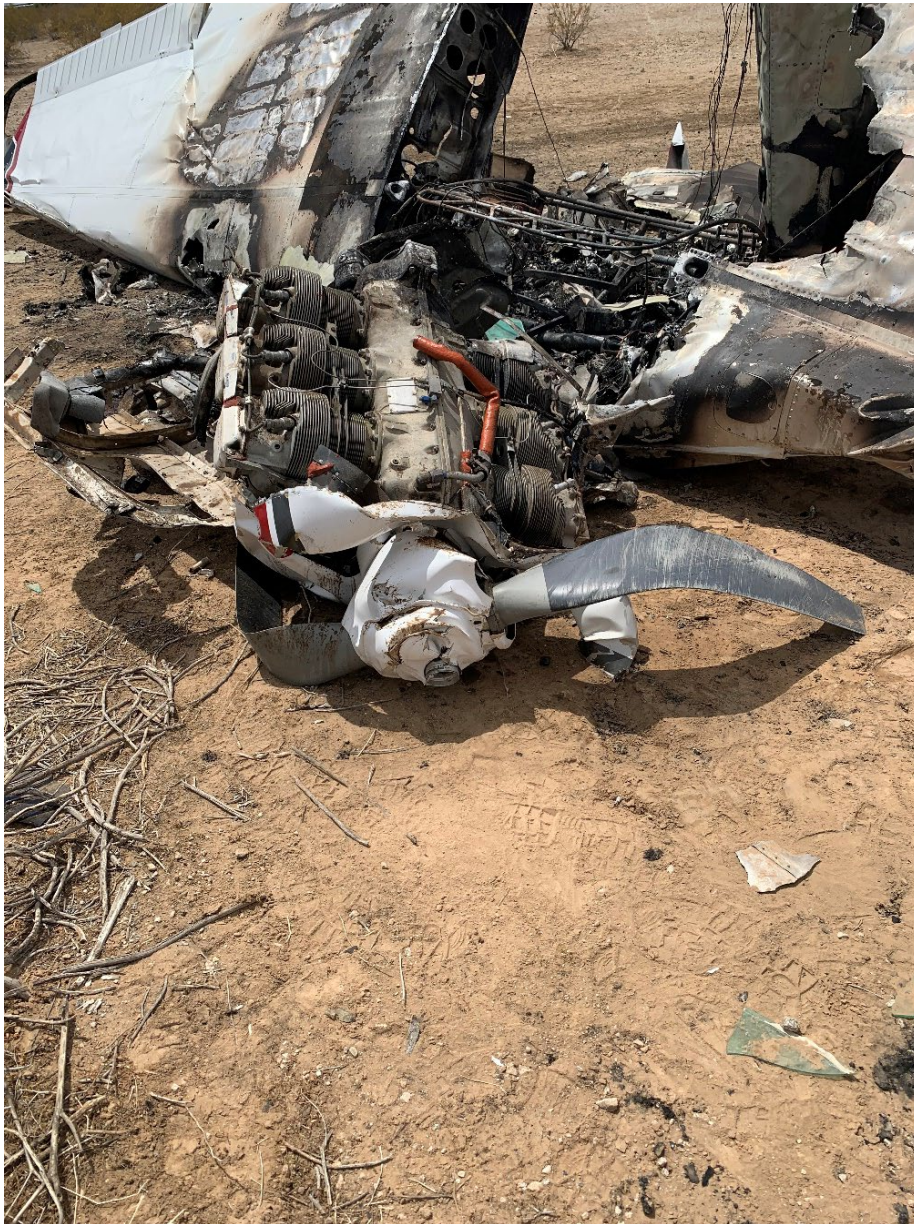
Figure 6 – Propeller Blades and Engine

Both propeller blades exhibited leading edge polishing and chordwise scratches. One blade was bent aft about 45° near the midpoint of the blade and was loose on the hub. The second blade was bent aft about 80° about 1/3 the length of the blade outward from the hub. See Figure 6.
