## **NATIONAL TRANSPORTATION SAFETY BOARD**

### **Field Report**

**WPR19FA086**

Aircraft: Beech D55, Registration Number: N533Q, Serial #: TE-616

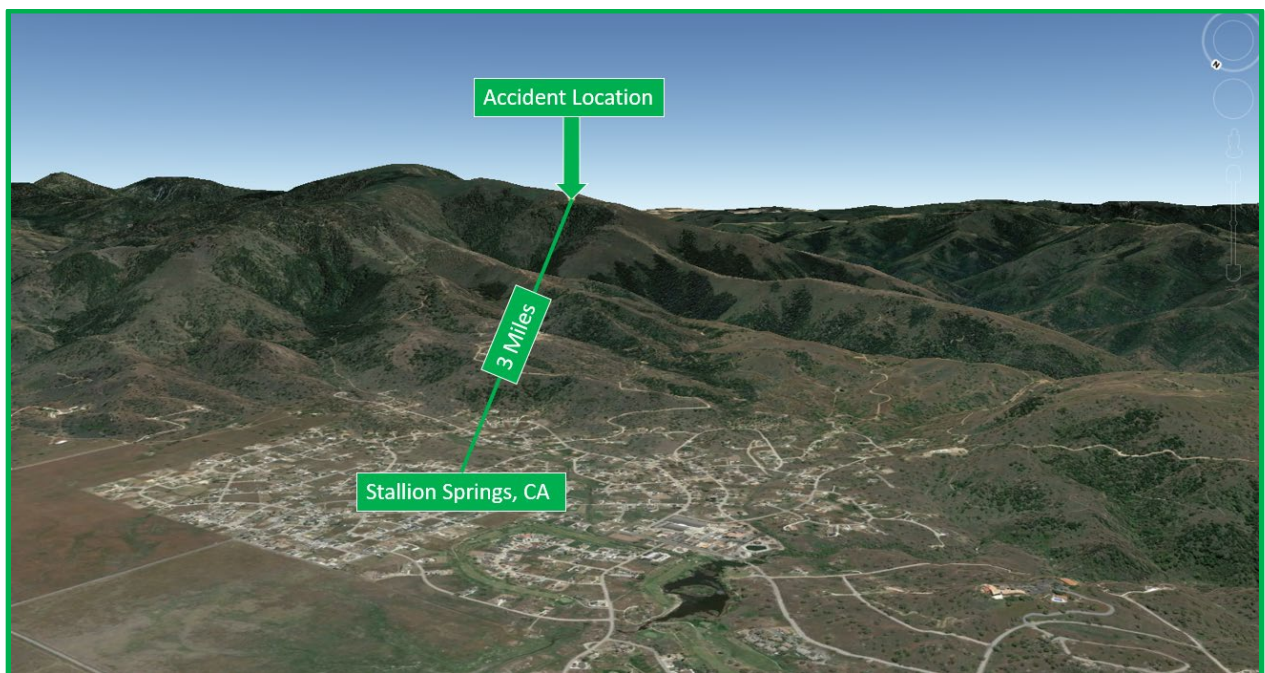
The airplane impacted rising terrain about 3 miles southeast of Stallion Springs, California.

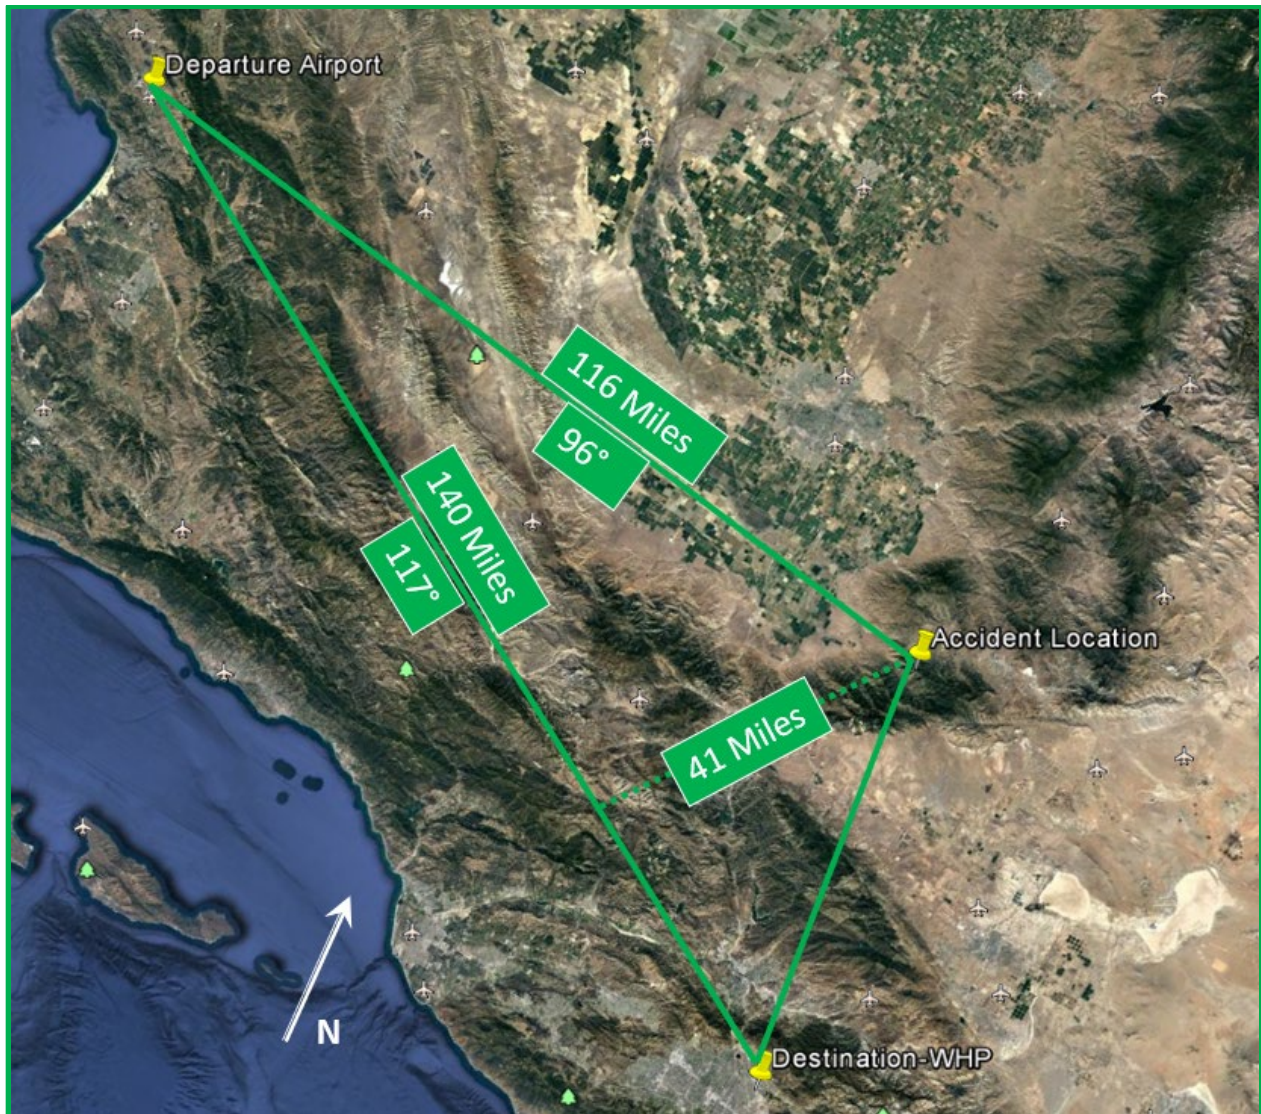
A review of the flight route revealed that the pilot deviated from his course about 41 miles east.

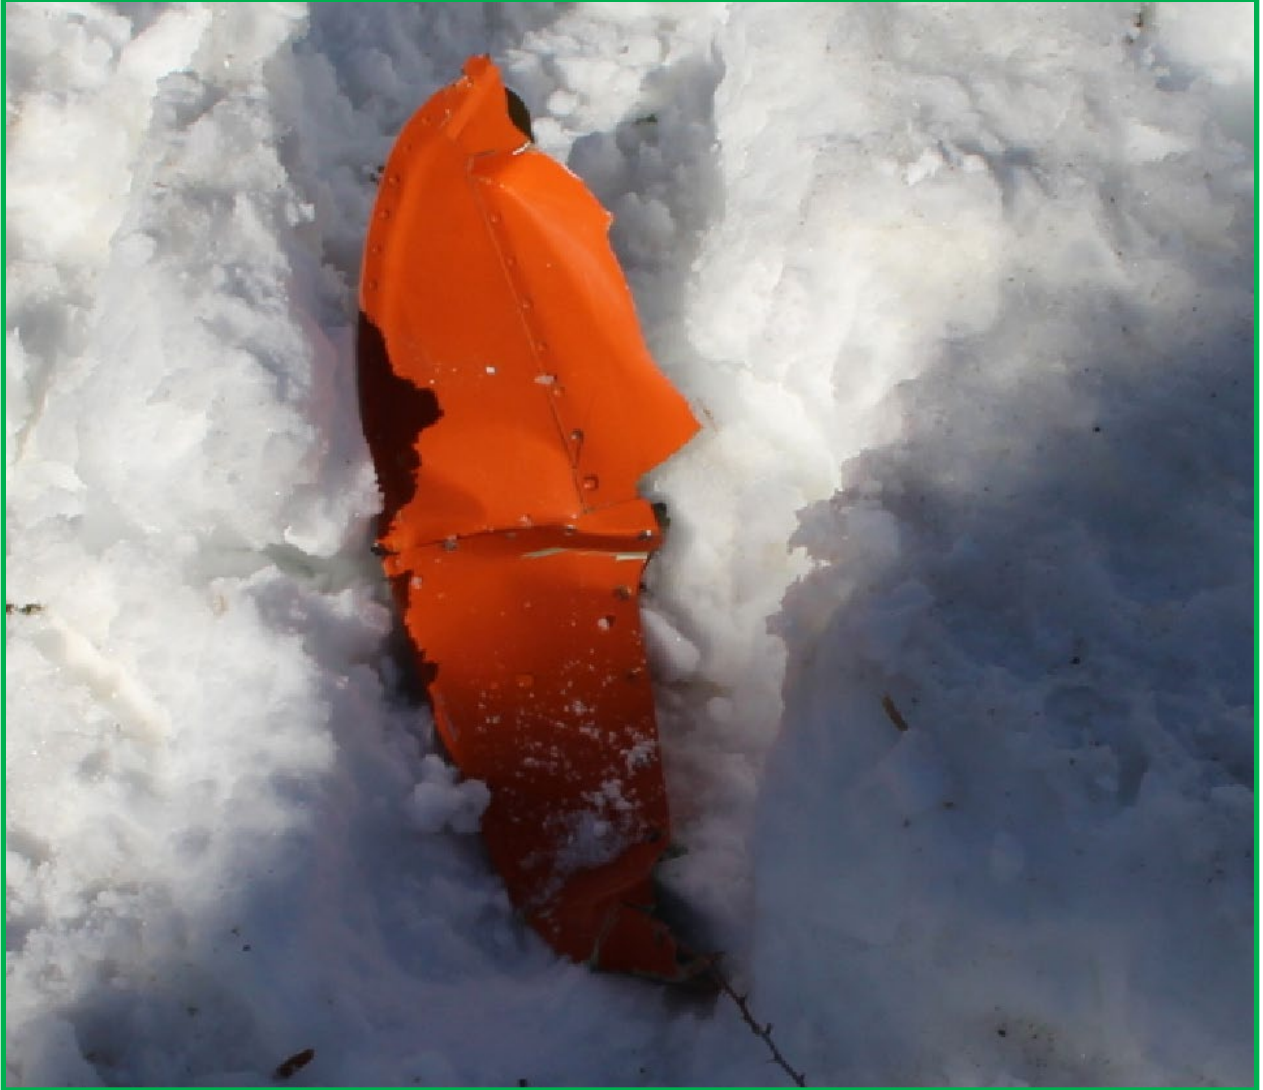
Figure 6: View of left elevator tip.

The initial impact point (IIP) was identified as a tree about 30 ft high. The top of the tree had recently been broken. A second tree that appeared to have been topped (broken) was identified about 20 ft from the IIP in the direction of travel. The first identified piece of wreckage was a fragment of the left elevator tip, which was about 140 ft in the direction of travel from the second tree that was topped.

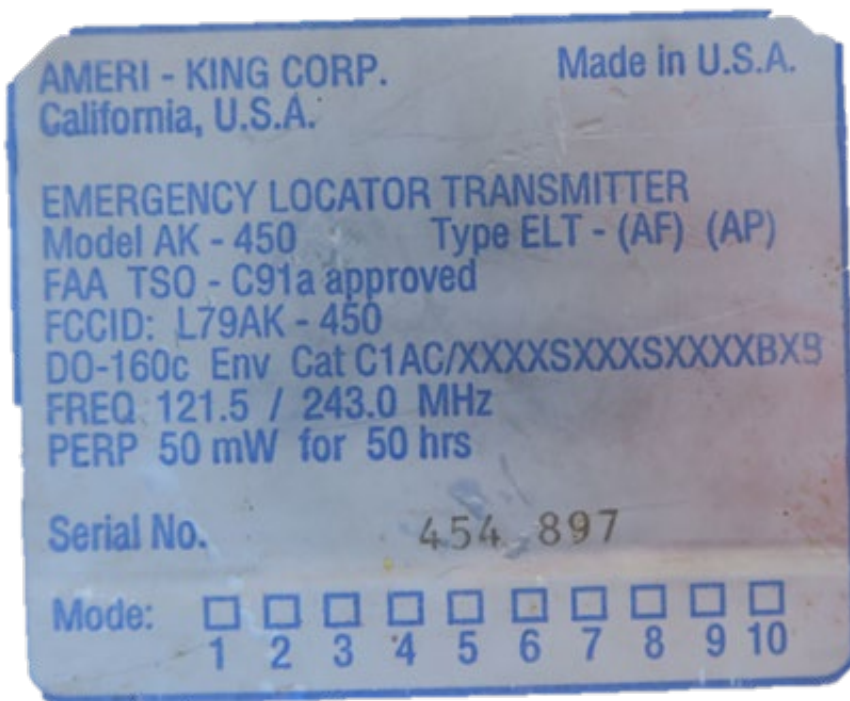
The fuselage split into two main pieces. The aft fuselage was found about 100 ft north of the forward fuselage/cockpit and consisted of the area from about fuselage station (FS) 100 aft to about FS 257. The ELT was found connected inside the fuselage.

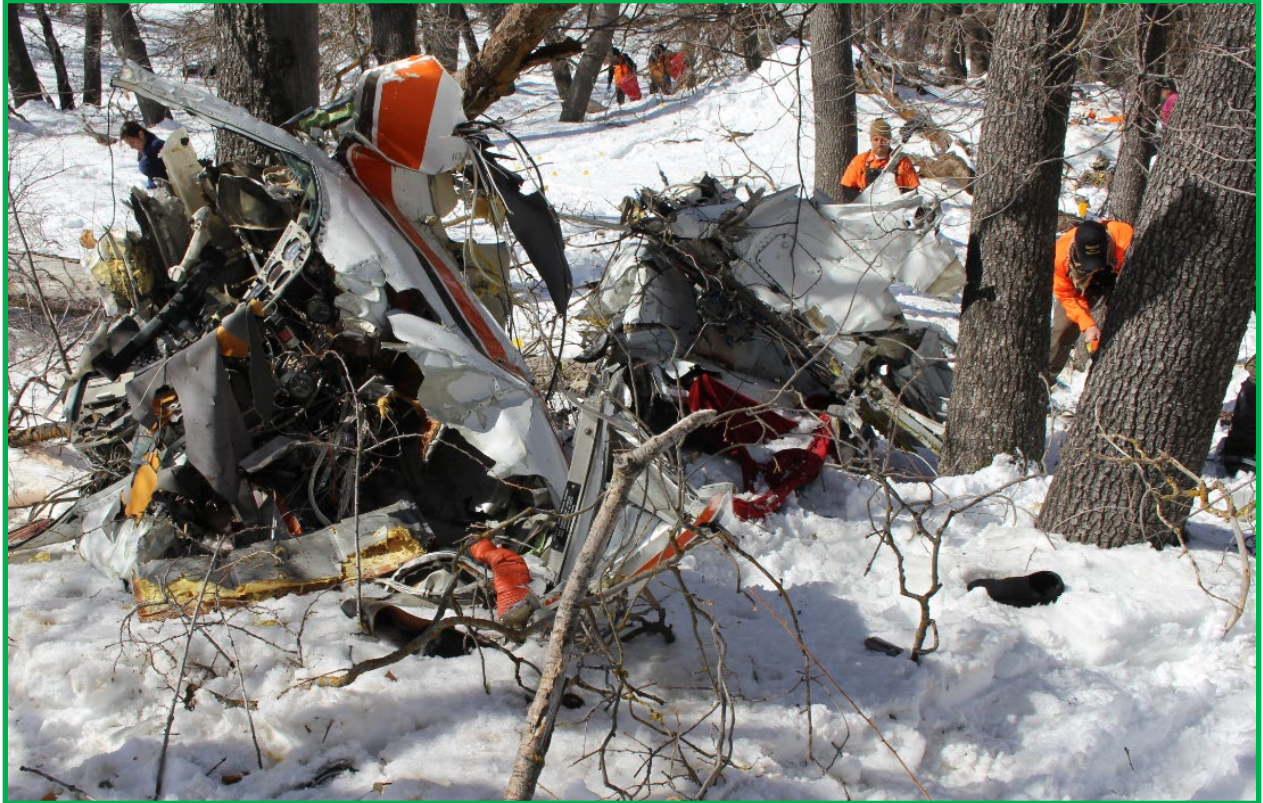
The cockpit area was the last piece of wreckage found in the debris path. The cockpit consisted of the fuselage area forward of FS 100.
