National Transportation Safety Board

PLD23LR002

EMERGENCY RESPONSE

Specialist's Factual Report - Supplemental

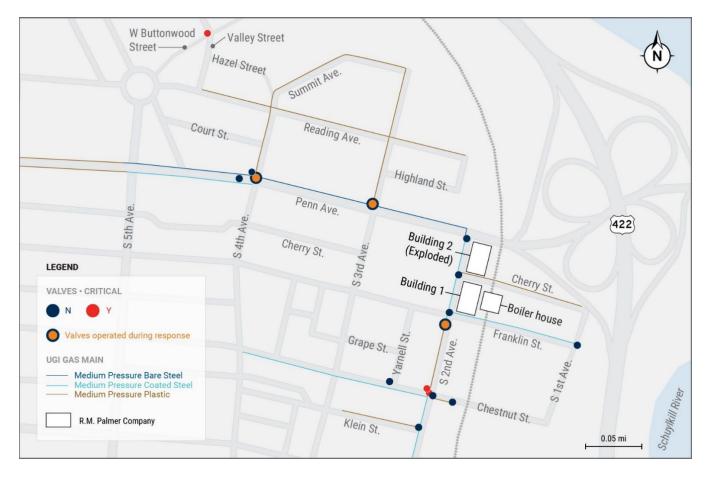
- South Second Avenue and Franklin Street valve would shut off gas flowing south from the South Second Avenue main. This valve was closed during the incident.
- South Second Avenue and Penn Avenue would shut off gas flowing west to east through the Penn Avenue main. This valve was not closed during the incident.
- South Third Avenue and Penn Avenue would shut off gas flowing north to south from the Summit Avenue main. This valve was closed during the incident.
- South Fourth Avenue and Penn Avenue would shut off gas flowing west to east through the Penn Avenue main. This valve was closed during the incident.

Figure 1: UGI distribution valves closed in response to the March 24 incident

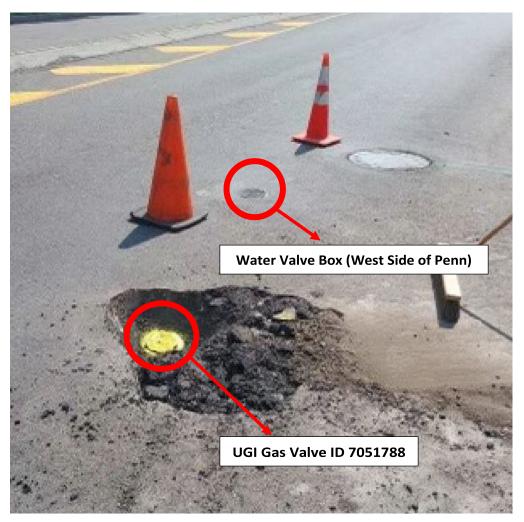
In July 2024, UGI excavated the Penn Avenue main near South Second Avenue. UGI reported to the NTSB that the distribution valve at South Second Avenue and Penn Avenue could not be located during emergency response efforts on March 24, 2023, because it had been paved over (see Figure 2). The company confirmed that this valve was the appropriate valve to isolate the distribution system at the accident site on March 24.

Figure 2: UGI excavation of gas valve ID 7051788 and its proximity to a water valve on Penn Avenue in July 2024 (*Photo courtesy of UGI*)

UGI reported that they are reviewing their valve maintenance procedure to include instructions for employees when they encounter a third party valve covers that are mistakenly marked as gas. The revision will be issued by December 31, 2024, and will take effect for UGI's 2025 valve inspection program. ⁶

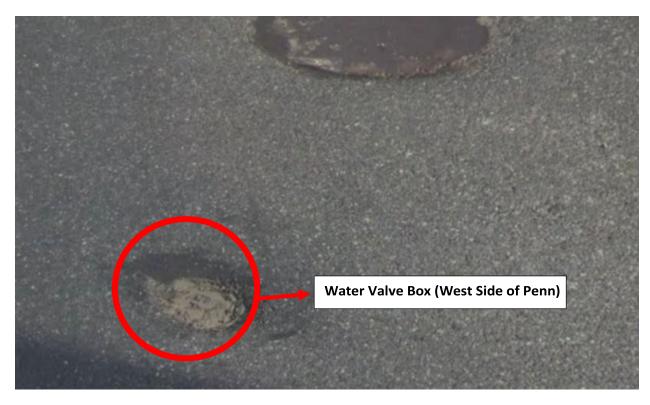
UGI also reported that UGI first responders, who reported a mismatched valve identification number during the response, had mistaken one of two water valves as a gas valve. UGI reviewed a 2018 google photo that identified a lid of one of the water valves had the letters "G" and "A" (See Figure 3). Because of mislabeled lid, the

company reported to the NTSB their responders mistook the water value as a gas value that had a wrong value identification number. They decided to leave it due to the uncertainty of the value and go to the next two values needed to isolate the distribution system. ⁵

Figure 3: Close up of a water valve lid from a 2018 google photo (Photo courtesy of UGI)

⁵ UGI contacted West Reading Borough officials on September 12, 2024, to inform them of the incorrectly marked lid found on their water valve box located at Penn Avenue and South Second Avenue. On September 12, 2024, the Borough replaced their water valve box lid with the appropriate designated lid.
