National Transportation Safety Board Aviation Accident Final Report

Location:	Windsor Locks, Connecticut	Accident Number:	ERA20MA001
Date & Time:	October 2, 2019, 09:53 Local	Registration:	N93012
Aircraft:	Boeing B17	Aircraft Damage:	Destroyed
Defining Event:	Landing area undershoot	Injuries:	7 Fatal, 5 Serious, 2 Minor
Flight Conducted Under:	Part 91: General aviation - Other work use

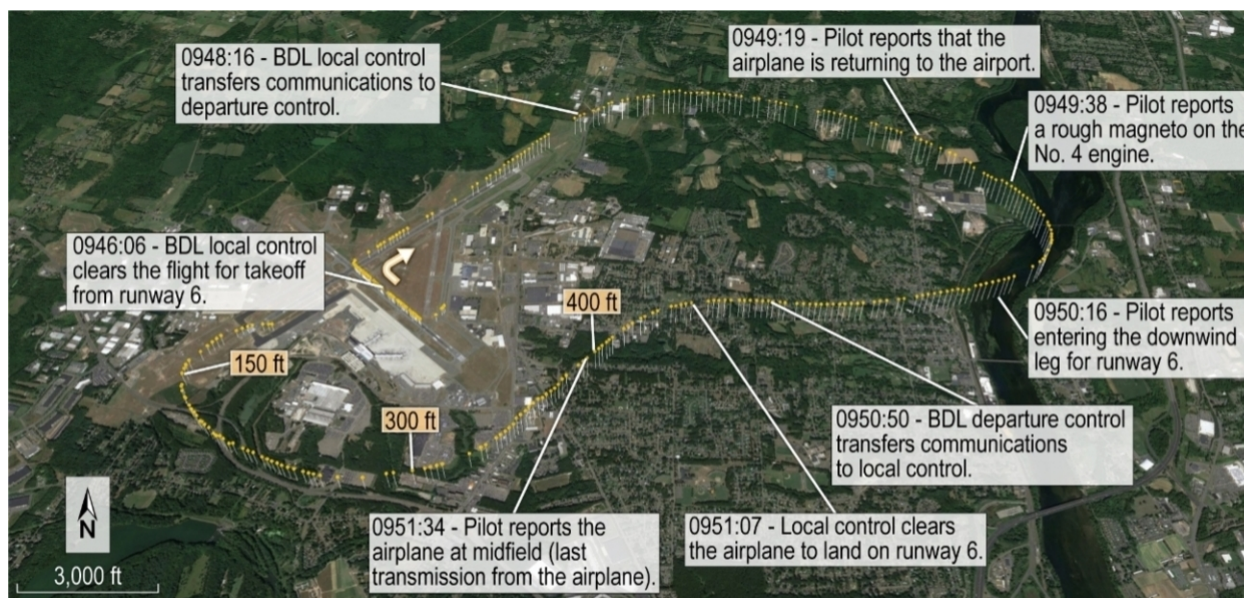
Figure 2. ADS-B-derived flightpath and select voice radio transmissions

The airplane was descending through an altitude of 300 ft as it turned onto the base leg of the traffic pattern for runway 6. The airplane then turned onto final approach at an altitude of 150 ft; at that time, the airplane was about 0.4 nautical mile from the runway threshold. Figure 2 depicts the airplane's ADS-B-derived flightpath overlaid onto aerial imagery of the airport and surrounding area along with relevant voice radio transmissions between air traffic control (ATC) and the airplane.

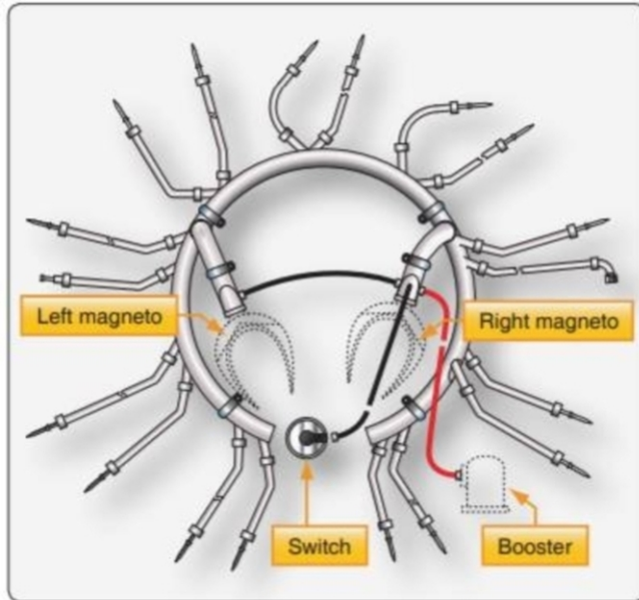
Figure 6. Radial engine ignition system.

Teardown examination of the No. 4 engine revealed no evidence of abnormal combustion or detonation on the cylinders or pistons. The left magneto's P-lead (the electrical connection between a magneto and the cockpit ignition switches) was partially pulled out of the magneto housing, and the grounding tab was in contact with the housing. Figure 6 shows a generic radial engine ignition system (similar to the one on the accident airplane) and the location of the left and right magnetos (for informational purposes only.) A single strand of safety wire was observed around the retaining nut. A functional test of the magneto showed that the contact between the grounding tab and the housing resulted in the magneto being shorted to ground and unable to function. When a piece of cardboard was placed between the grounding tab and the housing, the ignition leads for all nine cylinders produced a strong spark when the drive spline was rotated.

The right magneto's P-lead was partially engaged in its fitting, and the grounding tab did not contact the magneto housing. The right magneto's gap between the points was 0.004 inch, which was less than the minimum gap (0.008 to 0.010 inch) that the manufacturer required. When the magneto was tested, the ignition leads for the No. 8 cylinder did not spark; the ignition leads for the other eight cylinders produced sparks that were weak and intermittent. In addition, the right magneto's compensator cam and associated cam follower were worn.
