## Component Failure Investigation Final Report

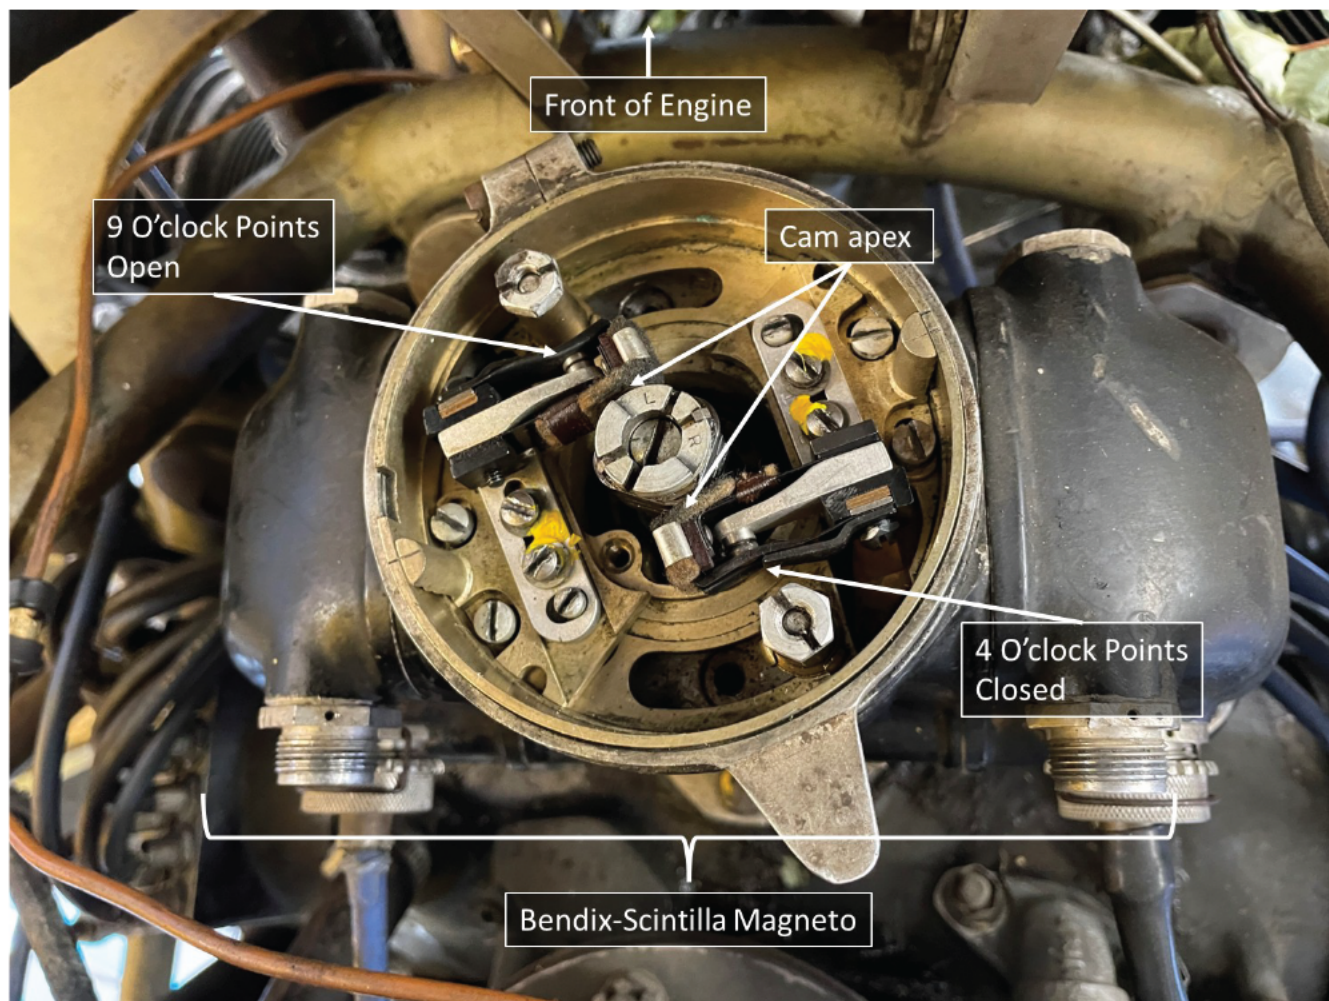
**Figure A**

On May 7, 2024, Fabian Salazar with the National Transportation Safety Board (NTSB) requesting assistance in a accident investigation in which he believed a magneto failure was the cause. He indicate, in an email from May 8, 2024 that, during an initial engine exam, one set of breaker points would not open even though the cam pushed on the cam follower whiled the other set of points did open. He included a photo, Figure A, with the question, "If one set of points does not open on a dual points system, how would that effect the firing on the spark plugs?" In response to this question on May 9, 2024 we stated, "Looking at the picture one set of points looks burned. If that is the case, the condenser would have been bad and would cause the magneto to miss fire. This would make the engine run extremely rough. If a set of point is not opening, one bank of spark plugs would not fire causing the engine to run on only one set of spark plugs. It also would cause the engine to run rough. Depending on which magneto model this is, the points may be staggered where one opens right after the other and not at the same time." These statements were made prior to receiving and inspecting of the magneto and were based only off of the photo and information provided by Fabian.

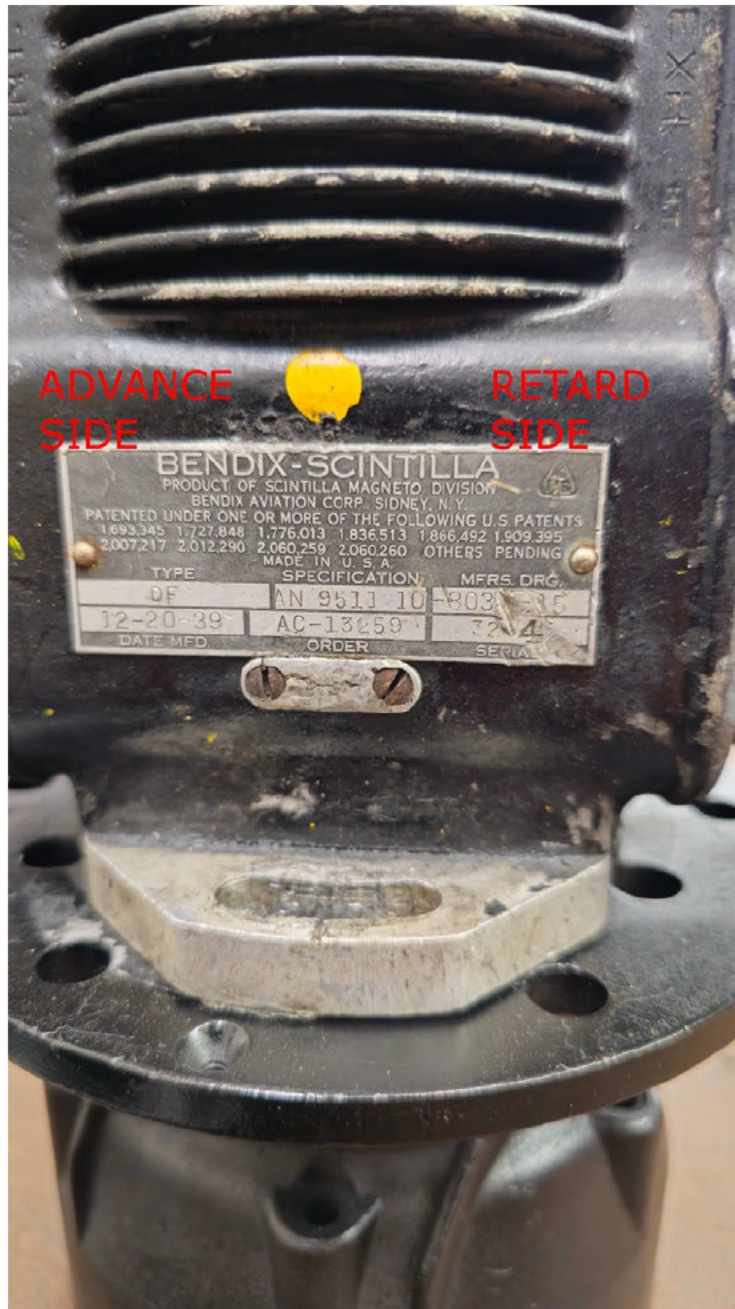
**Figure B**

Throughout this report the various components of the magneto will be referred to as retard and advance. For ease of reference the parts referred to as retard will be considered to the right of the center line of the data plate affixed to the magneto and those referred to as advance will be to the left. When applicable, the attached figures will be labeled for convenience Figure B.

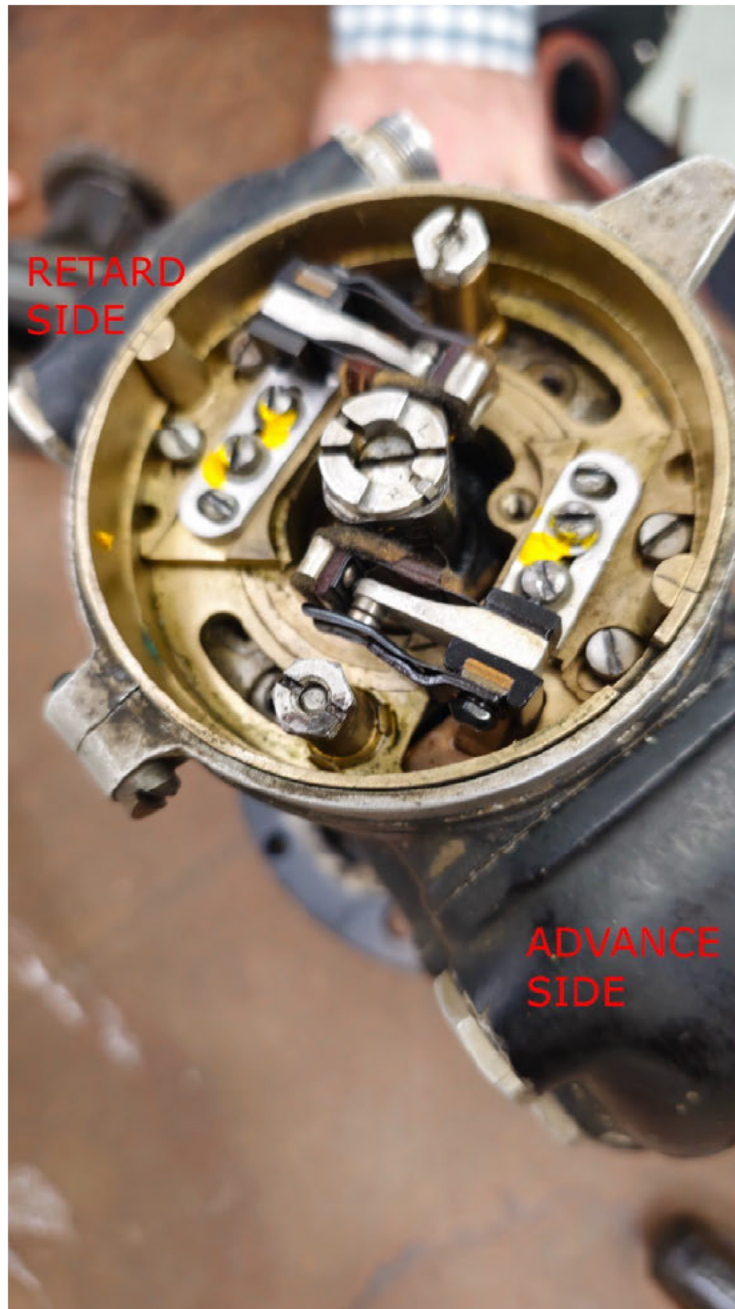
**Figure C**

The point cover was removed from the magneto and the the points were visually inspected Figure C. It was found that the the retard points appeared to have grease or oil burned onto the points and that the points themselves were not burned. The points were cleaned. It was found that the screws which hold the advance points in place were loose which caused the advance points to back away from the cam causing their timing to become off Figure D. It appears that the advance point screws were never tightened during the previous overhaul as the yellow tamper indicator was still intact, however it fell off when the advance screws were tightened prior to performing a bench test.

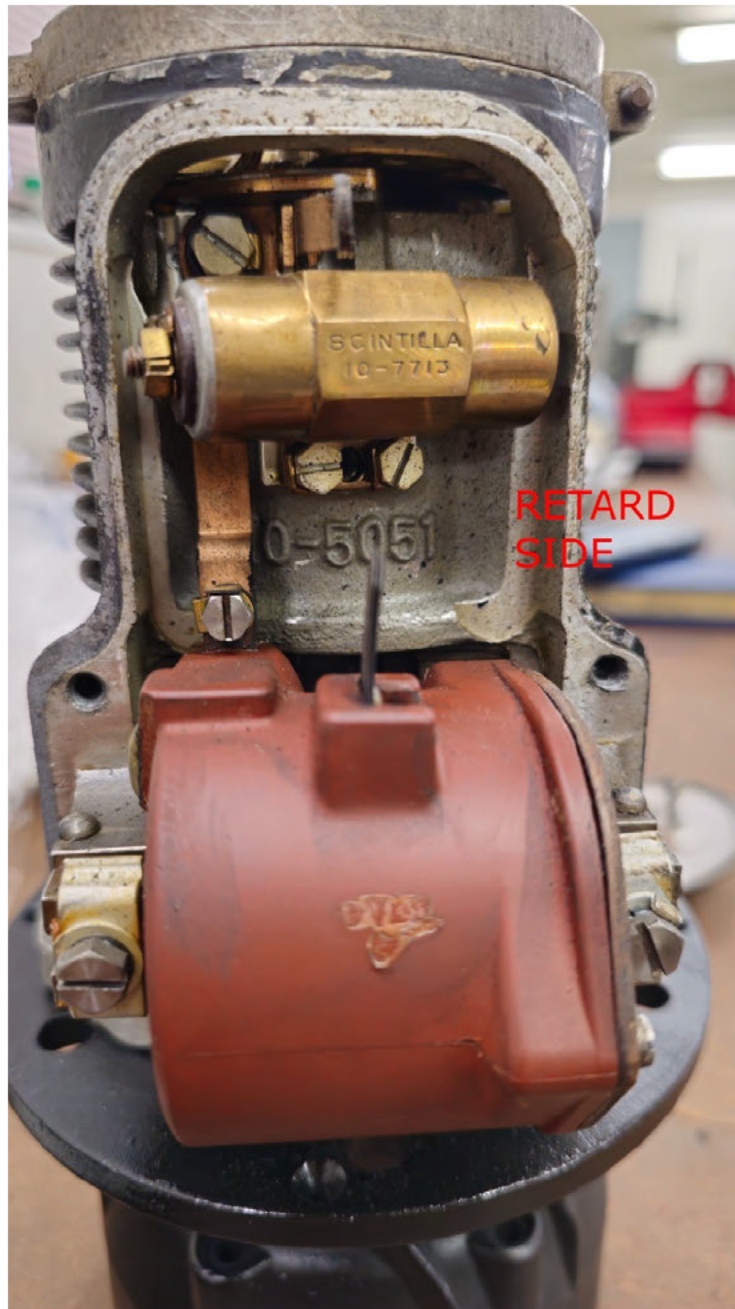
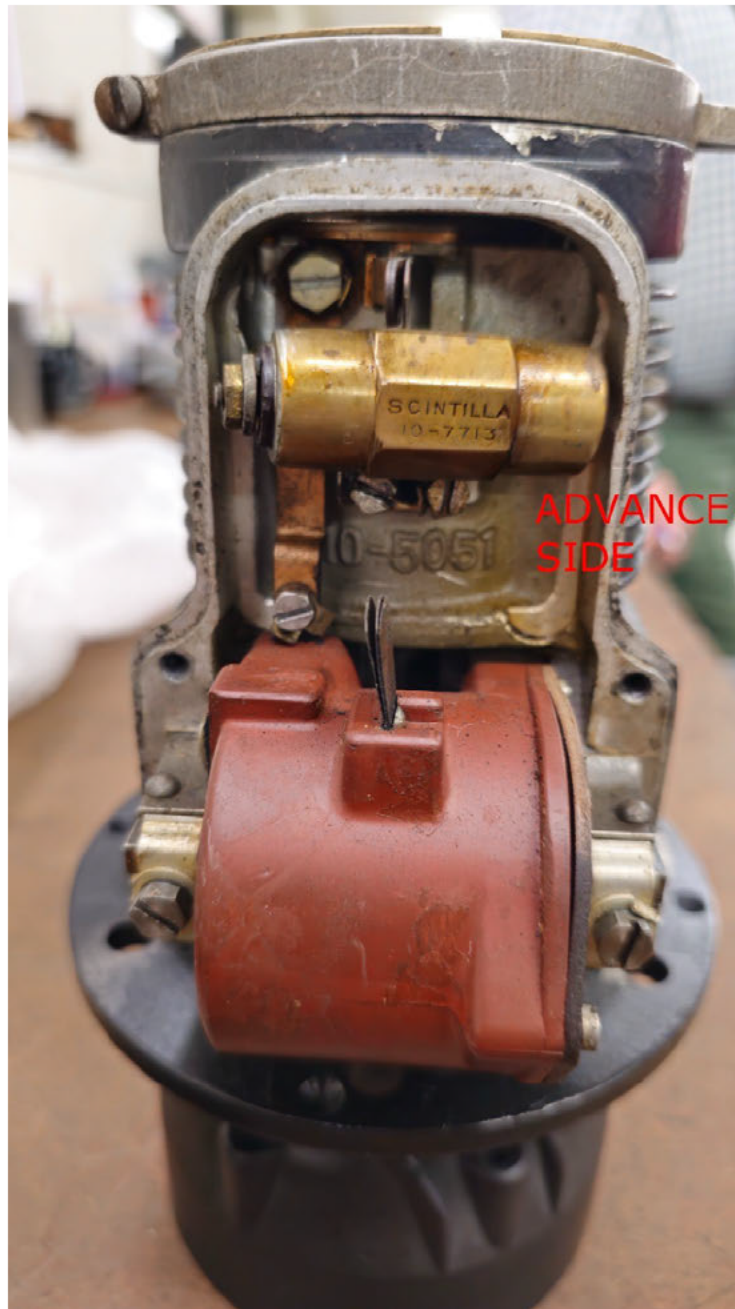
Both the advance and retard coil covers were removed prior to testing for inspection Figure E and F. Upon removal of the advance side coil cover, a P-lead spring fell out. Inspection of this spring indicated that it was not the correct part, and appeared to be modified to fit this magneto by the installing mechanic, or potentially left in the magneto during previous MRO activities. It is within a small margin of possibility that the spring being loose inside the coil area could have caused none, intermittent or complete grounding of the advance side preventing ignition if the magneto was firing during flight. While we can't rule out the possibility of this being a contributing factor of malfunction, it is our opinion that this is very unlikely due to the previously mentioned and the following finding as reported herein.

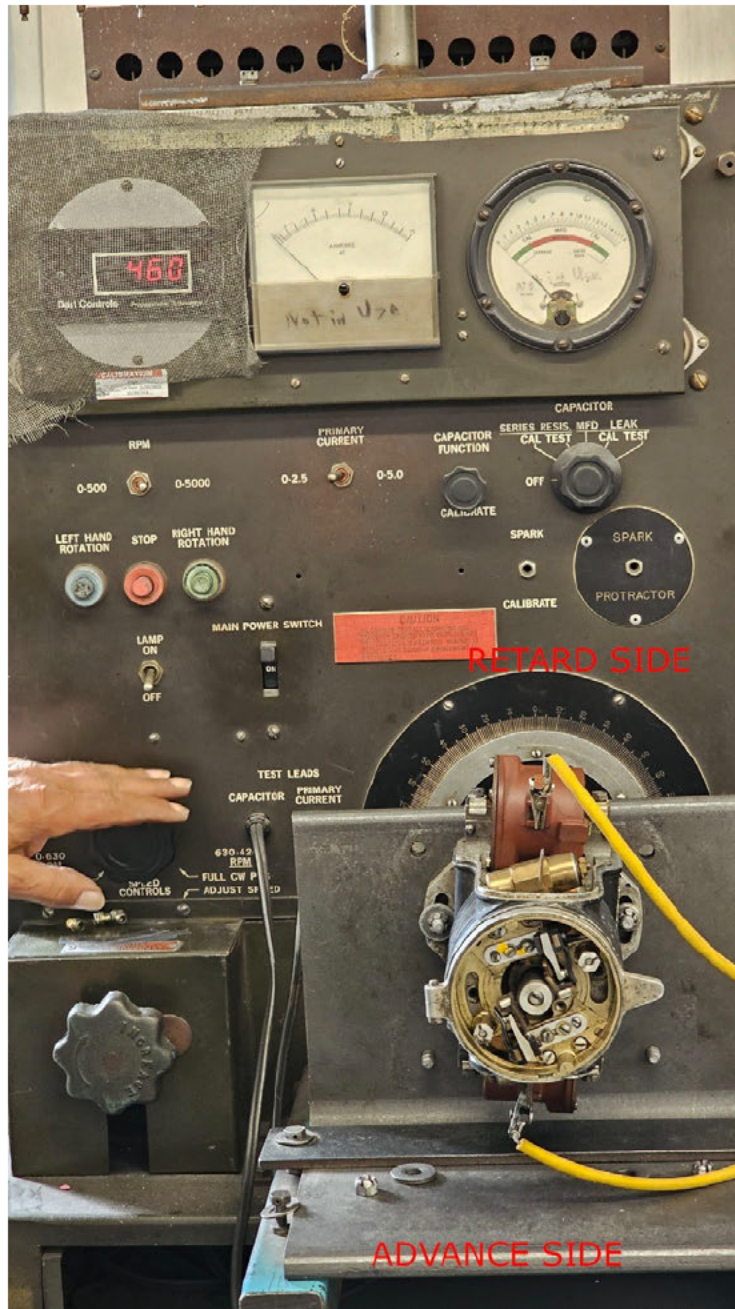
**Figure G**

The magneto was installed on the test bench and given a preliminary test. The test showed that the magneto was firing on the retard side and began firing at 400 to 500 RPM, however, it is required by the maintenance manual to begin firing consistently at 280 RPM for the retard points Figure G. The advance points did not fire at all, but should have begun firing consistently at 180 RPM.

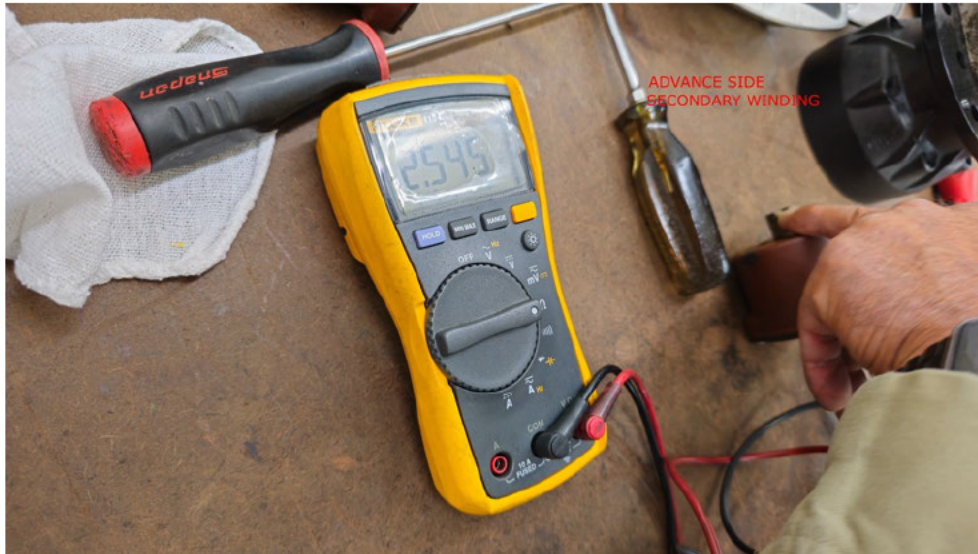
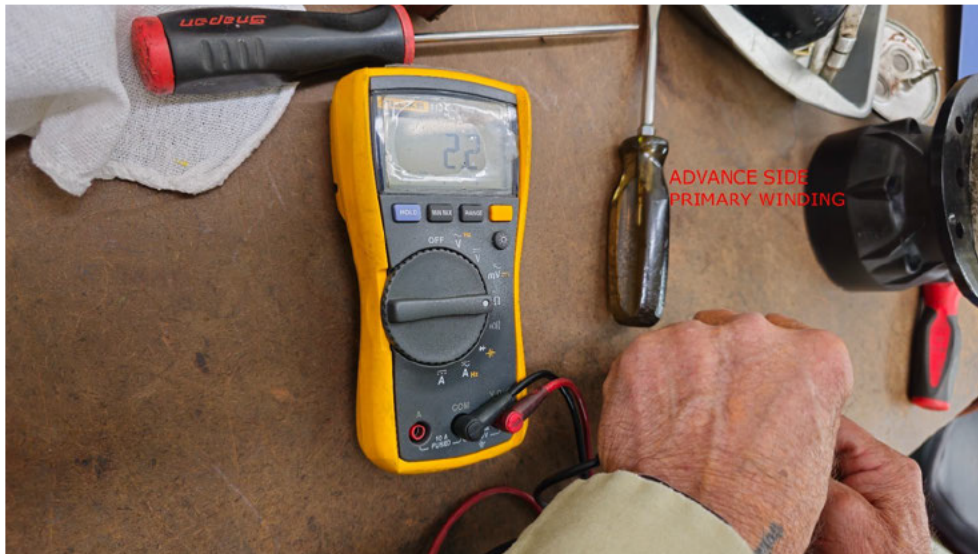
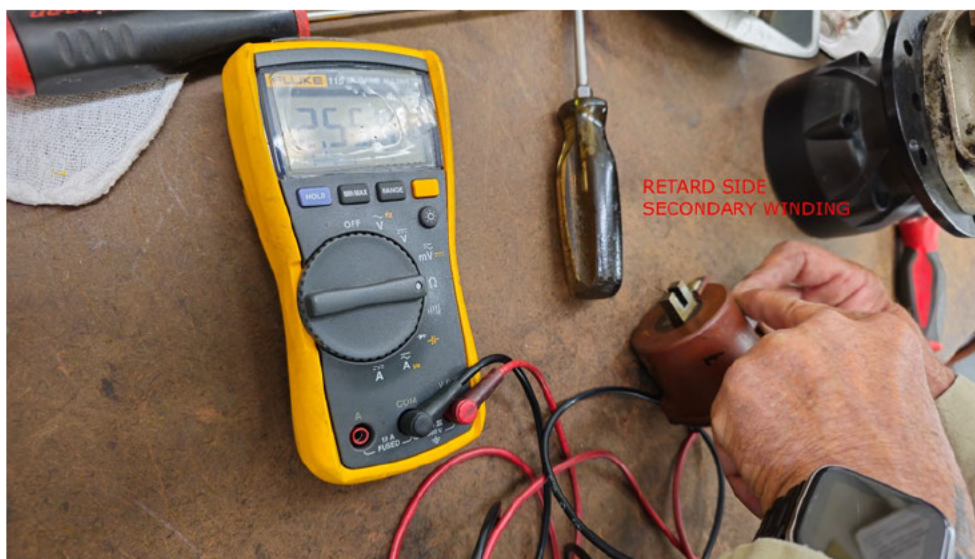
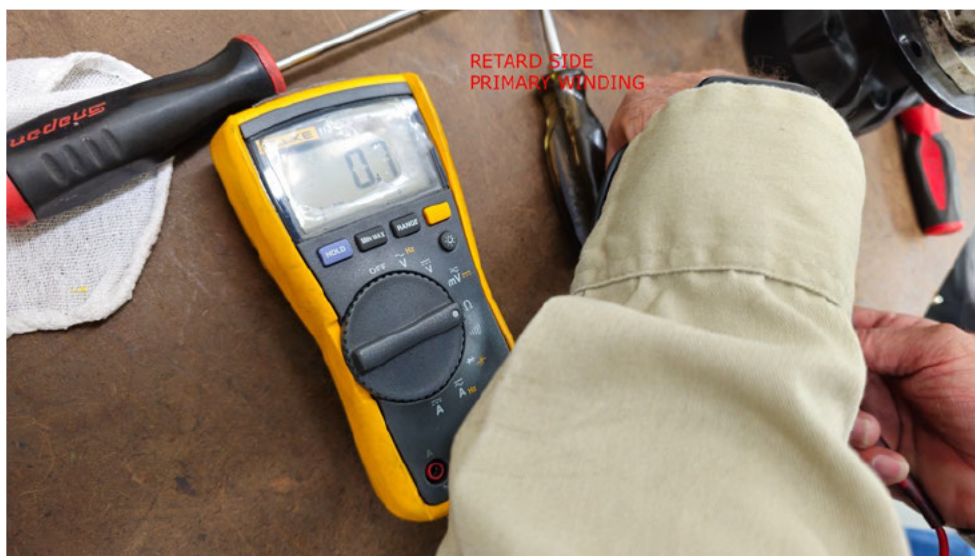
The magneto was removed from the test bench and was further inspected. The coils were removed and the resistance was checked. The secondary winding resistance of the retard coil was 2,545 $\Omega$  Figure H and the primary winding resistance was 2.2 $\Omega$  Figure I. The secondary winding resistance of the advance coil was 2,554 $\Omega$  Figure J and the primary winding resistance was 0.7 $\Omega$  Figure K. Both coils were found to be in tolerance with the maintenance manual for the secondary winding (2,000 $\Omega$  to 4,000 $\Omega$ ), there is no resistance requirement for the primary winding.

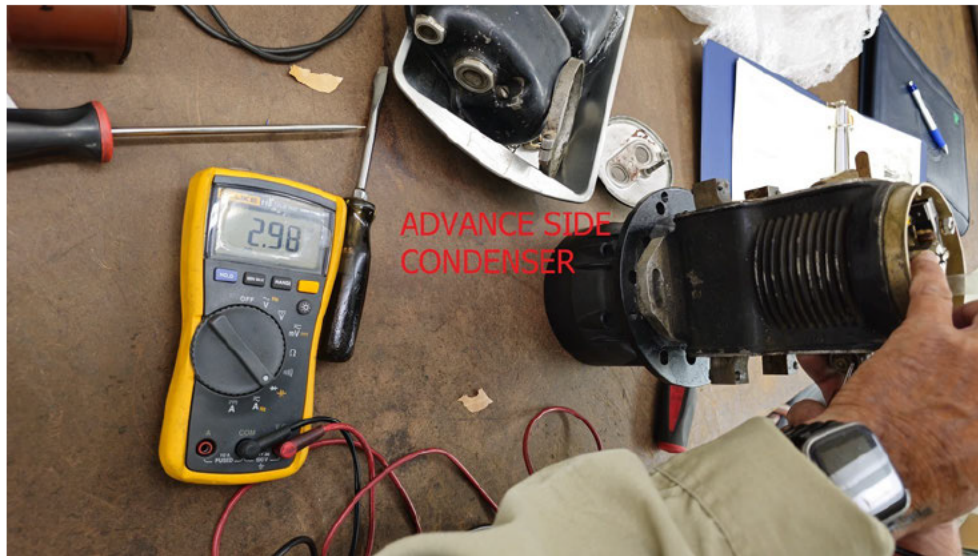
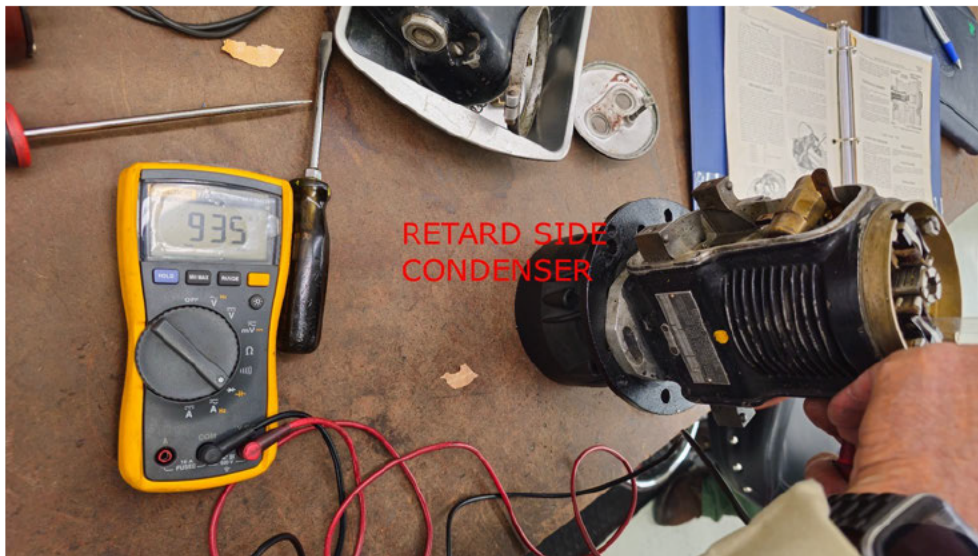
The condensers were checked and the advance condenser was found to be bad and had a value of 2.98 $\mu$ F Figure L, while the retard condenser was found to have a value of 0.935 $\mu$ F Figure M which is higher than it should be but would still be functional. There is no specification of values for the condensers in the maintenance manual, only to use a condenser tester. From many years of experience working on magnetos, we know that a value for the condenser in these magnetos should be around 0.425 $\mu$ F.
