Issued: 6/26/2023 Preliminary Report HWY23FH013

Roadway Departure and Crash with Parked Vehicles

Millersburg, Oregon May 18, 2023

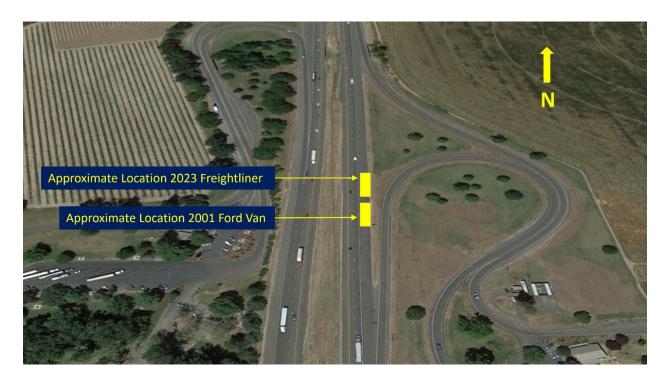
Figure 1. Aerial view of I-5 at the North Santiam rest area showing the approximate location of the 2023 Freightliner and the 2001 Ford van at impact. (Source: Google Earth; annotations by the NTSB)
