# National Transportation Safety Board

PLD23LR002

## **PHOTOGRAPH STUDY**

Location: West Reading, Pennsylvania  
Date: March 24, 2023  
Time: 4:55 p.m. Eastern Standard Time (EST)  
Type of accident: Leak/ Explosion/Fire  
Operator: UGI Corporation /UGI Utilities, Inc.

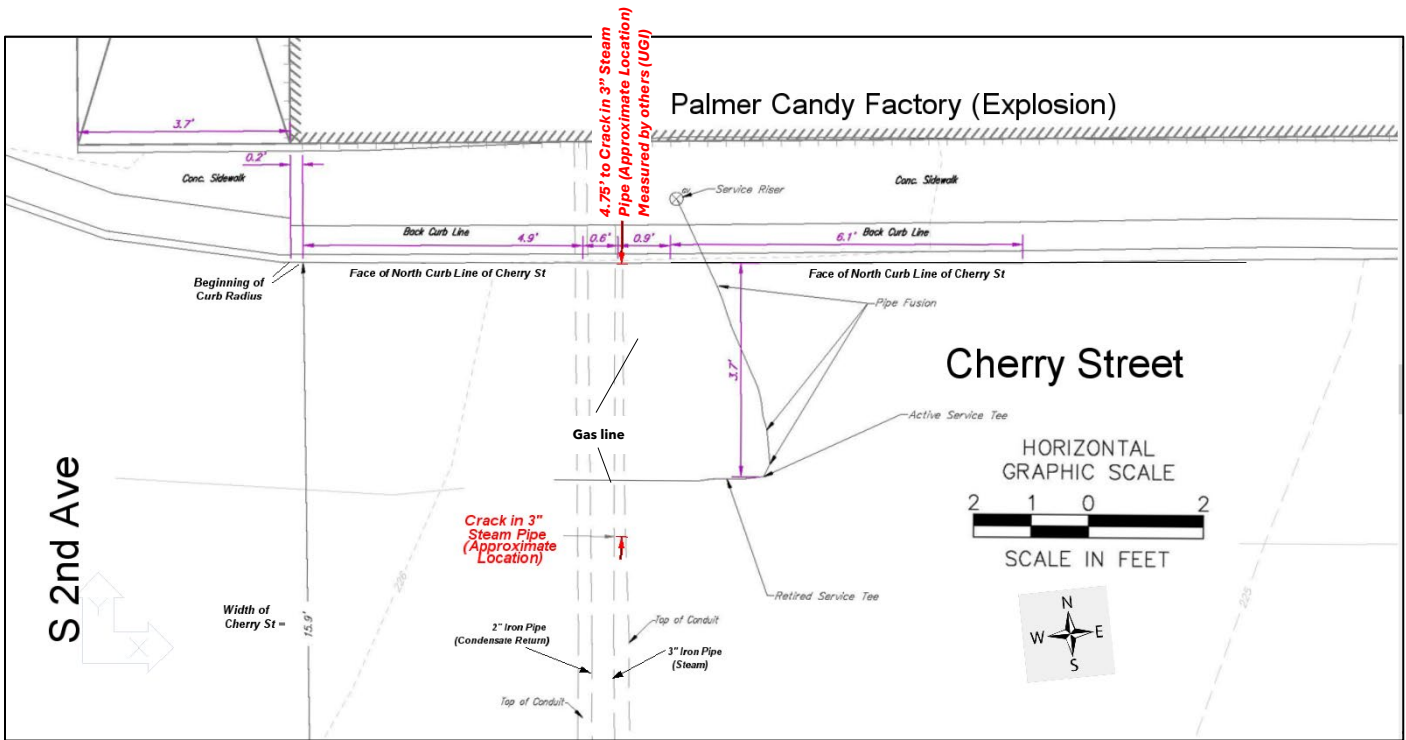
Figure 1. Diagram of Cherry Street showing location of the 3" steam pipe and the crack. (Source UGI)

As indicated by the survey data shown in Figure 1, the steam pipe ran north and south across Cherry Street and was located about 0.9 feet west of the natural gas riser pipe (the east-west zero point for this discussion). The crack in the steam pipe was located approximately 4.75 feet from the edge of the north curb line of Cherry Street.

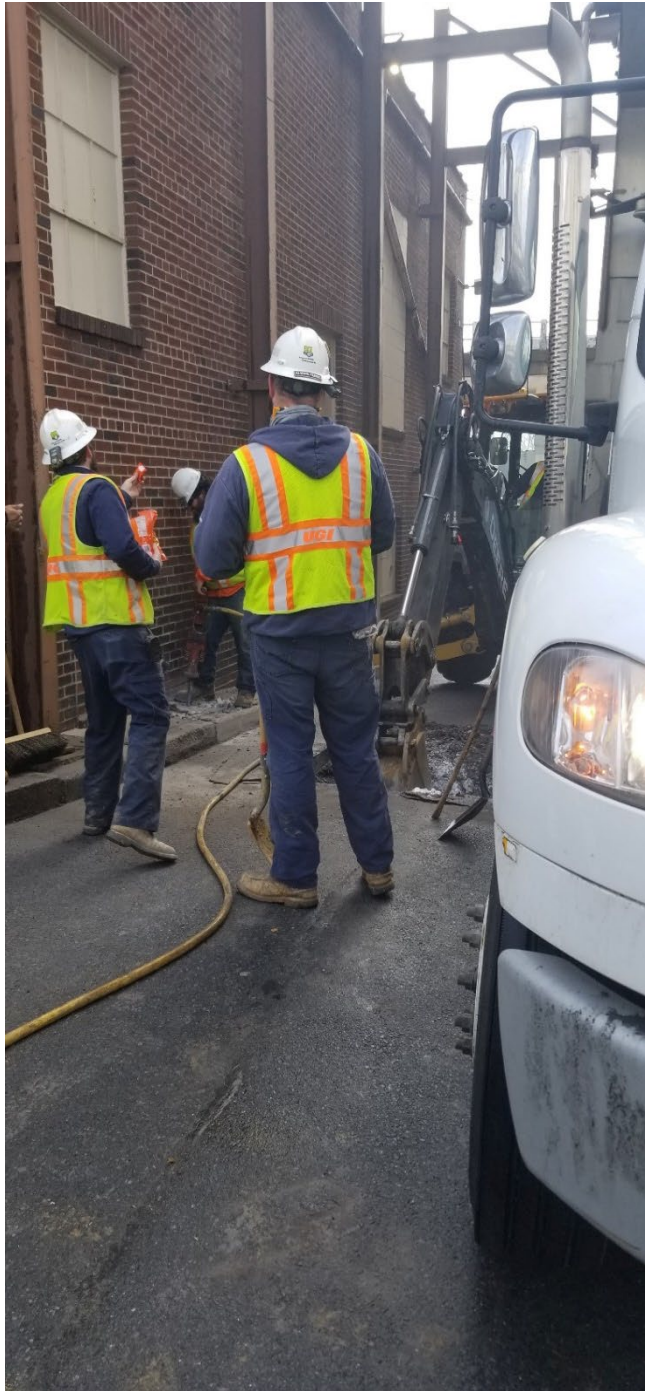
According to information received from the R.M. Palmer Company, the photograph in Figure 2 was taken with a Samsung Galaxy Note 8 cellphone camera. The aspect ratio of the photograph is 4032 x 1960 which is consistent with the "Full" image setting on the Note 8. (Based on the EXIF information, the photo has been previously rotated 90 degrees from its original orientation using Microsoft Windows Photo Viewer 6.1.7600.16385 so that its aspect ratio is now 1960 x 4032. The date of the photo listed in the EXIF information is 2023:04:20 18:23:17. There is no camera information available in the EXIF information.) Since the original camera was not available, an exemplar Note 8 camera was obtained, and the camera properties measured using two different sets of calibration targets. These measurements indicated the horizontal field of view was approximately 66 degrees, which is consistent with published information. The results of the camera calibration indicated that the distortion was minimal, which is consistent with lines in the brick wall being approximately straight in the photograph. The Note 8 camera is equipped with a zoom function. Evaluation of the zoom features determined that no zoom was used in taking the photograph.

Figure 2. UGI Crew working on Cherry Street outside the Palmer Candy Factory on February 16, 2021. (Source: Palmer)

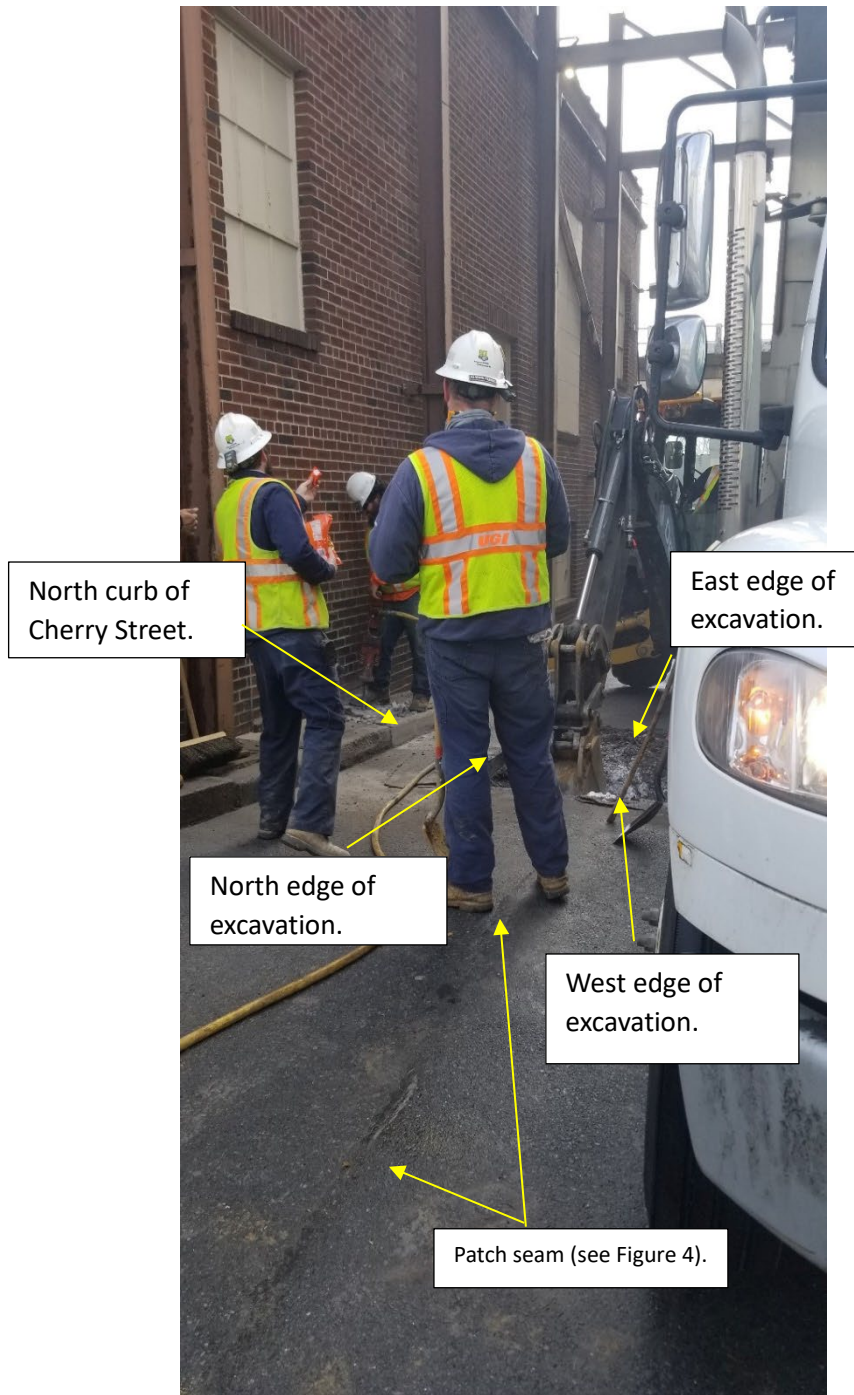
Figure 3. UGI Crew working on Cherry Street outside the Palmer Candy Factory on February 16, 2021. (Source: Palmer)

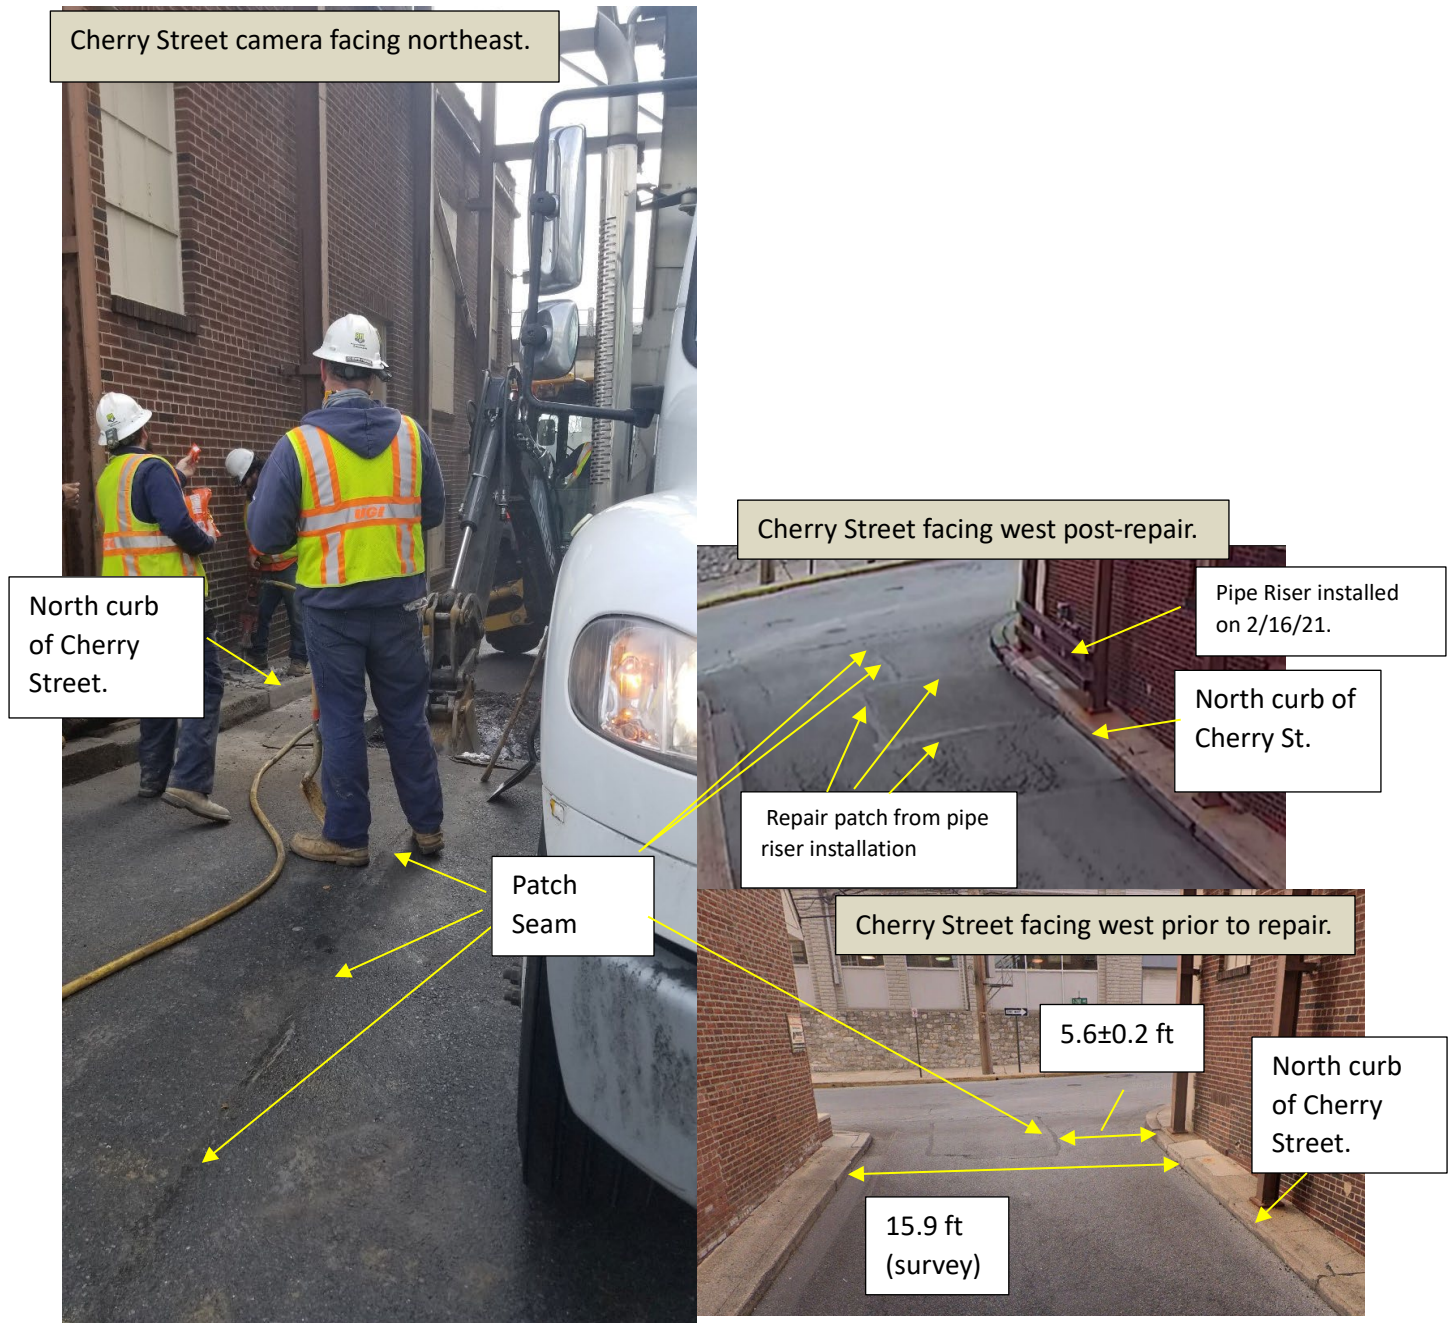
Figure 4. The photograph on the left shows the work crew on February 16, 2021. The figures on the right show the location before and after the maintenance performed on February 16, 2021. The location of the patch seam relative to the north curb of Cherry Street was estimated using the photo and road width and measurements taken by West Reading Borough Police Department after the event (Figure 5).

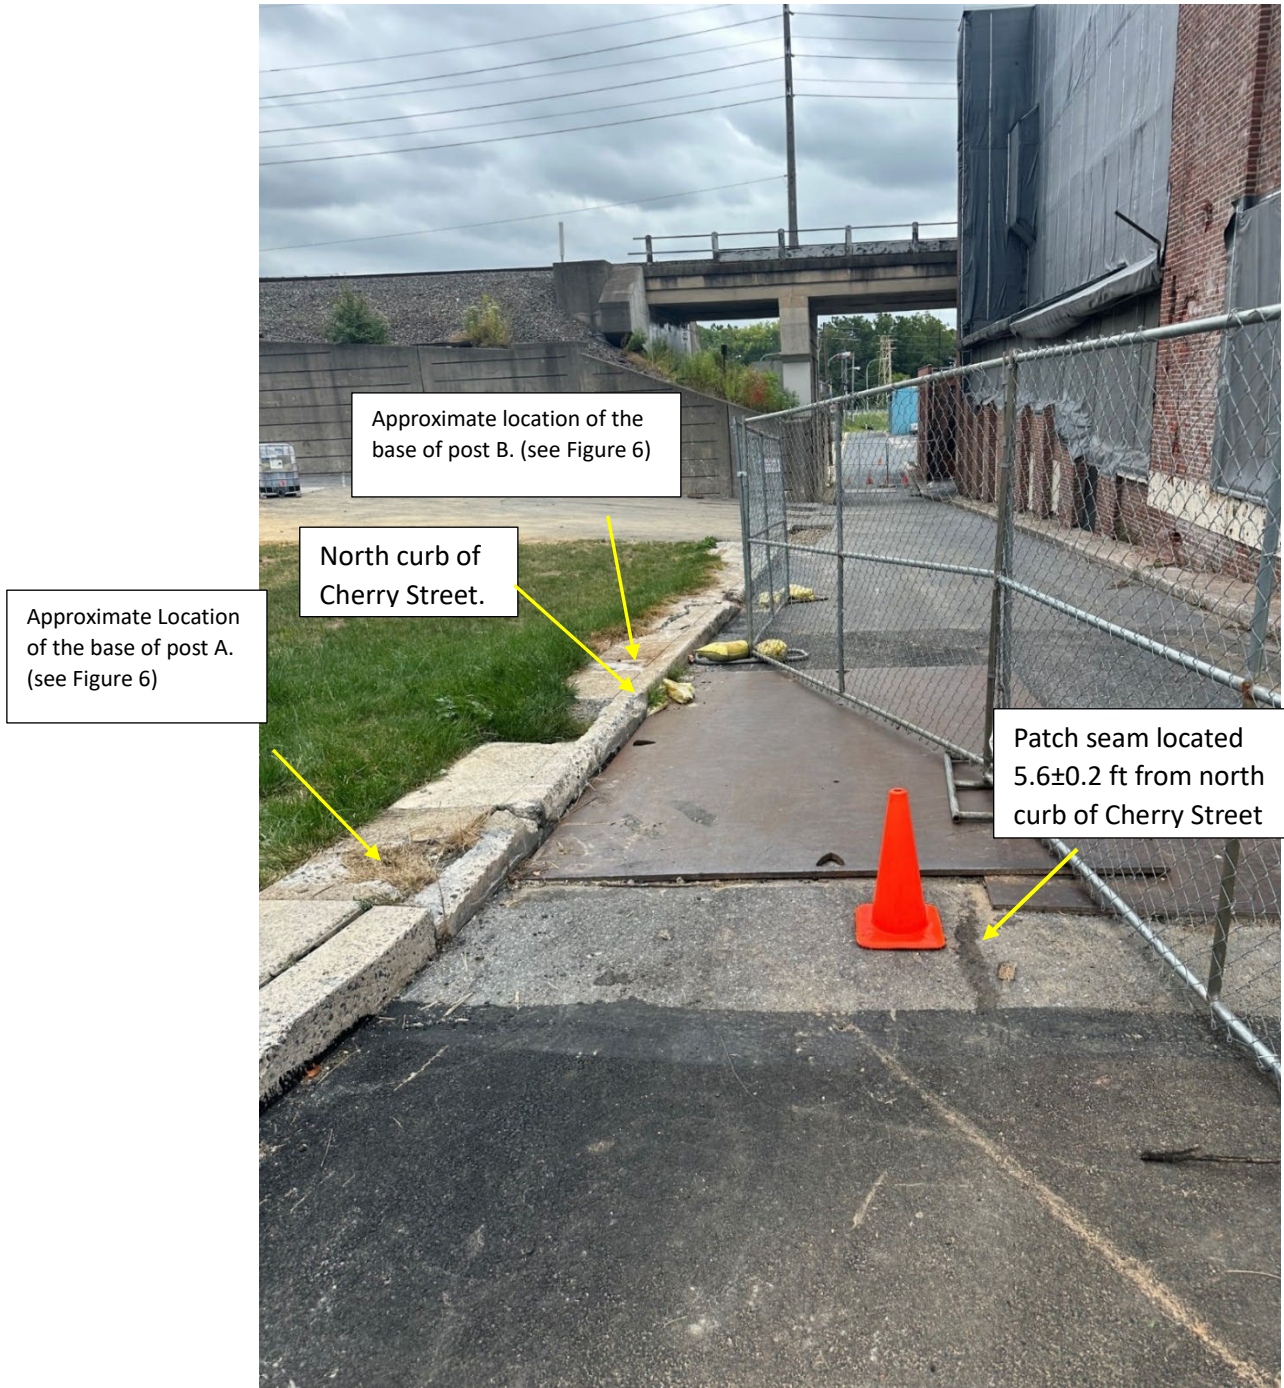
Approximate Location of the base of post A. (see Figure 6)

North curb of Cherry Street.

Approximate location of the base of post B. (see Figure 6)

Patch seam located  $5.6 \pm 0.2$  ft from north curb of Cherry Street

Figure 5. Cherry Street September 2024. Camera view is facing east. (Source of photo and measurements: West Reading Borough Police Department)

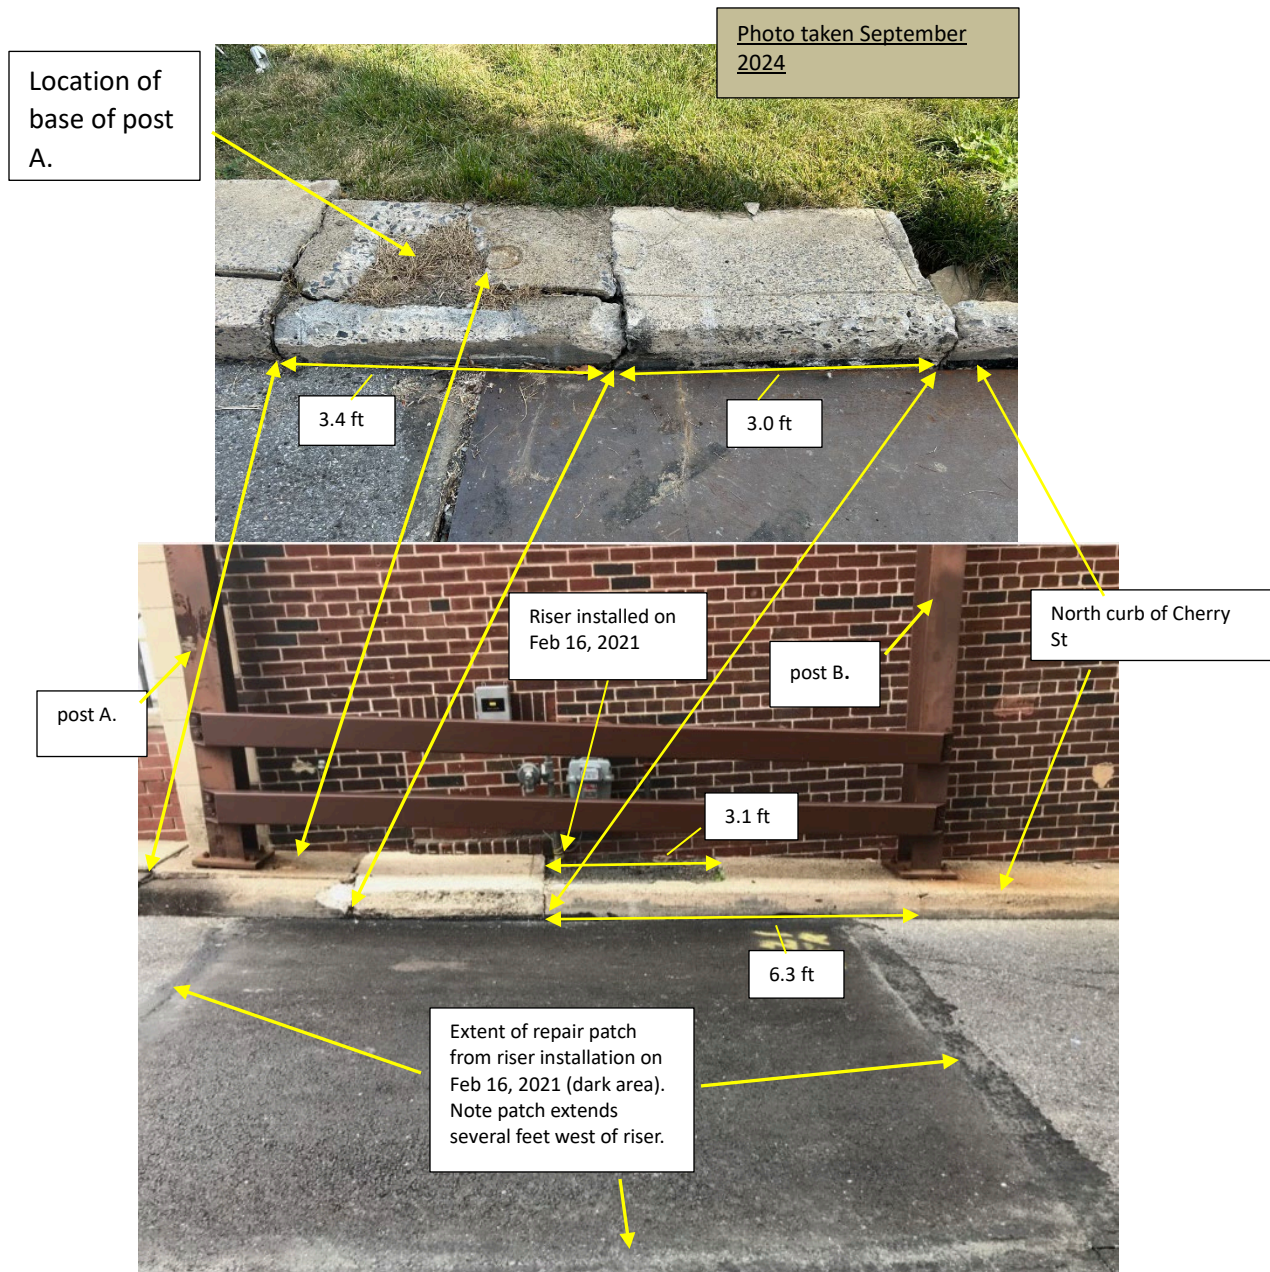
Figure 6. The top photo shows an image of a section of the north curb of Cherry Street photographed September 2024. The image at the bottom shows the riser after the maintenance performed on February 16, 2021. All measurements are post-explosion. (Source of top photo and measurements: West Reading Borough Police Department)

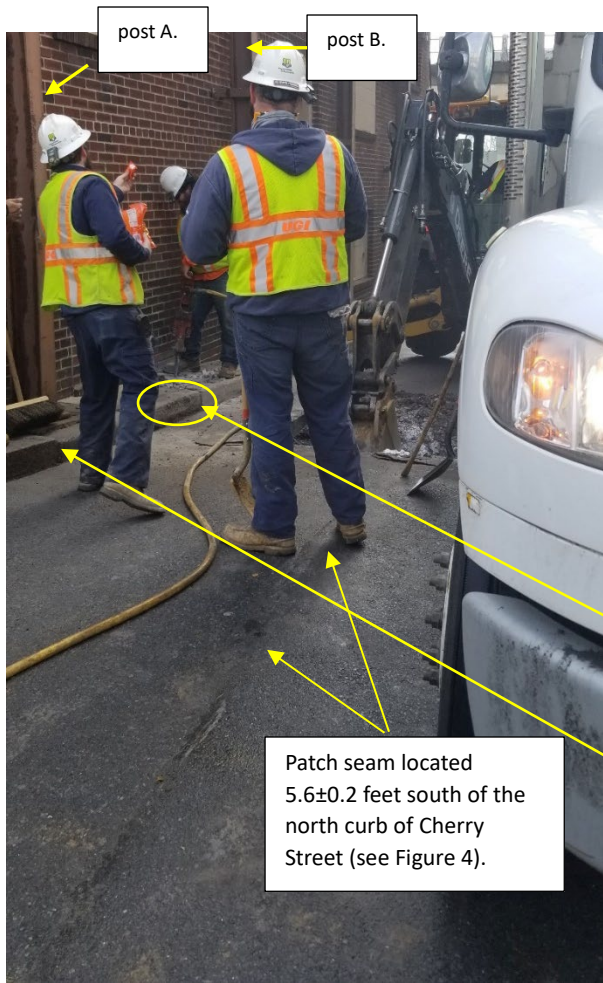
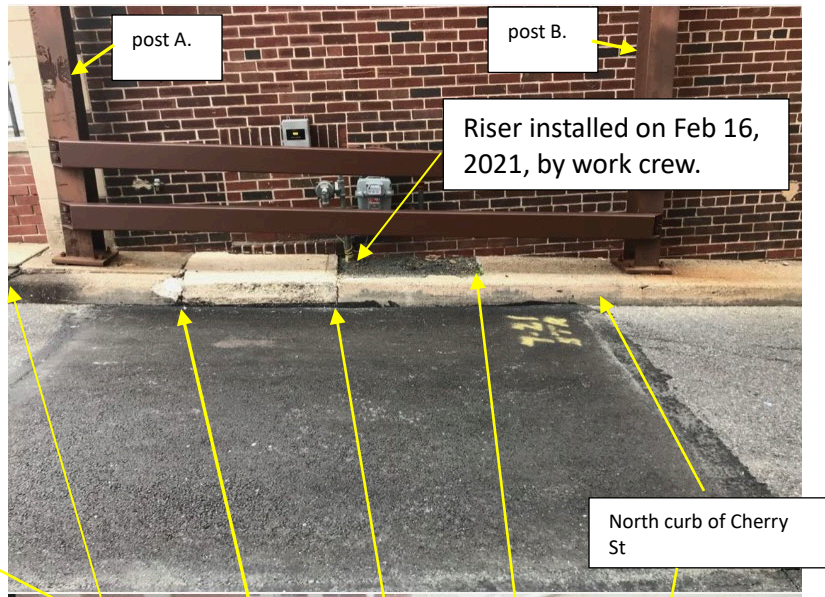
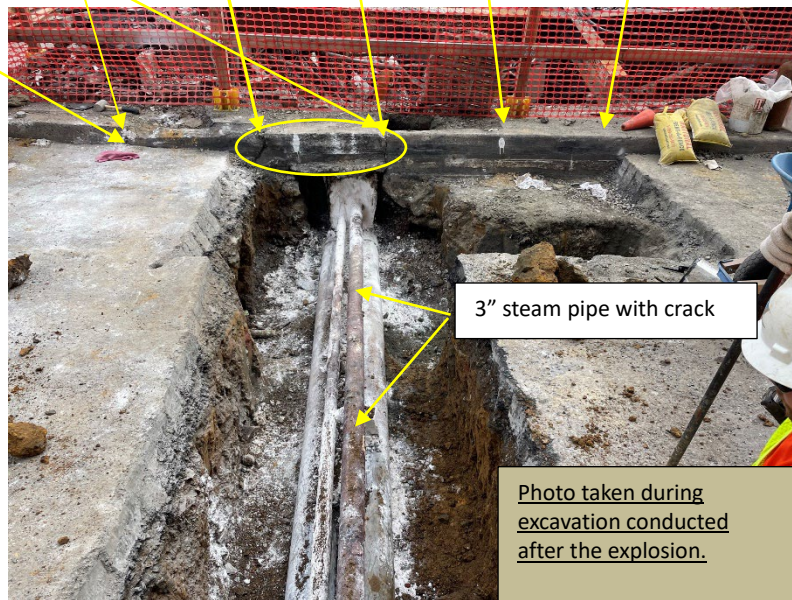
Figure 7. The photograph on the left shows the work crew on February 16, 2021 (Figure 2). The photograph on the upper right shows the location after the maintenance was performed on February 16, 2021 (prior to the explosion). The photograph on the lower right was taken during an excavation conducted after the explosion. Yellow arrows show corresponding features in the photographs.

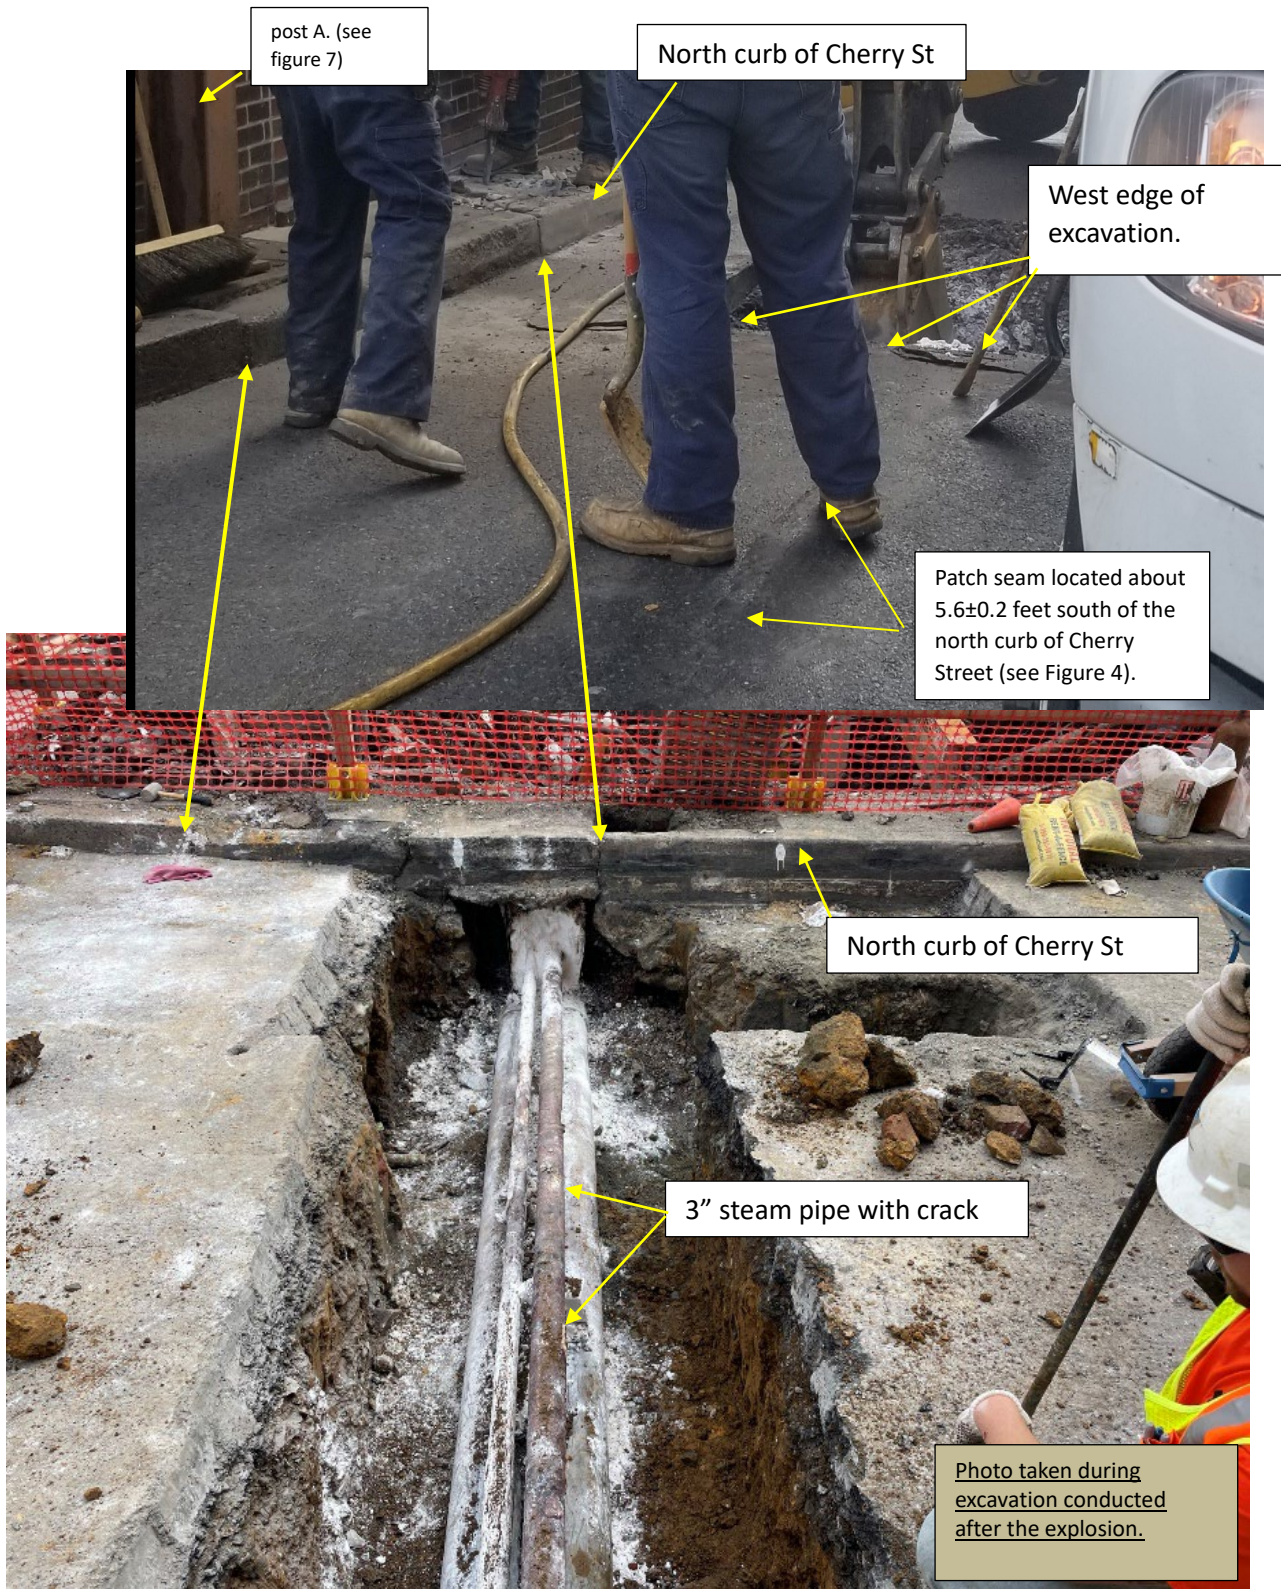
Figure 8. The top image shows the work crew and excavation in the photograph taken on February 16, 2021(Figure 2, zoomed). The bottom image was taken during the excavation conducted after the explosion.

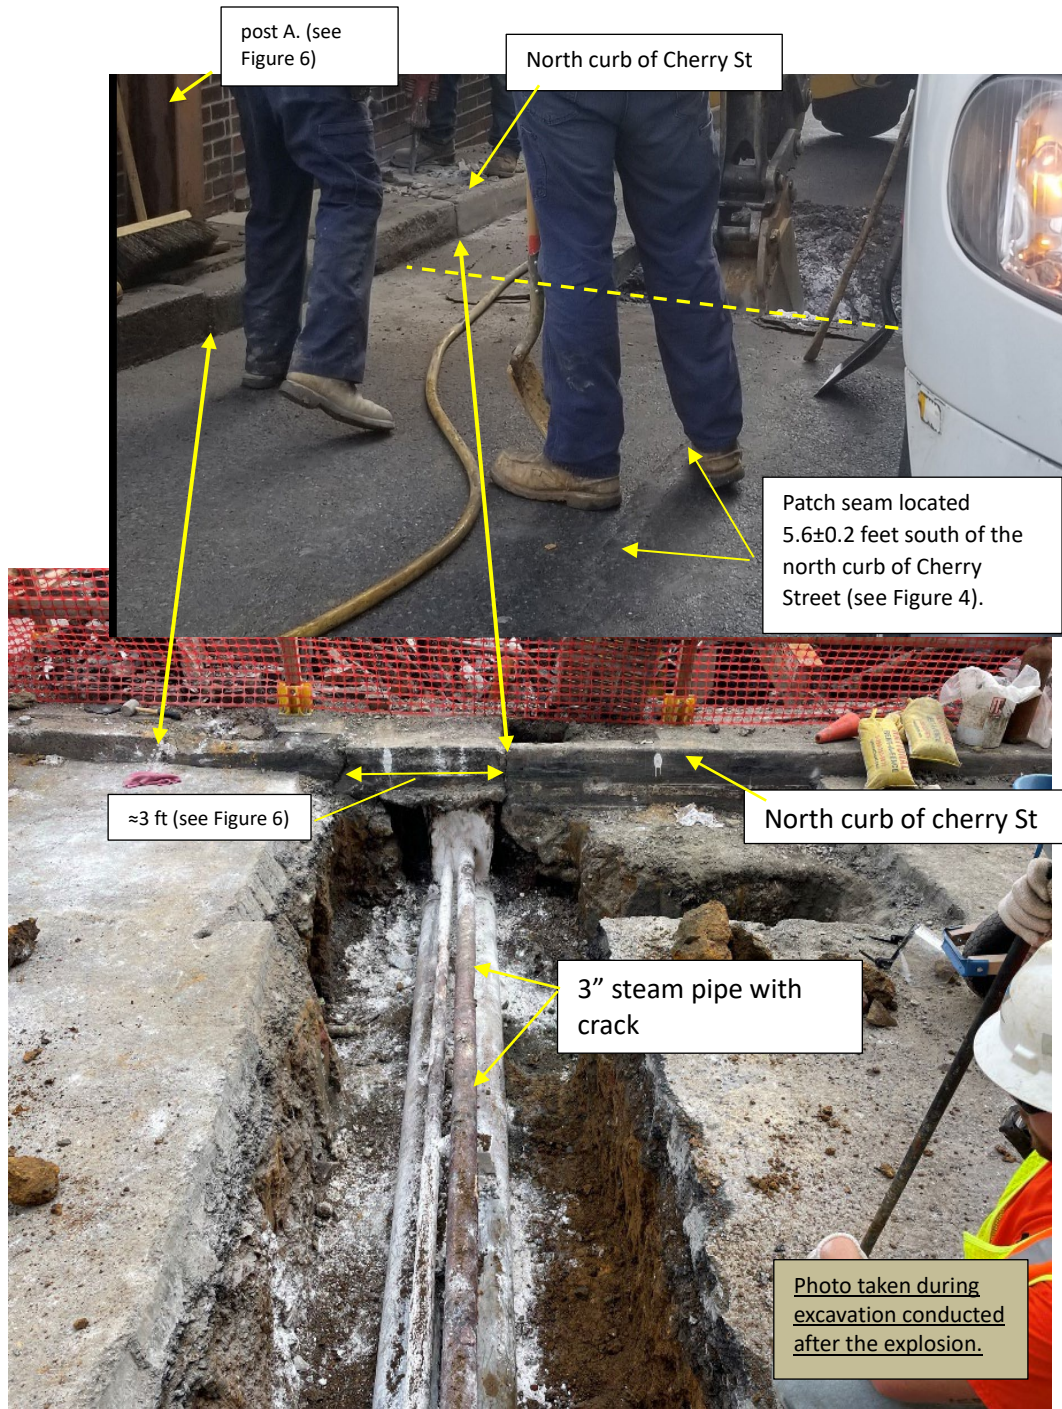
Figure 9. The upper image shows the work crew and excavation in the photograph taken on February 16, 2021 (Figure 2, zoomed). The bottom image was taken during the excavation conducted after the explosion. The broken yellow line shows the alignment of the west edge of the excavation with the north curb of Cherry Street. As indicated by the diagram the south edge of the excavation (hidden behind the truck) is located south of the pavement seam which is located  $5.6 \pm 0.2$  ft south of the north curb of Cherry Street (see also figures 3, 4 and 7).

Based on the measurements and photographs in the previous section, the western edge of the excavation (in Figure 2) was located within 2 feet to the west of the riser pipe (see figure 9) and the southern edge of the excavation was located more than 5.6 feet south of the north curb of Cherry Street (as indicated by the alignment of the pavement seam with the excavation in the photographs).

Examination of the images in Figure 9 make it clear that the position of the steam pipe was very close to the west edge of the excavation. Foreshortening of the curb blocks caused by the camera perspective and the obscuration caused by the workers next to the excavation make precise measurements difficult, but it appears that the west edge of the excavation was within about 1 foot of the location of the steam pipe. The crack in the pipe at 4.75 feet from the curb was north of the south edge of the excavation (hidden by the truck), which is at least 5.6 feet south of the curb.
