# National Transportation Safety Board

RRD23LR008

## **TRACK AND ENGINEERING**

Group Chair's Factual Report

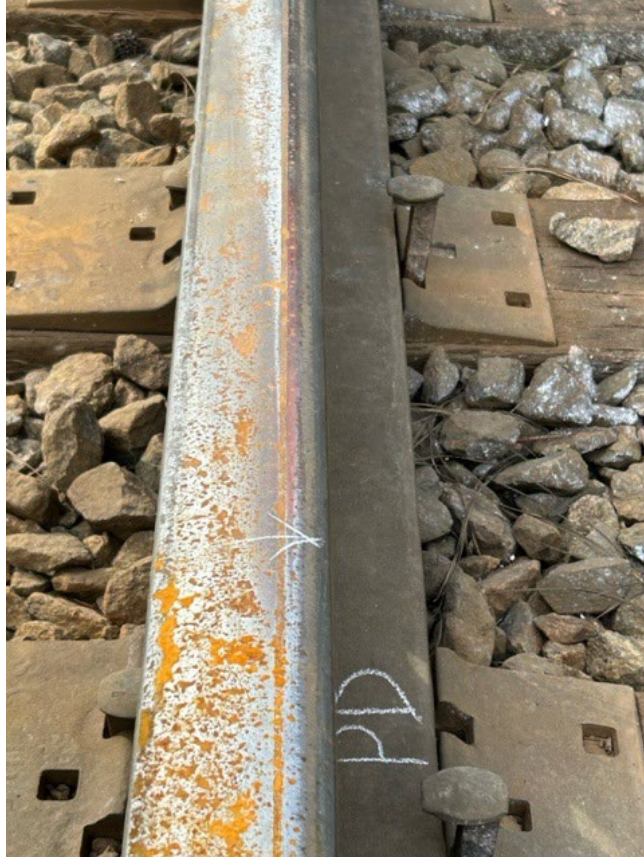
Investigators identified the point of derailment (POD) as a location on the south rail at about milepost 721.05. Investigators observed a wheel flange type signature departing the rail head and angling downward on the inside gauge corner of the rail head. Investigators also observed wheel flange type markings on the inside web portion of the south rail west of the POD marks indicating a continuation of the wheel flange type movement. The train was a westbound train. The "as found" condition of the south rail was that it had been 'rolled out' or 'rolled over'. Approximately ten feet west of the POD marks, investigators observed wheel flange type imprints on crossties. These markings appeared to be associated with a departure of wheels from the north rail. This area of the track became the consensus area of derailment.

Figure 2. View of POD.

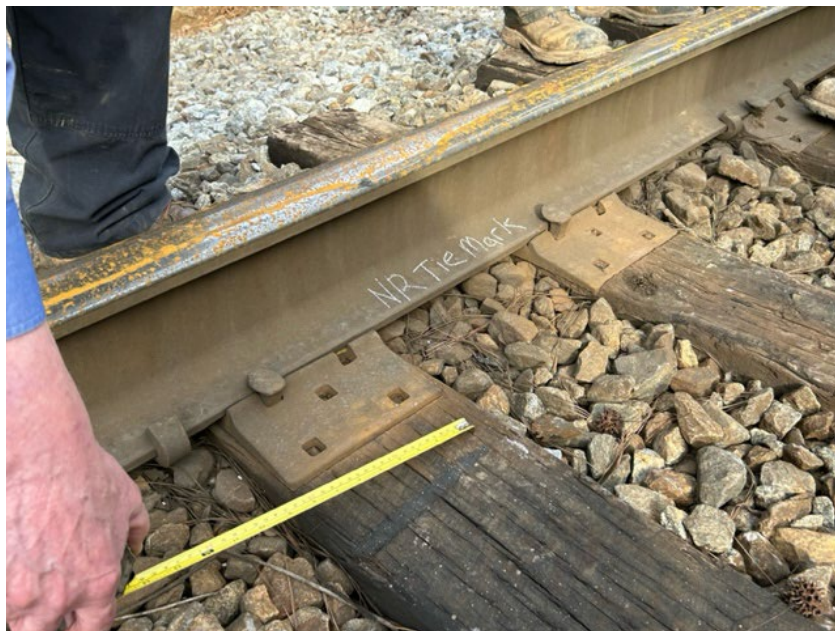
Figure 3. View of wheel flange marks on cross-ties near the north rail.

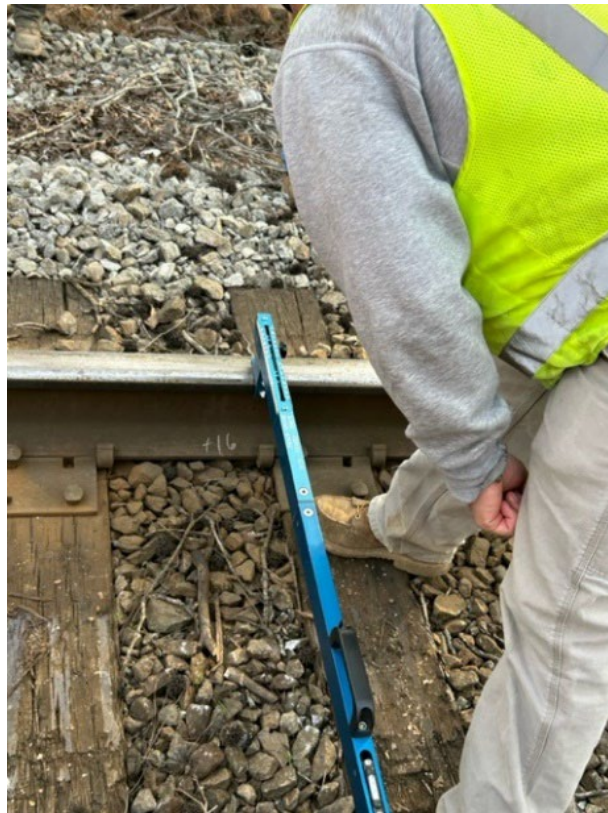
Figure 4. Investigator taking gauge and crosslevel measurements.

- The maximum measurement allowed for gauge in FRA Class 3 track, a maximum authorized speed of 60 mph for passenger trains is 57 3/4 inches. Investigators determined that the widest gage was 57 1/8 inches; or about 5/8 of an inch under the FRA maximum allowable limit. **Note:** The gauge measurement at POD was in disturbed track.
- The maximum allowable deviation from zero crosslevel at any point on tangent or reverse crosslevel elevation on curves may not be more than 1 3/4 inches for Class 3 track. Investigators determined from the field notes measurement data that there were no exceptions to this threshold.

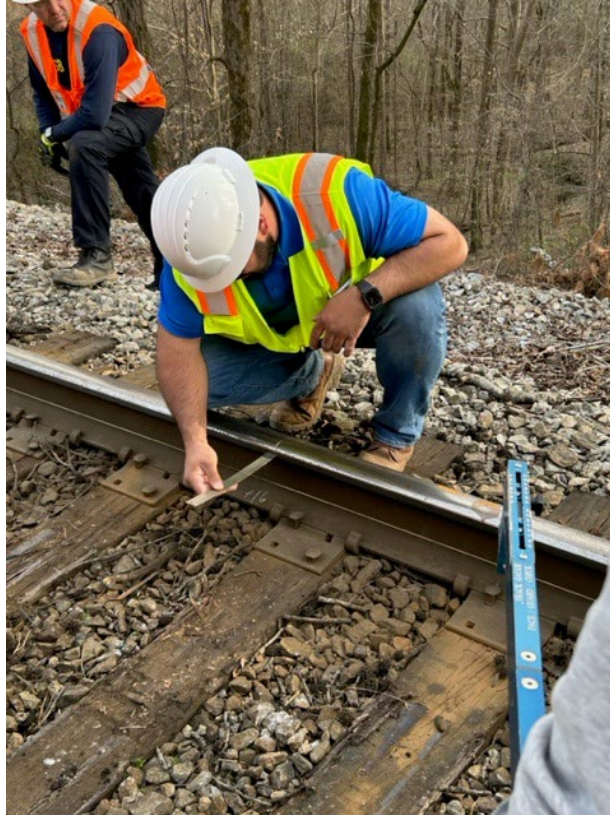
Figure 5. Investigator measuring alignment (degree of curvature).

Investigators measured the degree of curvature along with superelevation and determined that the curve's maximum operating speed using a 3 inch unbalanced was 43 mph for freight trains. The curve is currently authorized for 35 mph.

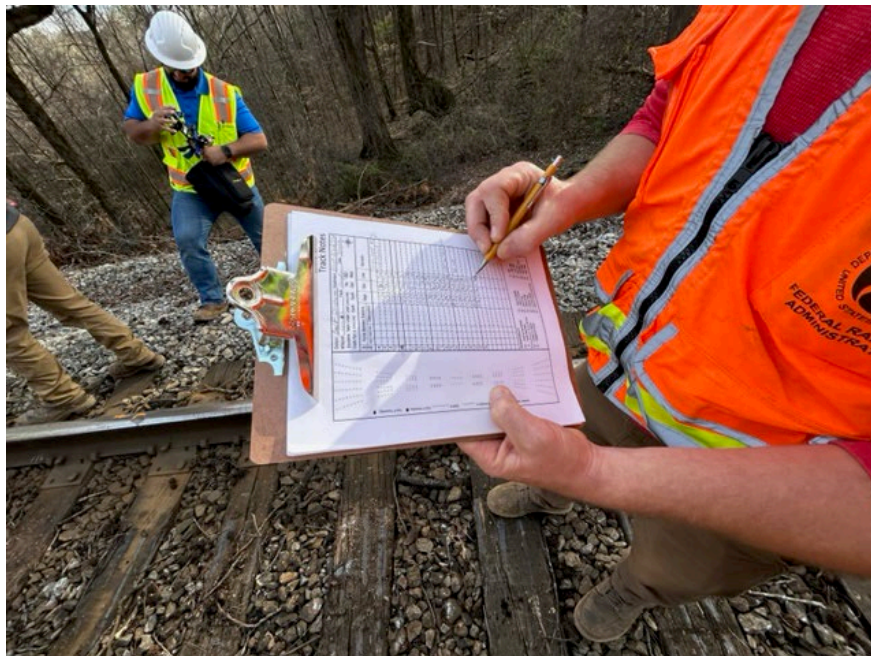
Figure 6. Investigator recording measurement values for track field notes.

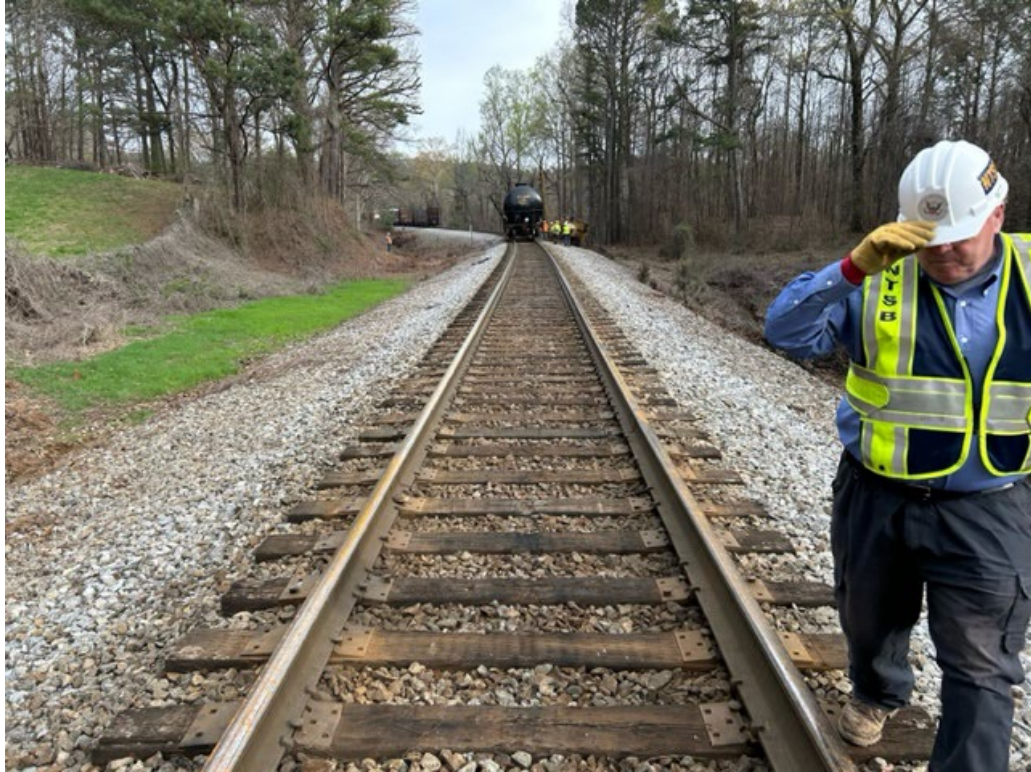
Figure 7. General view of the track looking eastward.
