# NATIONAL TRANSPORTATION SAFETY BOARD

FIRE INVESTIGATION FACTUAL REPORT

Report No. 21-010

Place : Pier 20, Blount Island, Jacksonville, Florida  
Date : June 4, 2020  
Vehicle : *Höegh Xiamen*  
NTSB No. : DCA20FM020  
Investigator : Marcel Muise

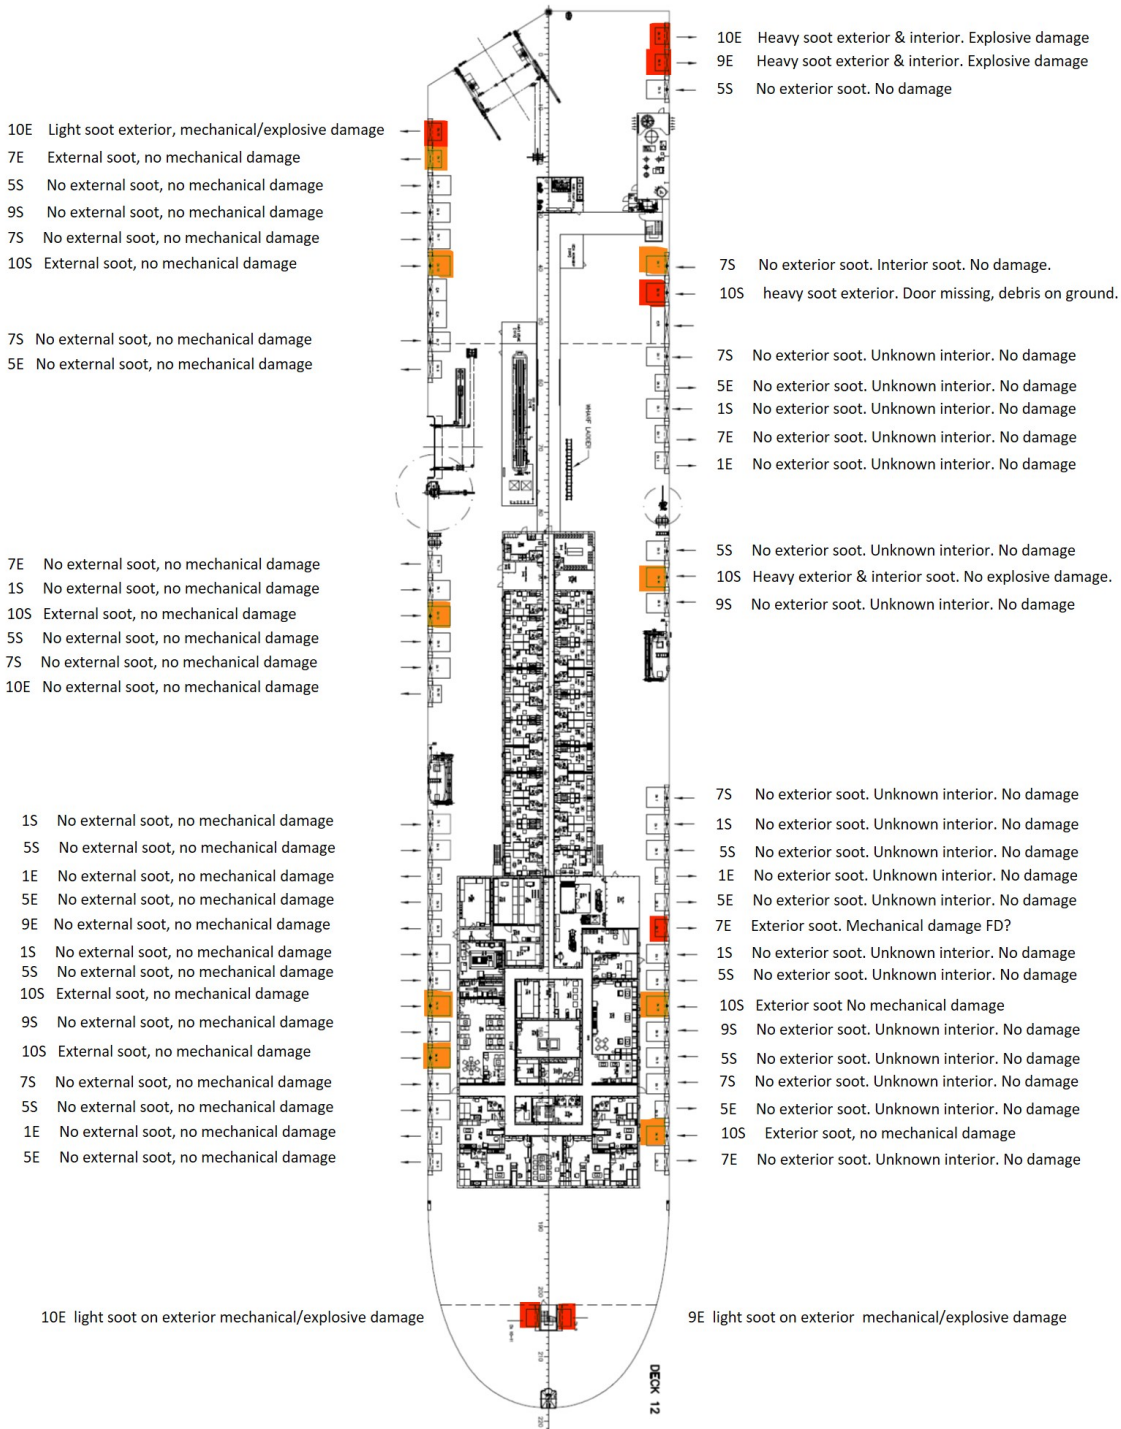
Overall, the condition of the doghouses fell into three categories. They either had no signs of external sooting and mechanical damage; they exhibited external sooting and no mechanical damage; or they exhibited both external sooting and mechanical damage. The only ventilation doghouses that exhibited sooting were those associated with decks 7/8, 9, and 10/11. The only doghouses that exhibited mechanical damage consistent with an overpressure event were associated with decks 9 and 10/11. The doghouses for deck 10/11 exhibited greater levels of mechanical damage than those of deck 9. A doghouse for a deck 7 vent exhibited some mechanical damage, but it did not appear to have originated from the inside. The diagram in figure 5 contains these observations and their locations on the weather deck.

Figure 5. Diagram of vent arrangement on deck 12. Red highlighted vents exhibited soot staining and mechanical damage. Orange highlighted vents exhibited soot staining only.

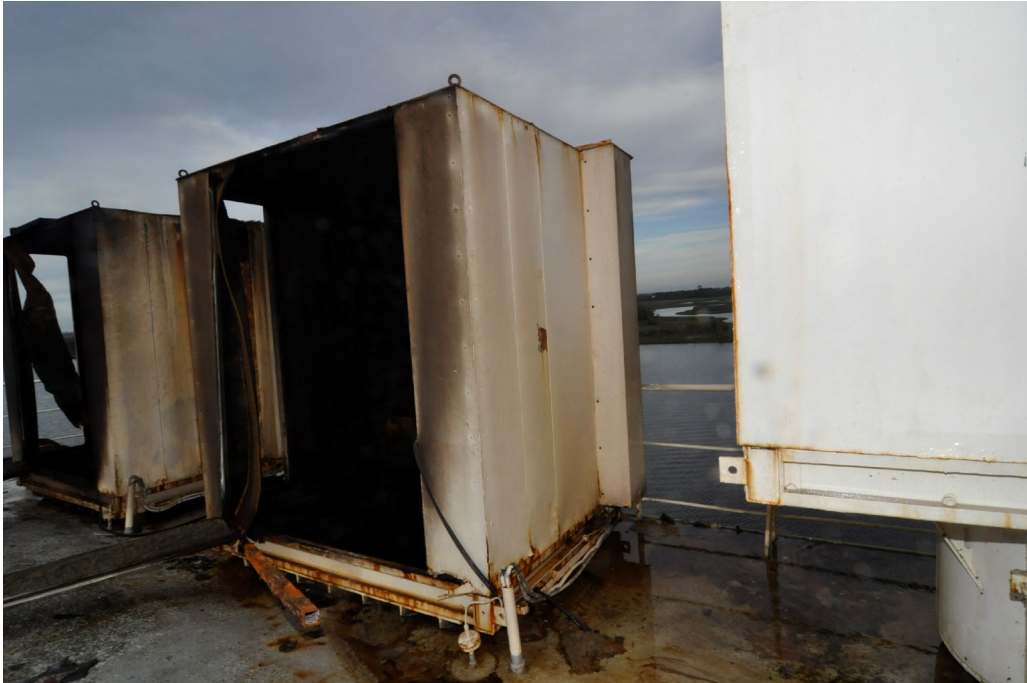
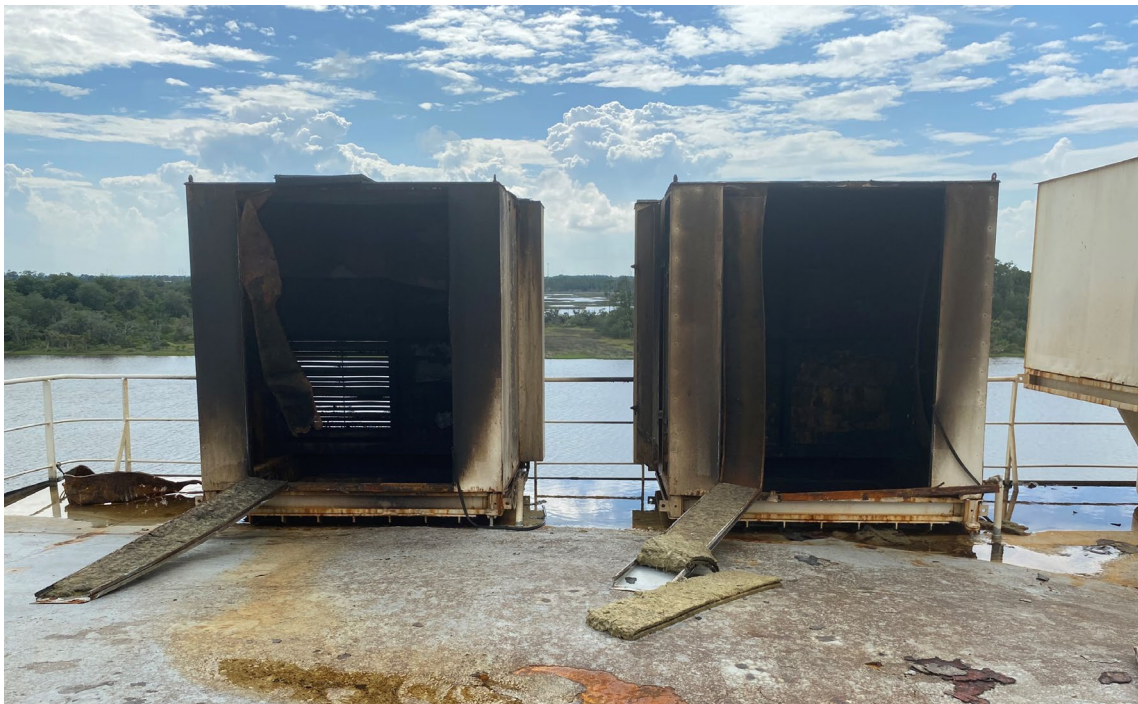
#### *10E and 9E (at the stern port side)*

Figures 6 and 7 show the doghouses for exhaust vents for decks 10/11 and 9. These doghouses exhibit external soot staining and portions of the doghouses have been forcefully separated. The mechanical damage is consistent with an overpressure event.

Figure 6. Vents 10E and 9E on the port side of the stern. Both exhibit soot staining and damage due to overpressure.

Figure 7. Vents 10E and 9E on the port side of the stern. Both exhibit soot staining and damage due to overpressure.

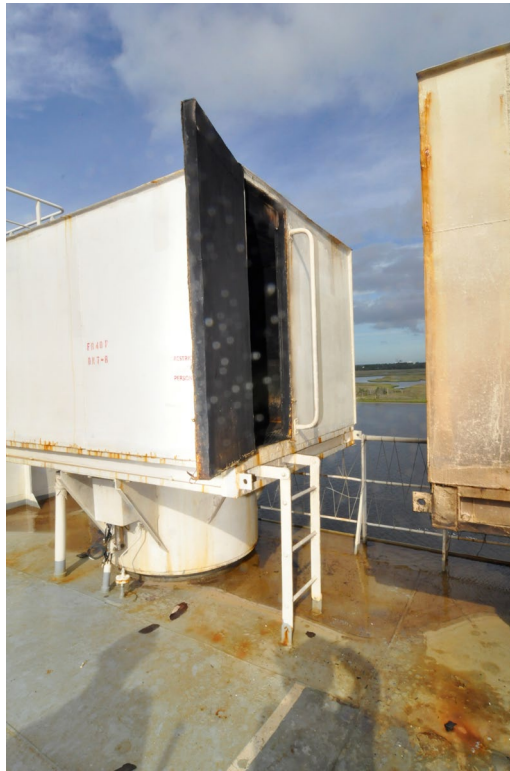
*7S (aft area port side)*

Figure 8 shows the doghouse for a supply vent for deck 7/8. There is no external soot staining visible, but the inside of the door (shown open) appears to have been soot stained.

Figure 8. Vent 7S on the port side exhibiting soot on the interior of the open door.

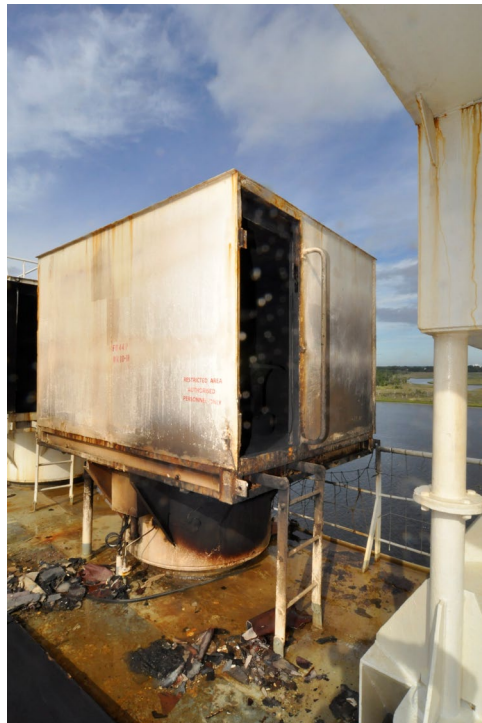
*10S (aft area port side)*

Figure 9 shows the doghouse for a supply vent for deck 10/11. There is external sooting of the doghouse and the door appears to be missing. There is also debris on the deck at the base of the doghouse.

Figure 9. Vent 10S on the port side exhibiting soot and thermal discoloration. The doghouse door is missing, and there is debris around the base.

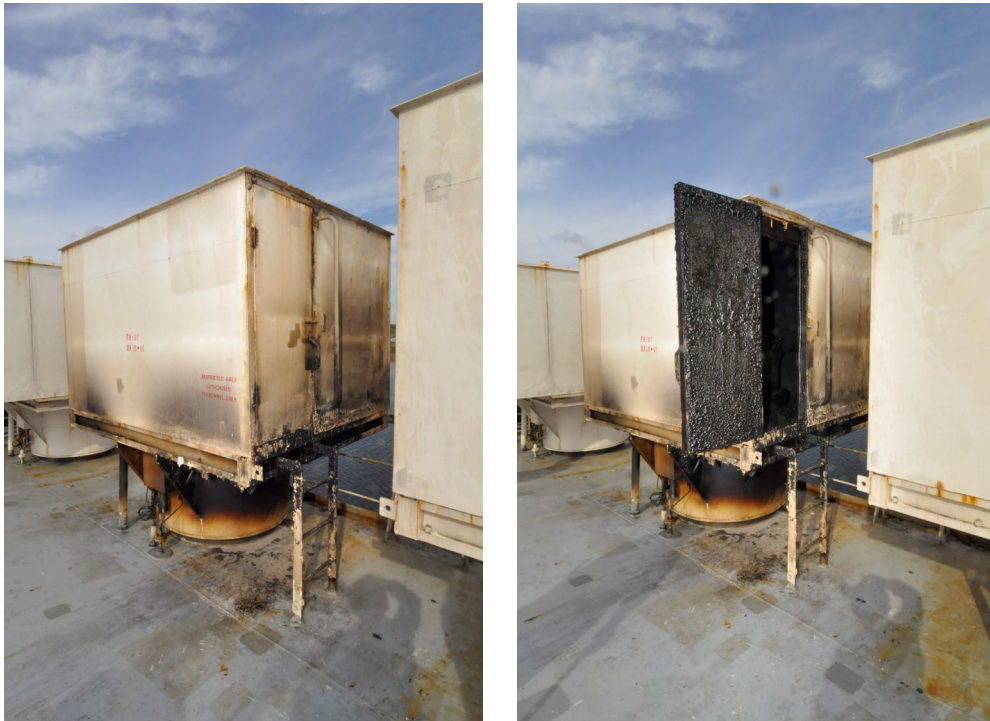
*10S (near midship port side)*

Figure 10 shows the doghouse for a supply vent for deck 10/11. There is external sooting and debris around the base. The interior of the doghouse door also exhibits heavy sooting. No mechanical damage was observed in the photos.

Figure 10. Two photos of vent 10S on the port side. Left: Exhibiting soot and thermal discoloration on the exterior. Right: Internal soot and thermal damage.

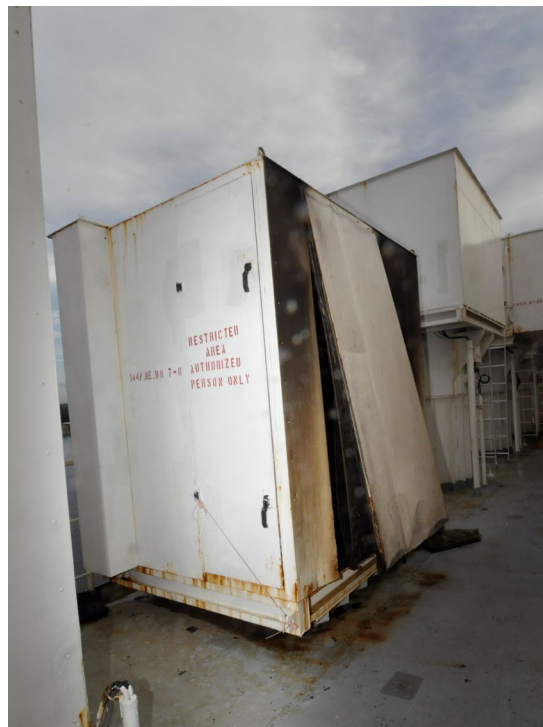
*7E (near accommodation space port side)*

Figure 11 shows the doghouse for an exhaust vent for deck 7/8. There is soot staining on the exterior of the doghouse. The inboard side of the doghouse is separated and pushed outward at the base. There is a sharp crease on the separated portion near the bottom. It is not clear if this is mechanical damage due to overpressure.

Figure 11. Vent 7E on the port side exhibiting external soot staining and the inboard doghouse wall displaced outward from the bottom.

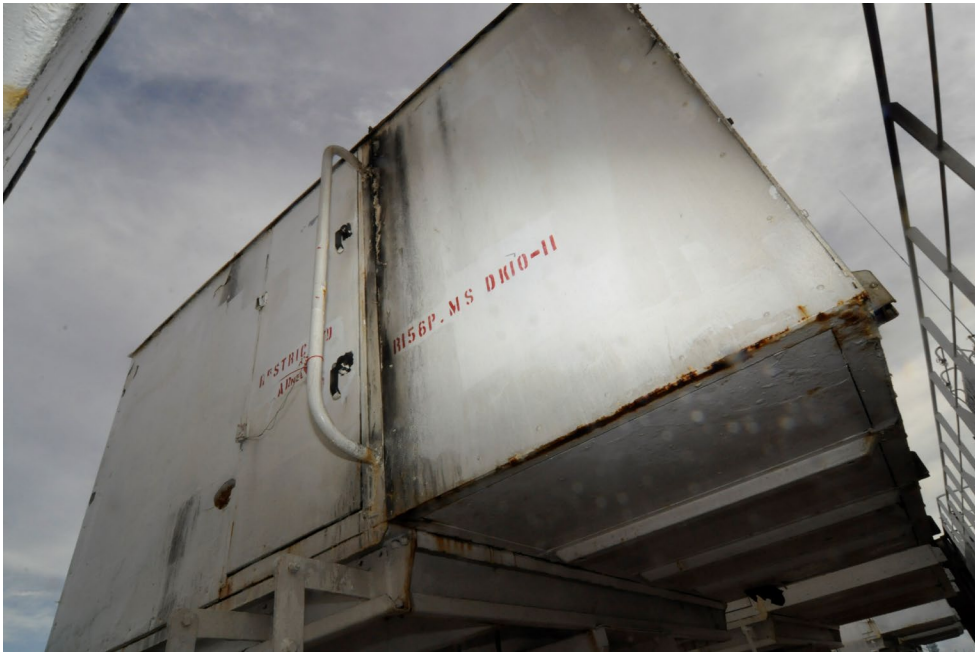
*10S (near accommodation space port side)*

Figure 12 shows the doghouse for a supply vent for deck 10/11. There is soot staining on the exterior and along the door jamb. There is no visible mechanical damage.

Figure 12. Vent 10S on the port side exhibiting soot staining on the exterior door seam.

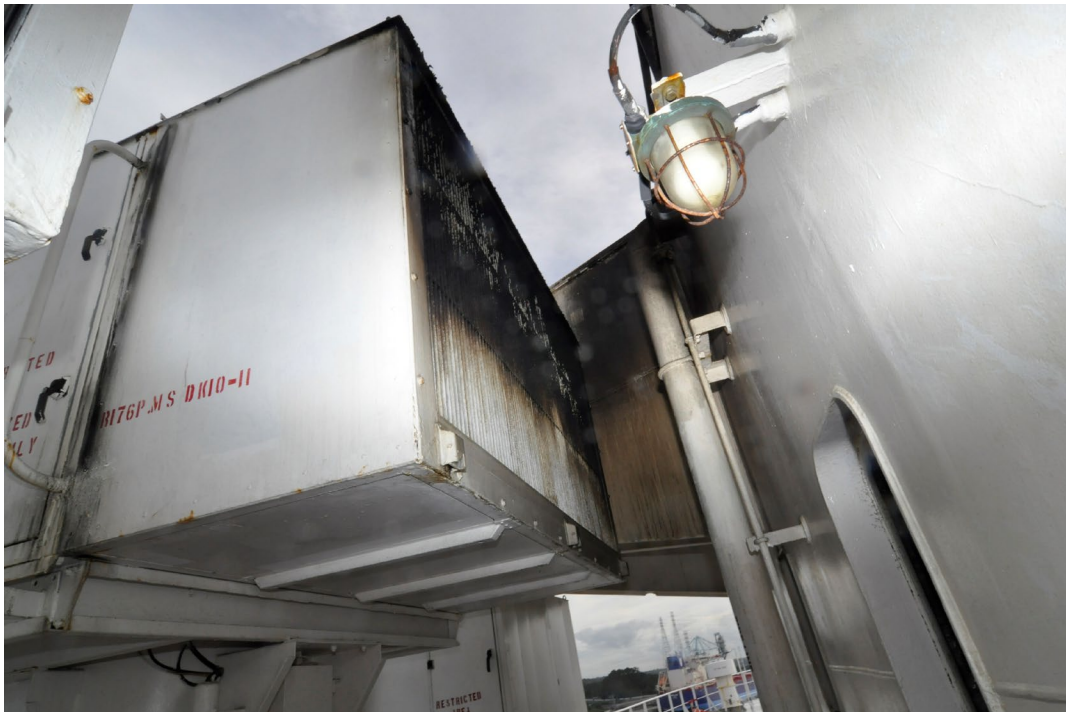
*10S (near the bridge port side)*

Figure 13 shows the doghouse for a supply vent for deck 10/11. There is soot staining on the exterior seen on the louvred side, which is directed inboard at this location.

Figure 13. Vent 10S on the port side exhibiting heavy soot staining on the exterior.

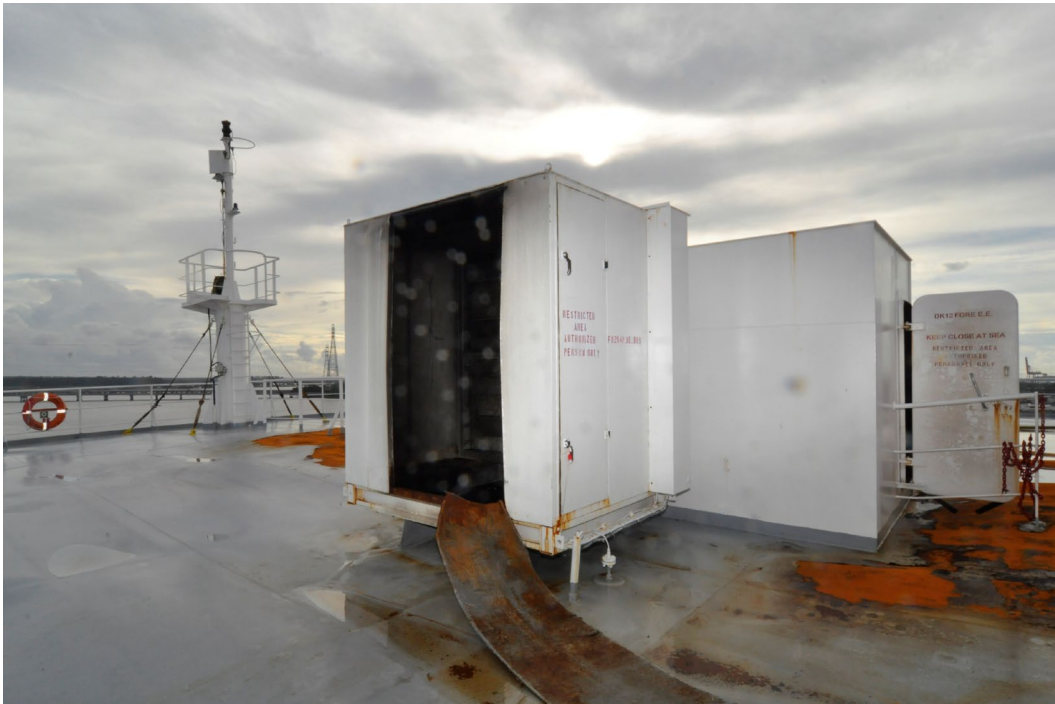
*9E (at the bow port side)*

Figure 14 shows the doghouse for an exhaust vent for deck 9. There is soot along the upper portion of the doghouse, and the one side of the doghouse is separated and laying partially attached at the base. This mechanical damage appears consistent with an overpressure event.

Figure 14. Vent 9E on the port side of the bow exhibiting soot staining near the top and mechanical damage consistent with overpressure on the outboard side.

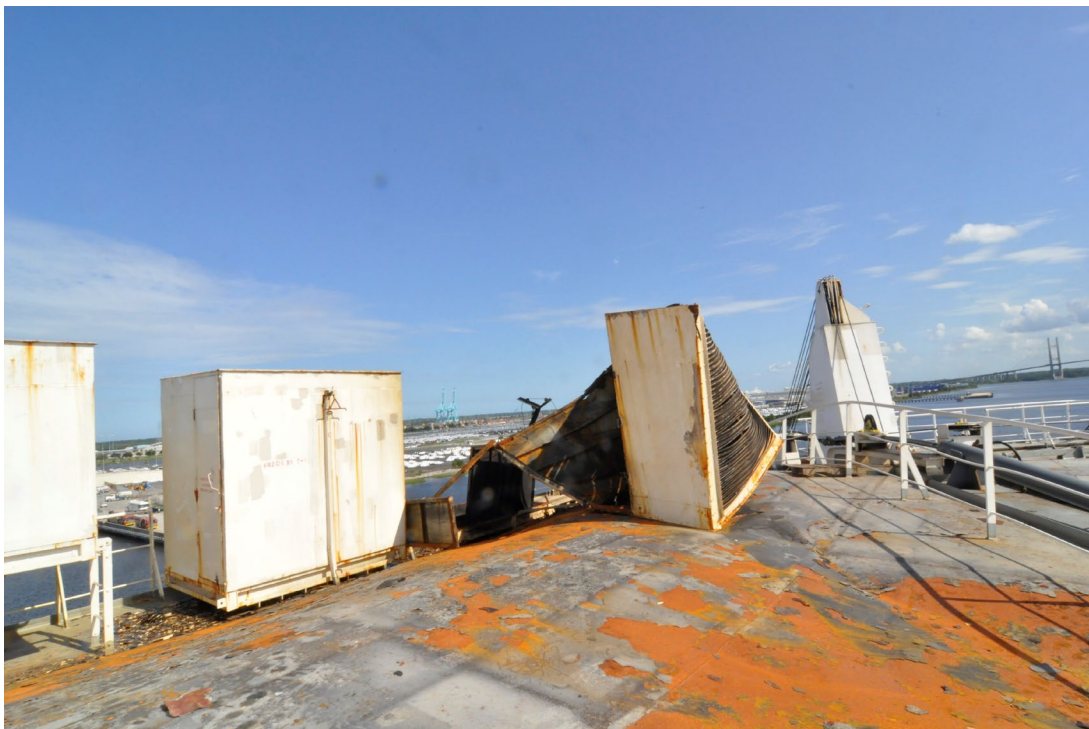
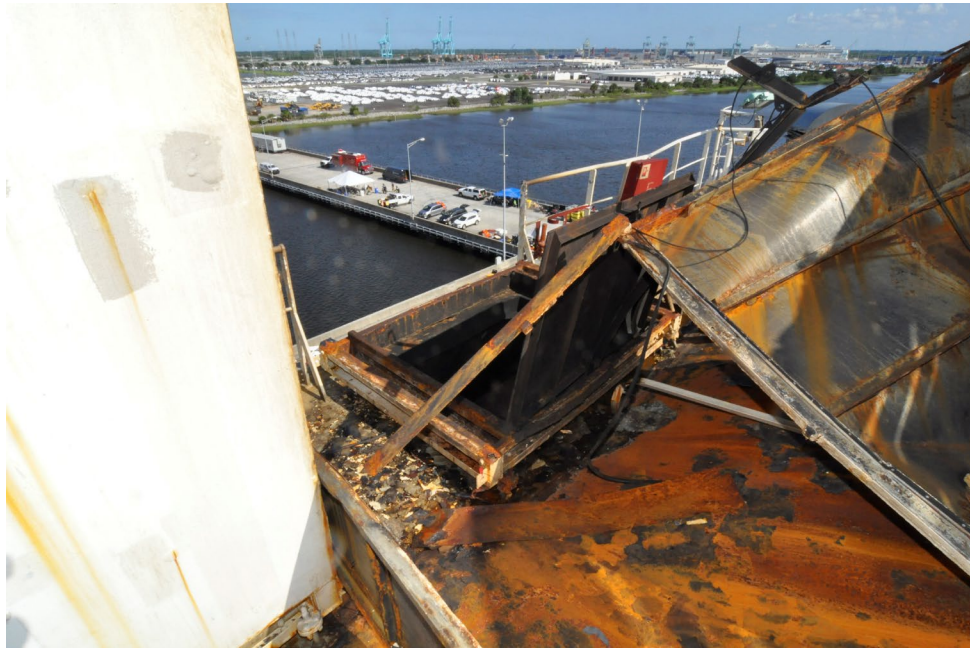
*10E and 7E (at stern starboard side)*

Figures 15 and 16 show the doghouses for exhaust vents for decks 10/11 and 7. The doghouse for the deck 10/11 exhaust vent is almost completely separated from the deck. The doghouse separated along three sides along the base and rotated about the remaining

attached side ending up inverted on the deck. The mechanical damage to the doghouse is consistent with an overpressure event. The doghouse for the deck 7 exhaust vent exhibited some soot staining on the upper aft side.

Figure 15. Vents 10E and 7E on the starboard side of the stern. Vent 10E exhibits mechanical damage due to overpressure. Vent 7E exhibits light soot staining on the upper corner.

Figure 16. Vent 10E on the starboard side of the stern separated from the deck.

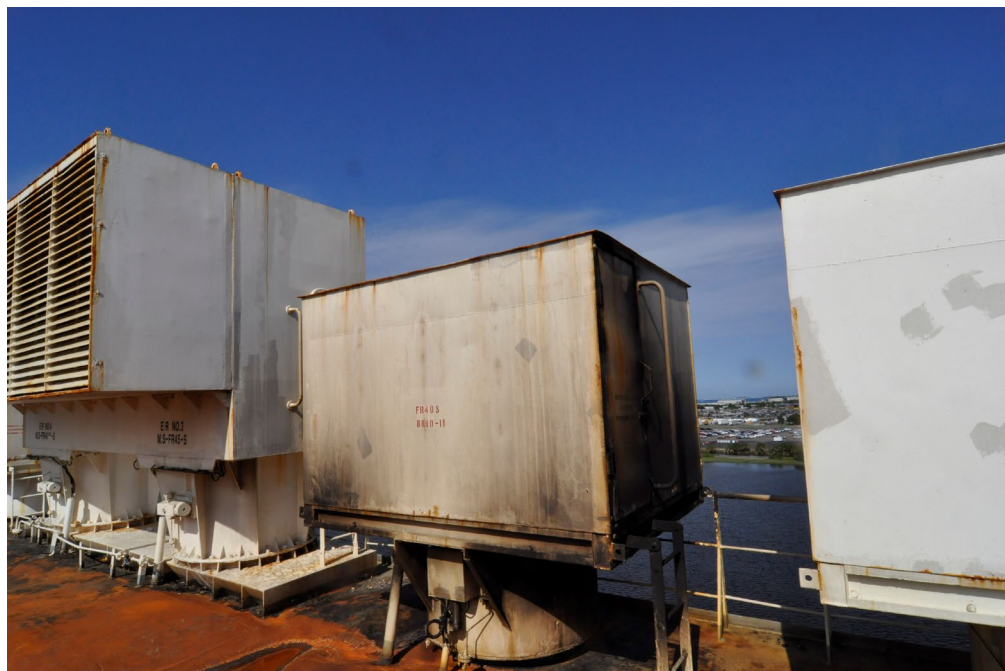
*10S (aft area starboard side)*

Figure 17 shows the doghouse for a supply vent for deck 10/11. There is soot staining on the exterior of the doghouse. There is no visible mechanical damage.

Figure 17. Vent 10E on the starboard side exhibiting external soot staining.

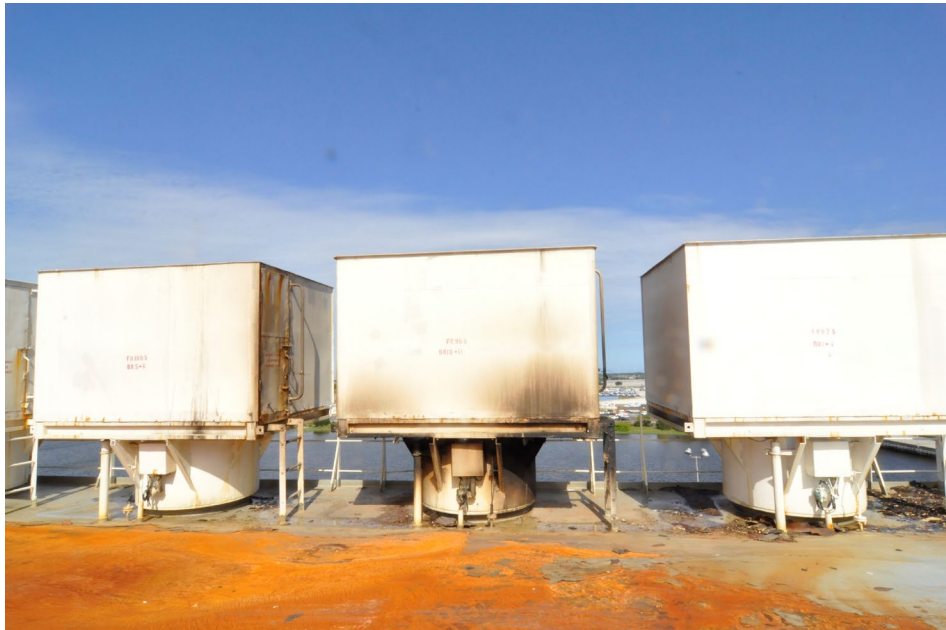
*10S (midship starboard side)*

Figure 18 shows the doghouse for a supply vent for deck 10/11. There is soot staining on the exterior of the doghouse. There is no visible mechanical damage.

Figure 18. Vent 10S on the starboard side exhibiting soot staining on the exterior.

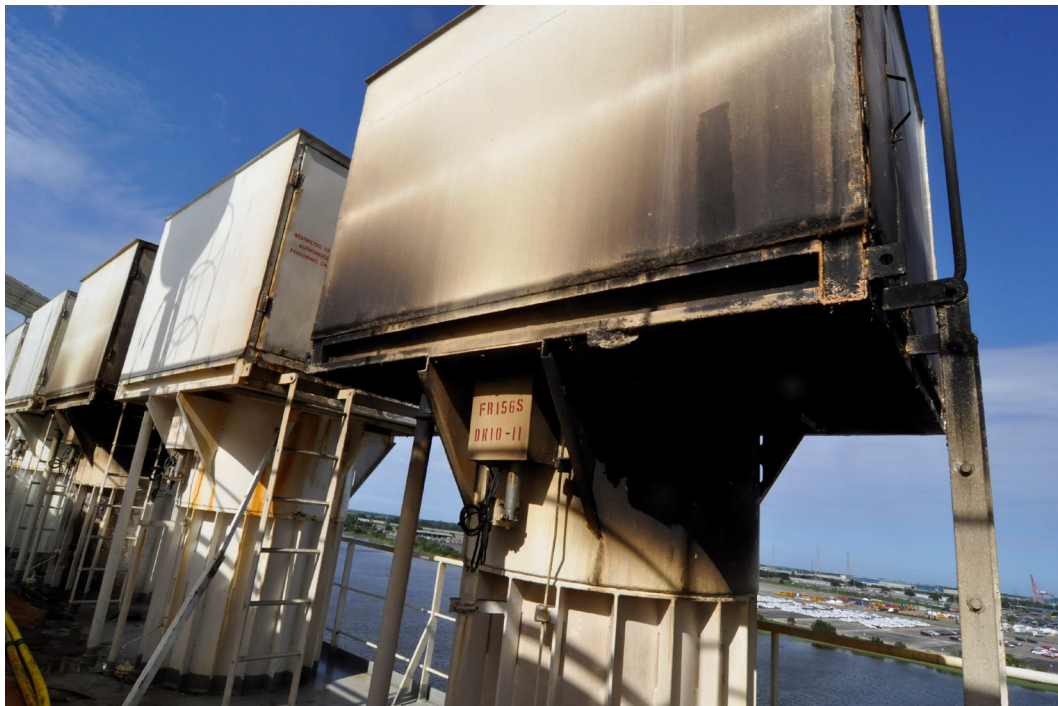
*10S (near accommodation space starboard side)*

Figure 19 shows the doghouse for a supply vent for deck 10/11. There is soot staining on the exterior of the doghouse. There is no visible mechanical damage.

Figure 19. Vent 10S on the starboard side exhibiting soot staining on the exterior.

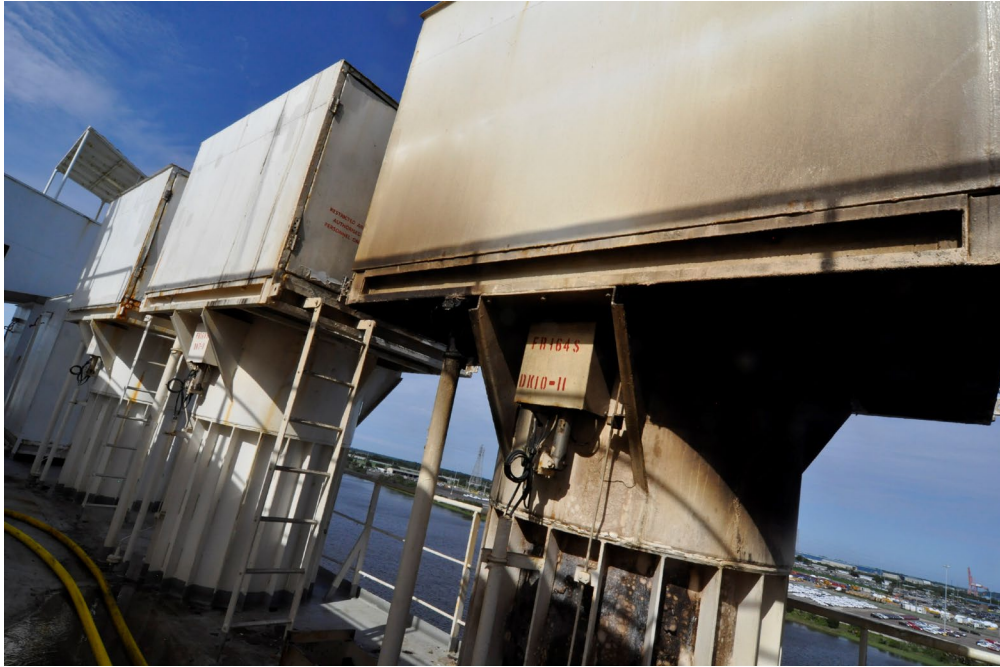
*10S (near accommodation space starboard side)*

Figure 20 shows the doghouse for a supply vent for deck 10/11. There is soot staining on the exterior of the doghouse. There is no visible mechanical damage.

Figure 20. Vent 10S on the starboard side exhibiting soot staining on the exterior.

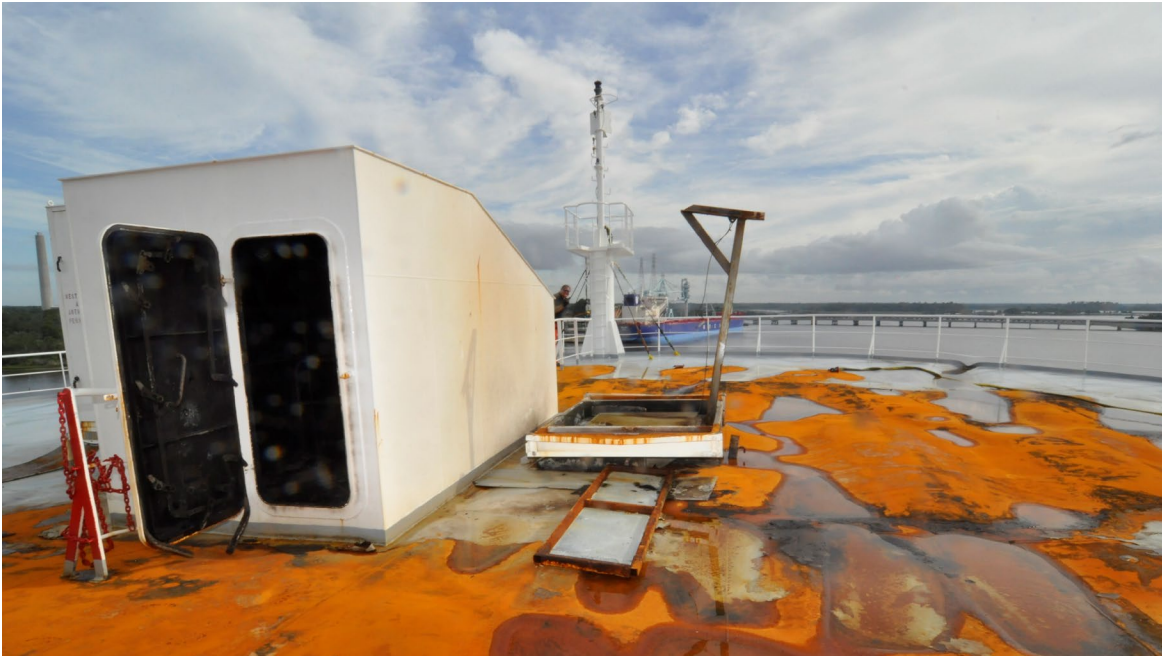
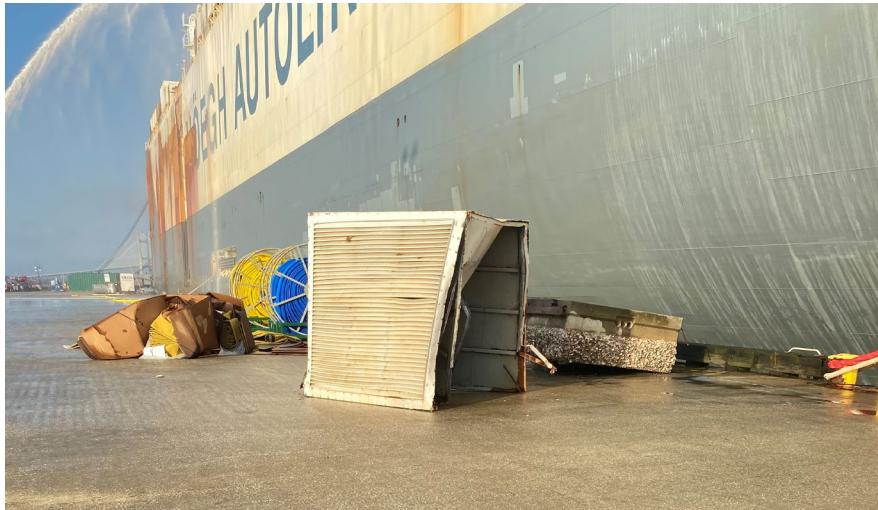
*10E (at the bow starboard side)*

Figures 21 and 22 show the doghouse for an exhaust vent for deck 10/11. There is some light soot staining on the bulkhead of the stairwell entrance adjacent to where the ventilation doghouse had been. The doghouse was completely separated from the deck and landed on the dock. The mechanical damage to the doghouse is consistent with an overpressure event.

Figure 21. Vent 10E on the starboard side of the bow. The upper portion of the doghouse is completely separated from the base and missing. This mechanical damage is consistent with an overpressure event. There is soot staining on the bulkhead adjacent to where the doghouse had been.

Figure 22. Ventilation doghouse from vent 10E on the starboard side of the bow found on dock.

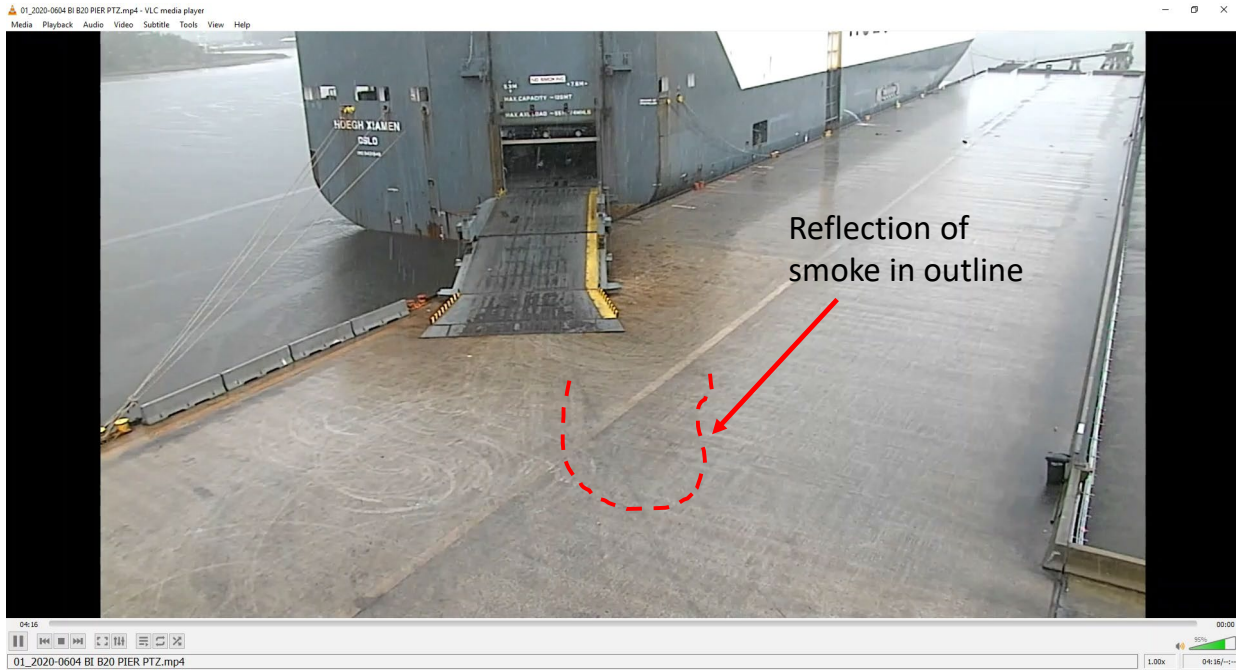
Figure 24. Two minutes after the crew leaves, there is the first sign of smoke seen as a reflection on the wet pavement. The reflection of the smoke is outlined.

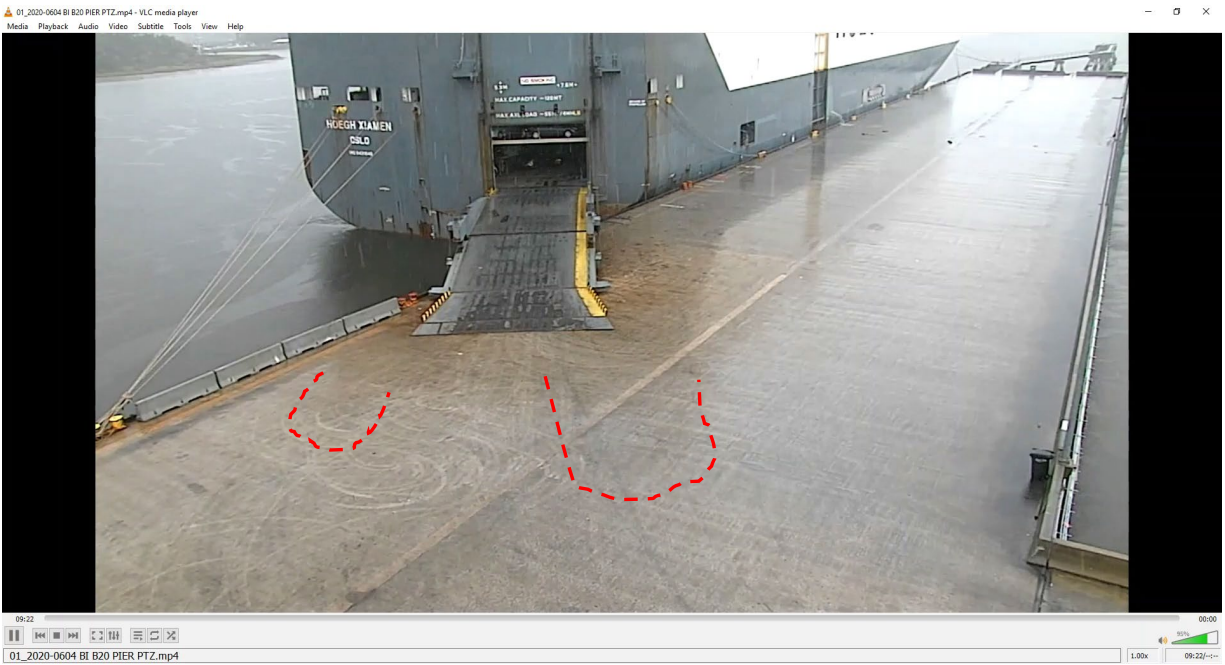
Figure 25. Seven minutes after the crew leaves, smoke starts to be seen on the port side. The reflections of the smoke are outlined.

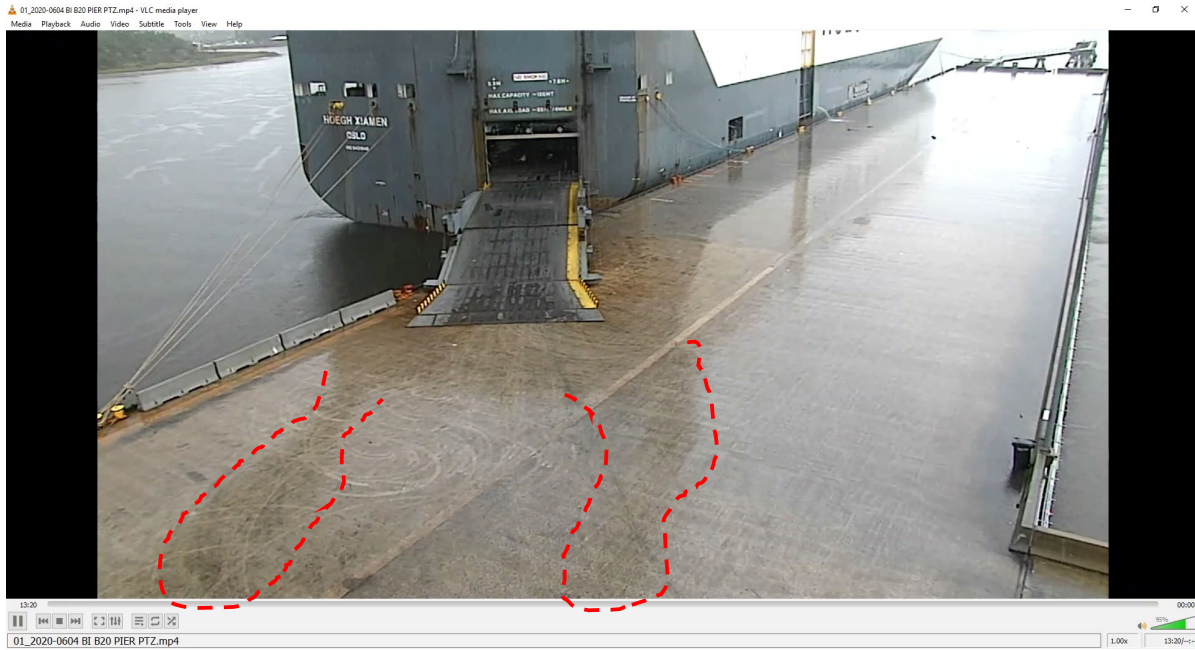
Figure 26. Eleven minutes after the crew leaves, heavy smoke can be seen from both the port and starboard sides of the stern.

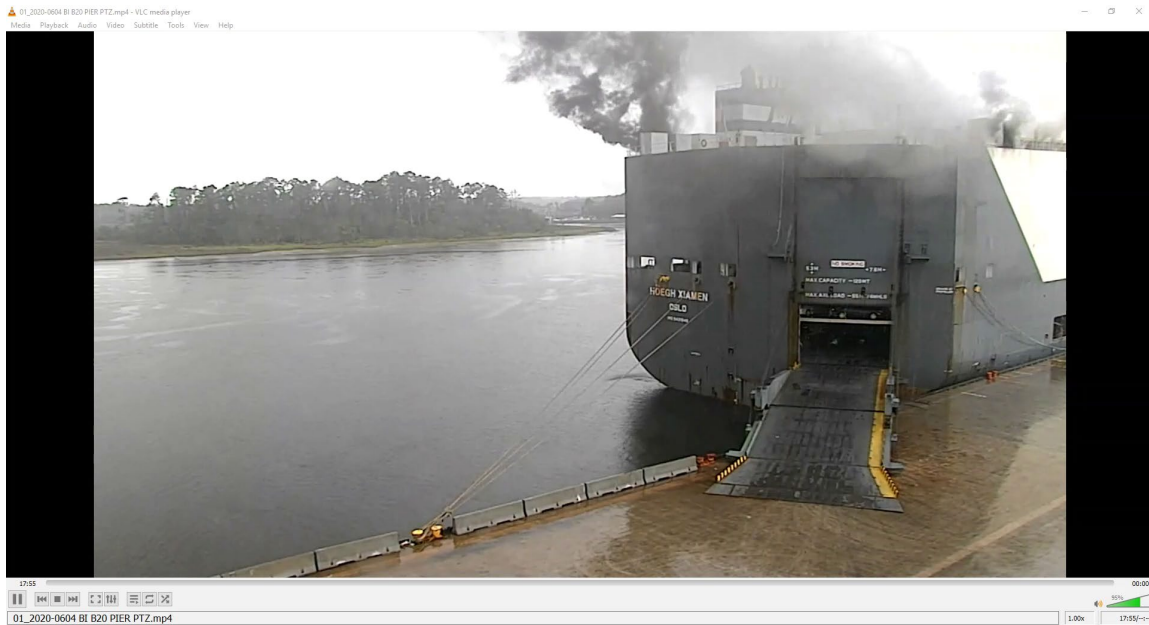
Figure 27. Sixteen minutes after the crew leaves, and the camera has panned upward. Smoke can be seen coming from vents on both the port and starboard sides of the stern.

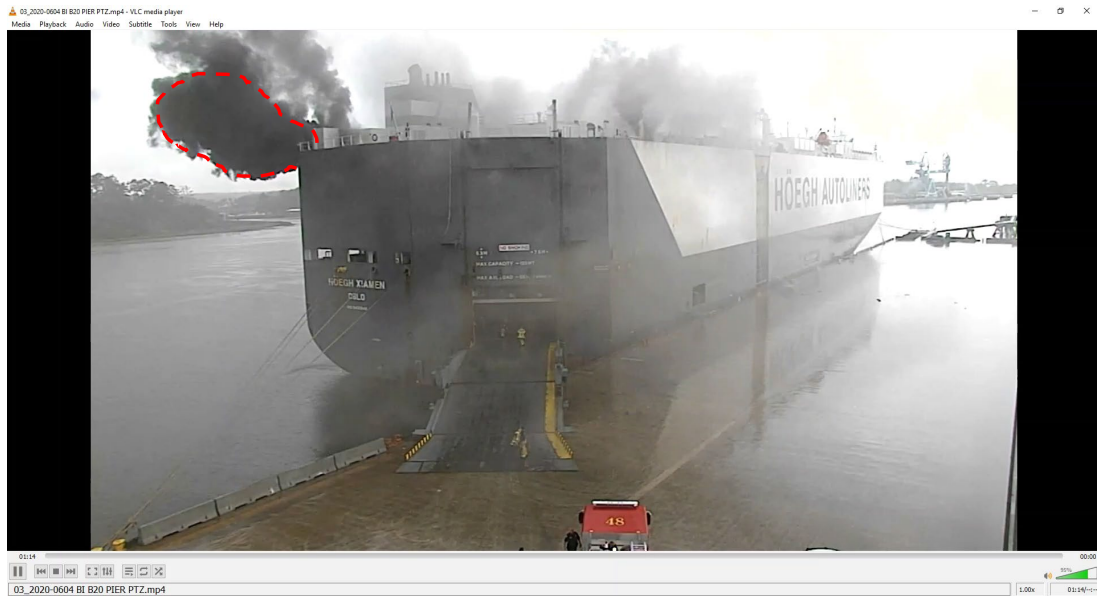
Figure 29. Fire department personnel walk up the stern ramp while a big puff of black smoke (outlined in red) exits from a stern port side vent.

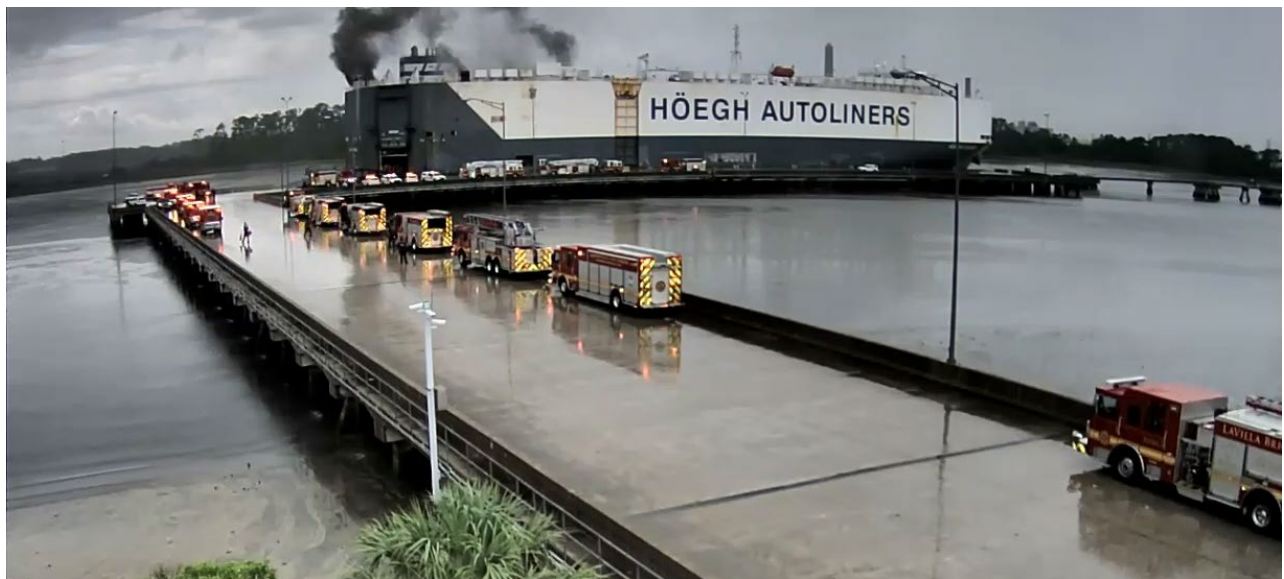
Figure 31. Approximately eleven minutes after truck E48 arrival. A thick column of black smoke can be seen emanating from the stern.

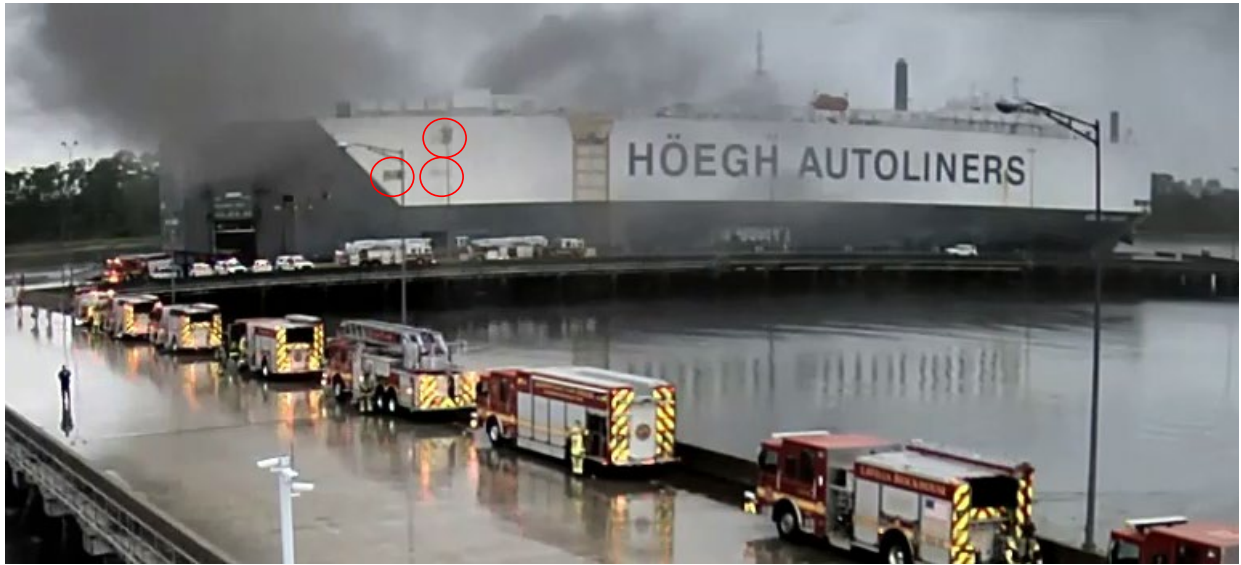
Figure 34. Thermal discoloration (circled in red) of the paint approximately 14 minutes after E48's arrival.

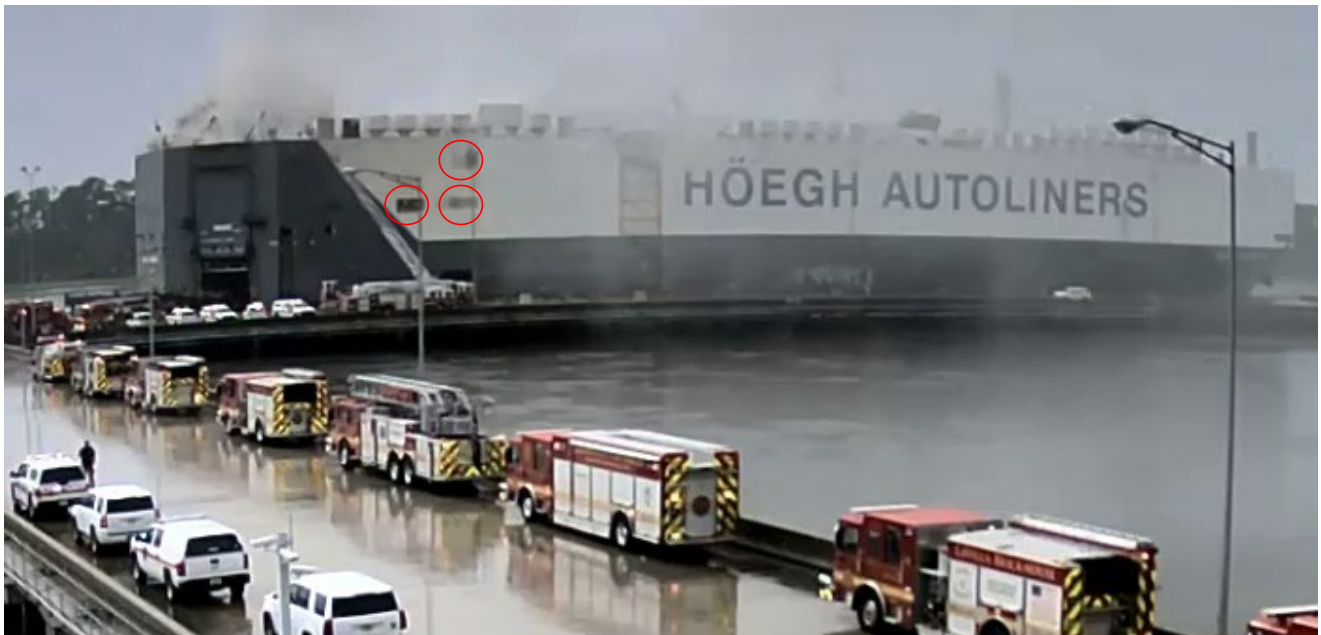
Figure 35. Thermal discoloration (circled in red) of the paint approximately 42 minutes after E48's arrival.

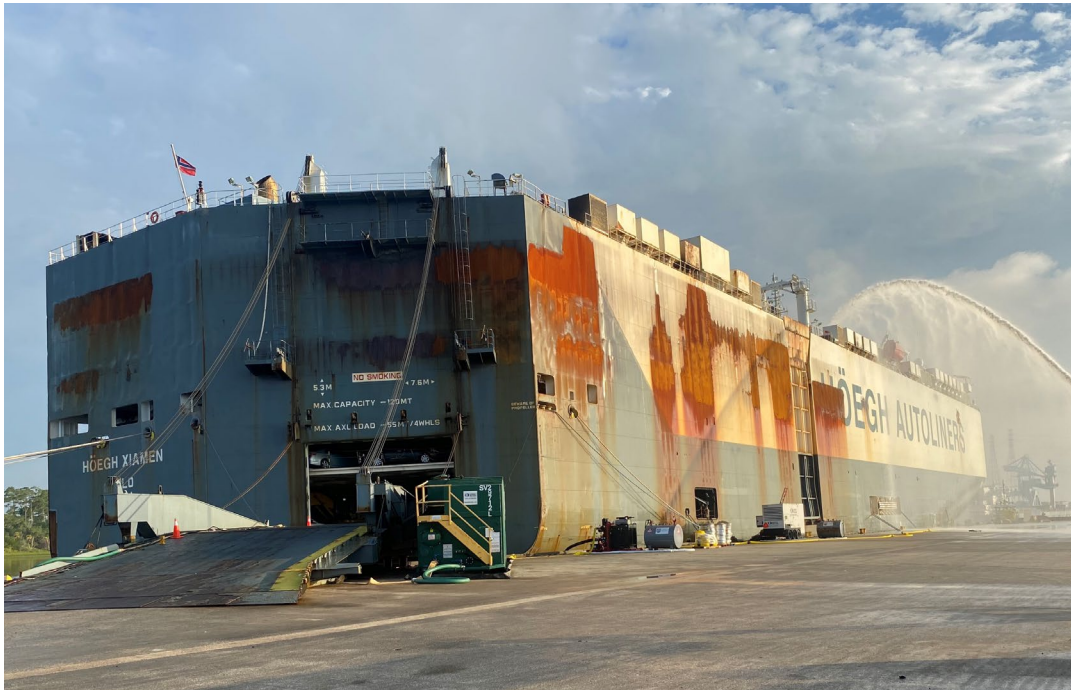
The ship burned for 8 days before the fire was declared extinguished. The ship was declared a constructive total loss. The fire caused thermal damage on the interior of cargo decks 7 to 11 and thermal damage to the deck and accommodation spaces on deck 12. This thermal damage extended from the stern to the bow. The Hazardous Materials Factual Report contains a description of the cargo. On the ship's exterior, the paint was discolored, charred, or burned off and rusted in areas where the fire had been burning adjacent to the ship's skin (figure 36). Photos taken by the Jacksonville Fire Department depict some of the overall damage from the perspective of the deck 12 weather deck (figures 37–43).

Figure 36. Thermal damage on the exterior skin of the ship denoting areas where the fire had been in proximity to the skin.

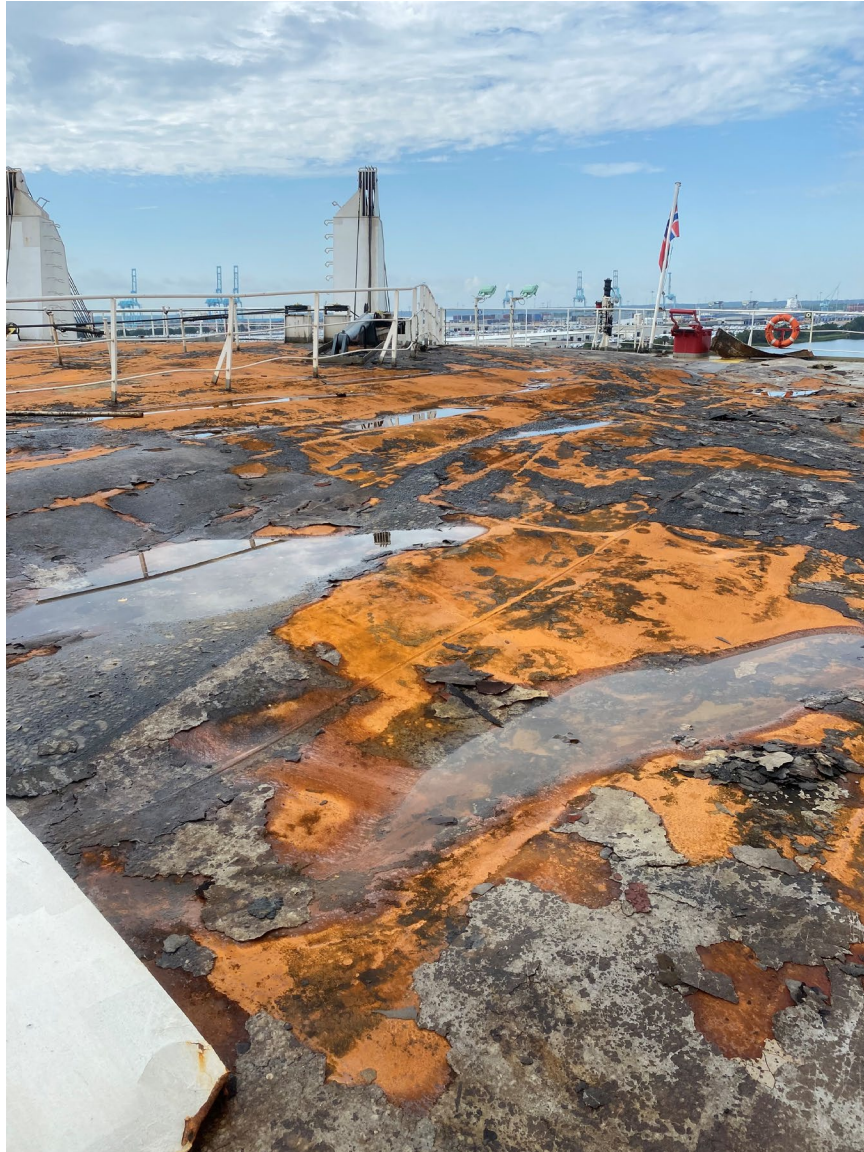
Figure 37. View from the port side toward the stern ramp. The surface of deck 12 is exhibiting deformation and charring/loss of paint.
