# NATIONAL TRANSPORTATION SAFETY BOARD

FIRE INVESTIGATION FACTUAL REPORT

Report No. 21-010

Place : Pier 20, Blount Island, Jacksonville, Florida  
Date : June 4, 2020  
Vehicle : *Höegh Xiamen*  
NTSB No. : DCA20FM020  
Investigator : Marcel Muise

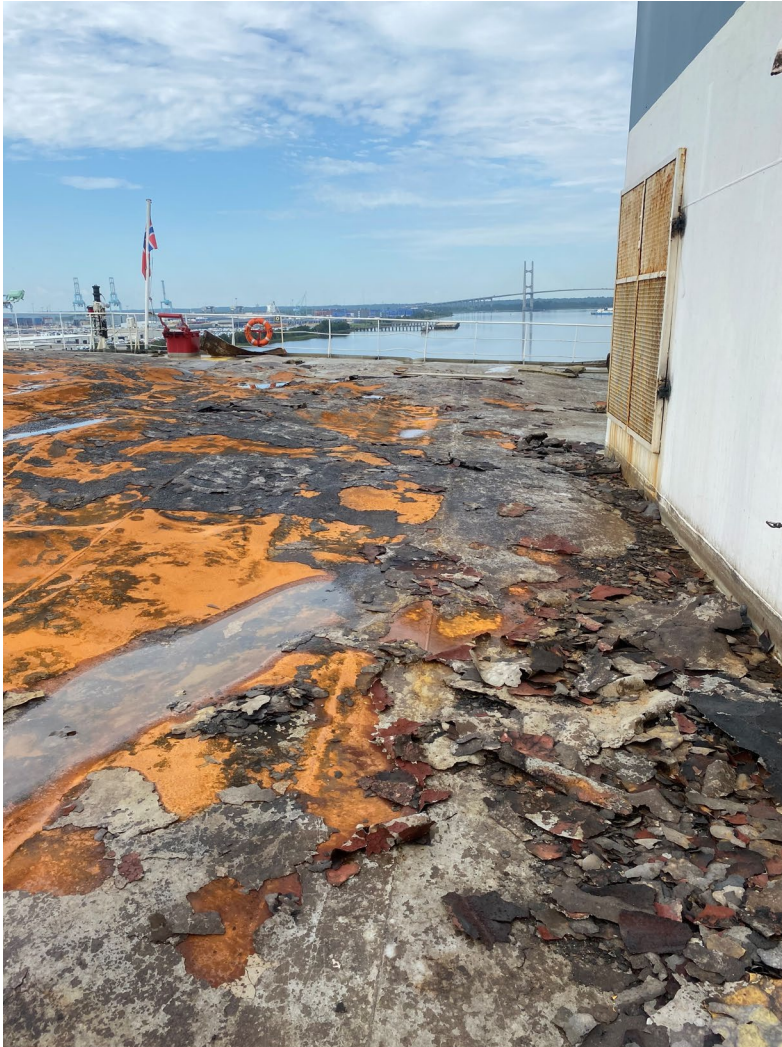
Figure 38. View of the port side stern of the ship. Thermal damage to the deck surface.

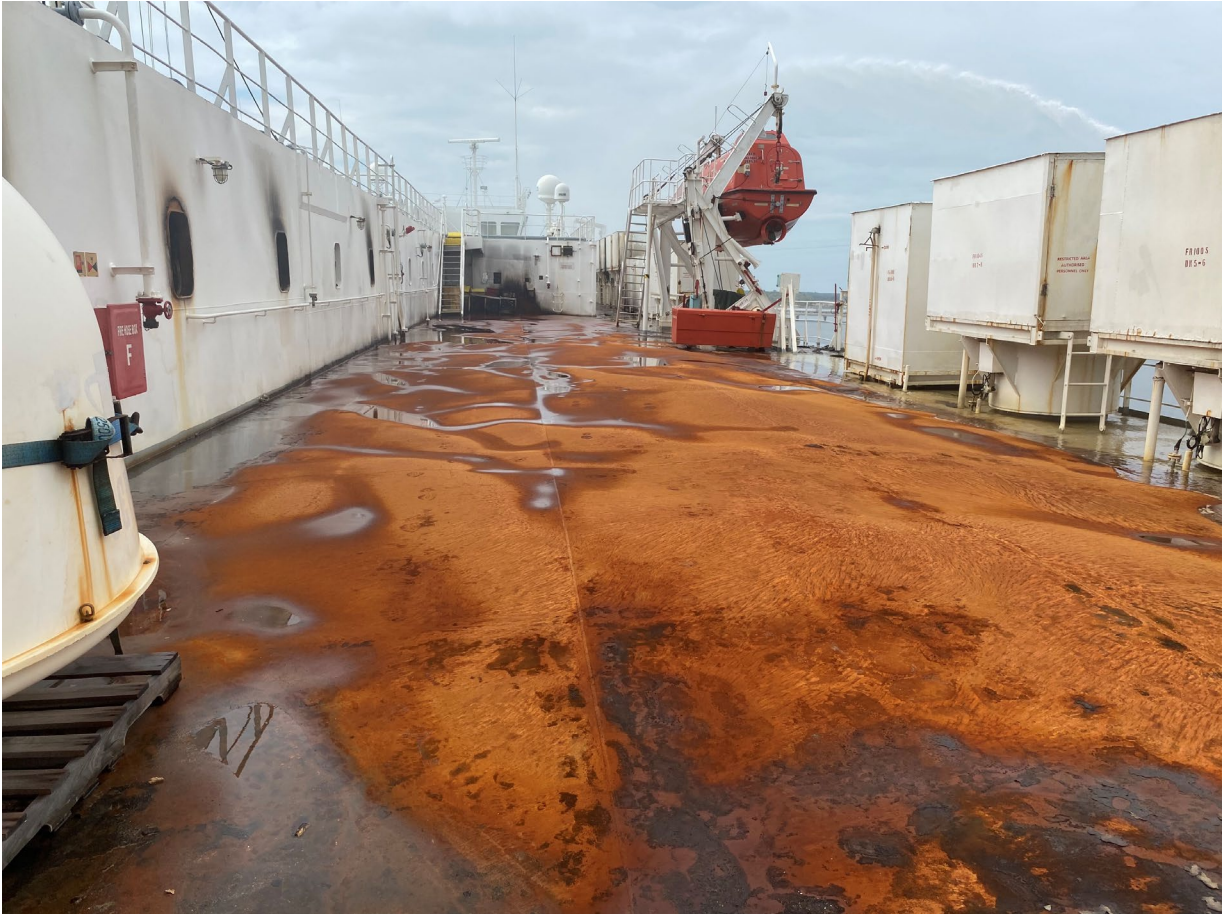
Figure 39. View of the starboard side near the accommodation space. There are soot stains coming from the accommodation space windows and thermal damage to the deck surface.

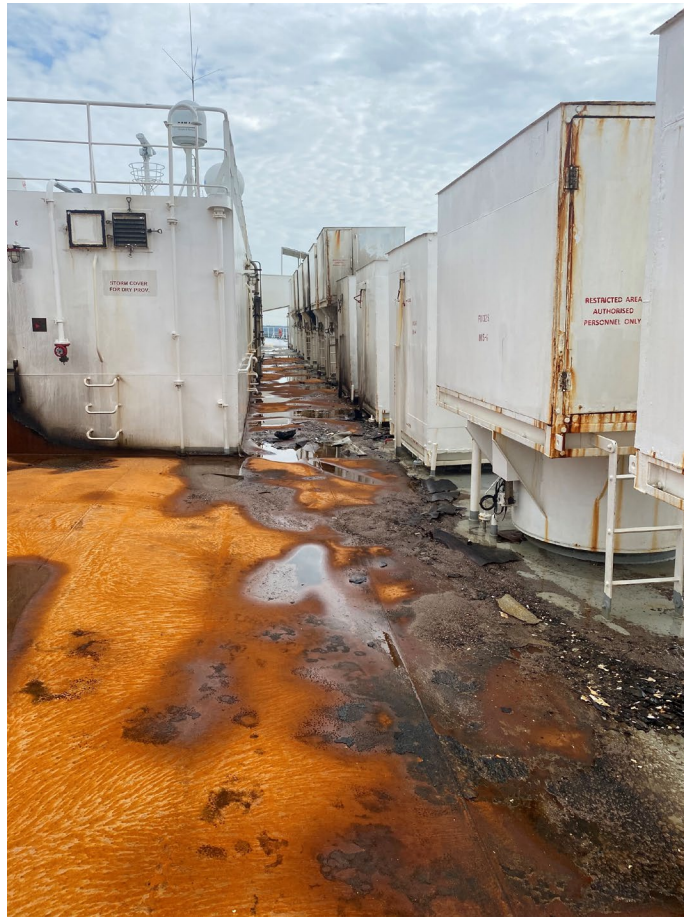
Figure 40. View of the starboard side near the accommodation space, including thermal damage to the deck surface.

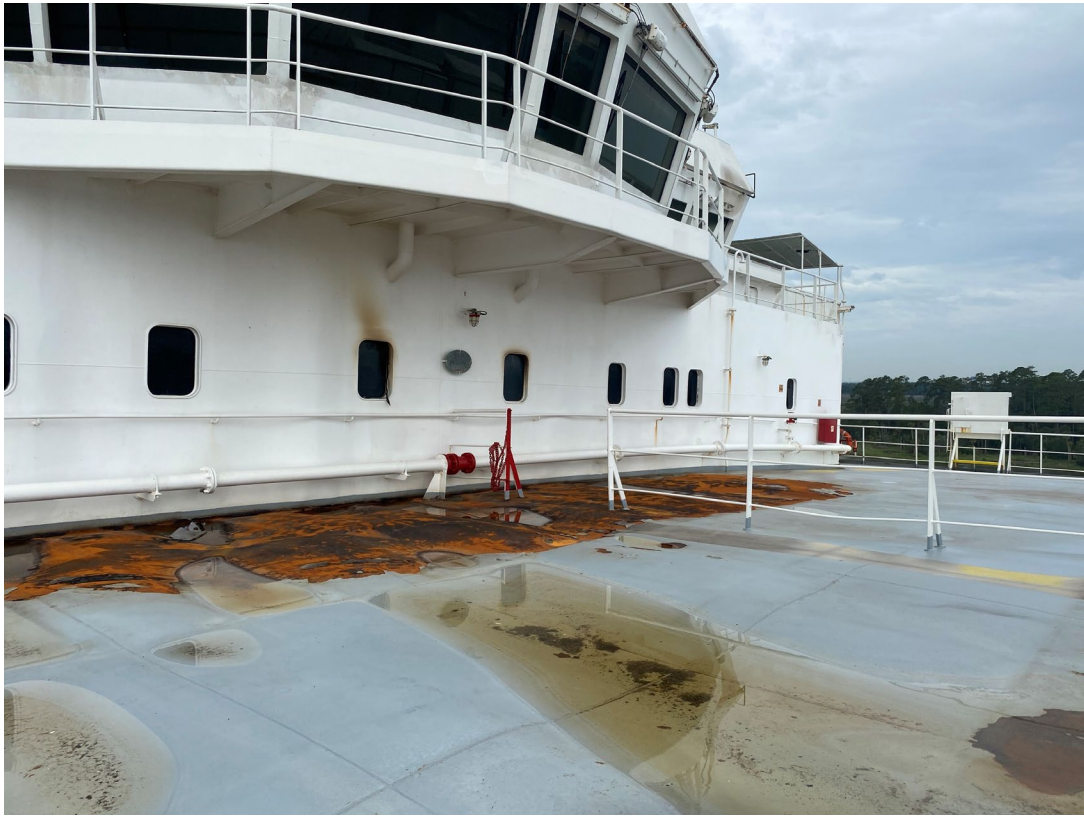
Figure 41. View of the area below the bridge, including thermal damage to the deck surface and smoke stains above the window of the space below the bridge.

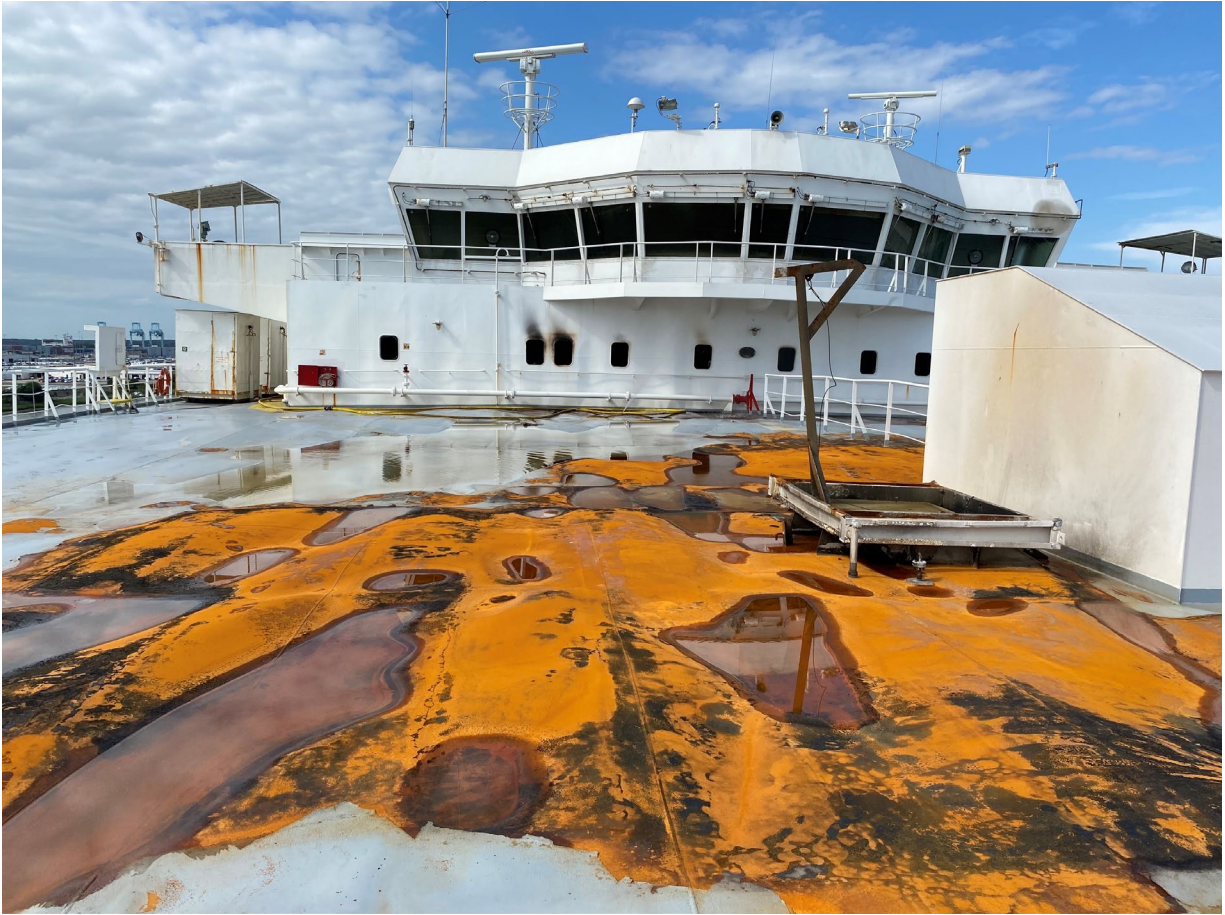
Figure 42. Thermal damage to the deck at the bow.

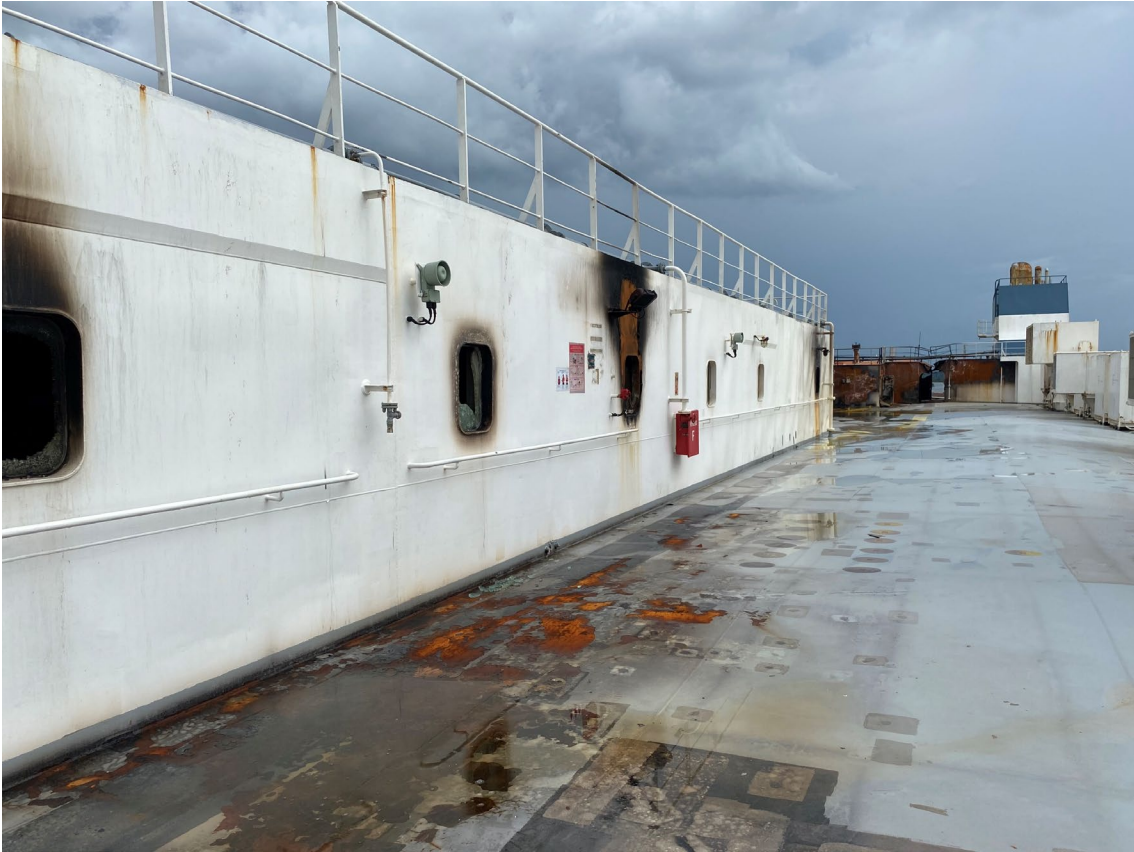
Figure 43. Thermal damage on the deck and smoke and thermal damage above the windows of the accommodation space on the port side.
