**National Transportation Safety Board
Washington, D.C. 20594**

Fire Factual
January 26, 2004

NTSB Accident Number:	DCA05MA004
Date of Accident:	Tuesday, October 19, 2004
Location of Accident:	Kirksville, MO
Aircraft:	British Aerospace Jetstream 32
Registration:	N875JX
Investigator:	Nancy B. McAtee, Joseph Panagiotou

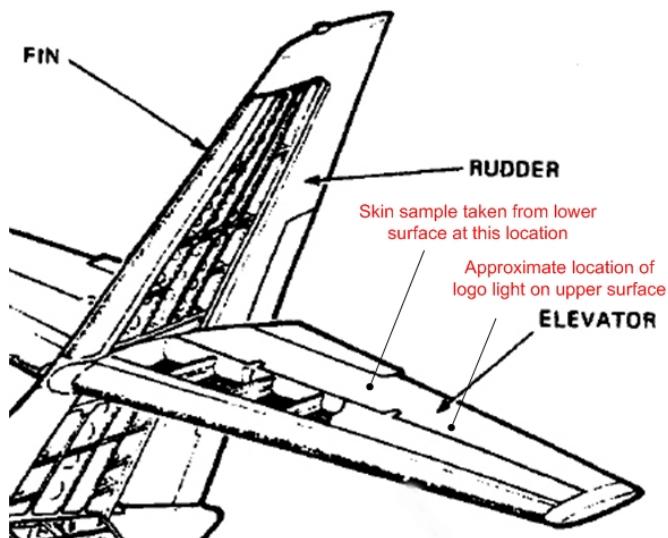
Figure 1 (Locations of parts submitted for inspection)

Two parts recovered from the accident aircraft were submitted for inspection. Both samples were prepared in the field and packaged in metal cans. One of the parts is the logo light located on the upper surface of the left horizontal stabilizer (Figure 1). The light was found in its originally installed location. The other part is a portion of aircraft skin recovered from the lower surface of the left elevator. The sample was removed from the elevator assembly using tin snips. The locations of these parts are shown in Figure 1.

The left horizontal stabilizer was found lying upside down at the accident site.

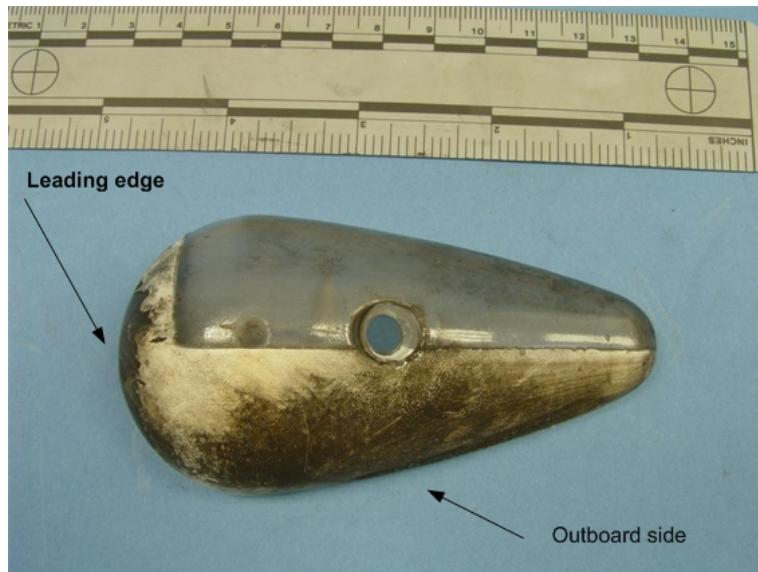
Photograph 1 (Logo light)

The logo light (Photograph 1) was found at the accident site in its original location of installation (Photograph 2). The approximate size of the light is 10cm long by 5cm wide and 2.5cm tall. The light is made of glass with a ceramic coating applied to the leading edge and outboard side. The surface of the logo light is scratched and gouged. The leading edge shows significantly more mechanical damage than the rest of the surface. The outboard side of the light (opaque part) shows more soot on the surface than the inboard side. There is no distinguishable thermal damage to the light on either the external or internal surface.

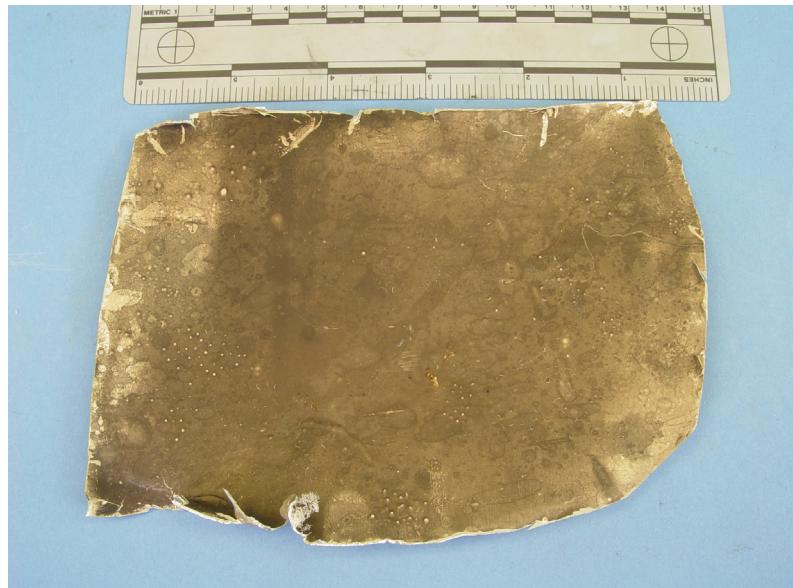
Photograph 3 (External surface of skin sample)

The skin sample (Photographs 3, 4, 5) was taken from the lower surface of the left elevator (Photographs 6, 7). The size of the sample is approximately 14cm by 10cm. The external surface of the skin sample shows generally uniform soot deposition without distinguishable flow patterns. The soot is easily removed using a damp swab. Removing the soot reveals a slight discoloration to the paint underneath. Originally, the paint was white. The discoloration is indicative of a surface temperature approximately 315°C ^{1,2}. Additionally some

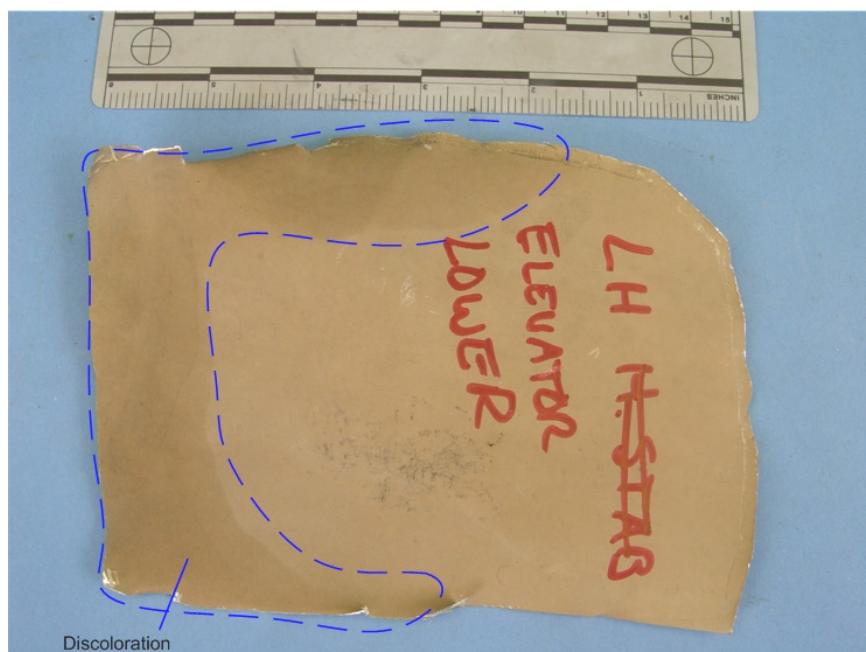
Photograph 4 (Internal surface of skin sample)

On the internal side (Photograph 4) the primer paint also shows some discoloration. Specifically there are regions where the tan primer has taken on a brown color. The regions where the color of the primer has changed are consistent with the regions showing blistering on the exposed side. The change in color, from tan to brown suggests a surface temperature of 260°C^{1,2}. Besides the soot and thermal degradation there are no other notable signs of damage.

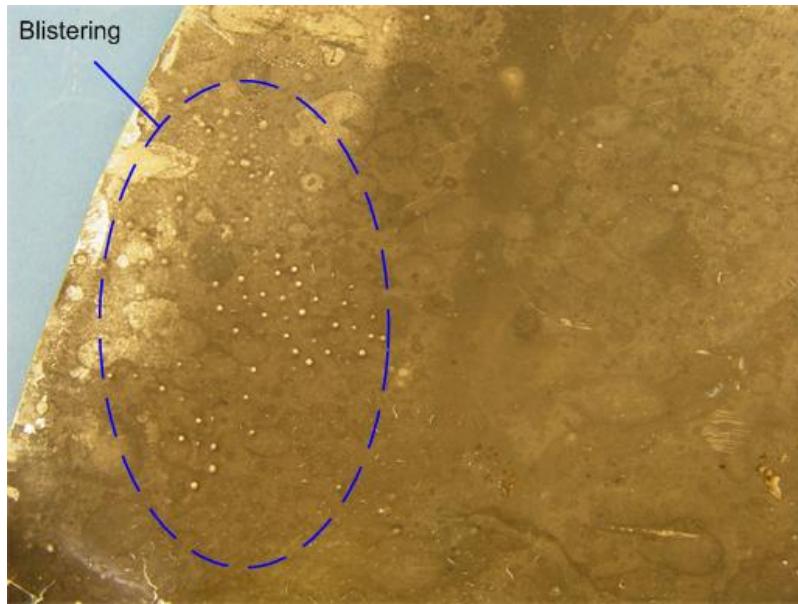
Photograph 5 (Close-up of blistering on external surface)

light blistering can be seen on the painted surface (Photograph 5). The blistering indicates a temperature at the surface in the range of 425°C - 450°C^{1,2}.
