**Flight details for N966EZ the morning of Saturday, Oct. 7, 2017**

**Provided to Dale Adams of the Scottsdale FAA**

Monday, Oct 9, 2017

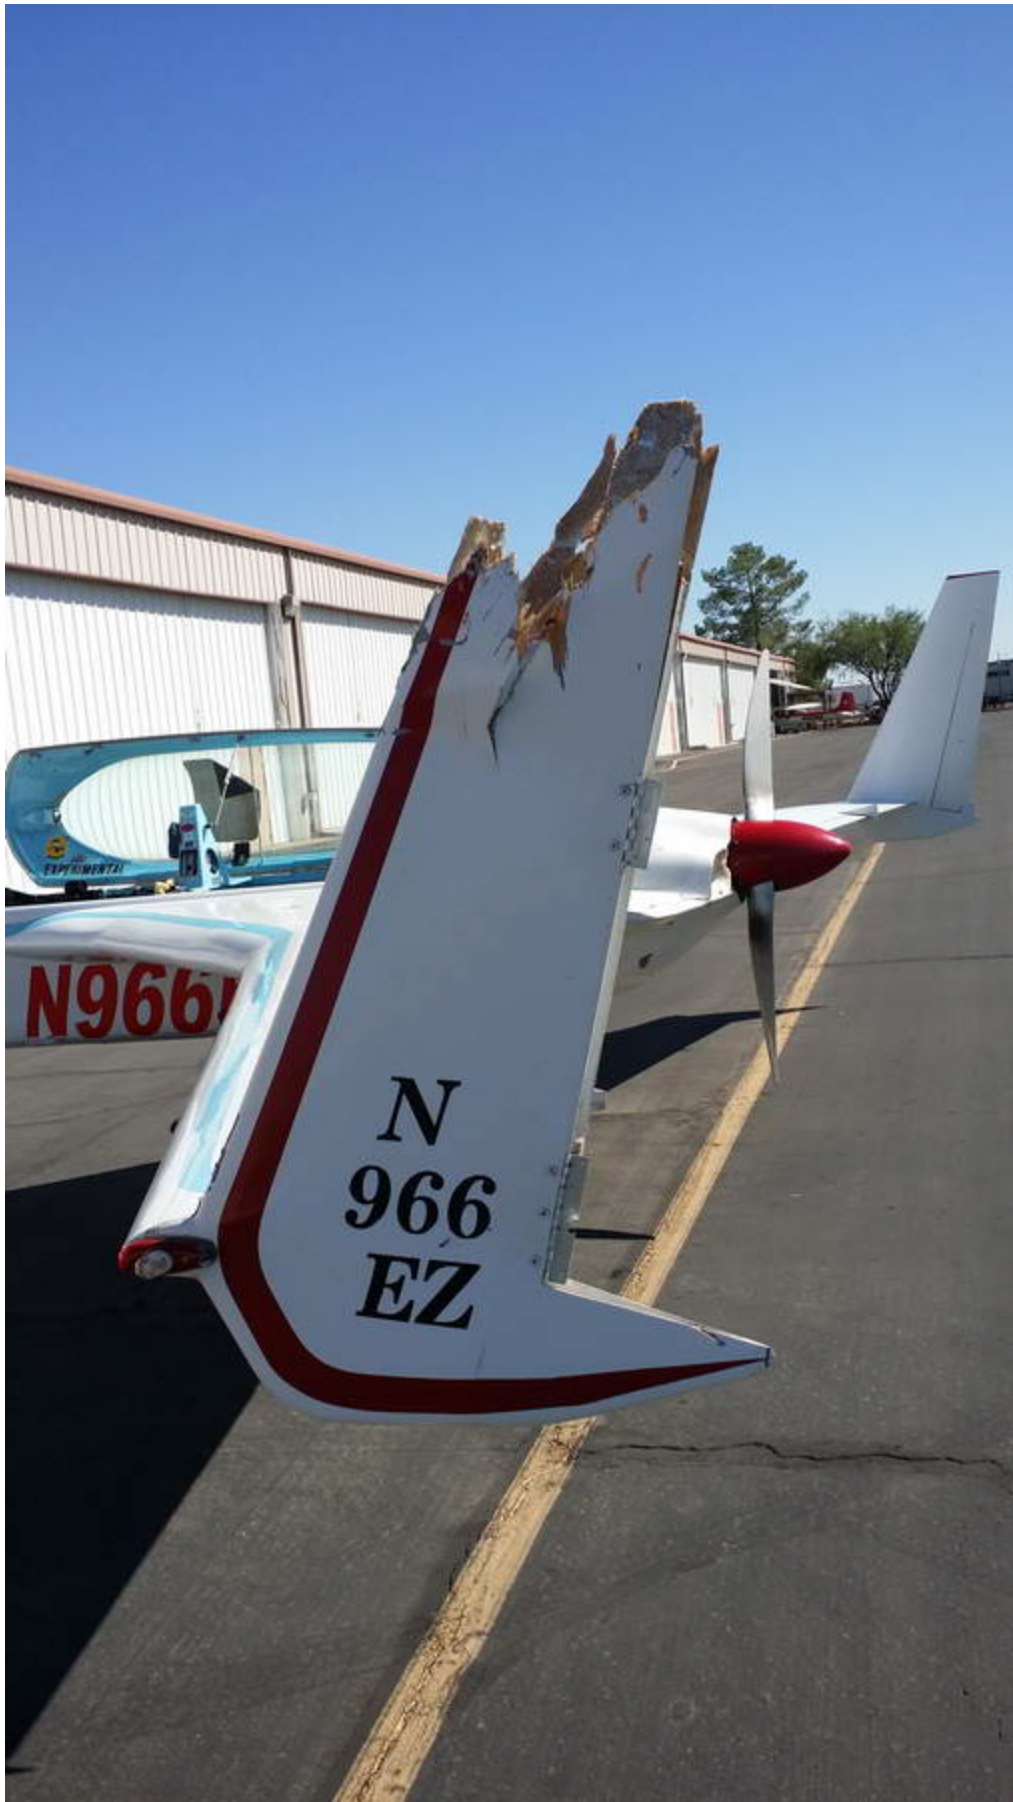
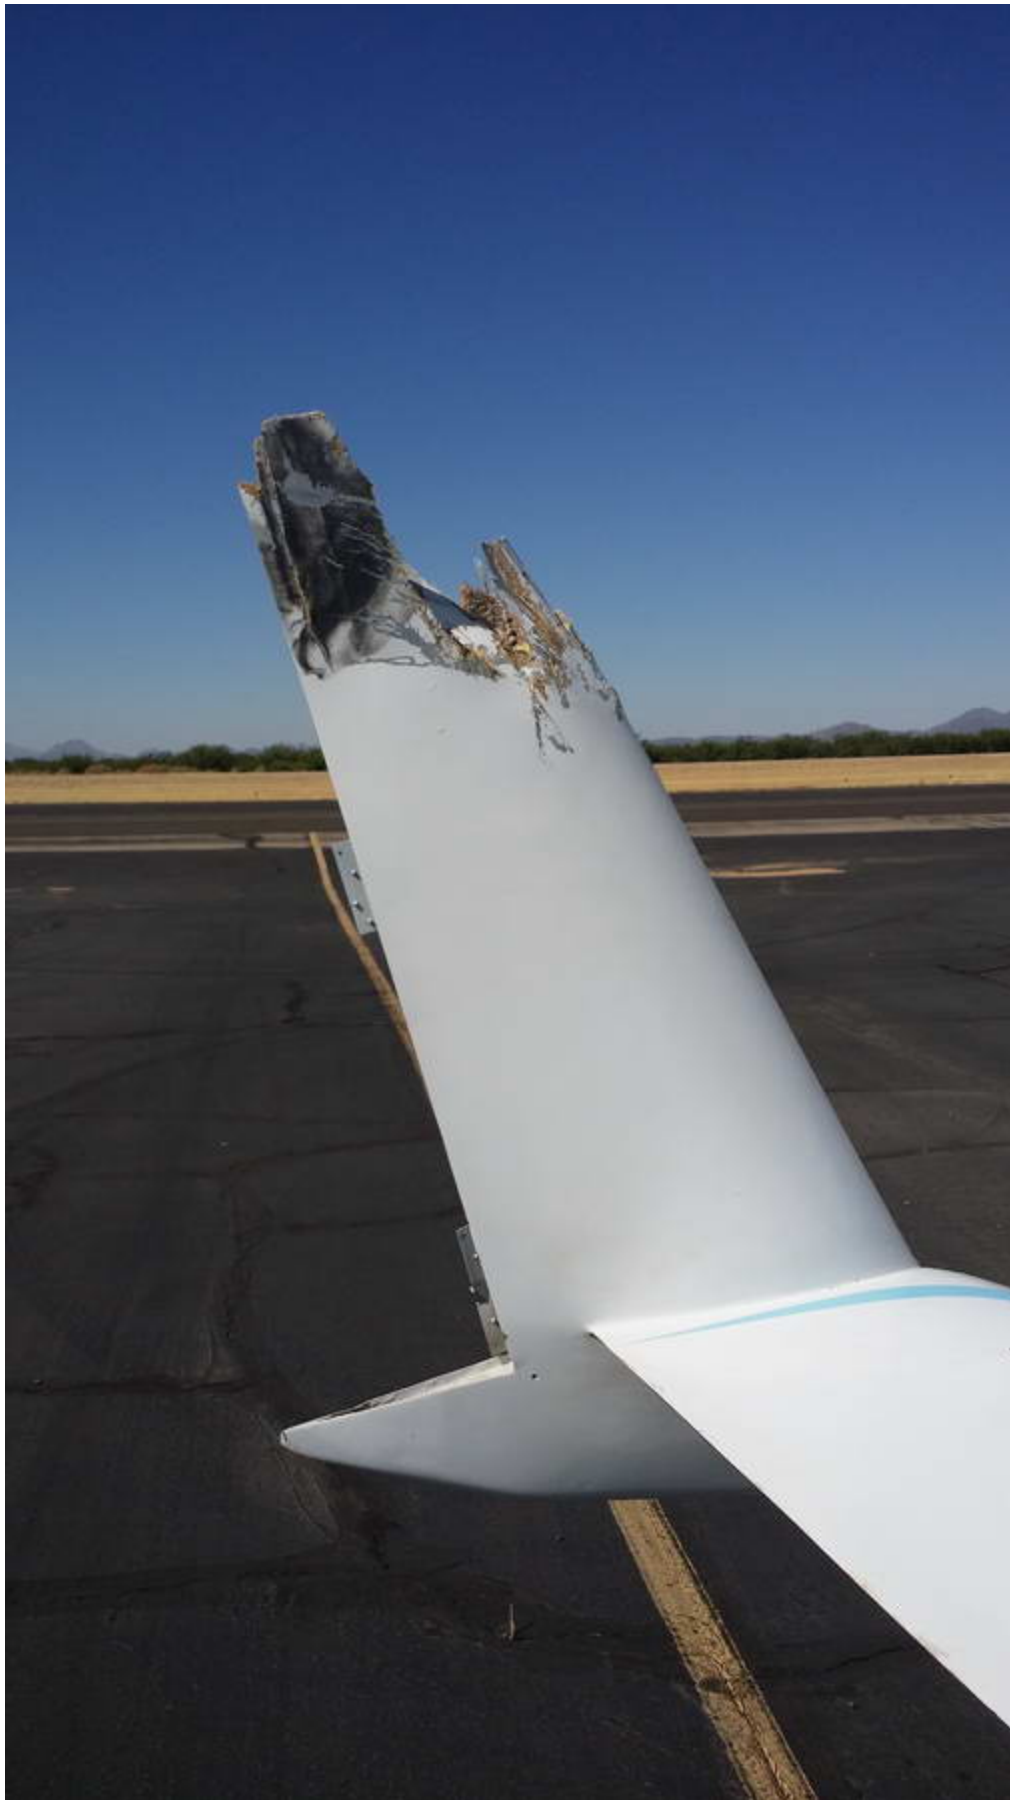
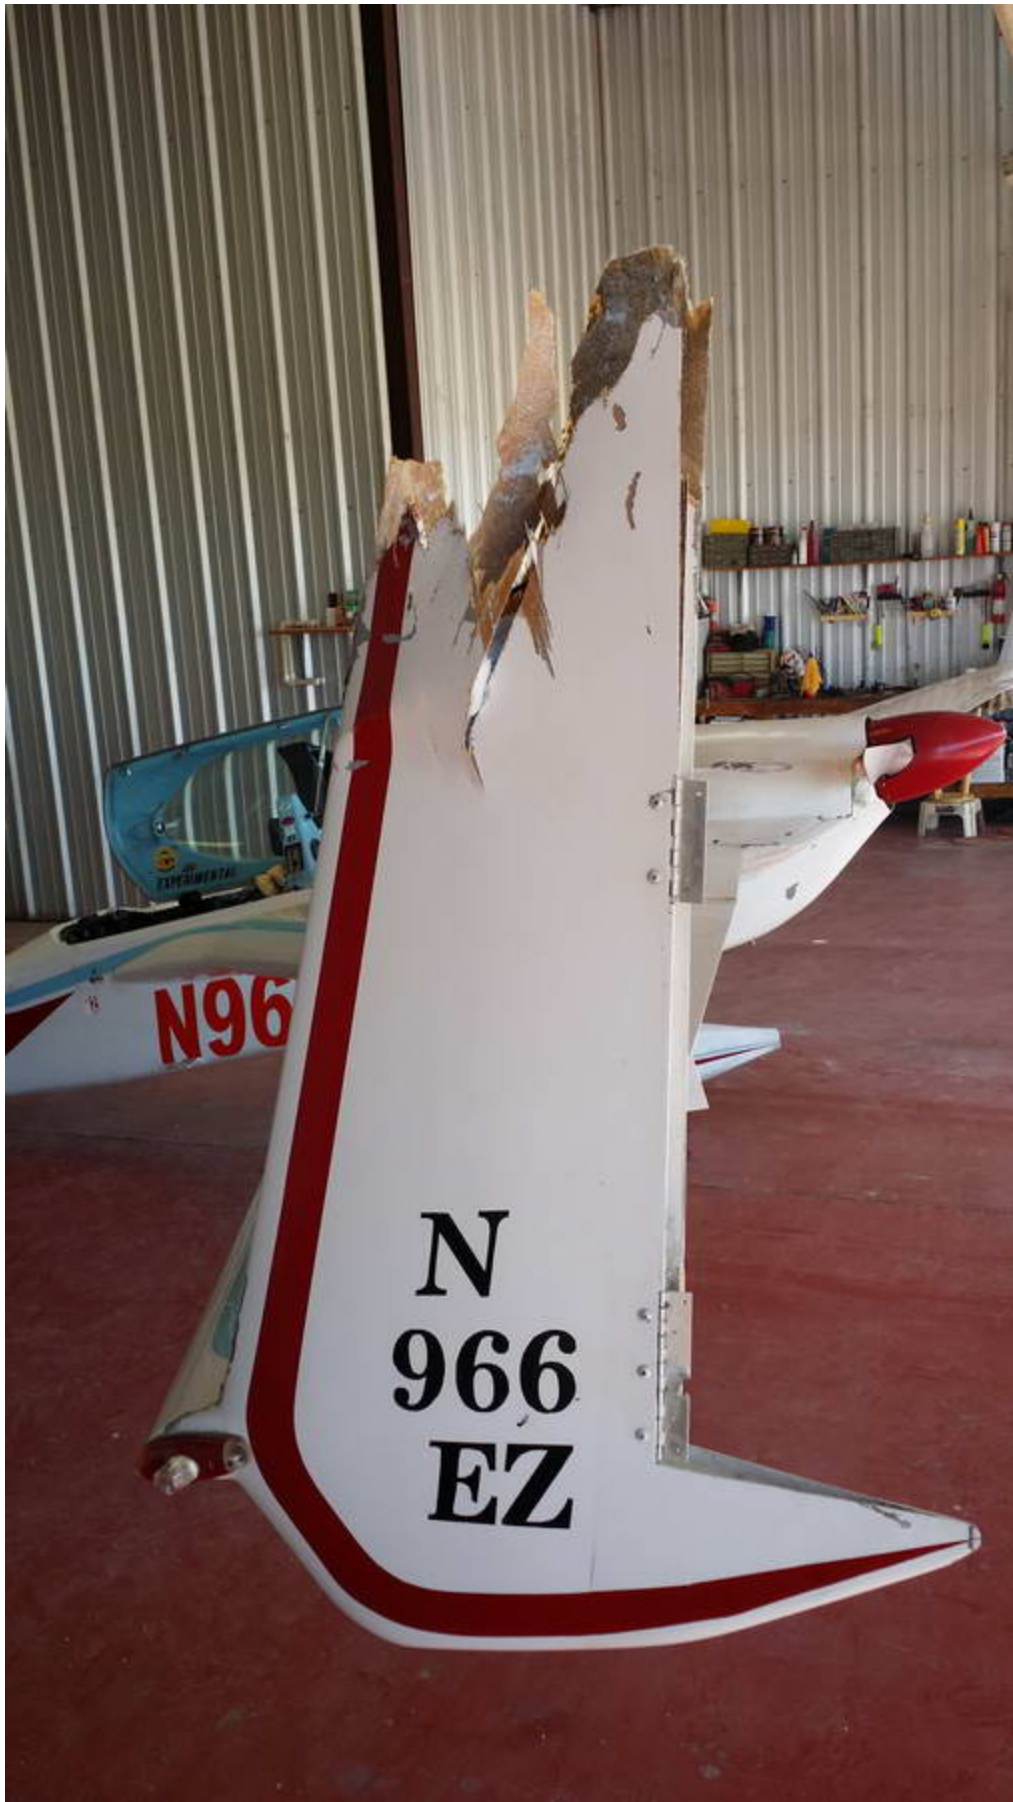
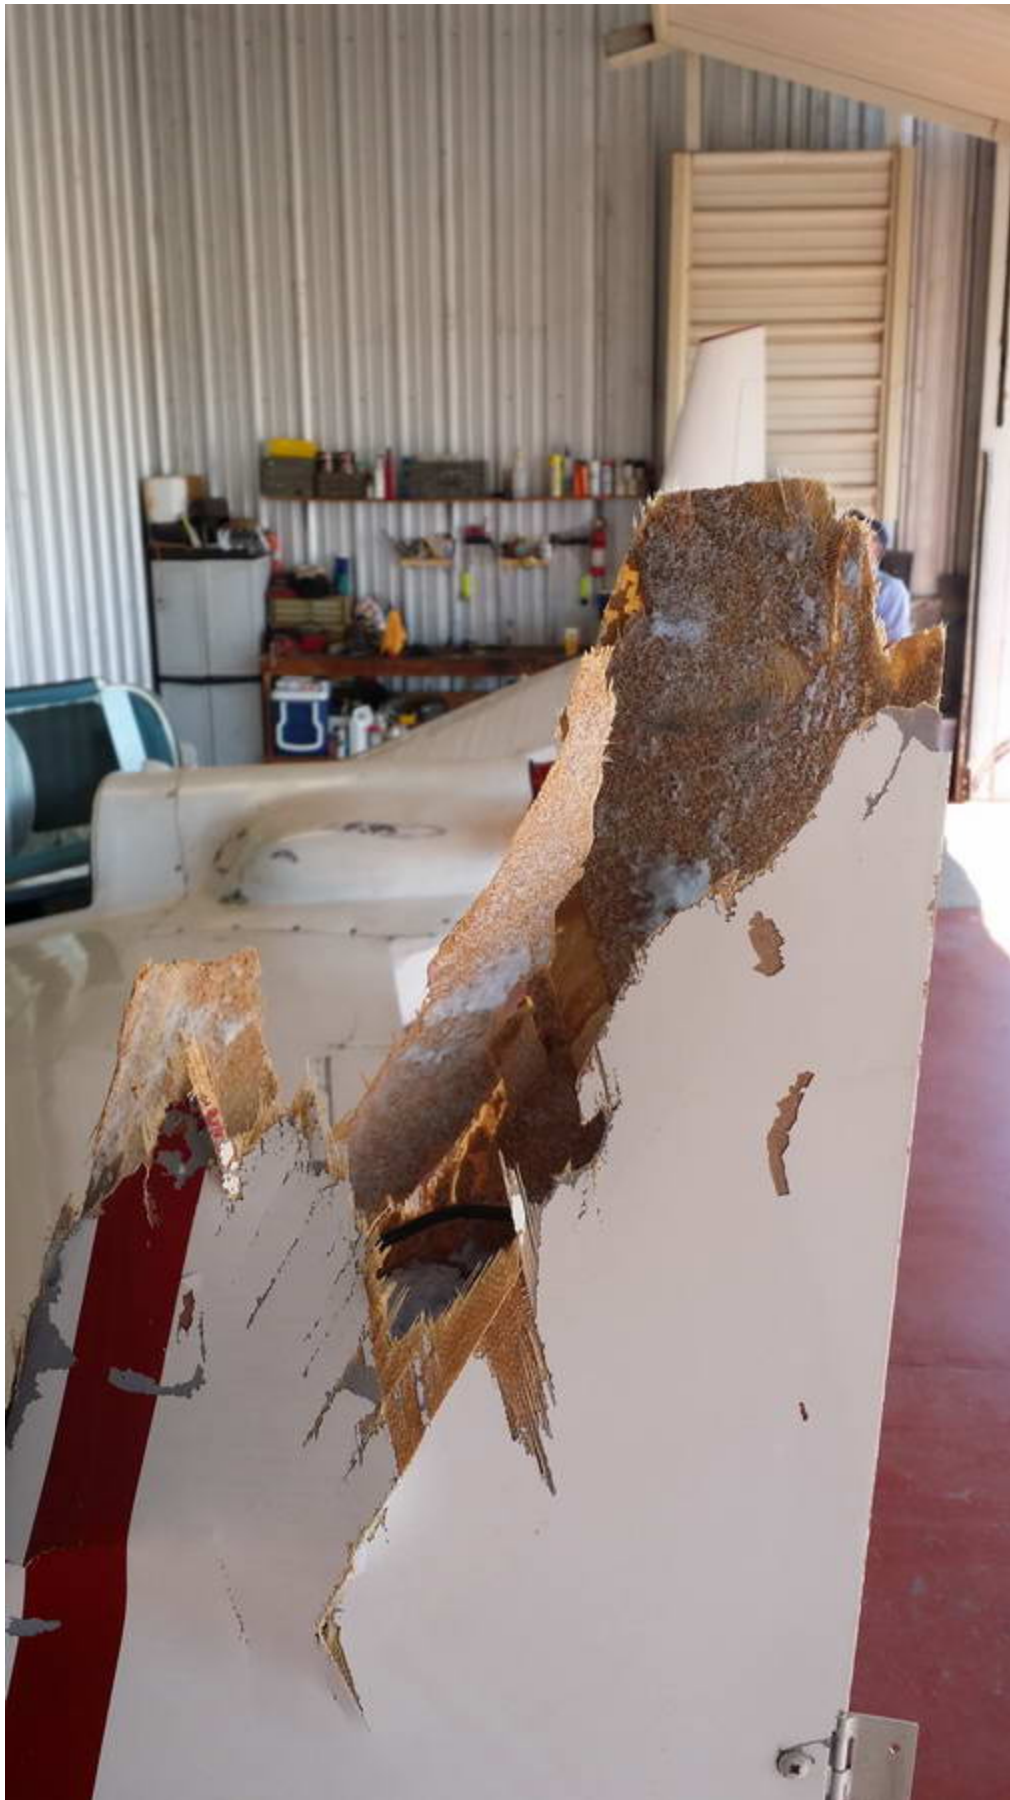
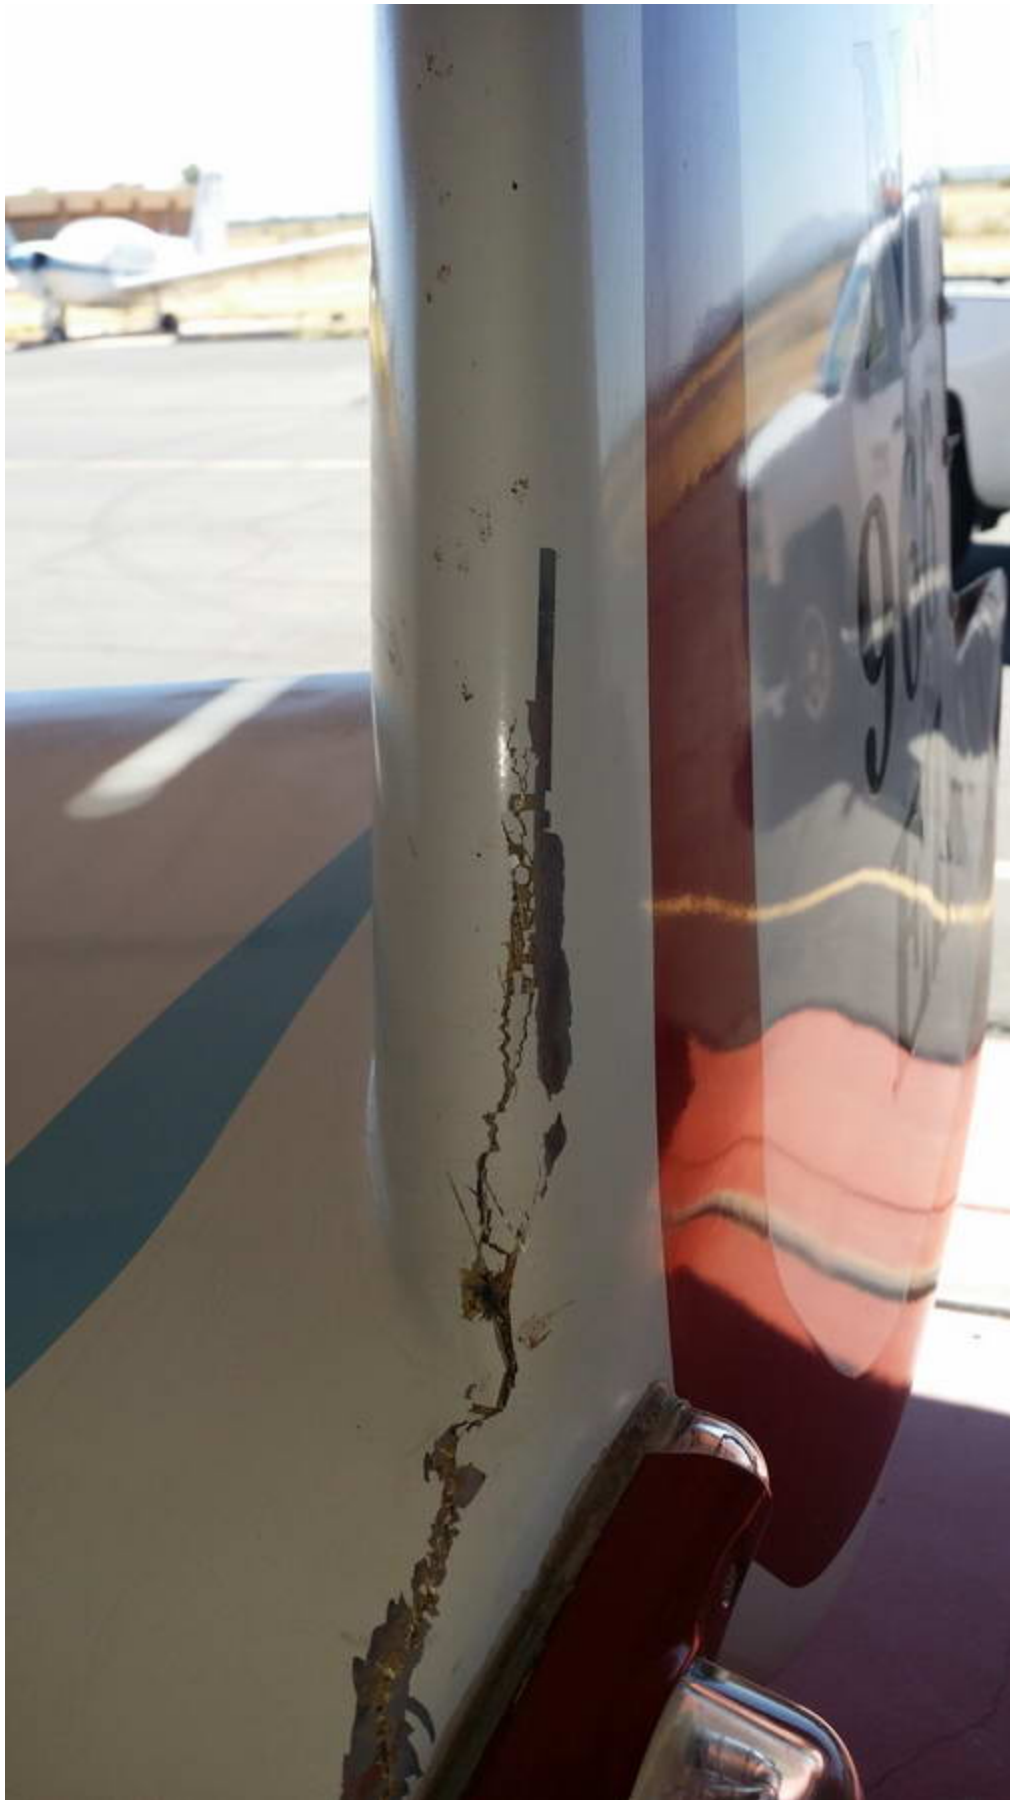
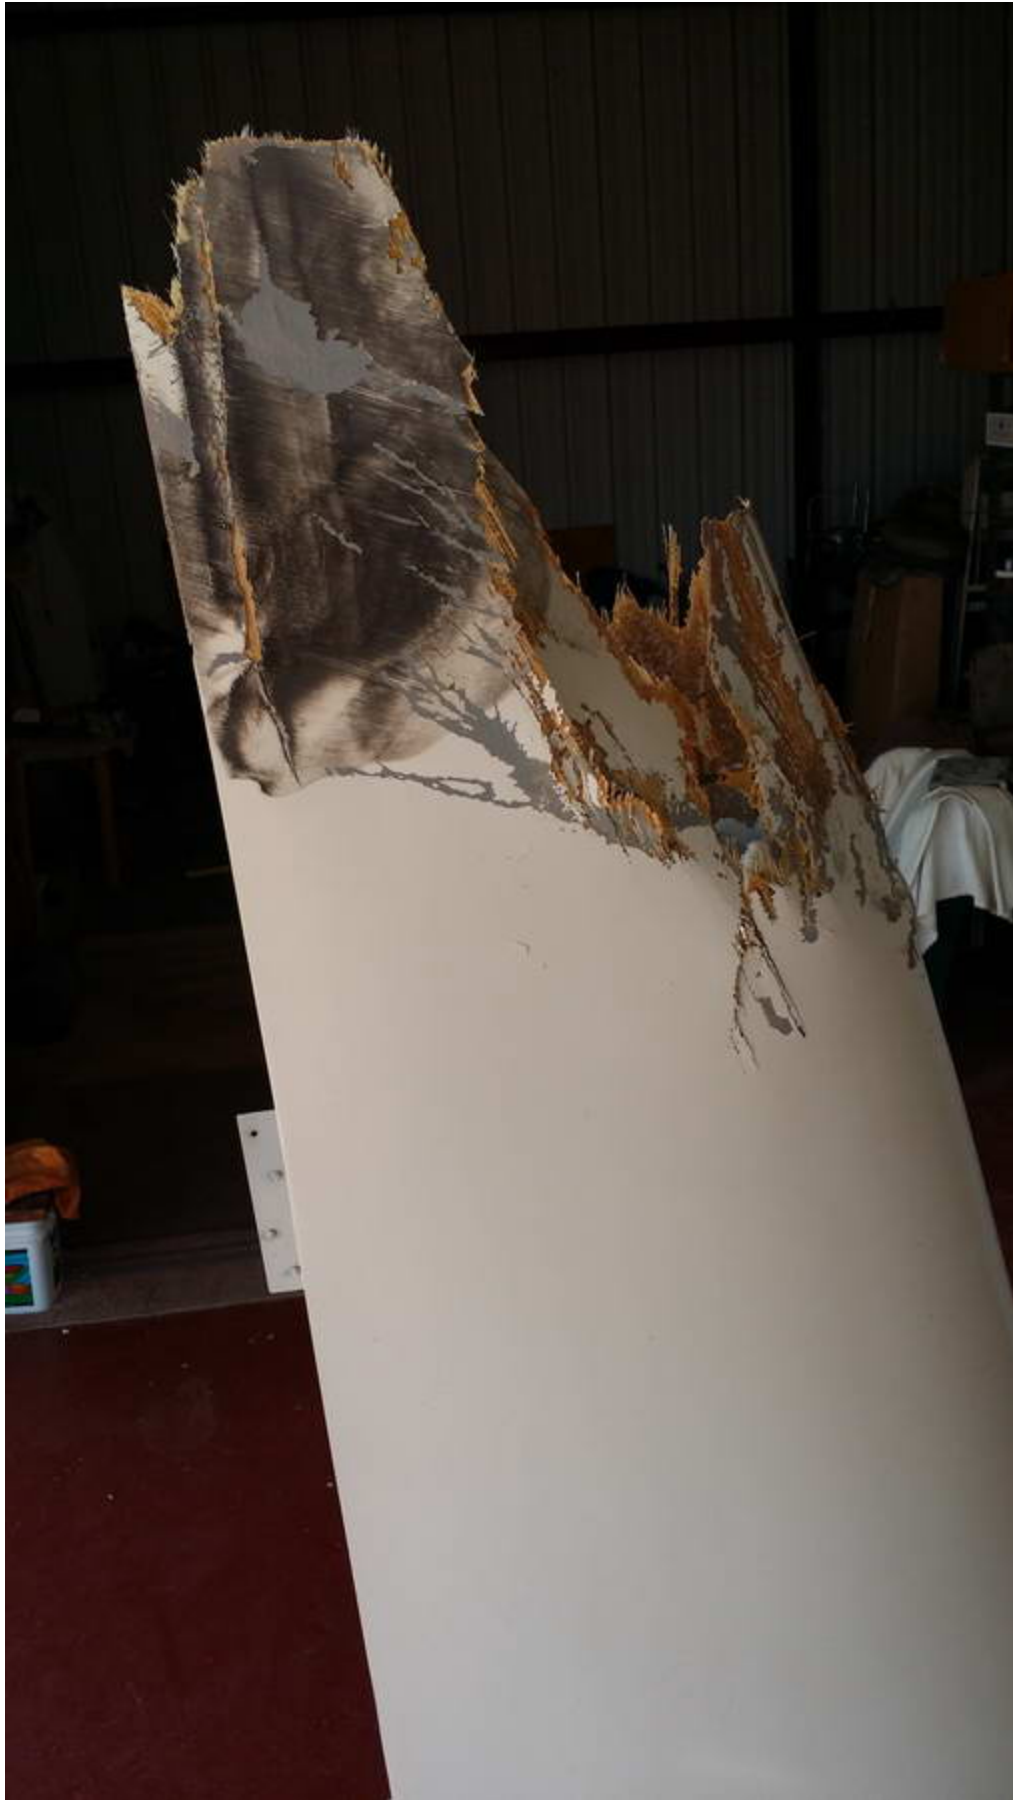
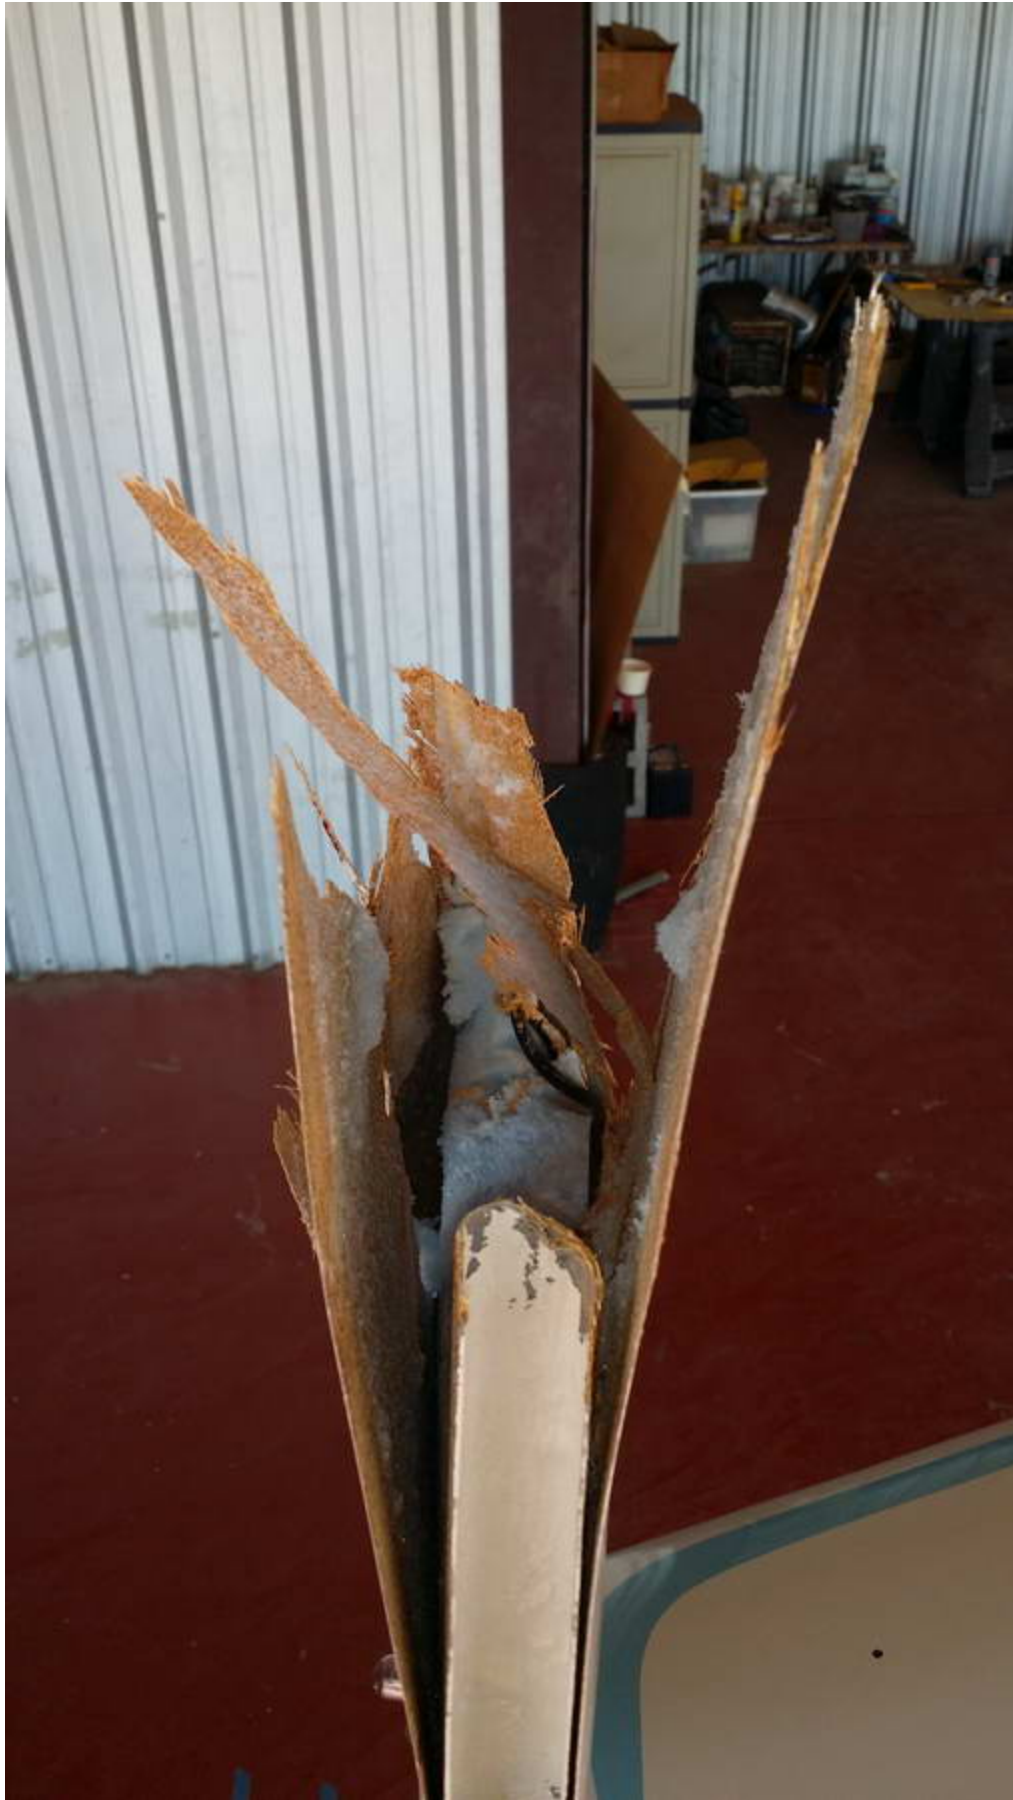
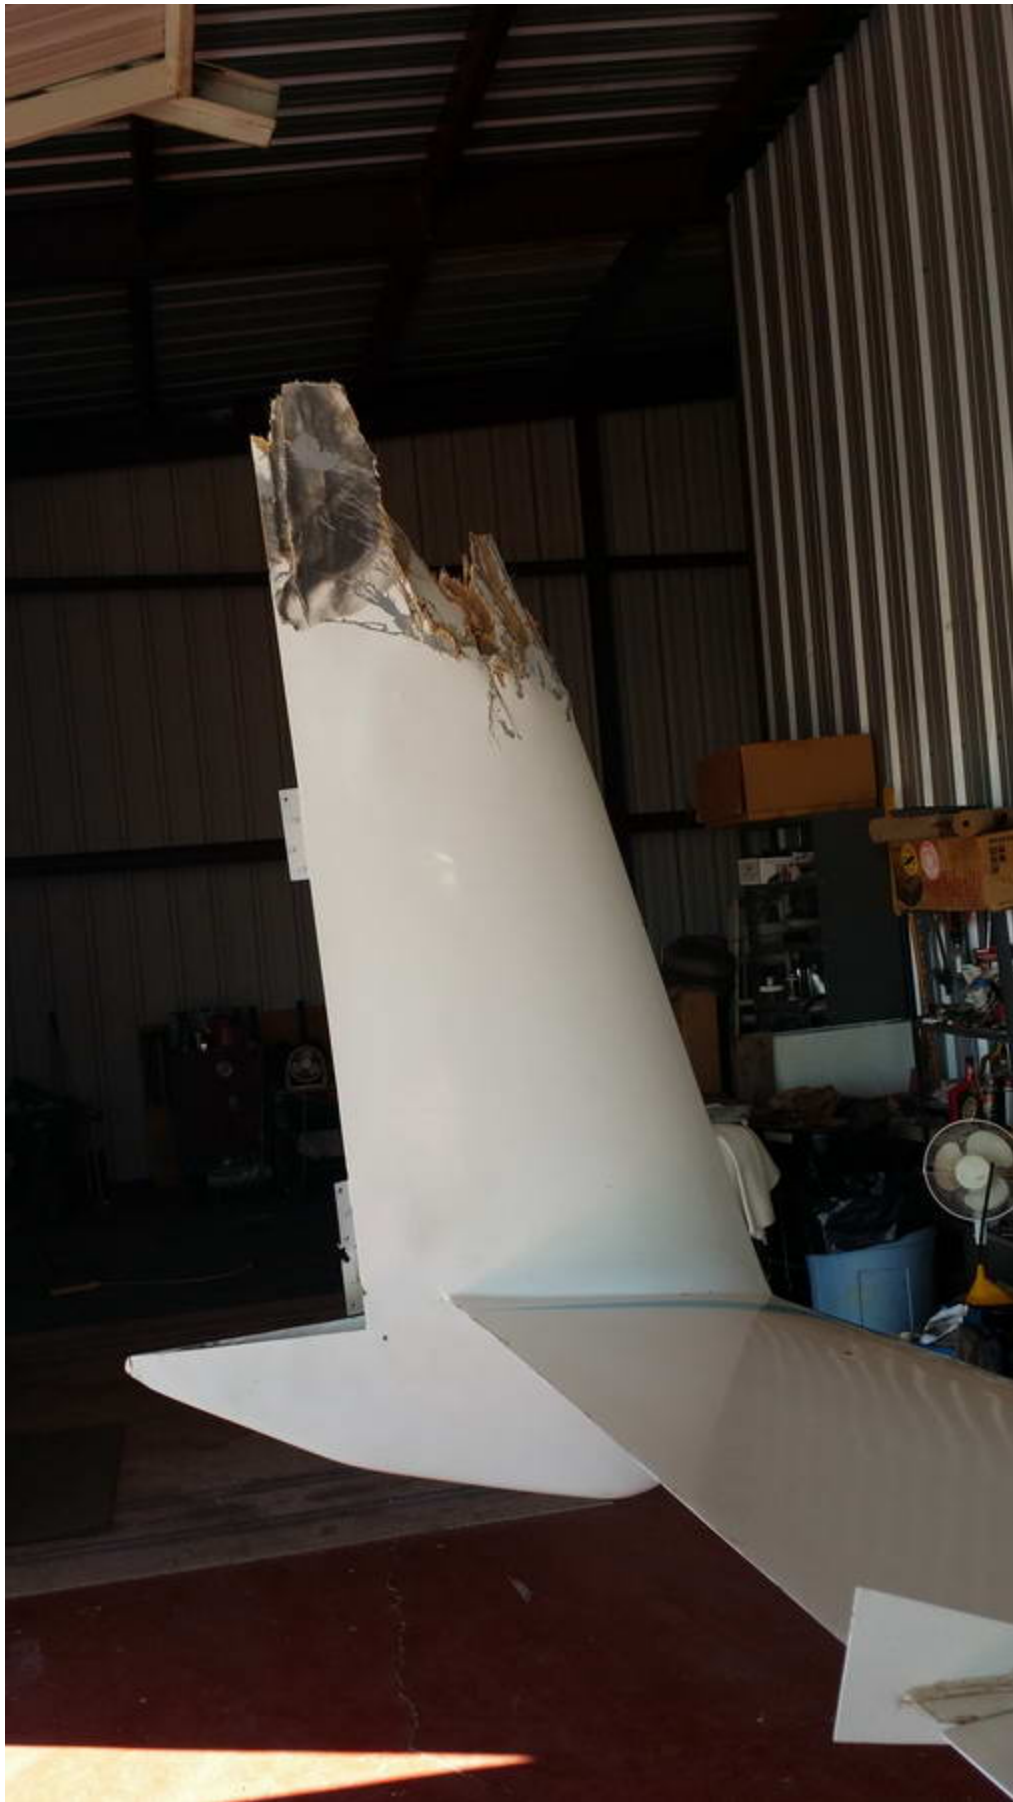
The collision: The Piper struck the left winglet of the LongEZ with its left main about 18 inches below the tip of the winglet and destroyed the structure down to more than 24 inches below the tip with compression tearing of the fiberglass at lower leading edge. The collision also extracted the rudder. That means that the nose gear of the Piper passed over the LongEZ canopy with only 16 inches to spare.

See attached photos of damage to the left winglet of the LongEZ.

Both aircraft survived with repairable damage and with no injuries to any of the three occupants (a pilot in each plane and one passenger in the Piper). The parts for the Piper are commercially available. The parts for the LongEZ have to be reconstructed by hand from plans. Reconstruction of both the upper and lower winglet and the rudder will probably be required since the reconstruction of the rudder is required to be an integral part of the construction of the upper winglet.
