National Transportation Safety Board

WPR22FA148

FOLLOW-UP EXAMINATION NOTES

July 12, 2022

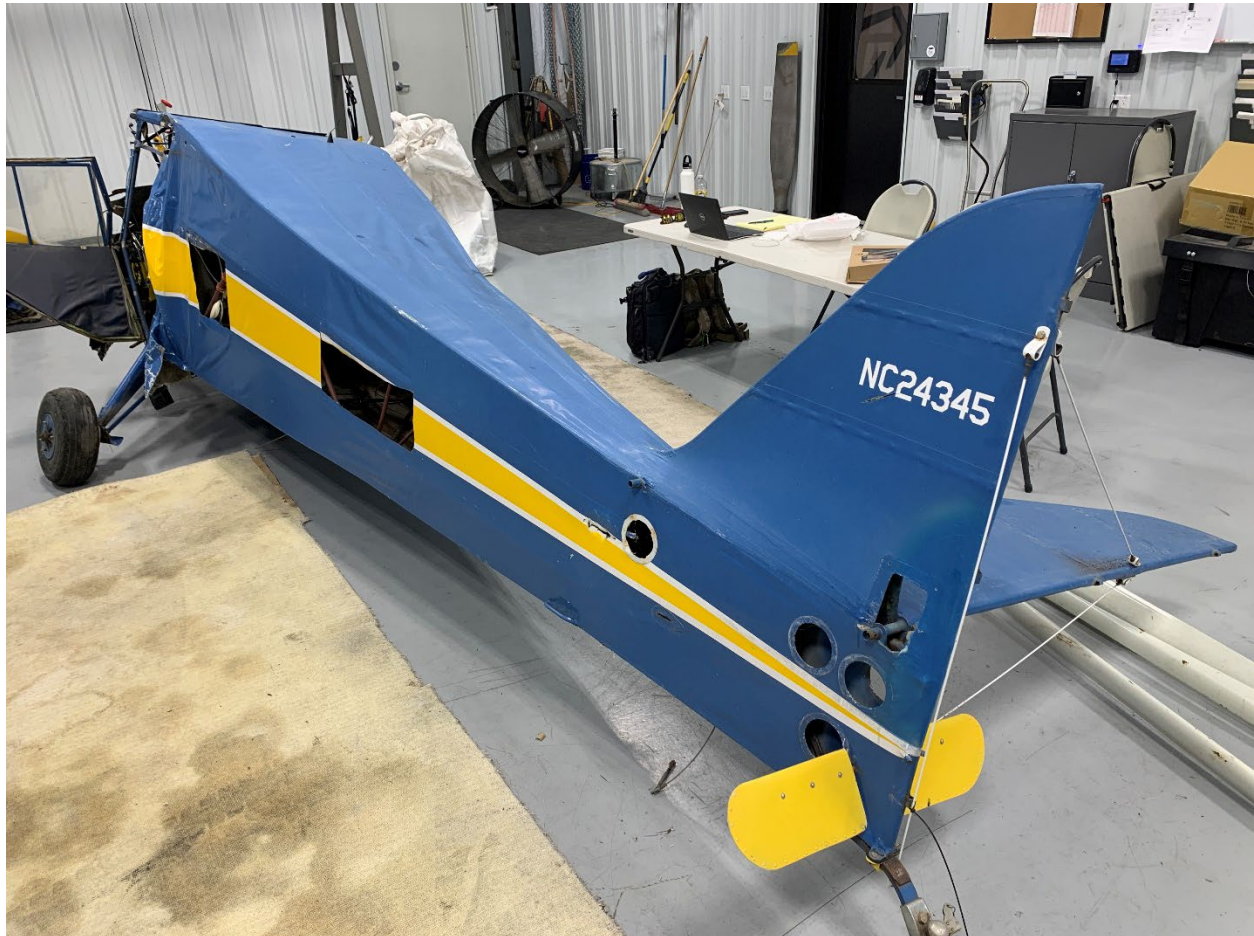
Figure 1. View of fuselage

The fuselage (figure 1) remained intact with compression damage to its steel frame adjacent the upper fuselage and cabin. The windscreen sustained consistent with impact.

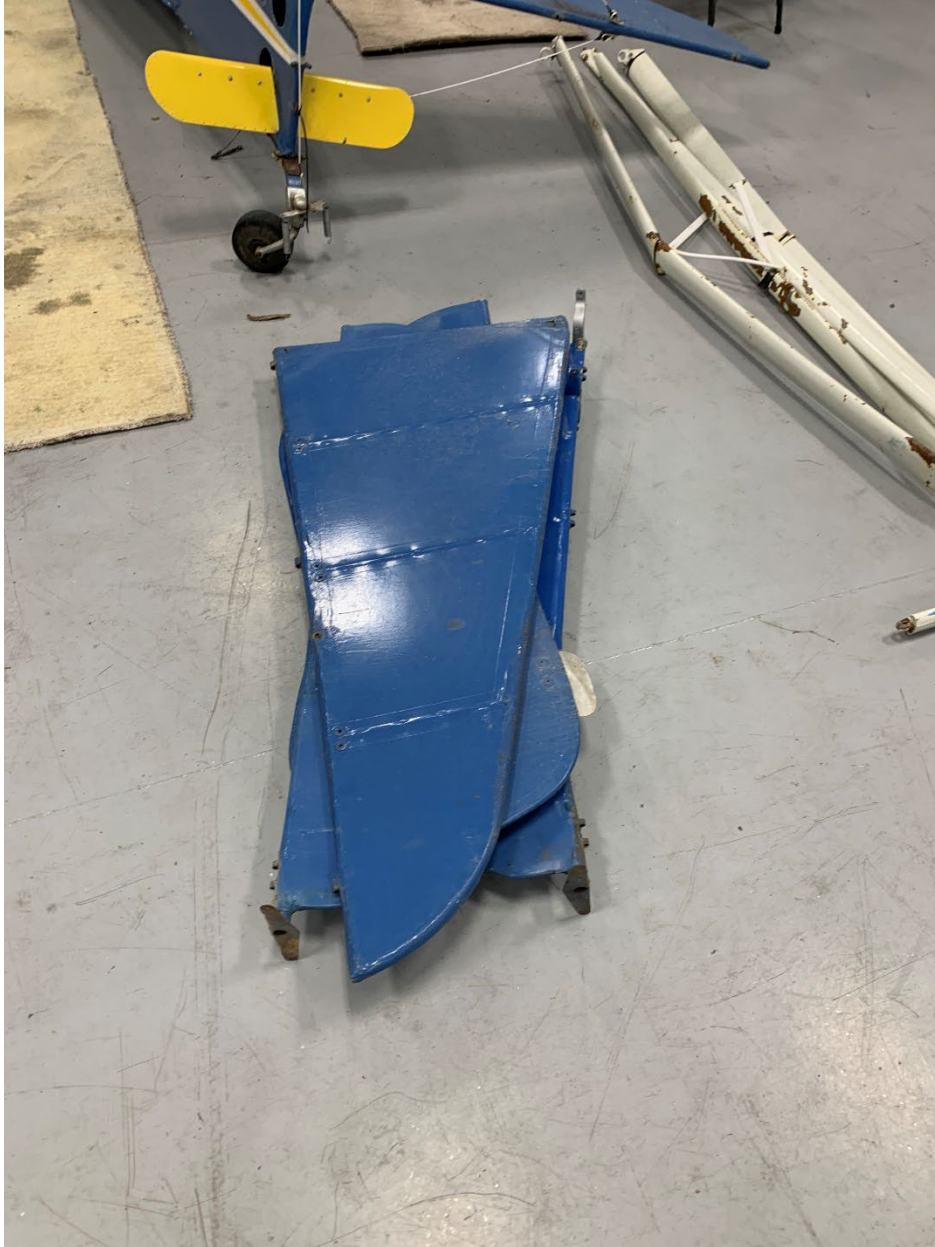
Figure 2. View of removed rudder, elevators and left horizontal stabilizer.

The left horizontal stabilizer, left & right elevators, and rudder were removed for transport and was found unremarkable (figure 2).

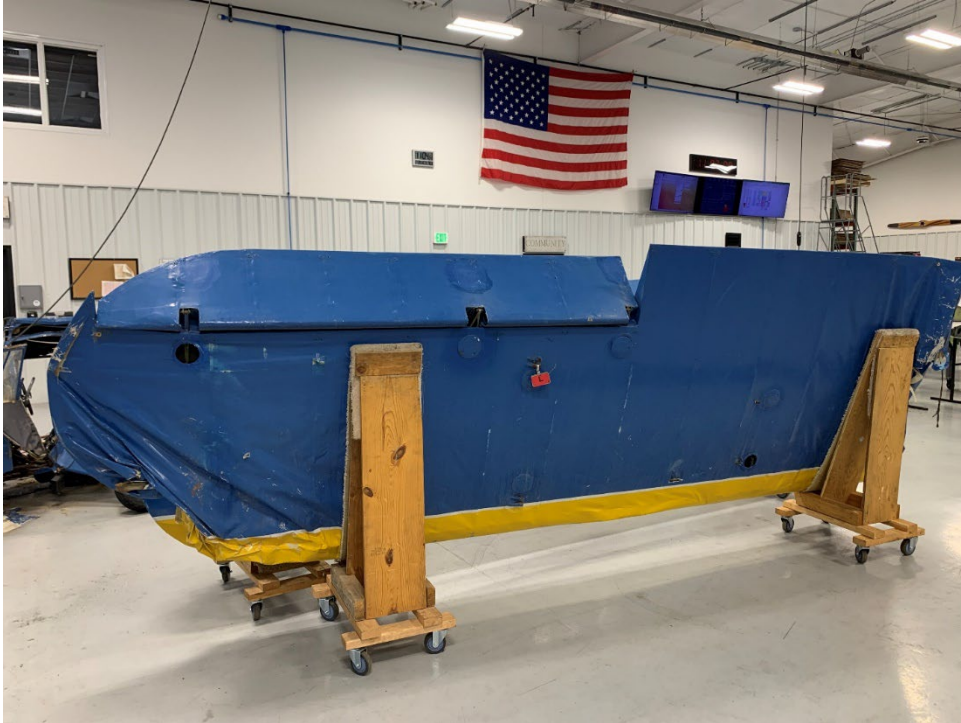
Figure 3. View of left wing.

The left (figure 3) and right (figure 4) wing were separated from the fuselage for recovery. The left wing sustained compression damage consistent with impact on its outboard leading edge. The left aileron remained secured to its mounting points. The right wing sustained minor damage. The right lift-struts sustained compression damage consistent with impact.

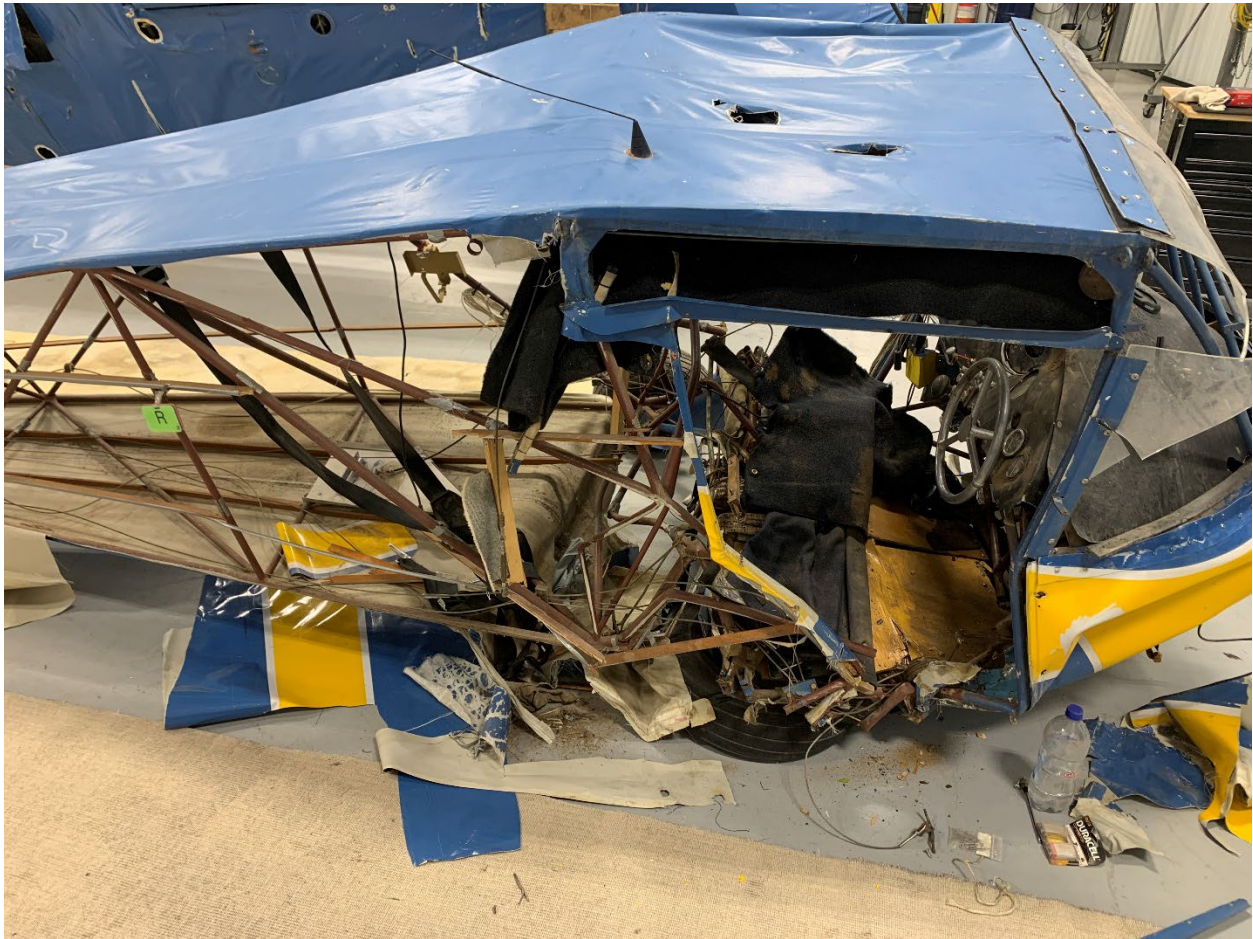
Figure 5. View of lower fuselage.

The lower fuselage (figure 5) sustained damage consistent with impact. External mounts for an iPad were found secured in the cockpit.

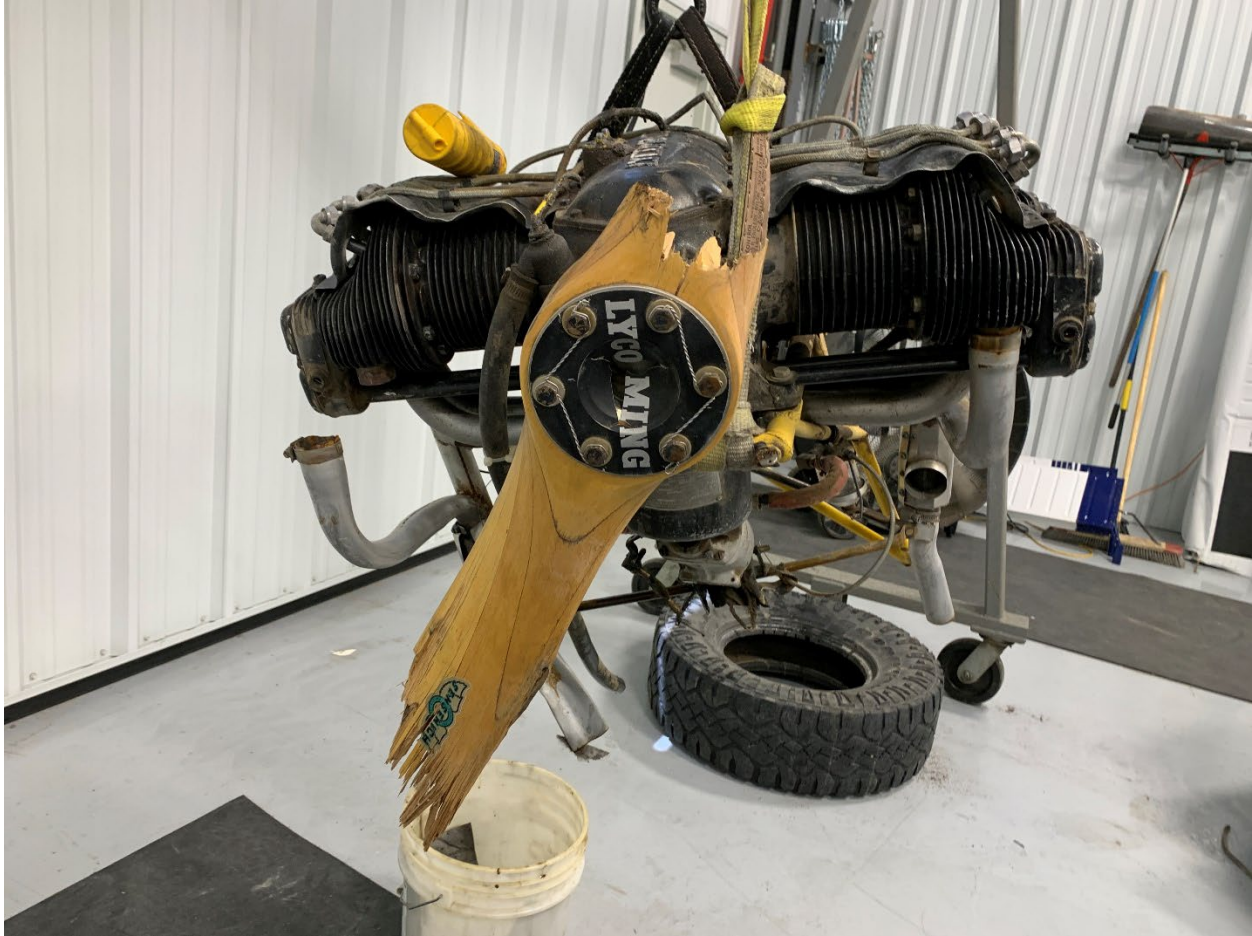
Figure 6. View of damaged engine and propeller.

The engine (figure 6), a Lycoming O-145-B2, serial number 5496-2, remained attached to its engine mounts, which were connected to the engine firewall. The engine truss sustained substantial damage consistent from impact. Both propeller blades remained attached to the propeller hub and flange, which was connected to the crankshaft. The carburetor was displaced from its mating flange and pressed onto the bottom of the oil sump. The mixture lever and throttle lever on the carburetor were damaged. The right exhaust tubes were displaced from their corresponding cylinders.

Examination of the cylinders combustion chamber interior components using a lighted borescope revealed normal piston face and valve signatures, and no indications of catastrophic engine failure.

The wood propeller and hub assembly remained attached to the engine. One blade was fractured at the blade root while the second blade was fractured and splintered midspan.

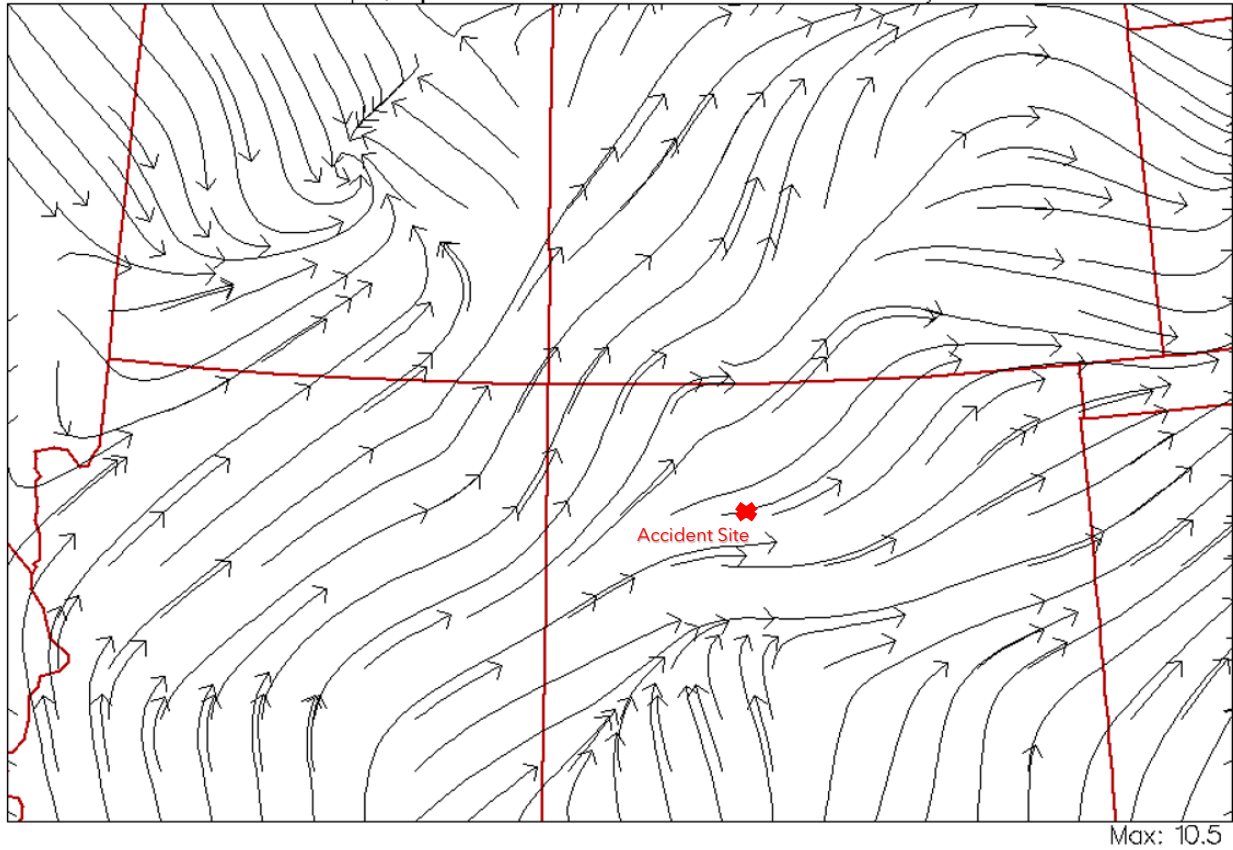
A witness reported that he saw the airplane at a low altitude maneuver towards a ridgeline to the southwest. Shortly after, the airplane made a 180° left turn away from the ridgeline, towards a nearby dirt road that ran northwest to southeast, lined with a powerline. The witness then saw the airplane impact terrain and nose over, short of the road and powerlines. The witness further reported that during the time of the accident, the winds were gusting from the southwest and over the ridgeline and that the engine was running.

Figure 10. Surface Wind WXP Analysis for time of accident.

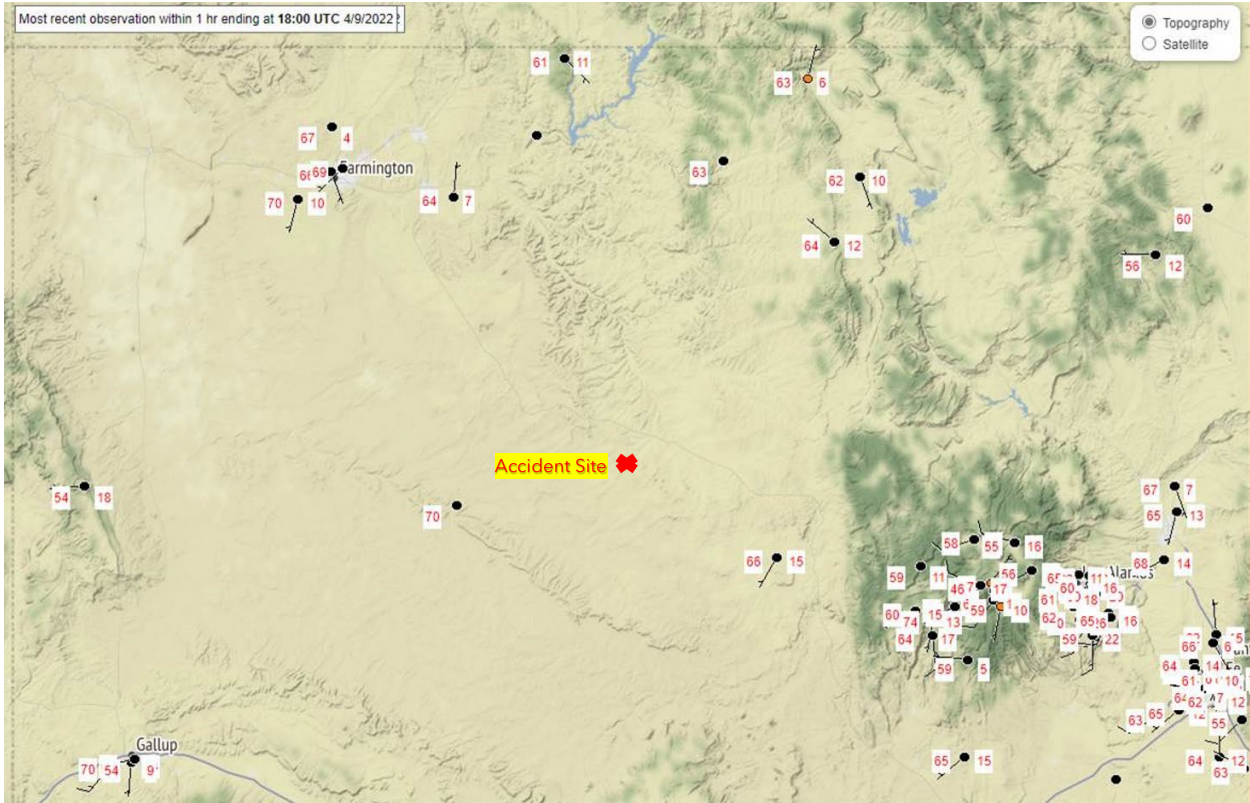
Figure 11. A Mesowest image of wind with temperature (°F) and peak wind gusts for 1800Z (winds in mph).
