NATIONAL TRANSPORTATION SAFETY BOARD

Union Pacific Railway Derailment
Fort Worth, Texas
April 24, 2019

NTSB Accident No. RRD19FR007

Railroad Operations – System Safety Factual Report

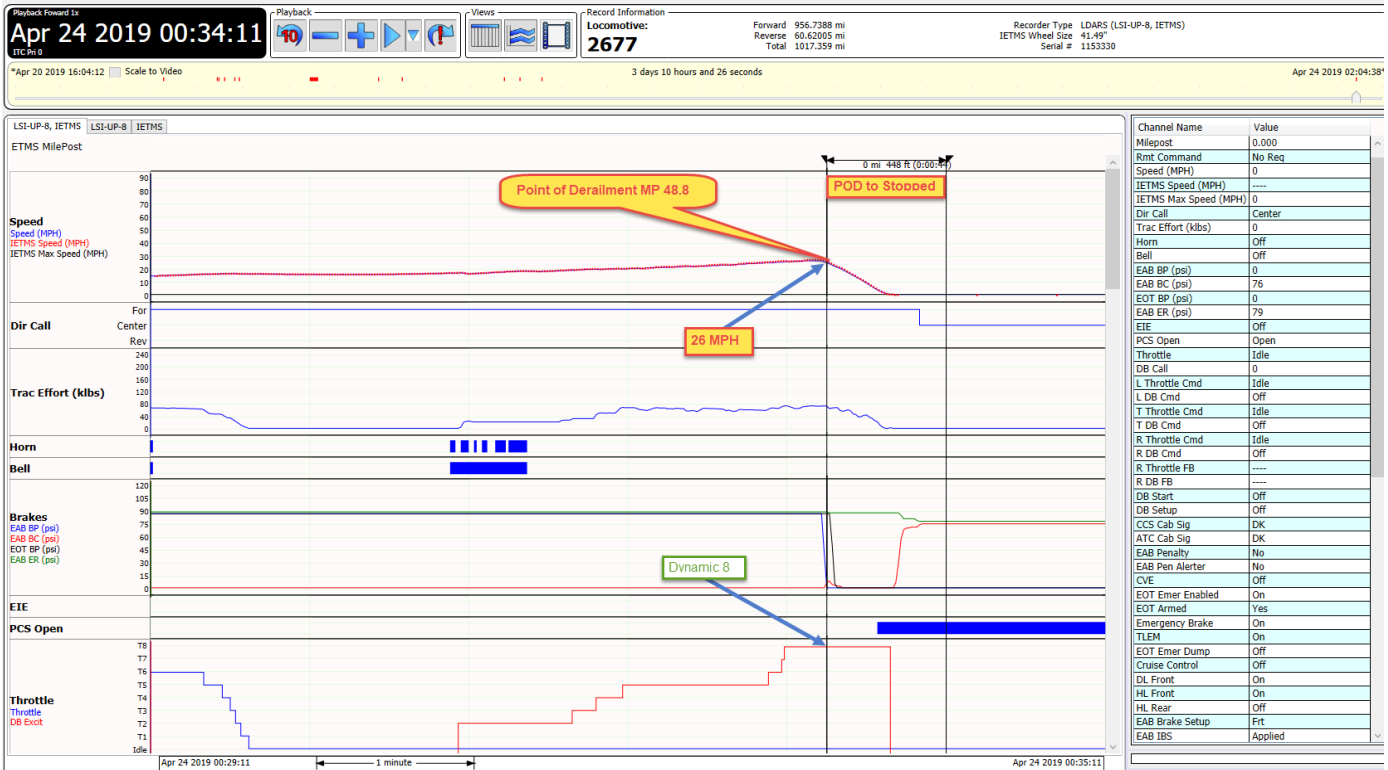
Figure 1: Locomotive Data Recorder provided by UP.

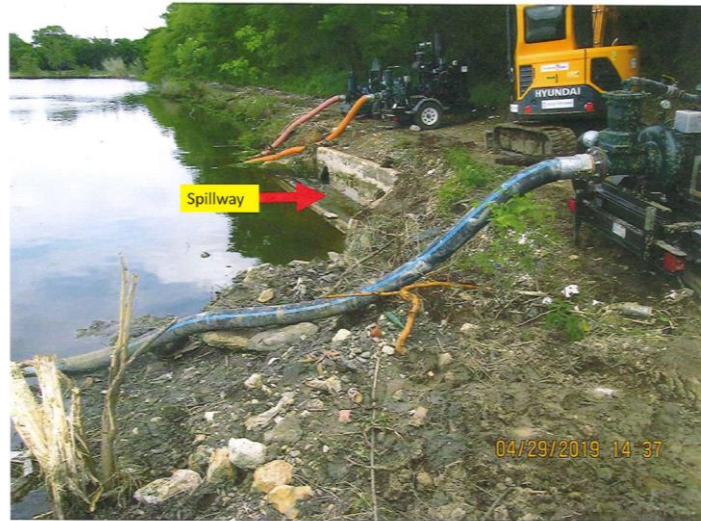
The below photographs detail the drainage system at Echo Lake. A spillway is routed to 3 drainage pipes. At the time of the accident, 1 of the three pipes was functional, 1 had been plugged, and the 3rd had been blocked by debris. As referenced in the photographs the emergency spillway location for the lake is located along the UPRR.

Figure 2: Echo Lake spillway, post-accident drainage pumps are present in the photograph.

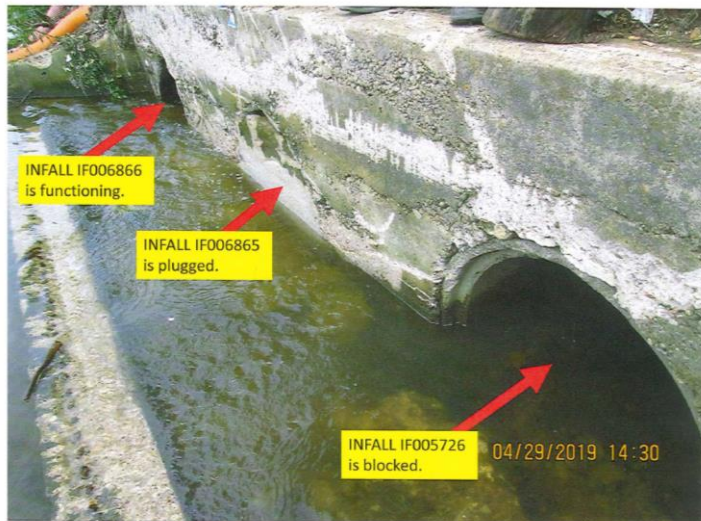
Figure 3: Close-up photograph on the spillway and drainage pipes

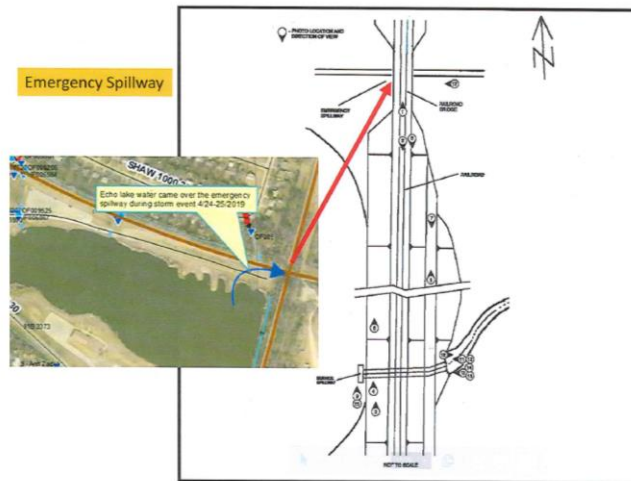
Figure 4: Diagram including image of emergency spillway location. The emergency spillway location is adjacent to the Midlothian Subdivision.

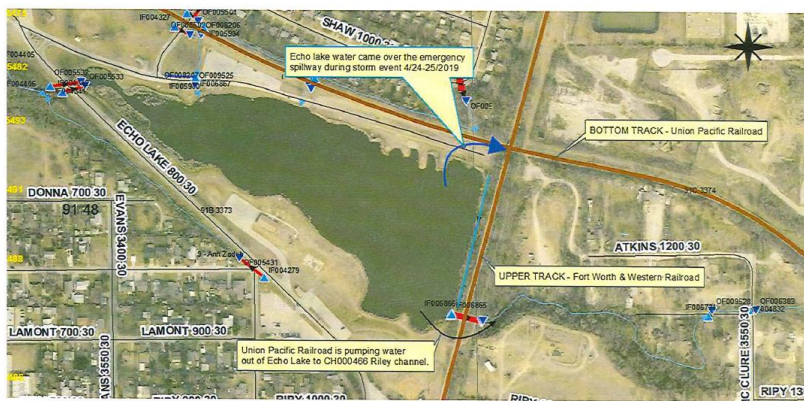
Figure 5: Image of emergency spillway location.

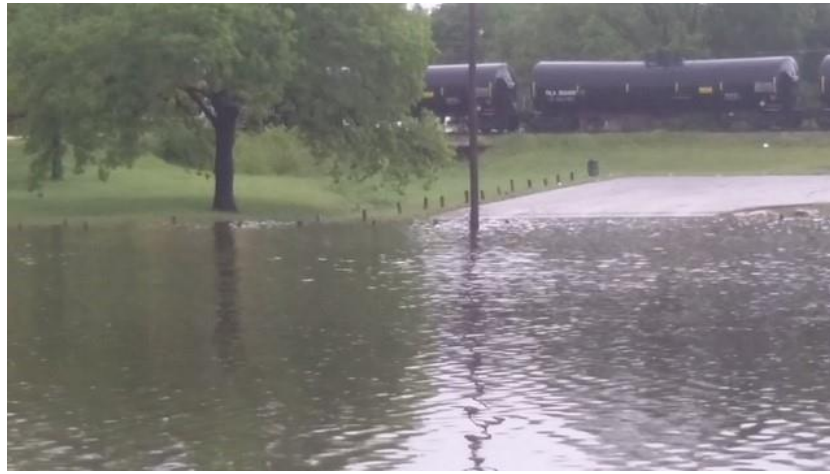
Figure 6: Photograph of high water in lake after the derailment.
