Evaluation of Fuel Boost Pump

Part Number: 8163-A

Serial Number: 08934

**From Make: Mooney, Model: M20J, Aircraft: N56039, for NTSB Case:
WPR18FA210**

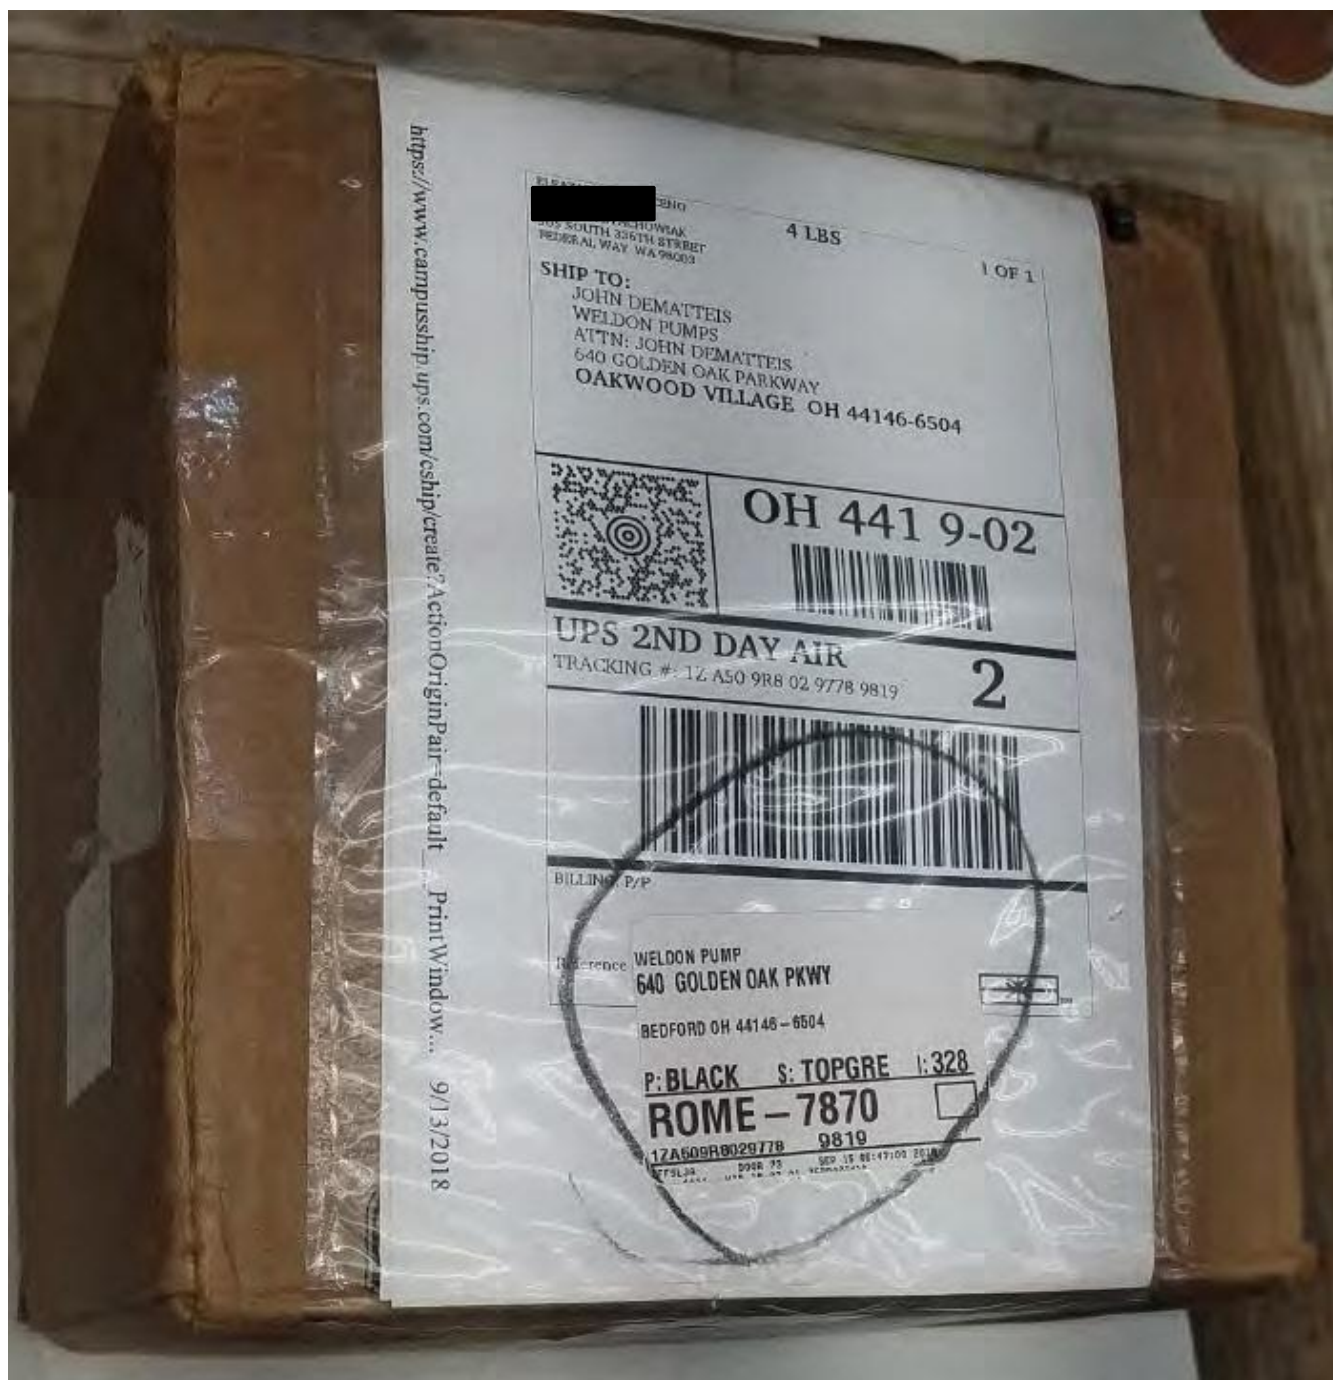
- See Figure I for image of exterior packaging, large box, and common carrier's shipping label.
- See Figure II for image of small enclosed box with hand written instructions "Do Not Open/Test Without FAA Oversight".
- See Figure III for image of Article in resealable Anti-Static bag (as removed from smaller enclosed box).
- See Figure IV for image of accompanying NTSB Evidence Control Form.

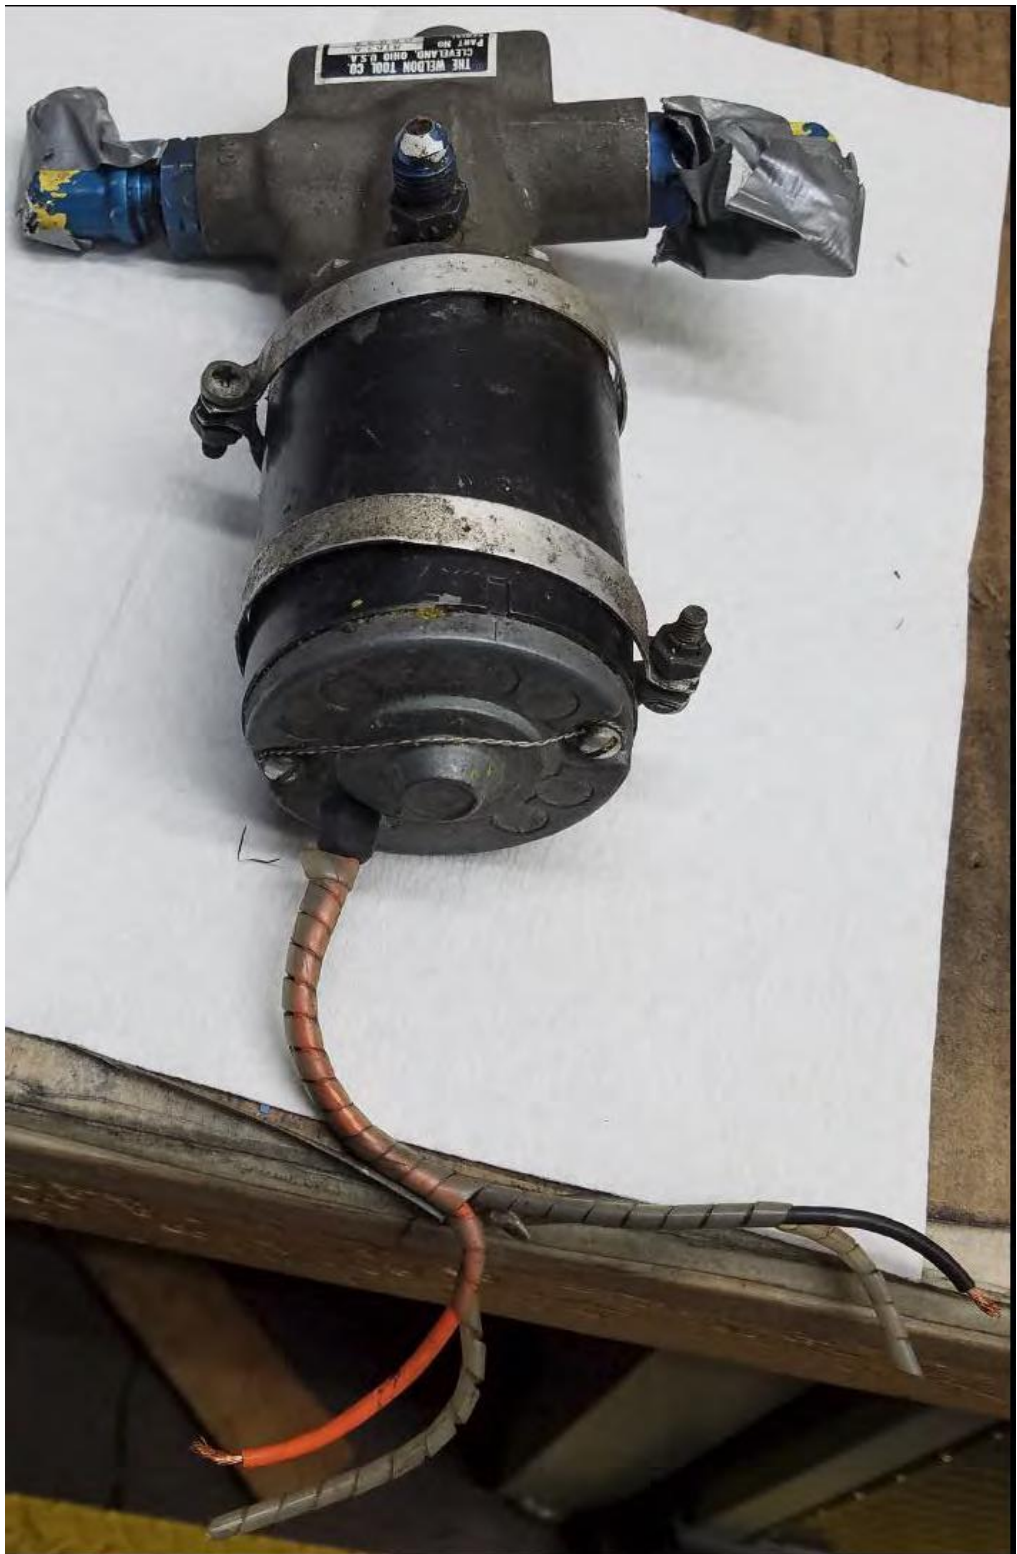
- See Figure V for image of the pump as removed from all packaging.
- The pump was supplied with the following items installed into both the inlet and outlet ports;
 - Mooney P/N: 610076-000, Description: Elbow ("Fitting Modified AN833-6D")
 - Note, the longer, bulkhead, end has the 37° flare removed and both inside diameters are drilled oversized from AN833 standard.
 - P/N: AN6289-6D, Description: Nut, Tube
 - P/N: AN6291-6, Description: Ring-Hydraulic Fitting, Gasket Back-Up.
 - Note, this part number is listed in the aircraft IPC yet is obsolete and superseded by MS28777
 - P/N: MS29512-6, Description: Packing, Preformed, Hydrocarbon Fuel Resistant, Tube Fitting, "O"Ring.
 - See Figure VI for image of the above four items sub-assembled.

- See [Figure V](#) , [Figure VII](#), and [Figure IX](#) for images of the AN816-4D installed in the overboard drain port.
- The pump was supplied with two each the following items, as mounting provisions, around the motor;

- See [Figure V](#) for the above three items sub-assembled and installed on the pump.
- The pump was supplied with the following item, as wire loom, around the motor hook-up wires;

- P/N: B47287-I-1/8, Description: Tube, Spiral Wrap, Polytetrafluoroethylene and Polymide.
 - See [Figure V](#) for the above wire loom installed on the pump's hook-up wires.

- Both Inlet and outlet fittings had duct tape as a covering for the remaining 37° ends. When the tape was removed adhesive residue remained on the sealing surface.
 - See [Figure V](#) and [Figure IX](#) for images of duct tape covering inlet and outlet fittings.
- The overboard drain fitting's ID was completely blocked/mostly filled with impacted dirt/debris. There was no cap or tape on this fitting, as supplied, and worth mentioning that it didn't appear to have the normal/expected witness marks, on the 37° surface, from having been mated to a tube.
 - See [Figure VII](#) for close-up image of dirt/debris blocked AN816-4D fitting installed in pump housing.
 - See [Figure VIII](#) for image of AN816-4D fitting removed with dirt/debris along side.

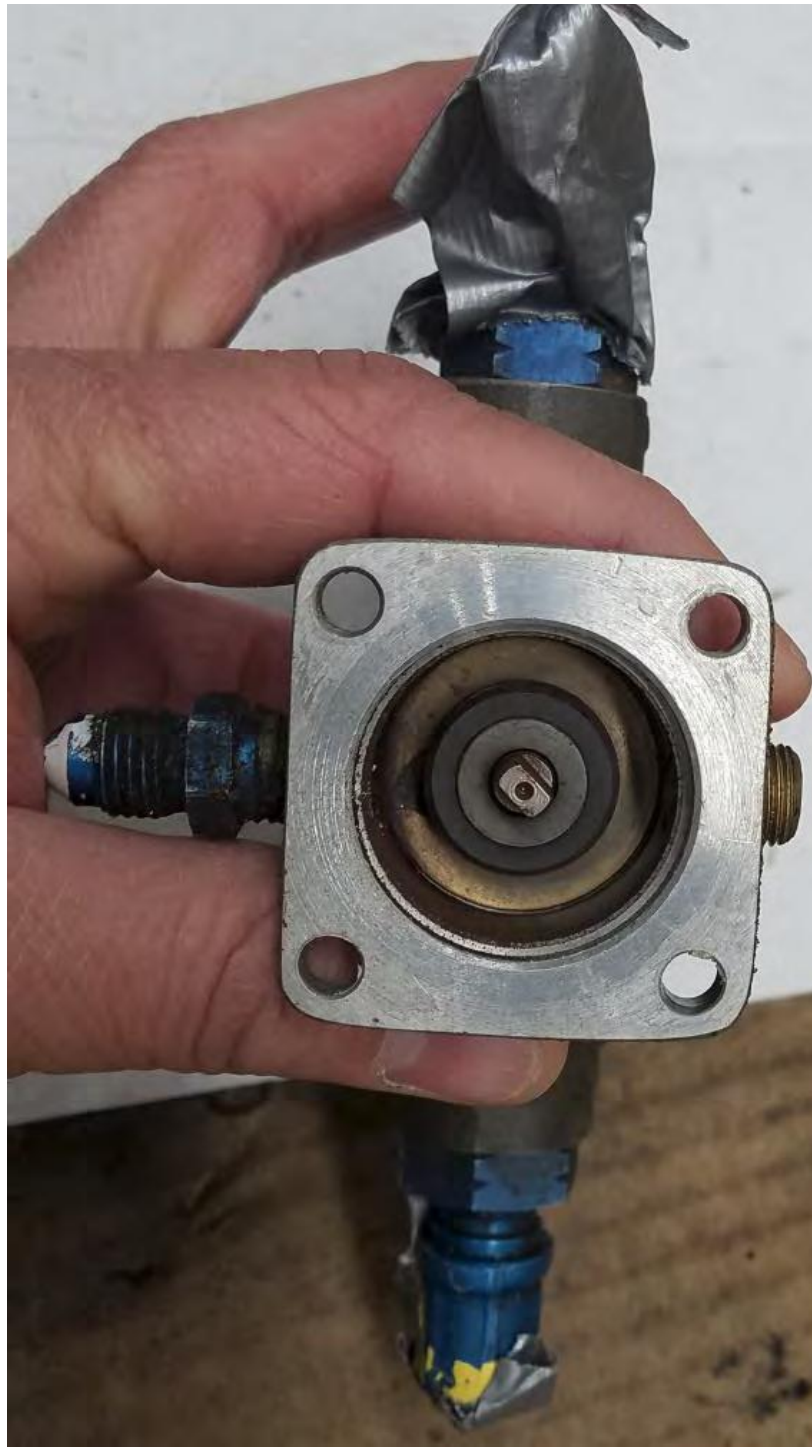
- See Figure IX and Figure X for images of the pump and motor drives respectfully.
- Once apart, the pump assembly was turned by hand and found to turn freely/normally for a completely dry pump. In general, pumps have some assemble oil or residual fuel thus aren't dry to this extent. Note, the wear is minimal on the rotor's drive tenon consistent with only several tens of hours of operation.

- See Figure IX , Figure XI , and Figure XII for the progression of the pump disassemble.
- The motor armature was turned by hand and found to be spin albeit a bit rough. Note, the wear is also minimal in the motor's drive slot consistent with rotor's drive tenon wear.

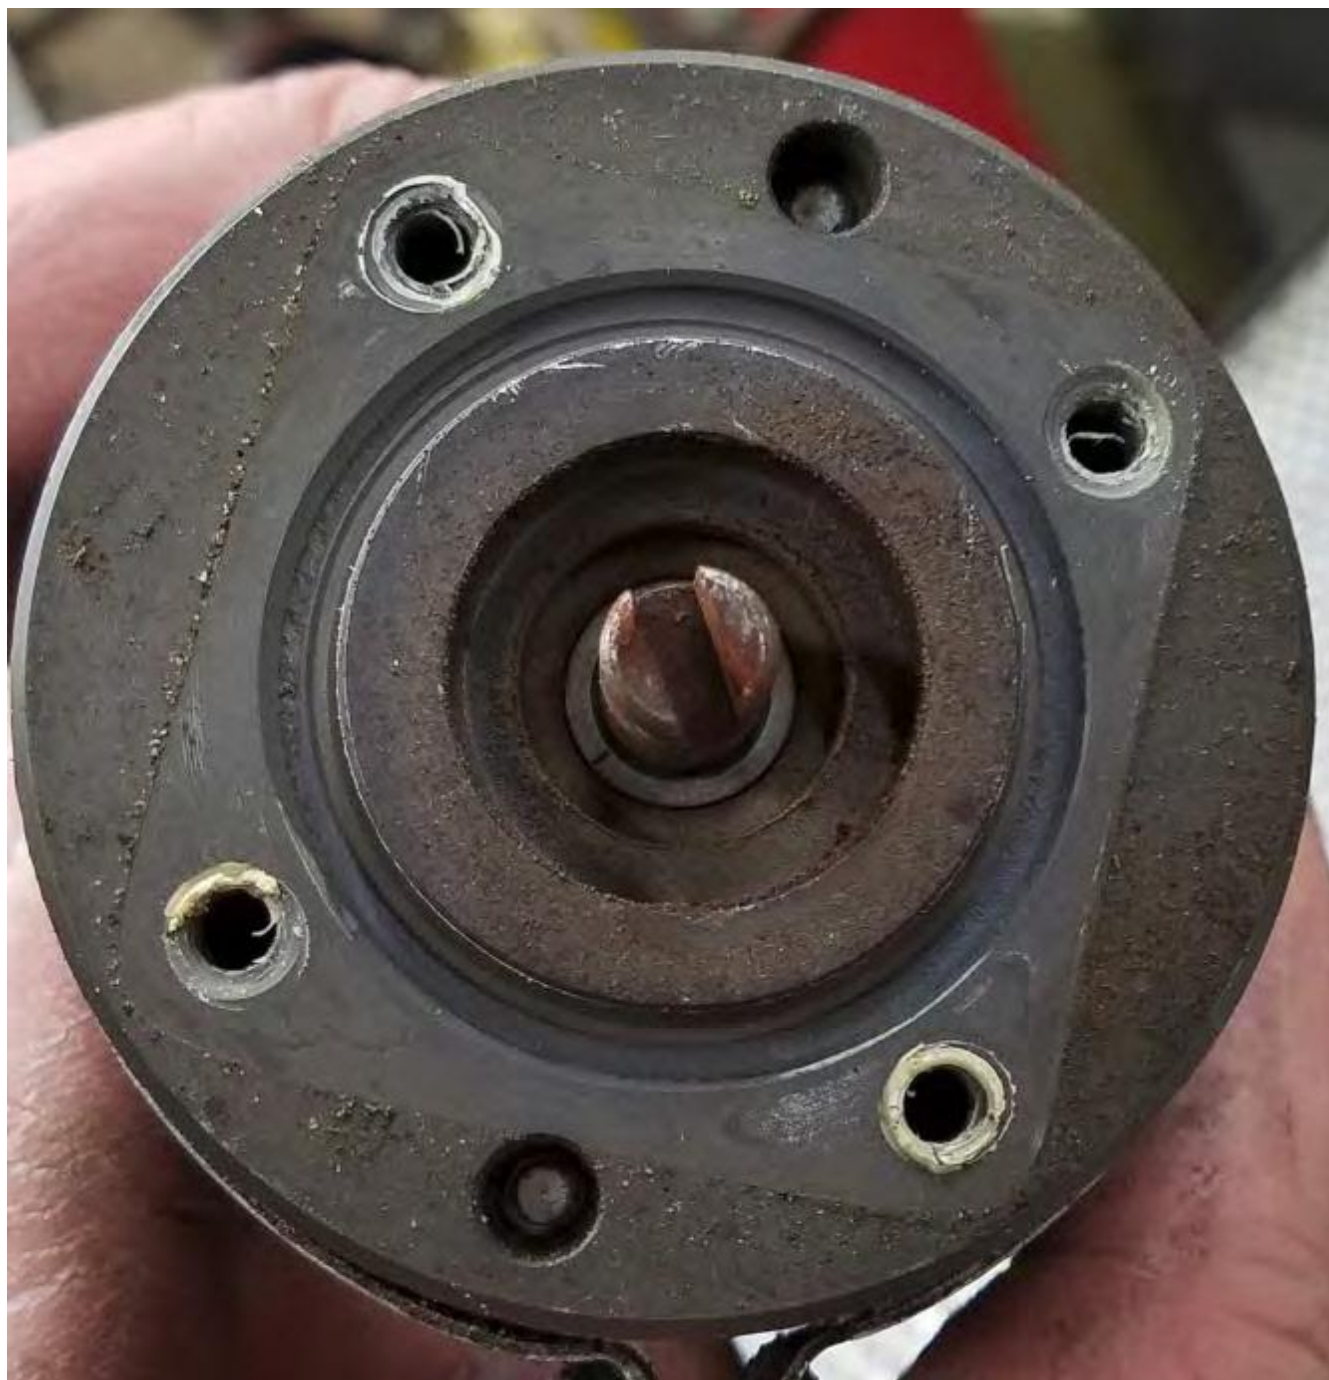
- See Figure X for image of the motor's drive.
- 14 volts direct current was set, and applied, to the motor assembly. The motor functioned but with inconsistent/above average amperage draw. These results are consistent with, one or both, armature bearings having damage.

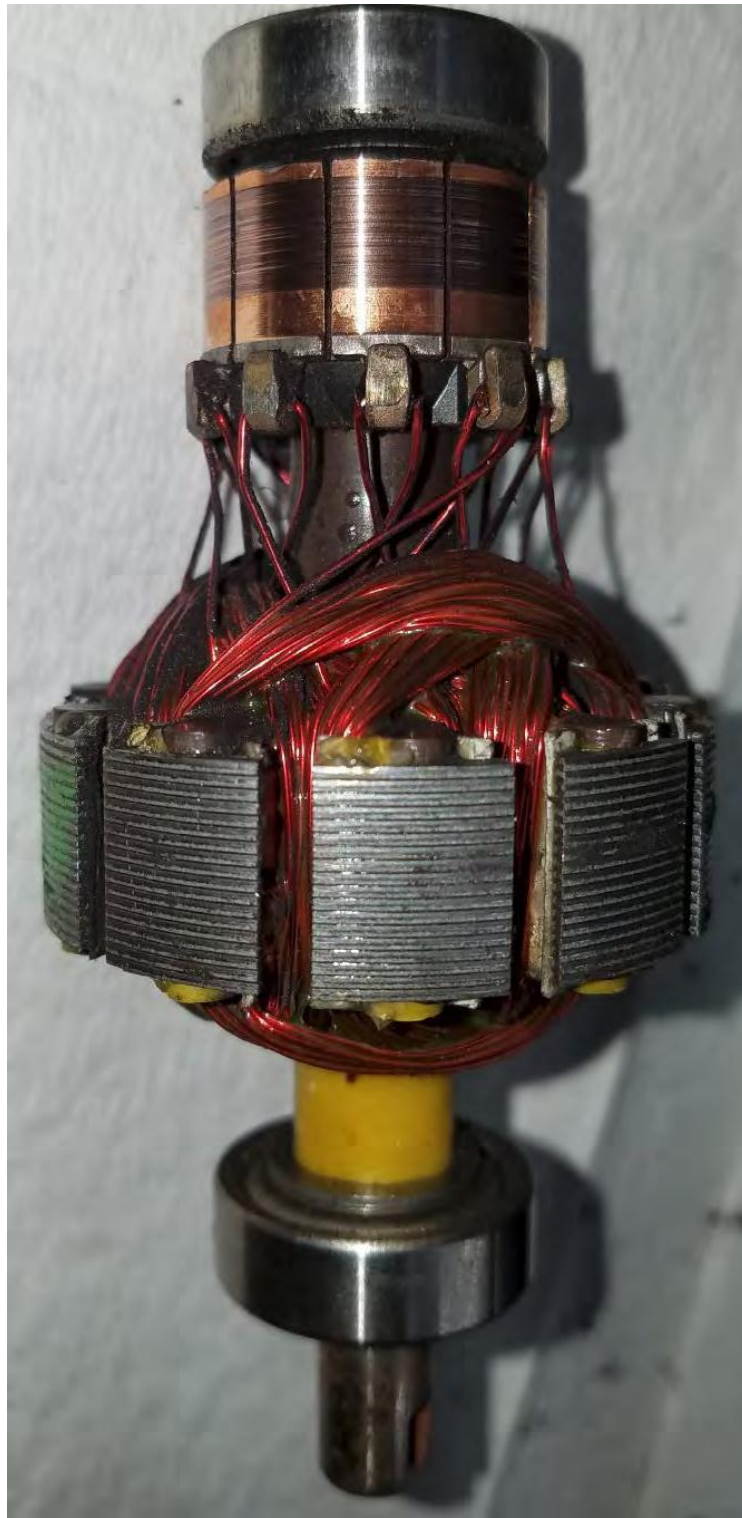
- The motor was disassembled to discover its' drive end armature bearing damaged and not turning smoothly. Otherwise, the motor internally is in very good condition with little wear consistent with both rotor's drive tenon wear and its' own drive slot wear.

- See Figure XIII for image of the motor's armature.
- The motor's drive end bearing was removed from the armature and one of its' shields removed. Once said shield was removed it was evident that there was no grease remaining. There was a piece of the ribbon cage broken off , a calcium like chalky white residue on the cage, and both inner/outer races were rusted.

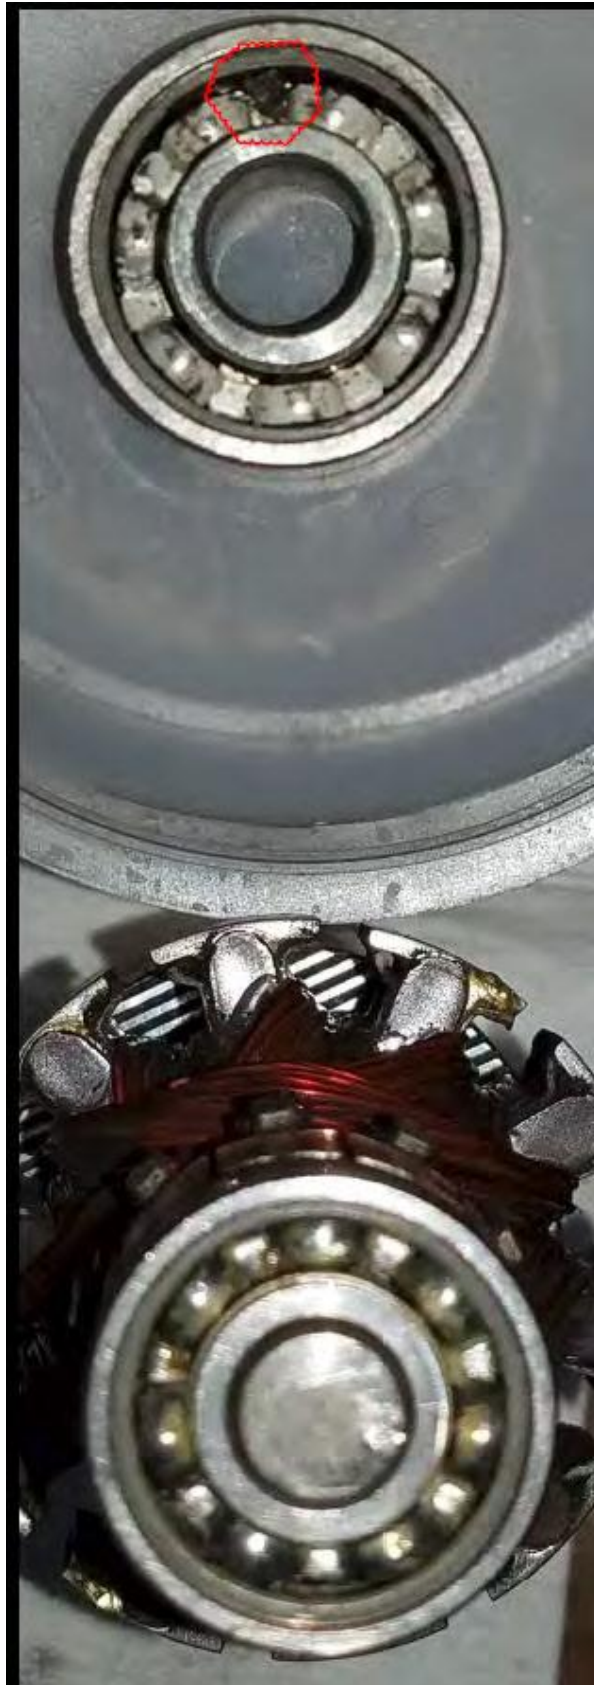
- See Figure XIV (top, with piece of broken ribbon cage circled) , Figure XV (with piece of broken ribbon cage circled), and Figure XVI for images of the motor's drive end bearing.

- The motor's commutator end bearing was in good working condition so one of its' two shields was removed for comparison purposes.
 - See Figure XIV (Bottom) and Figure XVII for images of the motor's commutator end bearing.

As provided for this evaluation the pump, identified as part number: 8163-A serial numbers: 08934, had very low hours of operation yet was not functional. The mode of failure was a "locked armature" caused by the poor condition of the motor's drive end bearing. The condition of the drive end bearing was likely caused by the improperly plumbed overboard drain thereby exposing said bearing to moisture and/or clean agents. Based on the condition of said bearing, it is speculated that this pump was nonfunctional for many months (or years) prior to the crash event (an abrupt failure would not have calcified/dried the bearing nor given it time to oxidize as it did).
