National Transportation Safety Board

CEN22FA317

GPS & COMMUNICATION DEVICE

Specialist's Factual Report

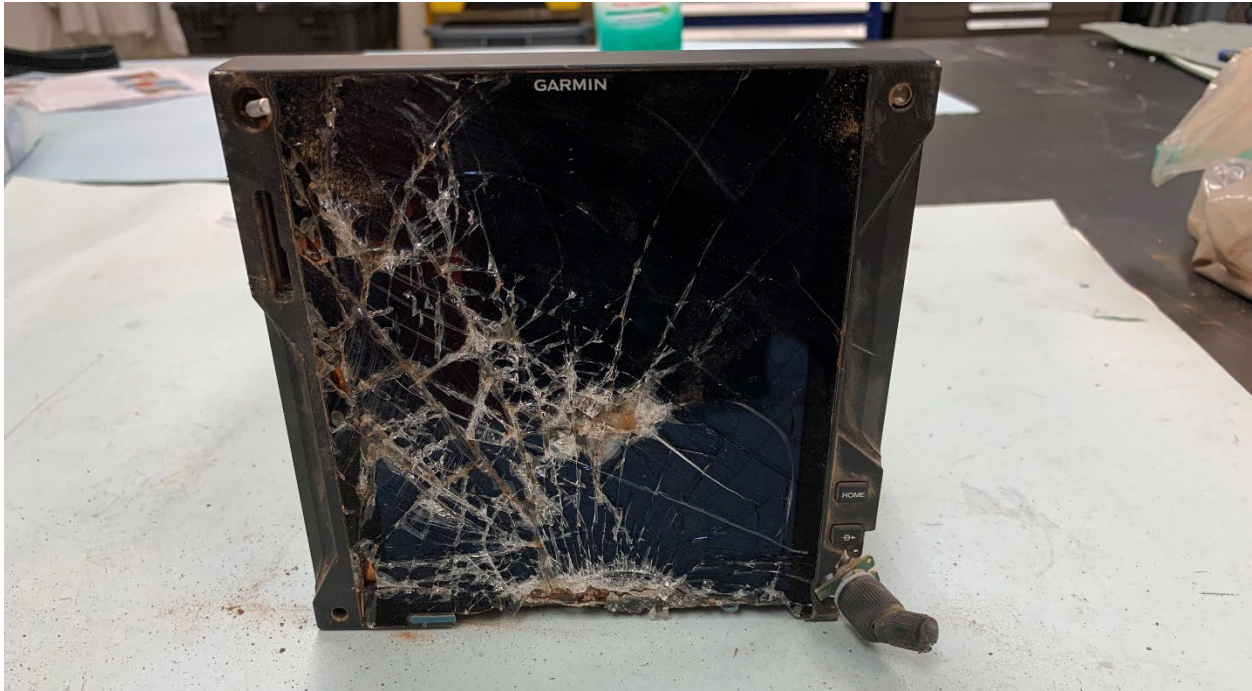
Upon arrival at the Vehicle Recorder Laboratory, an exterior examination revealed the unit had sustained significant impact damage as shown in Figure 1. The front screen was shattered, and the display did not appear to function when power was applied. It was noted that the device was contained within a sturdy enclosure, and only the display was broken, so an attempt was made to use the display from a Garmin GTN 650, which had the same electrical connections as a GTN 750, but a smaller screen. The smaller display worked, but the user interface for downloading the logs was off the screen. Garmin provided instructions on how to make the 750 operate as a 650, and the data logs were downloaded using the manufacturer's procedure for this device.

Figure 1. Photo of the GTN 750Xi showing impact damage.

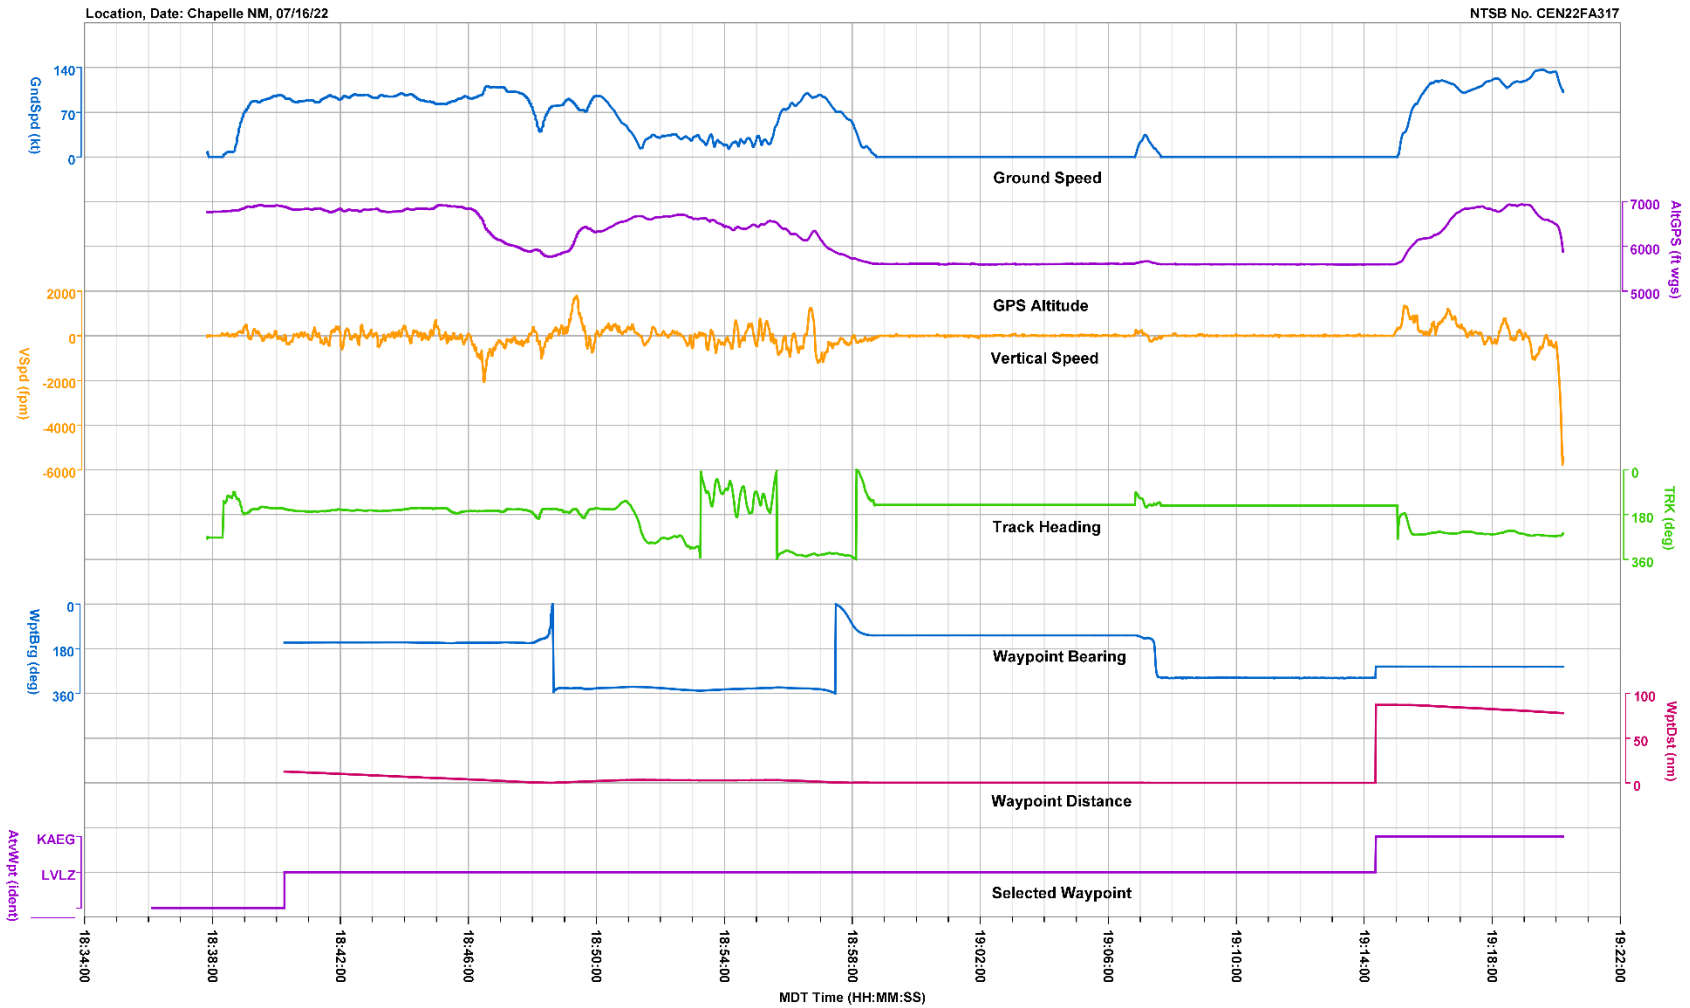
Figures 3 and 4 are plots of data that were recorded by the GTN-750Xi. Figure 3 is a plot of the entire recording, figure 4 is a plot of the last few minutes of the flight.

Figure 3. Plot of GPS parameters for the entire recording.

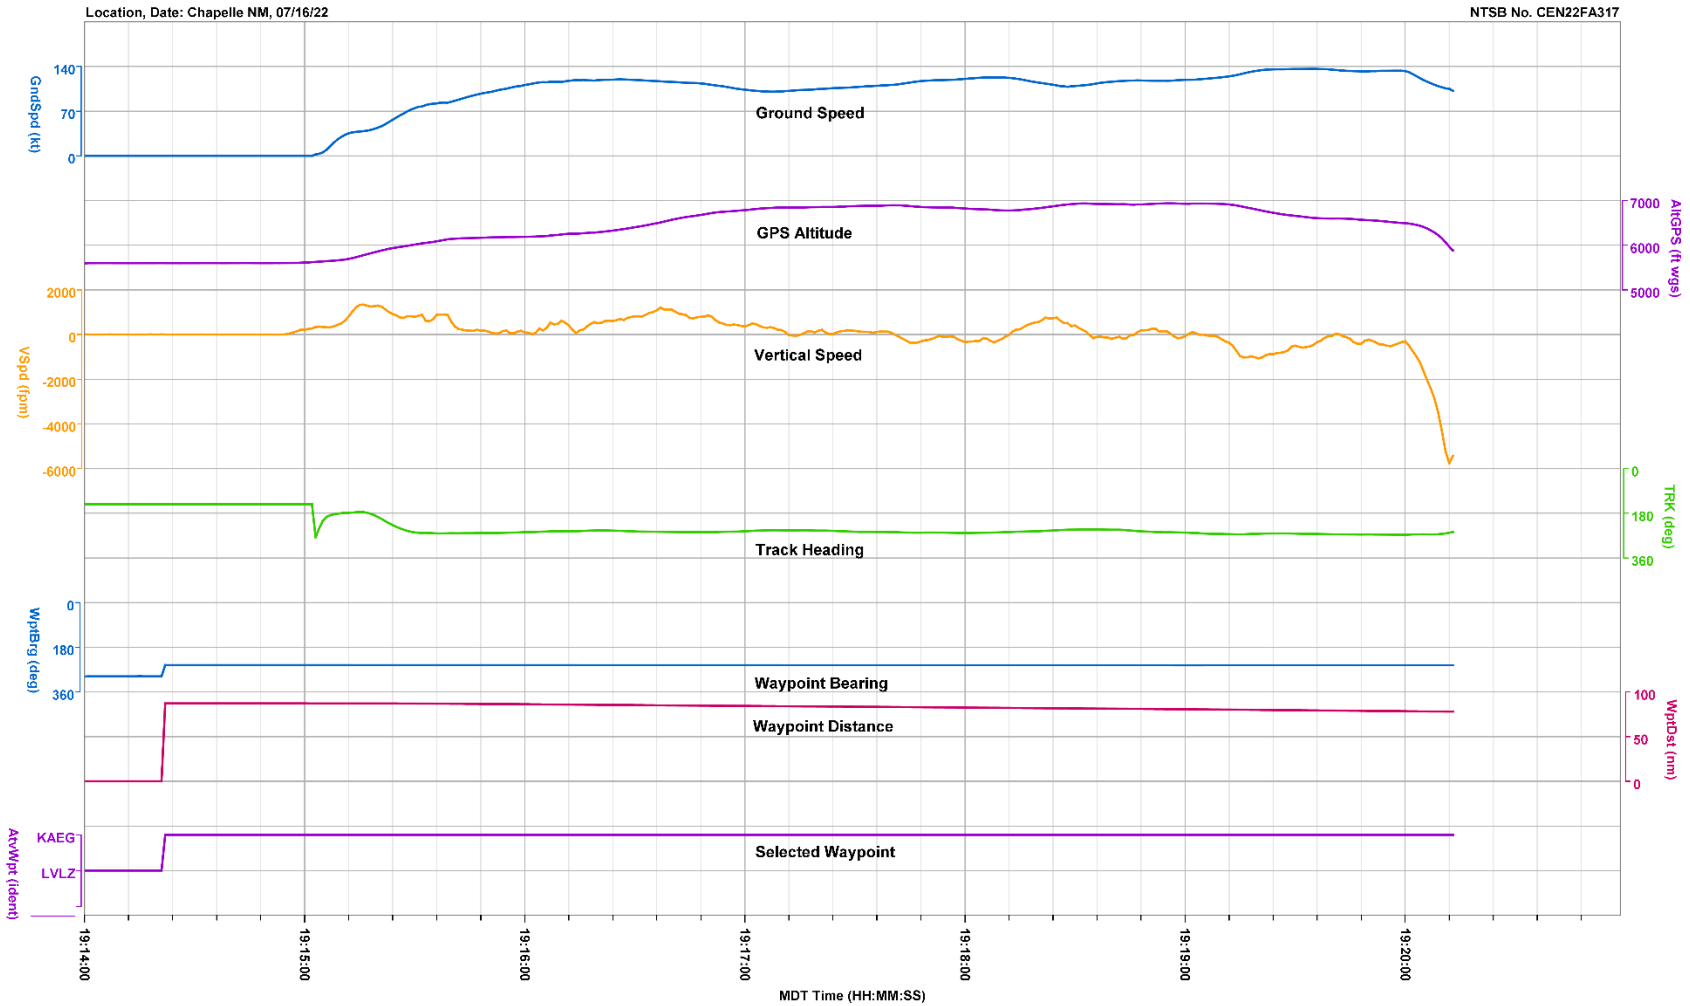
Data obtained from the GTN-750Xi was used to produce the following overlays and tabular data. Due to data buffering on the GPS unit, the data likely ended a few seconds before the accident. A steep descent towards the recorded accident site was noted at the end of the recording.

Figure 4. Plot of GPS parameters for the accident.

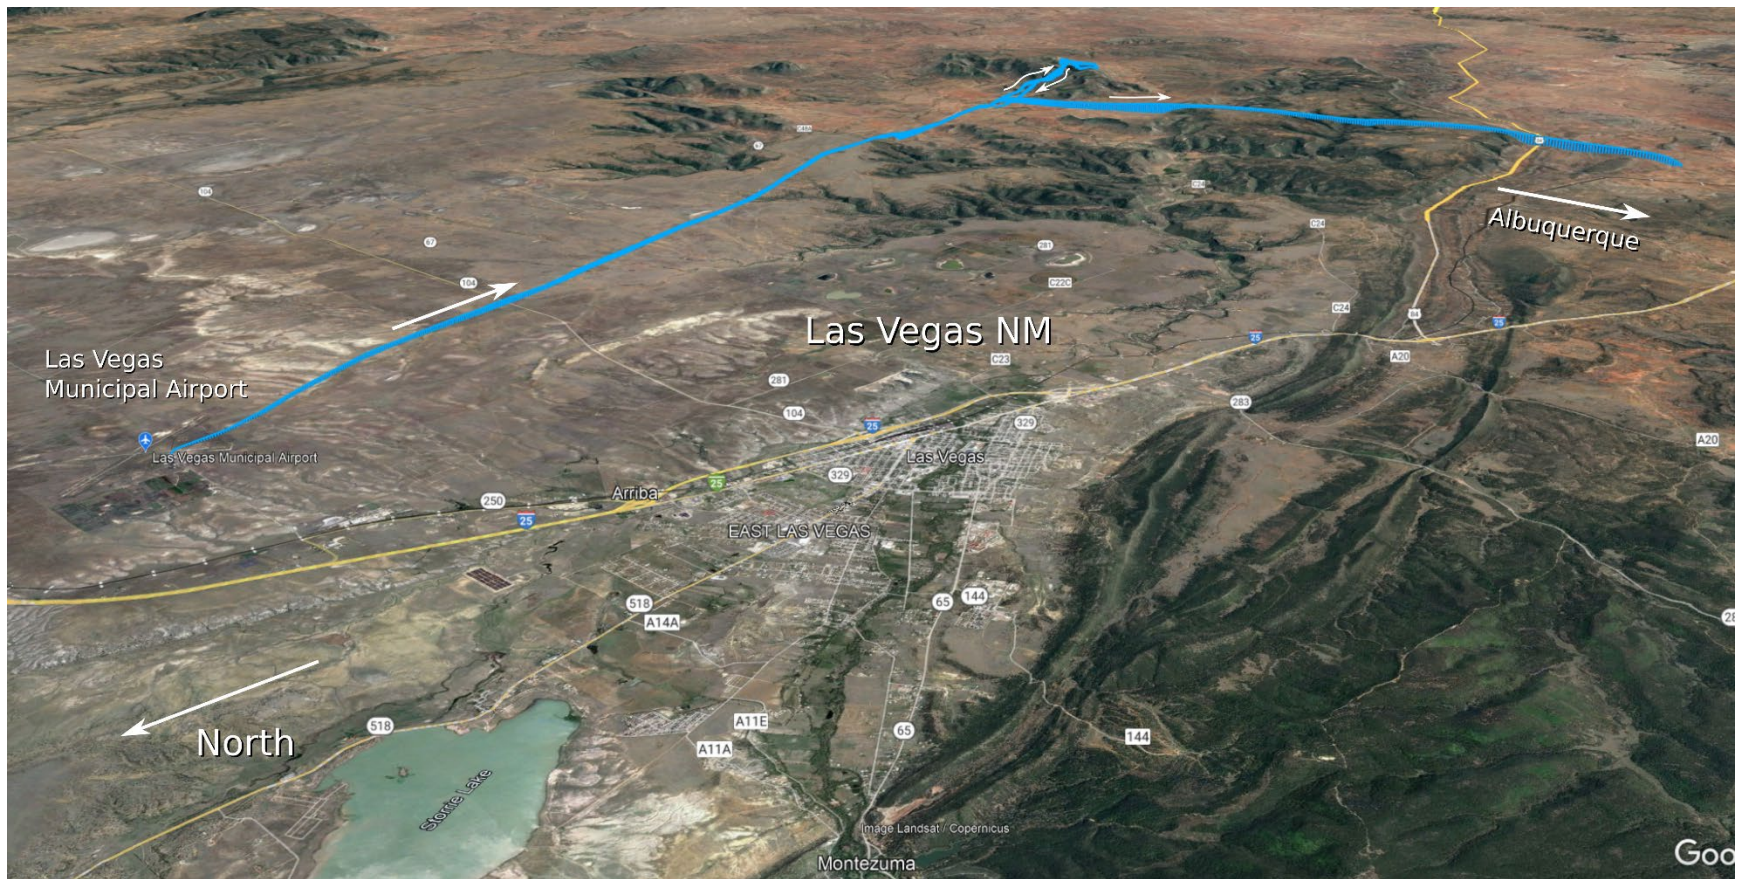
Figure 5 contains the entire recording, including takeoff, flying to and around a ridge south of Las Vegas New Mexico, two short landings, and then a turn to the west in the direction of Albuquerque.

Figure 5. Plot of the aircraft's flight path for the entire recording.

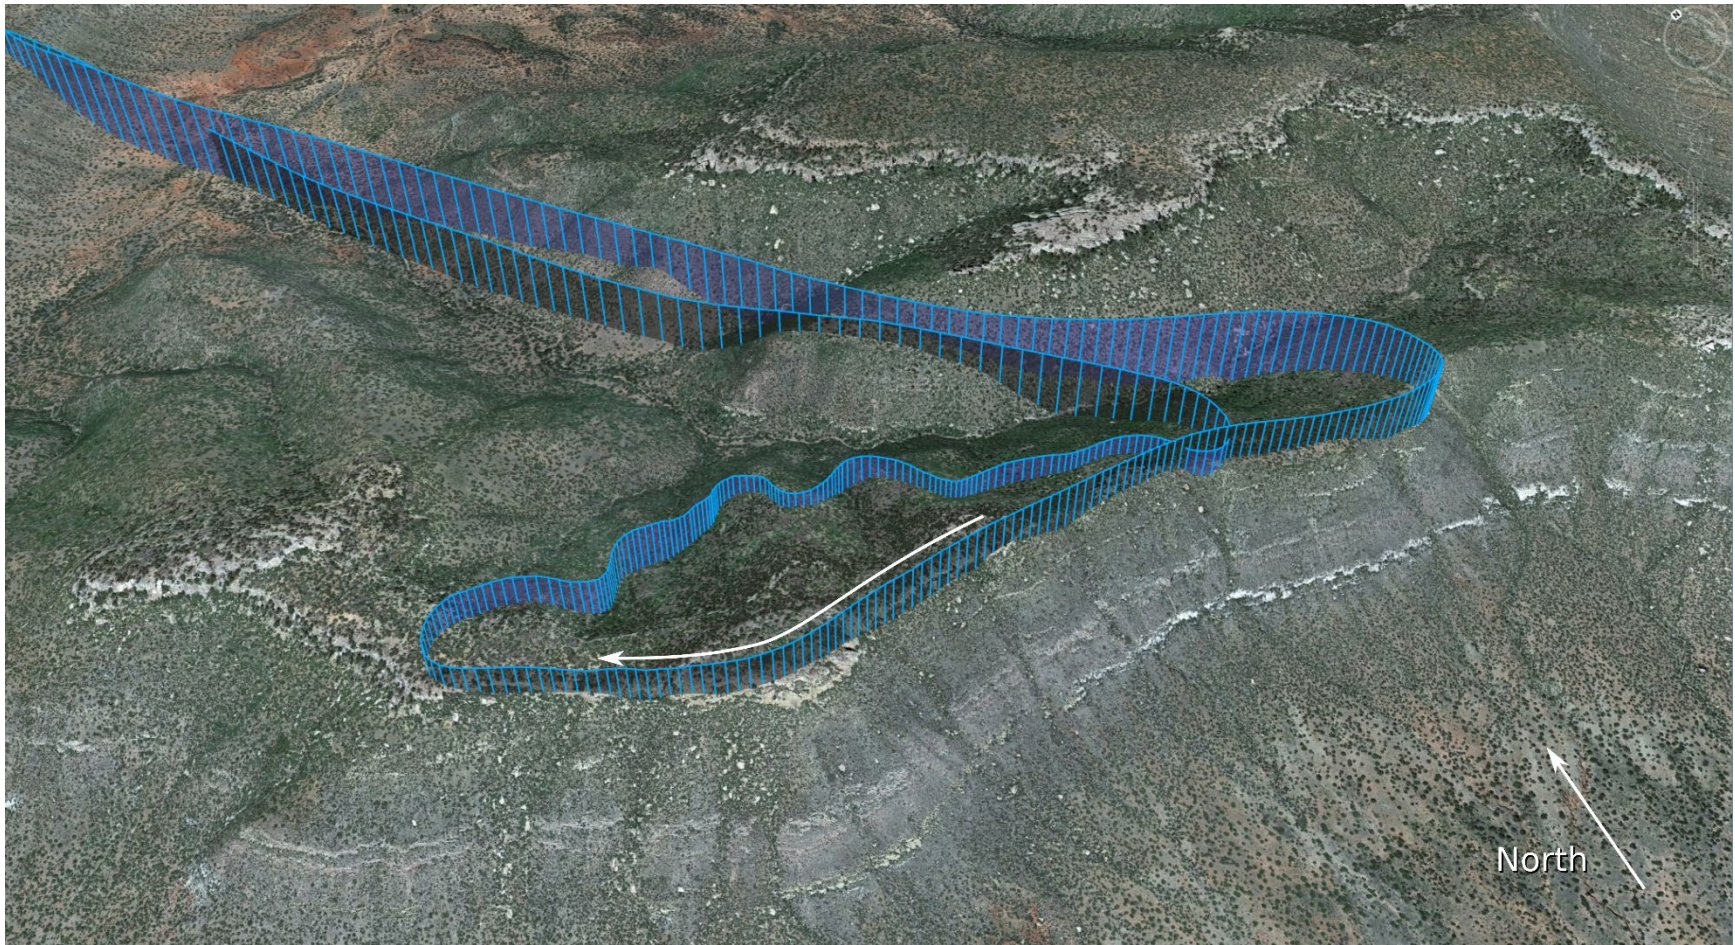
Figure 6 shows flying south to a location west of Mesas Cuatas, continuing over a connected mesa/ridge that appears consistent with firefighting operations, and then a turn back north.

Figure 6. Map overlay of the aircraft's flight along a ridge near Mesas Cuatas south of Las Vegas, NM.

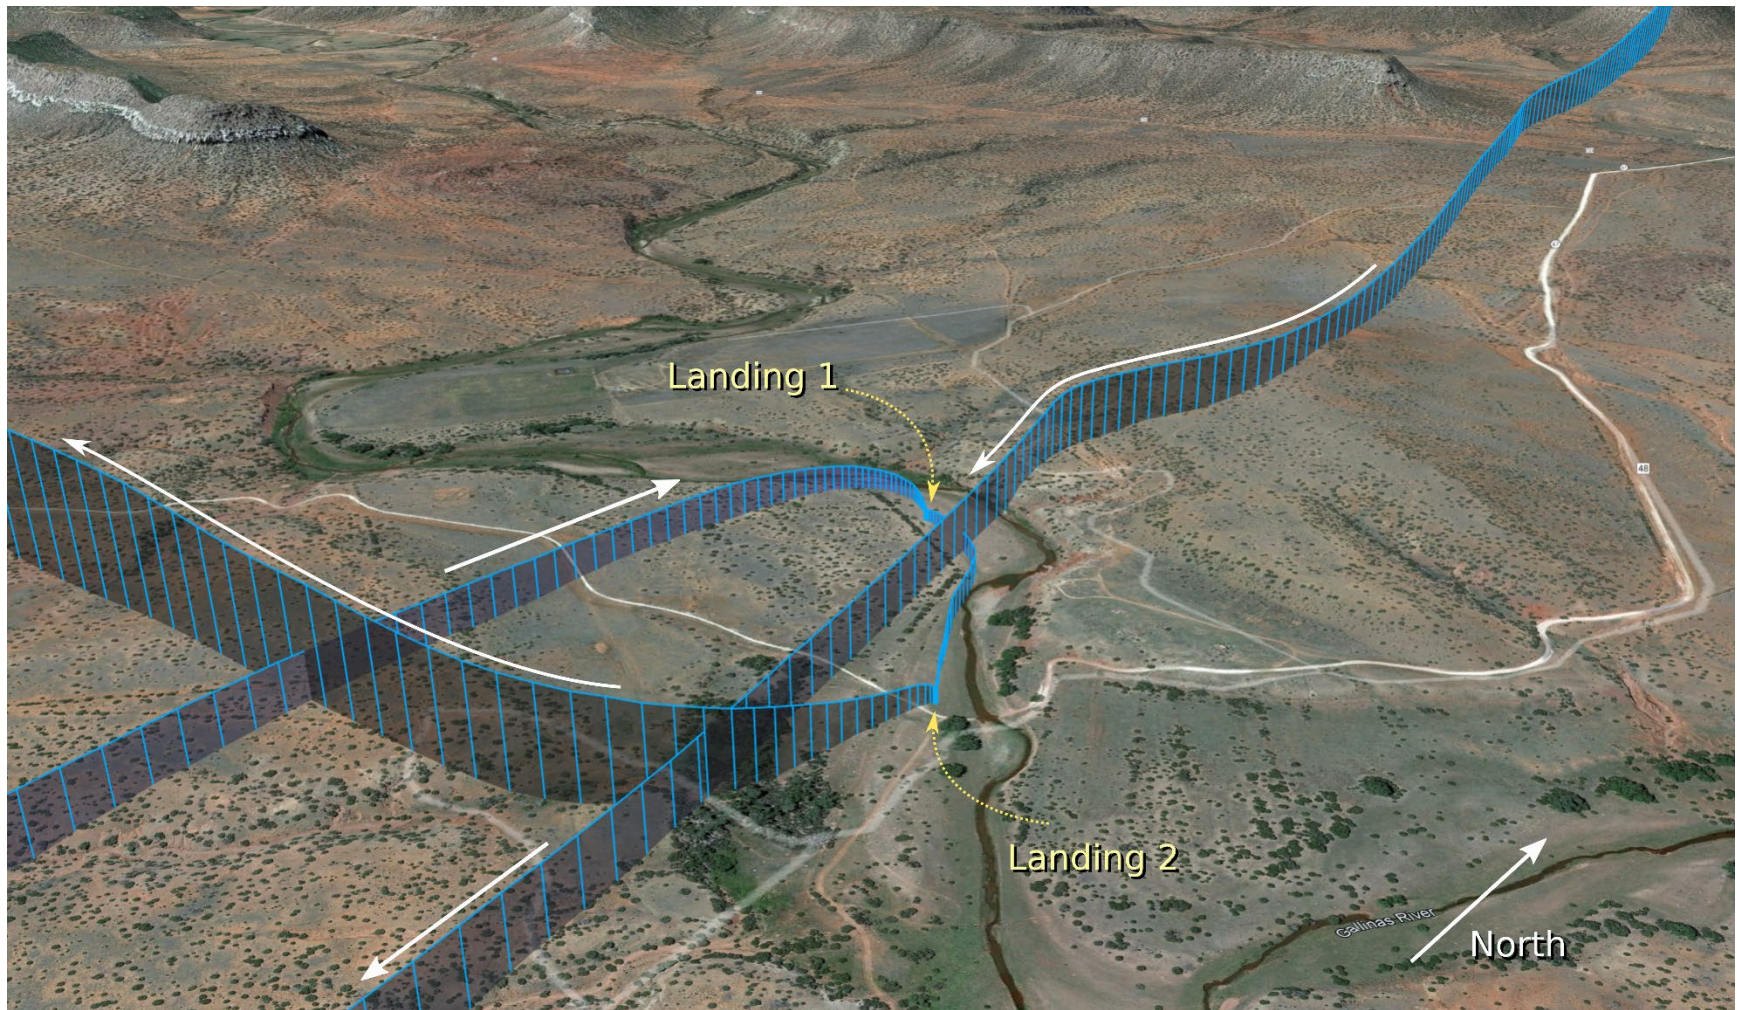
Figure 7 illustrates the helicopter flying north, then circling back south making two stops, and then heading west towards Albuquerque.

Figure 7. A map overlay showing the location of the 2 landings in the middle of the recording.

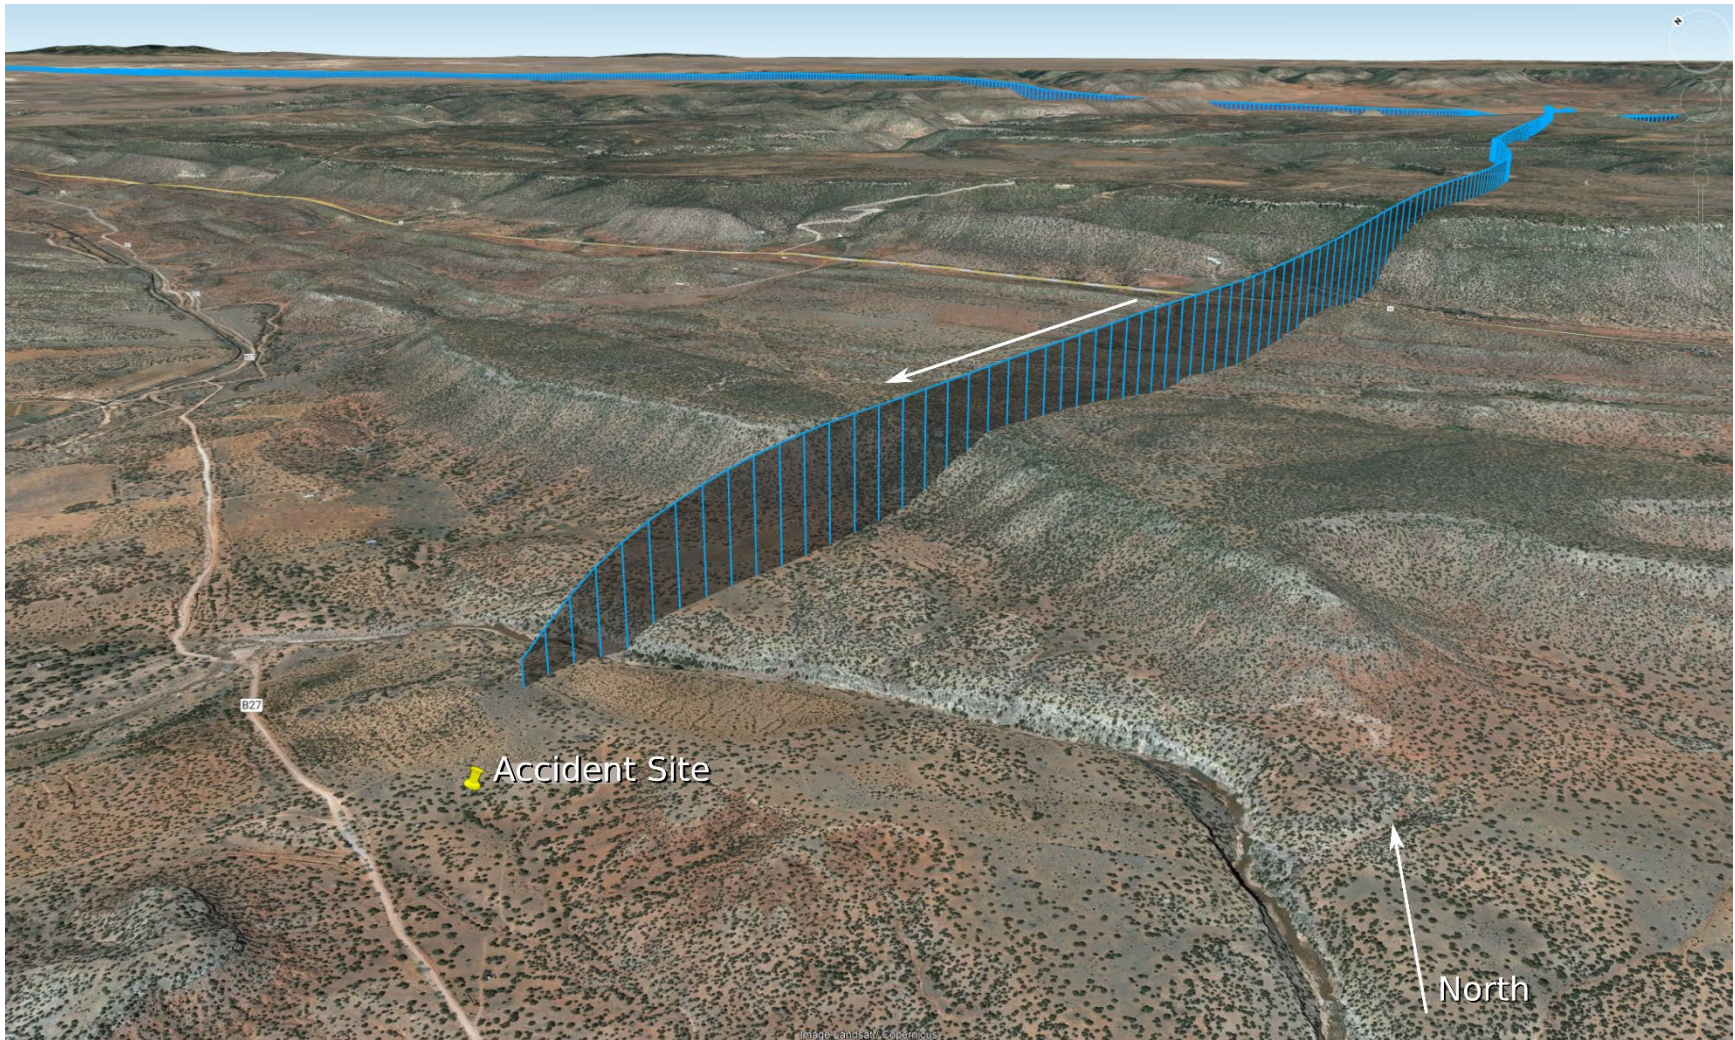
Figure 8 shows the end of the recording, including a rapid descent pointed towards where the helicopter was found after the accident.

Figure 8. The end of the recording, showing the helicopter flying towards Albuquerque and descending.
