# National Transportation Safety Board

ANC22FA041

## **GARMIN GTN 650**

Specialist's Factual Report

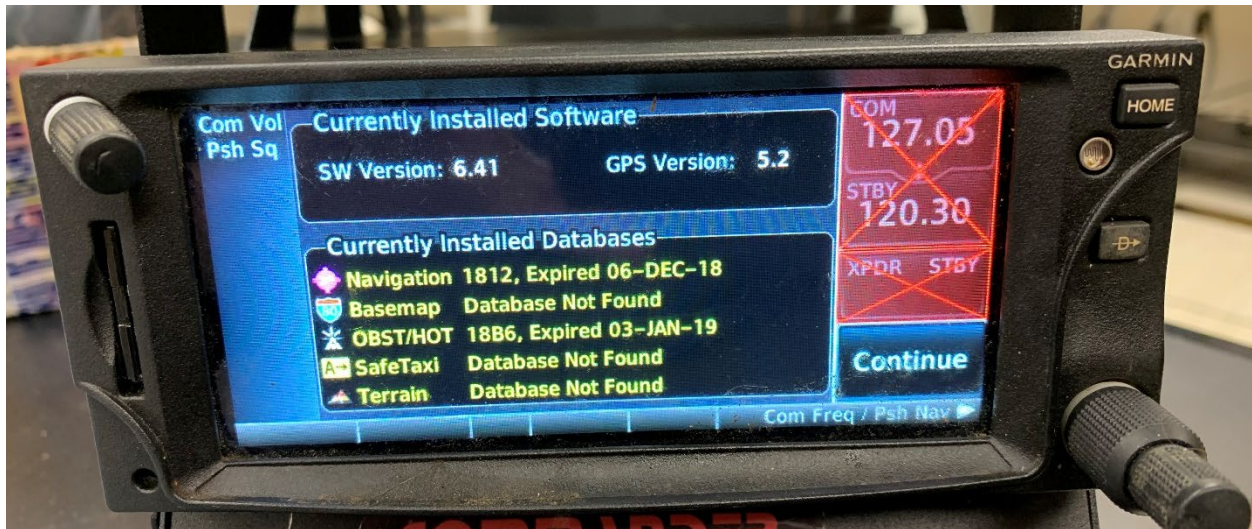
The GTN 650 was damaged in the event. The extent of the damage is shown in figure 1. The device powered on normally, and the touch screen interface still functioned. The software version was determined to be 6.41, which is older than the software version that implemented the logging functionality (6.5).

**Figure 1.** Front panel of GTN 650, showing current software revision on the device.

No data were logged due to the software on the device being too old.

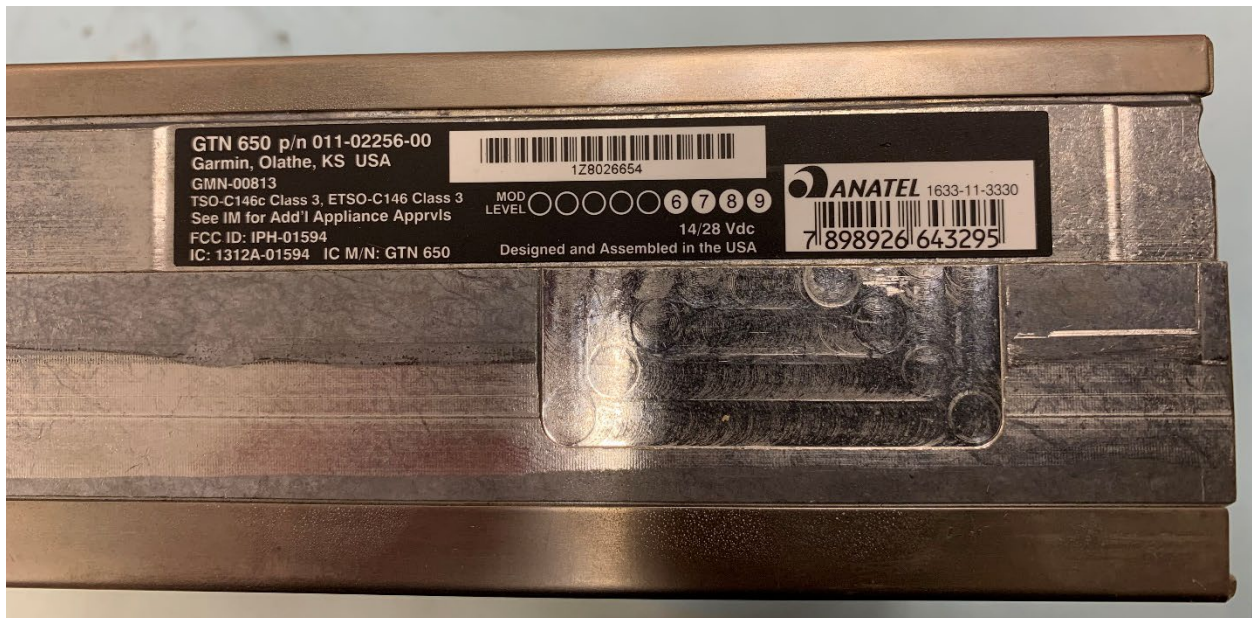
**Figure 2.** Serial number, part number, and modification level.
