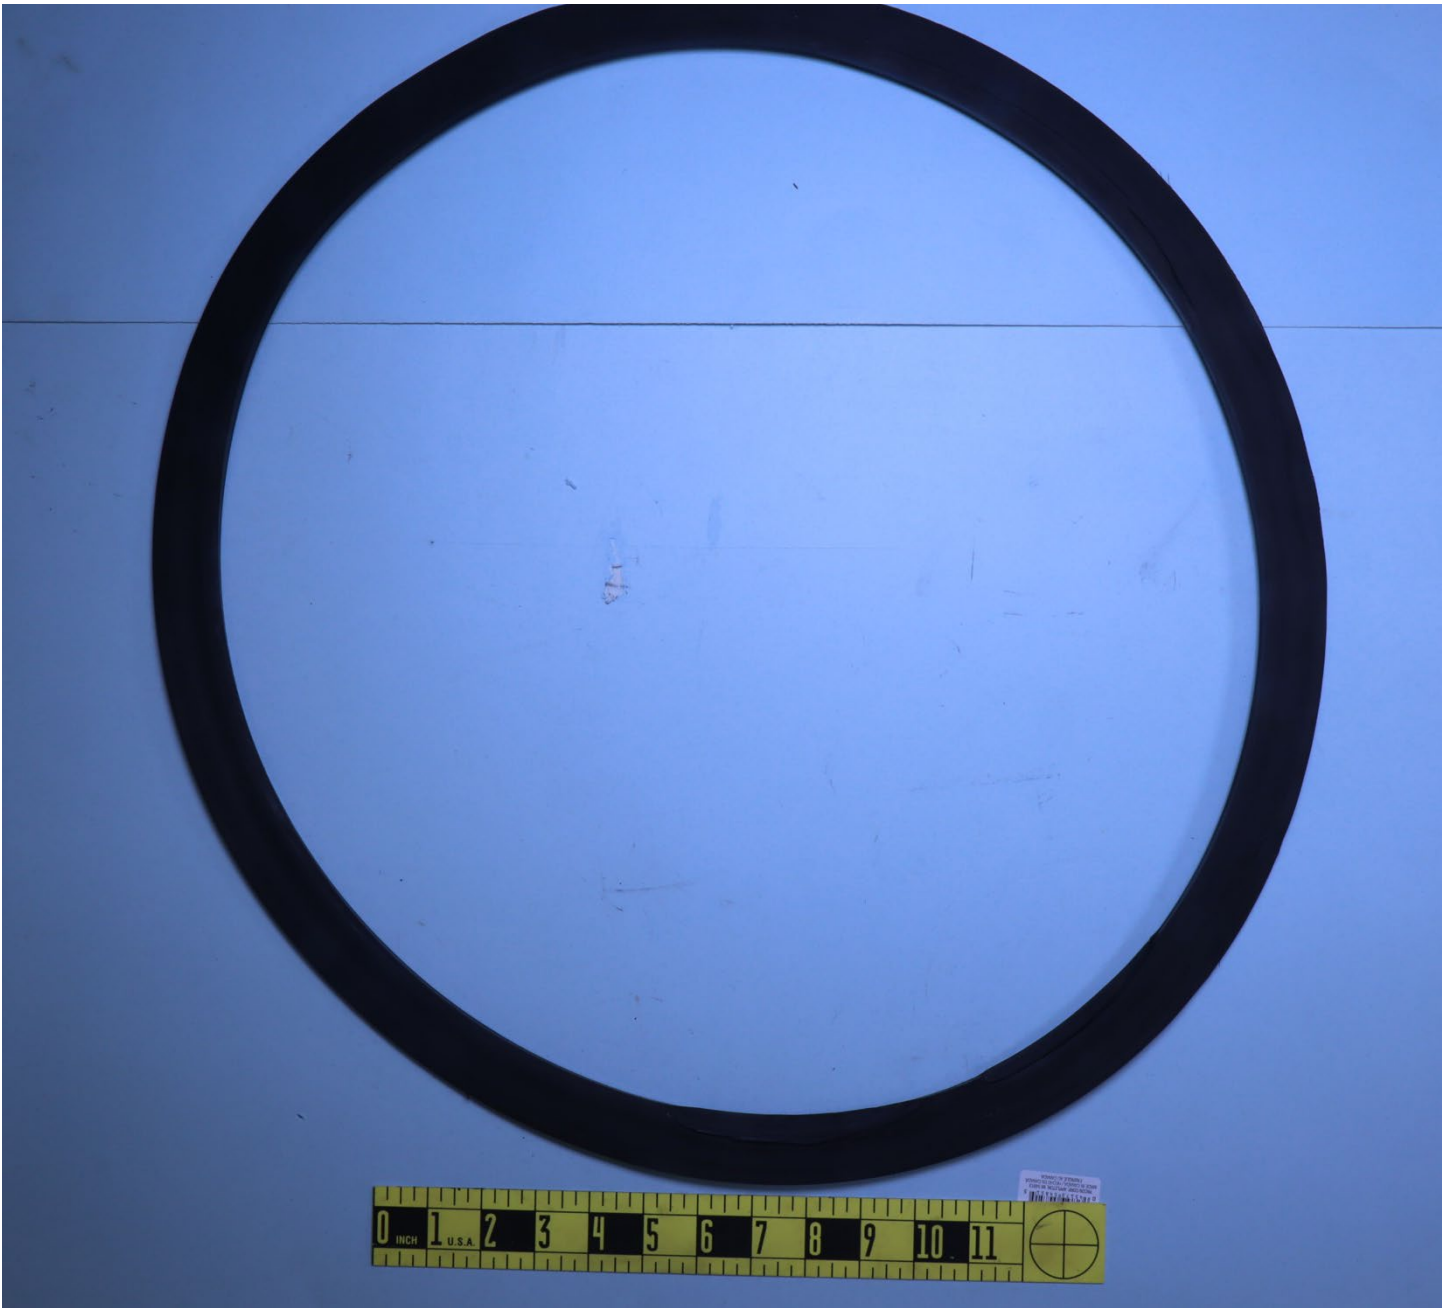
Figure 1. Exemplar gasket (HMD22LR001-HAZ-005 taken from TILX731779 (line 37))

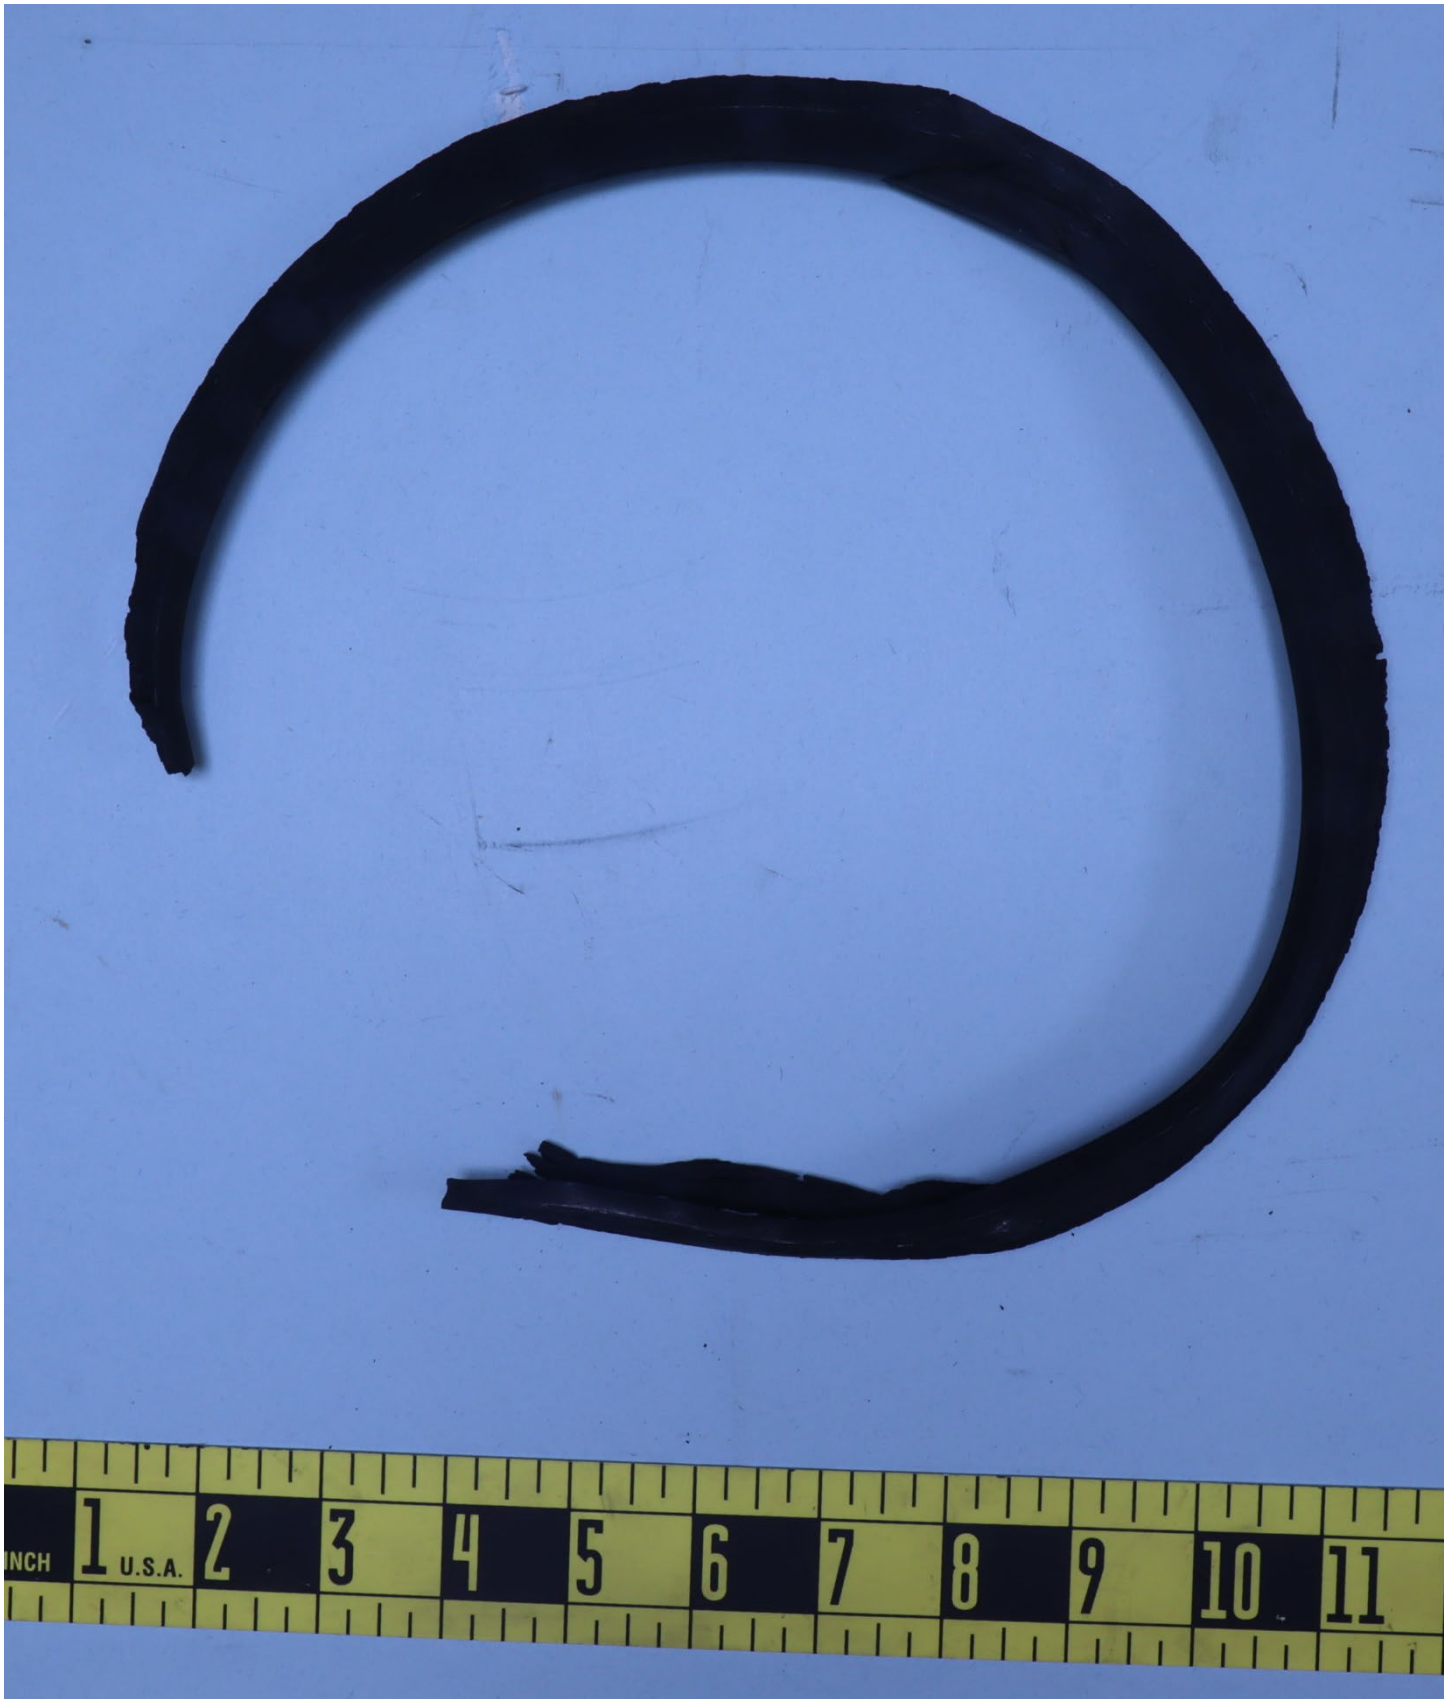
Figure 2. Damaged gasket (HMD22LR001-HAZ-004 taken from TILX731758 (line 65))

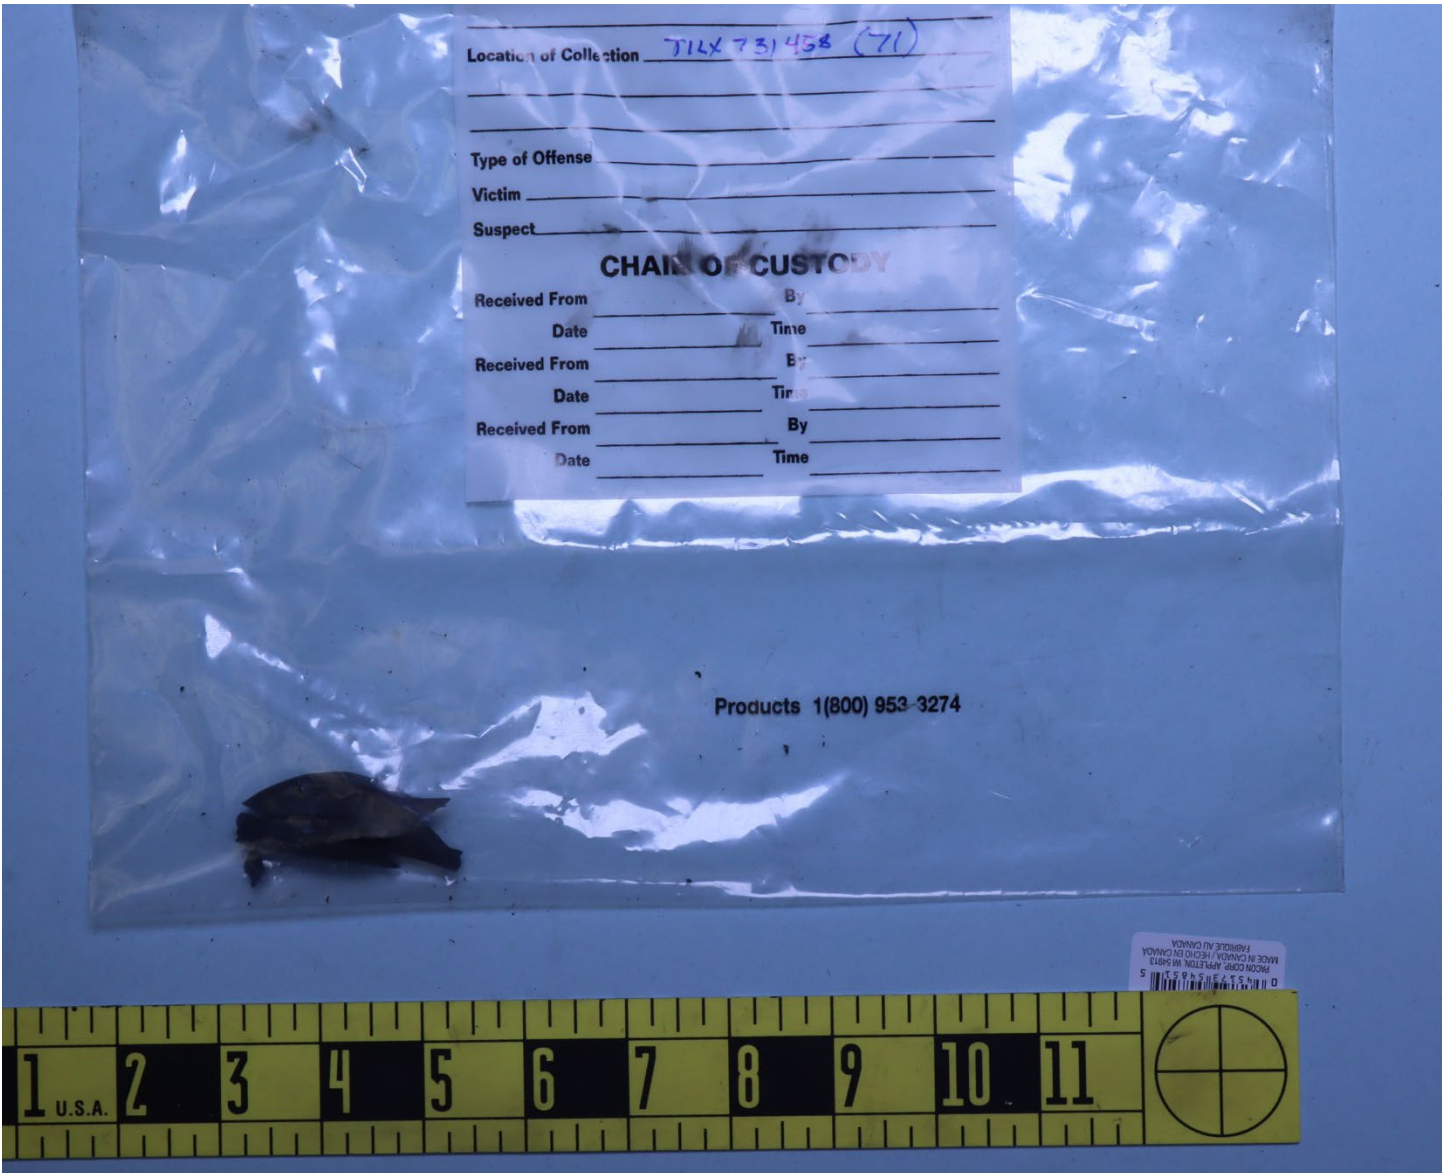
Figure 3. Damaged portion of gasket (HMD22LR001-HAZ-006 taken from TILX731458 (line 71))

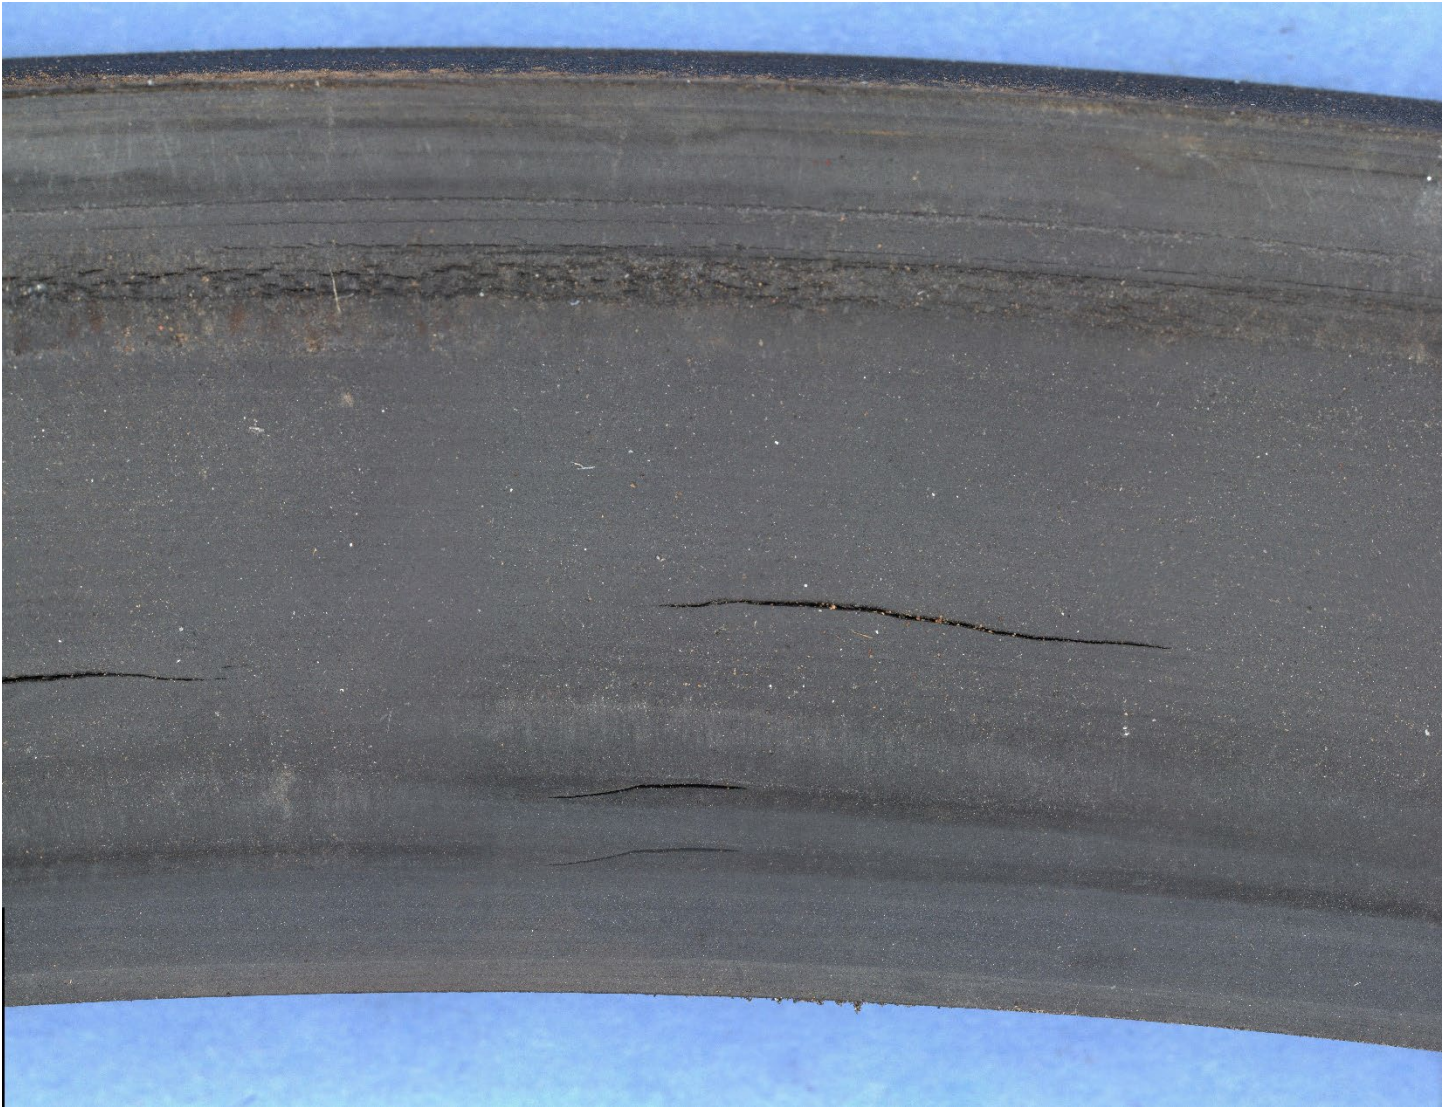
Figure 4. Closeup photograph of surface of exemplar gasket (HMD22LR001-HAZ-005 taken from TILX731779 (line 37))

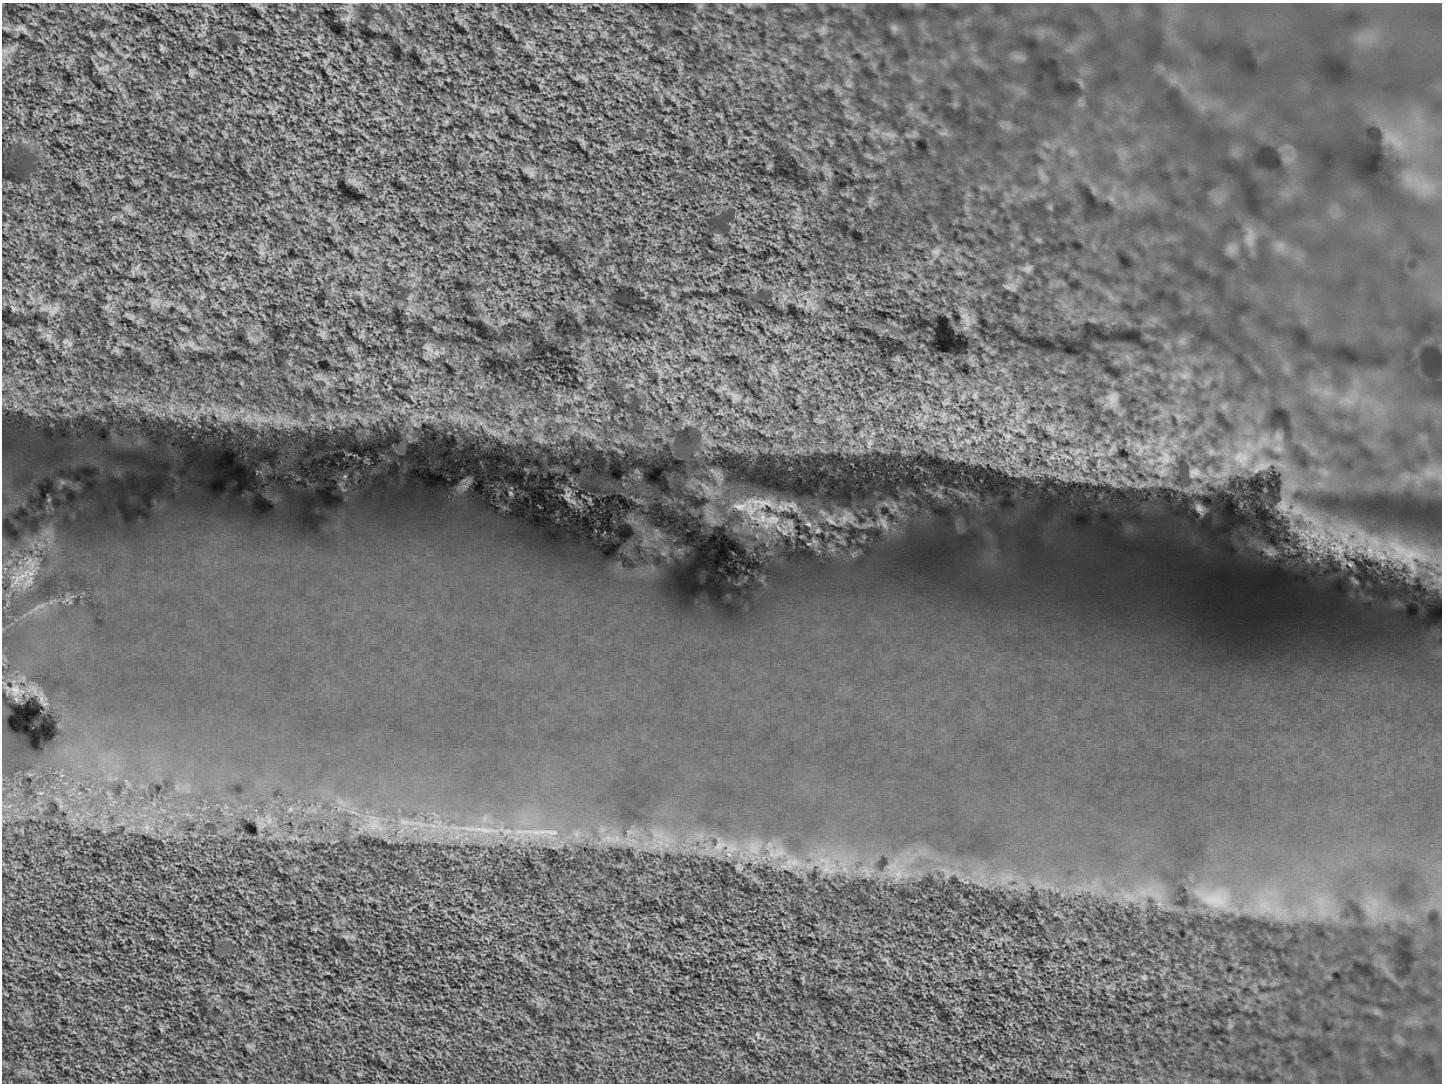
Figure 5. Micrograph of surface split in exemplar gasket (HMD22LR001-HAZ-005 taken from TILX731779 (line 37))
