Memorandum

Date: 7 July 2022

Subject: Memorandum Addressing Cause of Ground Movement
Edwardsville, Illinois
Geosyntec Memorandum: TXG0258-0700-MM-001 (Rev. 1)

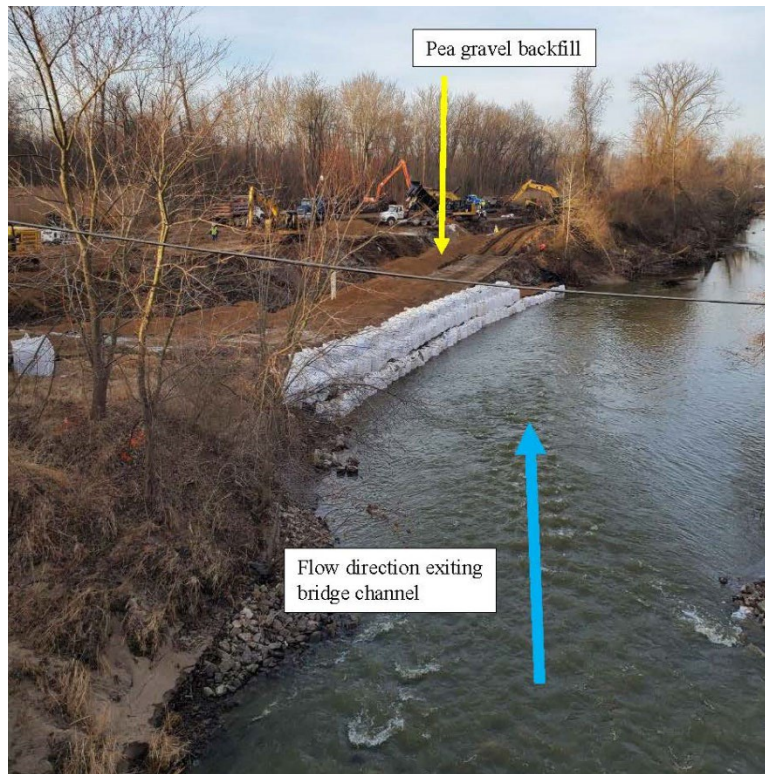
- Water in the Creek, as it passes underneath the bridge north of the Site, flows directly toward the south stream bank (left bank looking downstream) near the southwestern extent of the ground movement, as shown in Figure 1.
- Sandy flood deposits were observed along the streambank more than 15-feet above the observed water elevation, suggesting episodic high-flow and associated erosional events occur within the Creek.
- Streambank deposits along the Creek are alluvial deposits which are susceptible to scour.

Figure 1 - View Looking Southwest from Edwardsville Road Bridge (Photo Taken 17 March 2022)

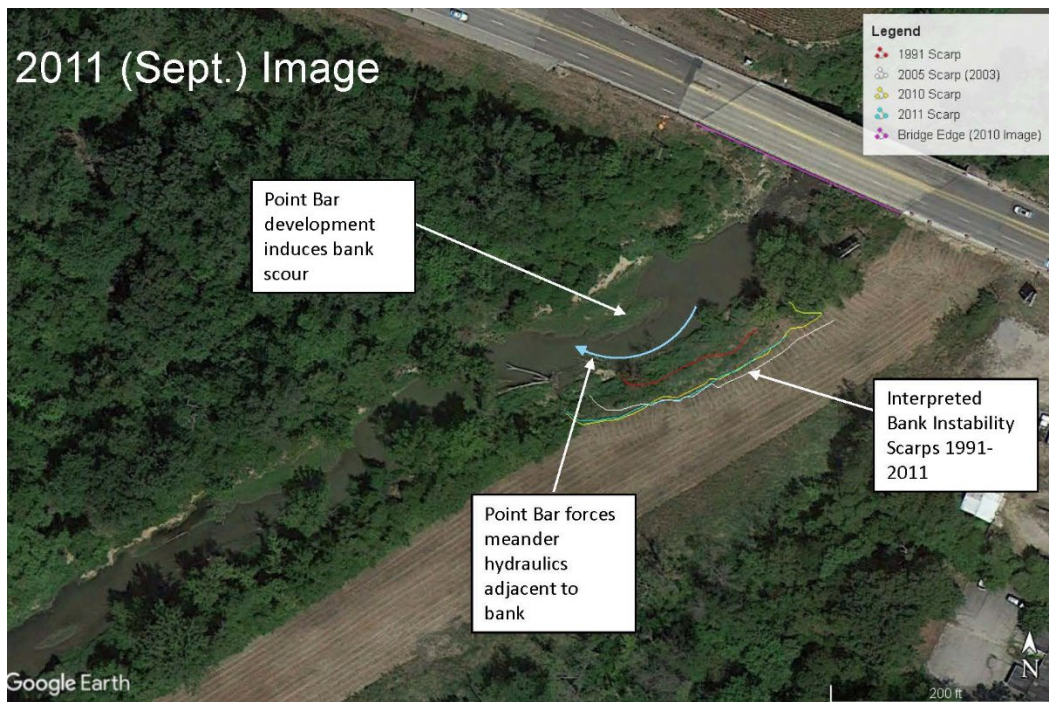
- The image from September 2011 (Figure 2) shows the absence of deep-rooted forest canopy along the streambank, a defined scarp at the head of the ground instability, presence of large woody debris (LWD), and a point bar on the opposite side of the creek that is re-directing the flow hydraulics toward the Site.

Figure 2 - Aerial Image Dated September 2011 (from Google Earth™)

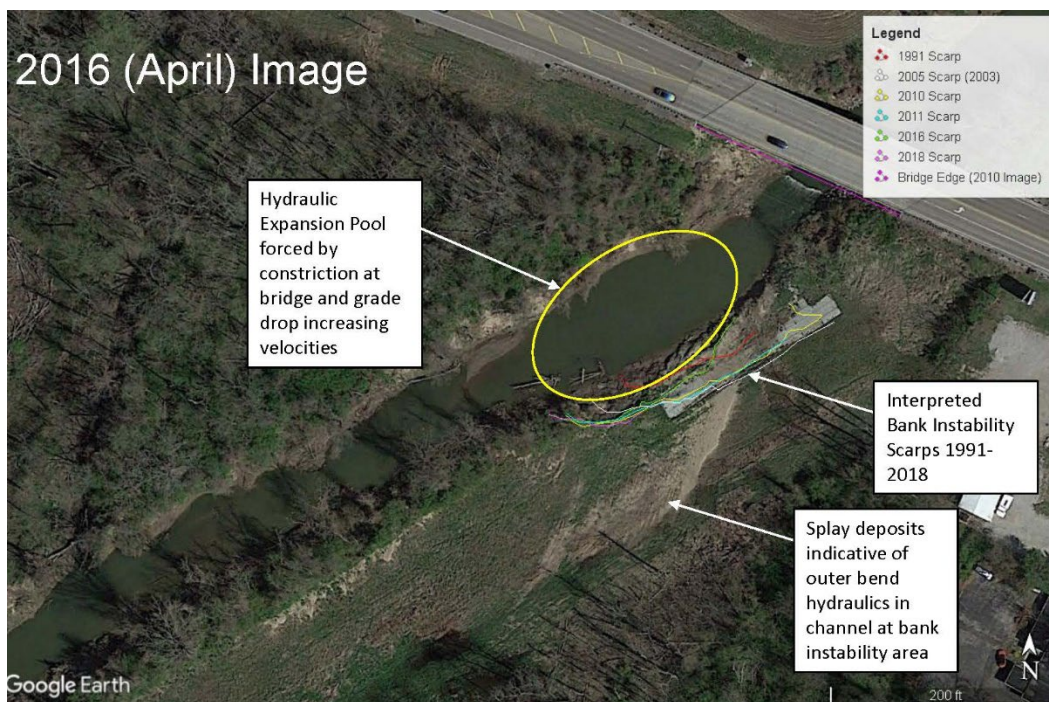
- The image from April 2016 (Figure 3) shows the bank conditions without vegetive cover along the streambank, presence of LWD along downstream end of left bank at Site, the development of hydraulic expansion pool created by increased flow velocities downstream from the bridge floodway constriction and grade drop downstream of the bridge, and splay deposits indicative of flooding and outer bend hydraulics. The photo also shows articulated concrete mats that were installed for erosion control above a section of the Pipeline in 2014, but which generally do not appear to be protecting the bank from scour or contributing to the stability of the slope.

Figure 3 - Aerial Image Dated April 2016 (from Google Earth™)

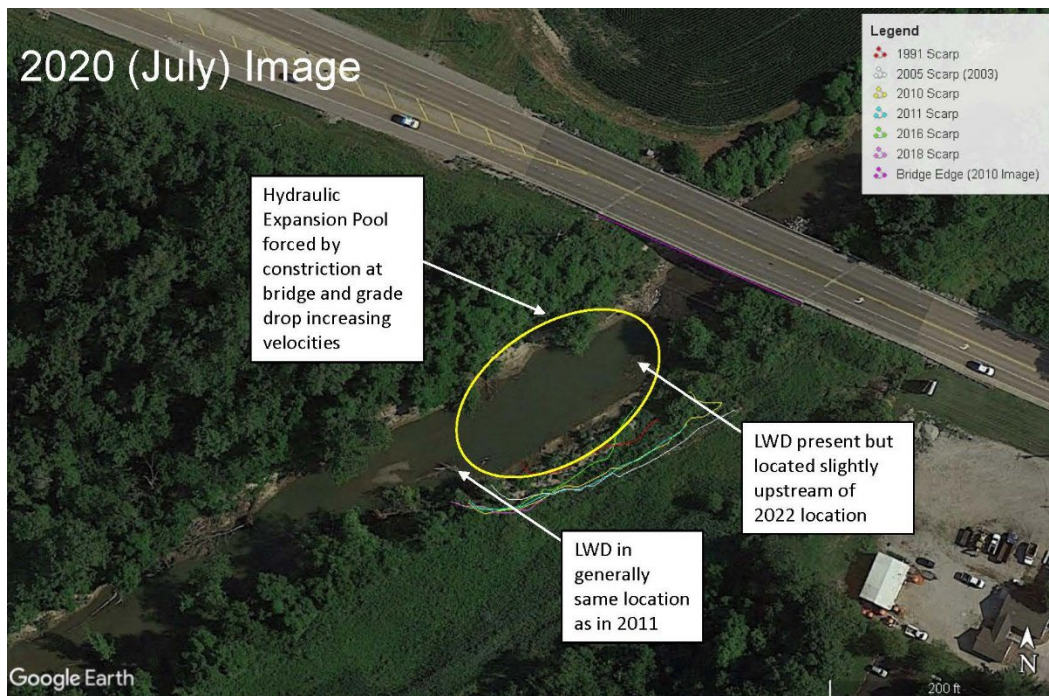
- The image from July 2020 (Figure 4) shows an additional area of LWD accumulation at the upstream end of the left bank at the Site. The existence and proximity of LWD to the left bank complicate scour hydraulics creating local scour conditions resulting for localized velocity accelerations and multidirectional flow patterns.

Figure 4 - Aerial Image Dated July 2020 (from Google Earth™)

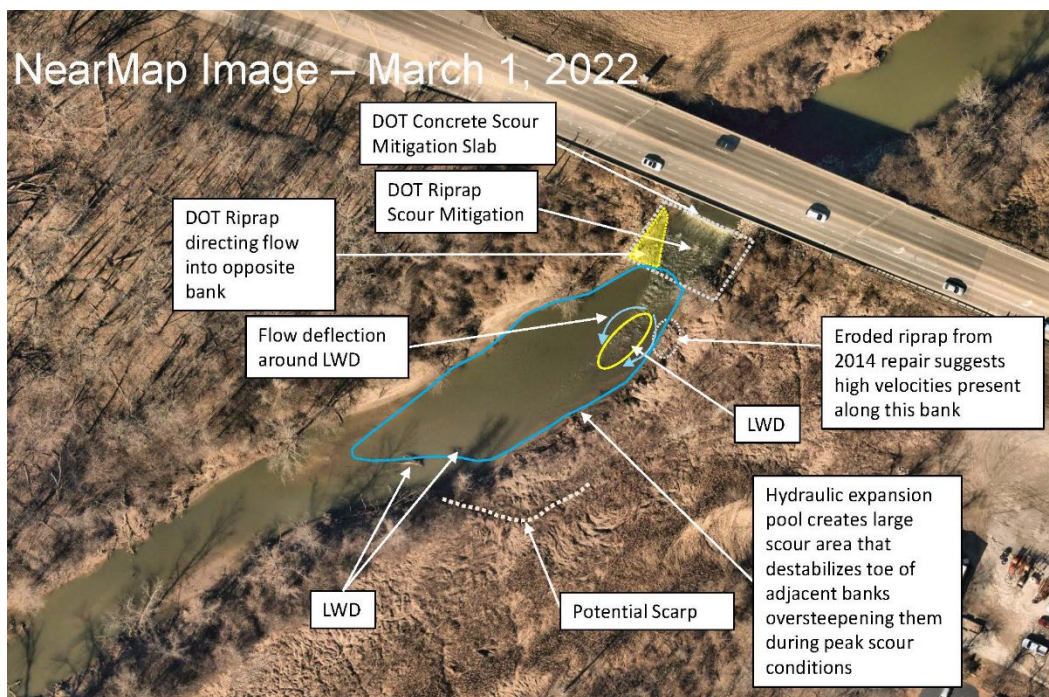
- The image from 1 March 2022 (Figure 5) shows flow through the Illinois Department of Transportation (IDOT) installed scour mitigation riprap directed towards the left bank and accumulations of LWD.

Figure 5 - Aerial Image Dated 1 March 2022 (from NearMap)

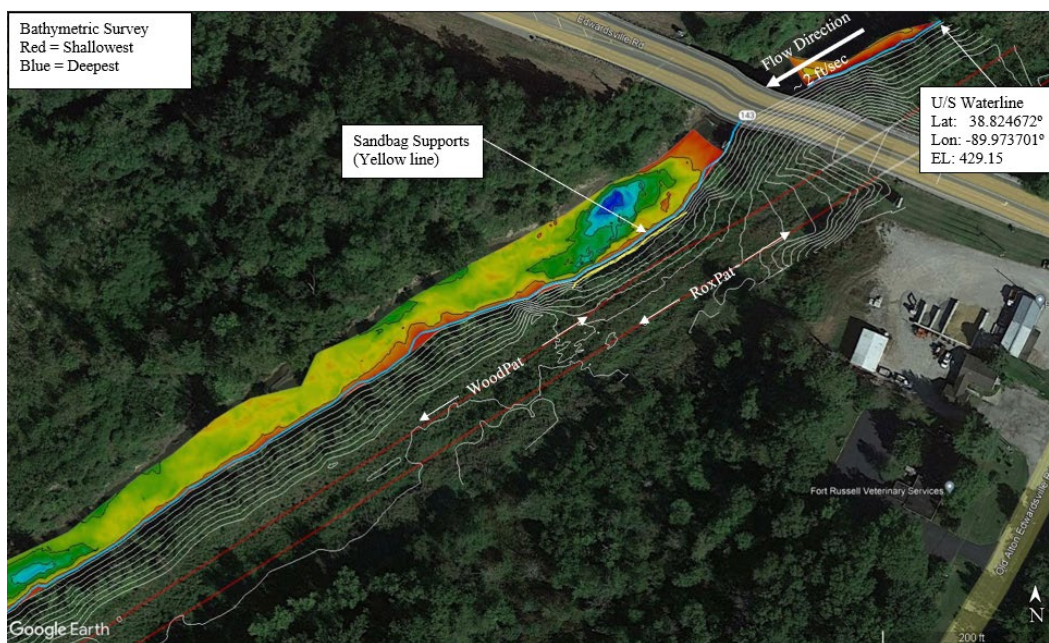
The creek bathymetry and bank topography collected by DoC Mapping LLC after the 11 March 2022 ground movement is shown in Figure 6. These contours, along with the cross sections in Figure 8, illustrate topographically the impact of scour and ground movement on the left bank relative to the forested upstream and downstream streambanks. The instabilities along the left bank are coincident with deeper creek bed depths (i.e., resulting from bed scour), lateral bank position, and altered bank slope inclination. As shown in Figure 8, in the area of the ground instability, the creek bed depth is about five feet deeper and the bank is recessed laterally about 15 feet, compared to the upstream and downstream streambanks.

Figure 6 - Site Plan with Bathymetric and Ground Contours Obtained April 2022 (from DoC Mapping LLC)

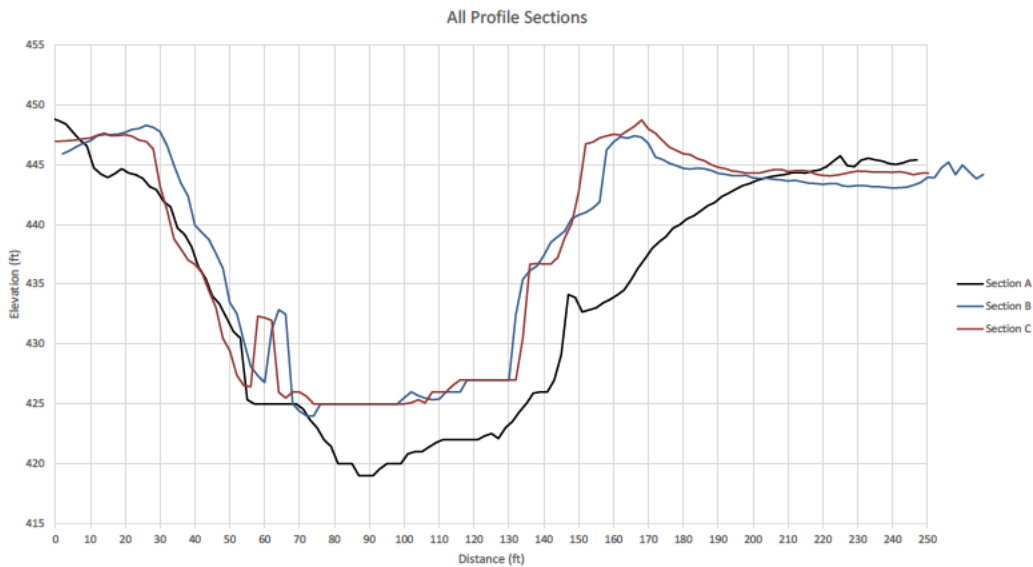
Figure 8 - Cross Section Profiles

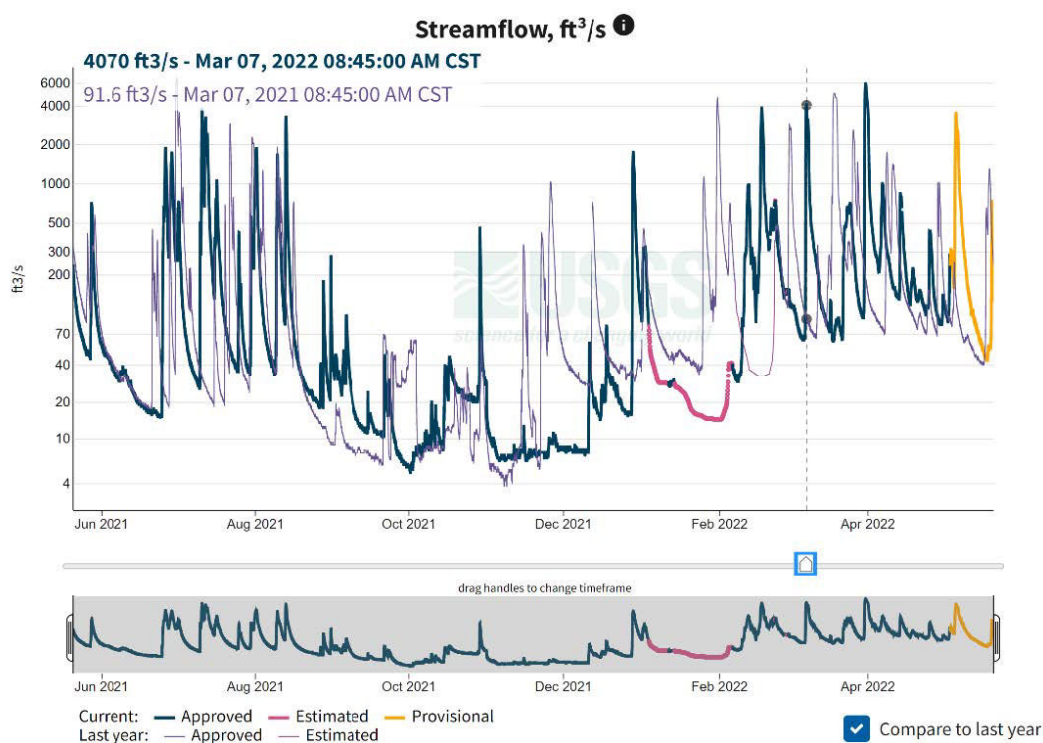
The flood event which occurred on 7 March 2022, preceding the Pipeline rupture by several days, is reported to have had a stream flow magnitude of 4,070 cubic feet per second (cfs), which corresponds to approximately a 1.5-year return period event. This is equivalent to a “bankfull” event responsible for the dominant sediment transport annually. It is suspected that a single flood event is not responsible for the scour which led to the conditions at the Site, but rather a series of multiple smaller events, such as the 7 March 2022 flood event. Figure 9 contains a hydrograph with stream flow data for the Creek showing the relatively frequency of flood events with stream flows in the range of 4,000 cfs from May 2021 to April 2022.

Figure 9 - 1-yr Cahokia Creek Hydrograph (from USGS)

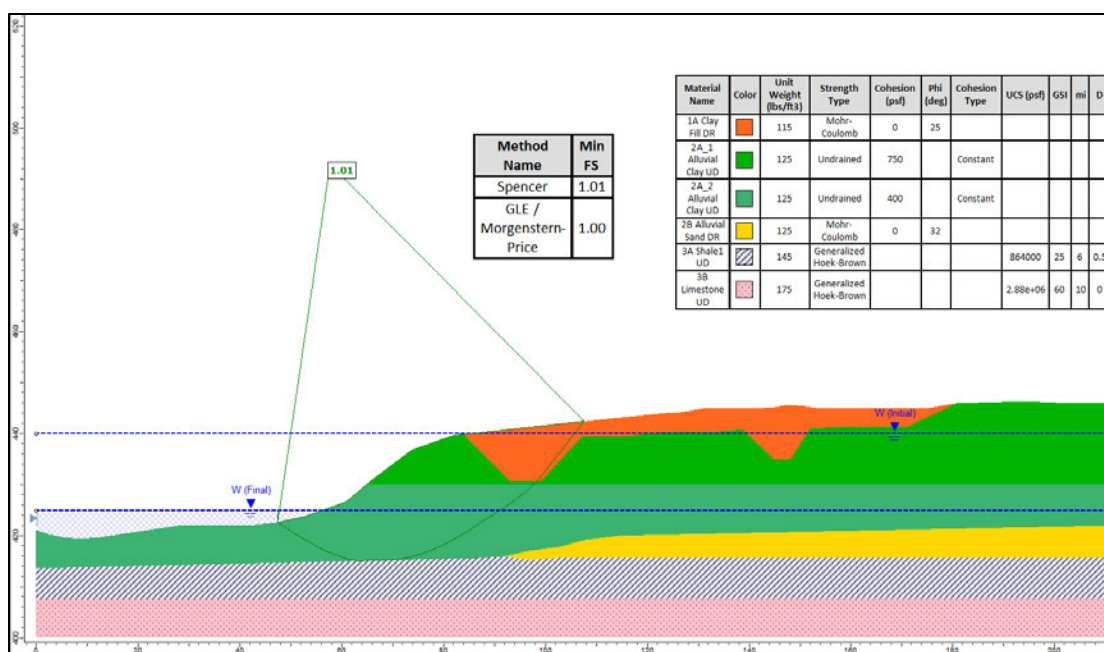
The slope stability analysis results for Section A-A' under the assumed conditions at the time of instability are shown in Figure 10. This scenario considers a streambank slope of approximately 1.2H to 1V with material removed at the slope toe from riverine scour. Groundwater is modeled as a rapid drawdown condition with initial and final water elevations changing from EL. 440 feet¹ to EL. 425 feet within the model to match flooding conditions observed prior to the event on 11 March 2022. The undrained shear strength of the alluvial clay (Unit 2A) below EL. 430 feet was adjusted until a factor of safety equal to 1.0 was achieved. The resulting undrained shear strength is 400 pounds per square foot (lbs/ft²), a value that is consistent with the range of shear strengths for this material measured from laboratory testing.

Figure 10 - Limit Equilibrium Slope Stability Analysis at Section A-A'

The slope stability analyses indicate that a combination of streambank scour in the Creek and a reduction of undrained shear strength in the subsurface soil is the plausible cause of instability which led to ground movement. The slope stability sensitivity analysis results presented in Geosyntec's *Slope Stability Assessment* calculation package, dated 26 May 2022, which generally utilize the material parameters provided in the Geosyntec's *Geotechnical Report*, dated 13 May

2022, closely simulate the conditions that are suspected to have led to the 11 March 2022 instability at the Site. The analyzed cross sections indicate a deep-seated sliding surface with entrance/exit locations generally consistent with field observations. As such, mitigation should be designed to address the apparent deep-seated or global instability at the Site.
