NATIONAL TRANSPORTATION SAFETY BOARD

Systems Group Chairman's Factual Report

DCA-15-IA-089

Operator: Gojet Airlines
Location: Chicago O'Hare International Airport (ORD), Chicago, Illinois
Date: March 14, 2015
Time: 1521 central daylight time
Airplane: CRJ 700, registration N157GJ

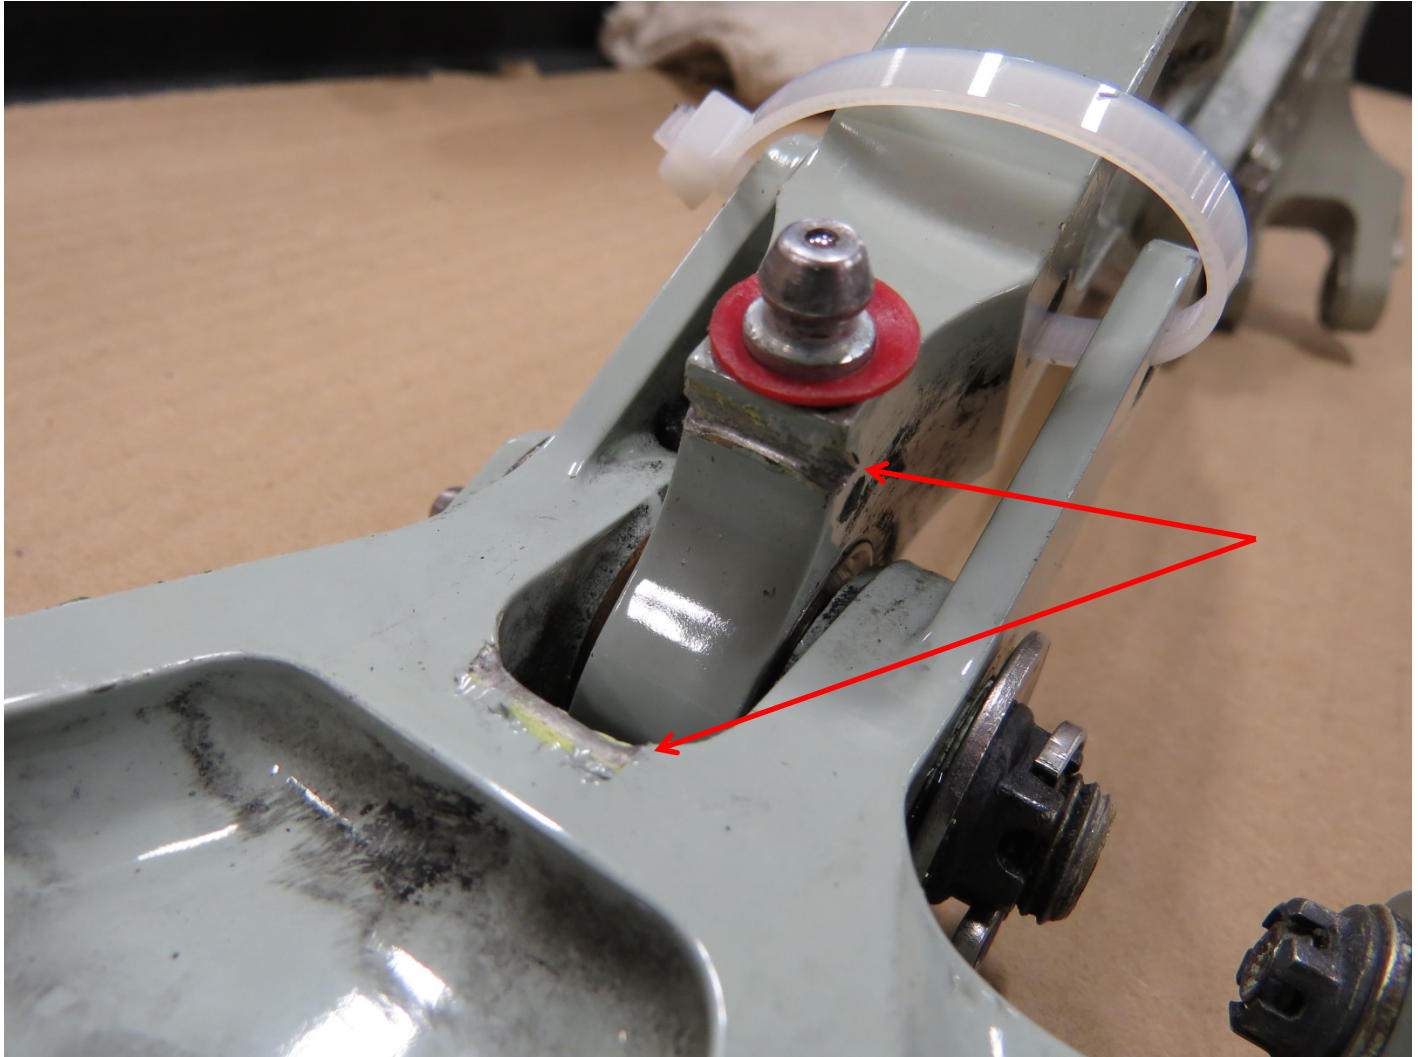
Figure 4
Contact area between upper link and lower link (after cleaning of the parts)

A contact area was noted between the grease nipple area of the upper link and the lower link (see figure 4). This area was identified for further investigation in the UTAS M&P laboratory.

The spherical bearing between the upper link and lower link was noted to potentially have excessive movement (play), and was identified for further investigation in the UTAS M&P laboratory.

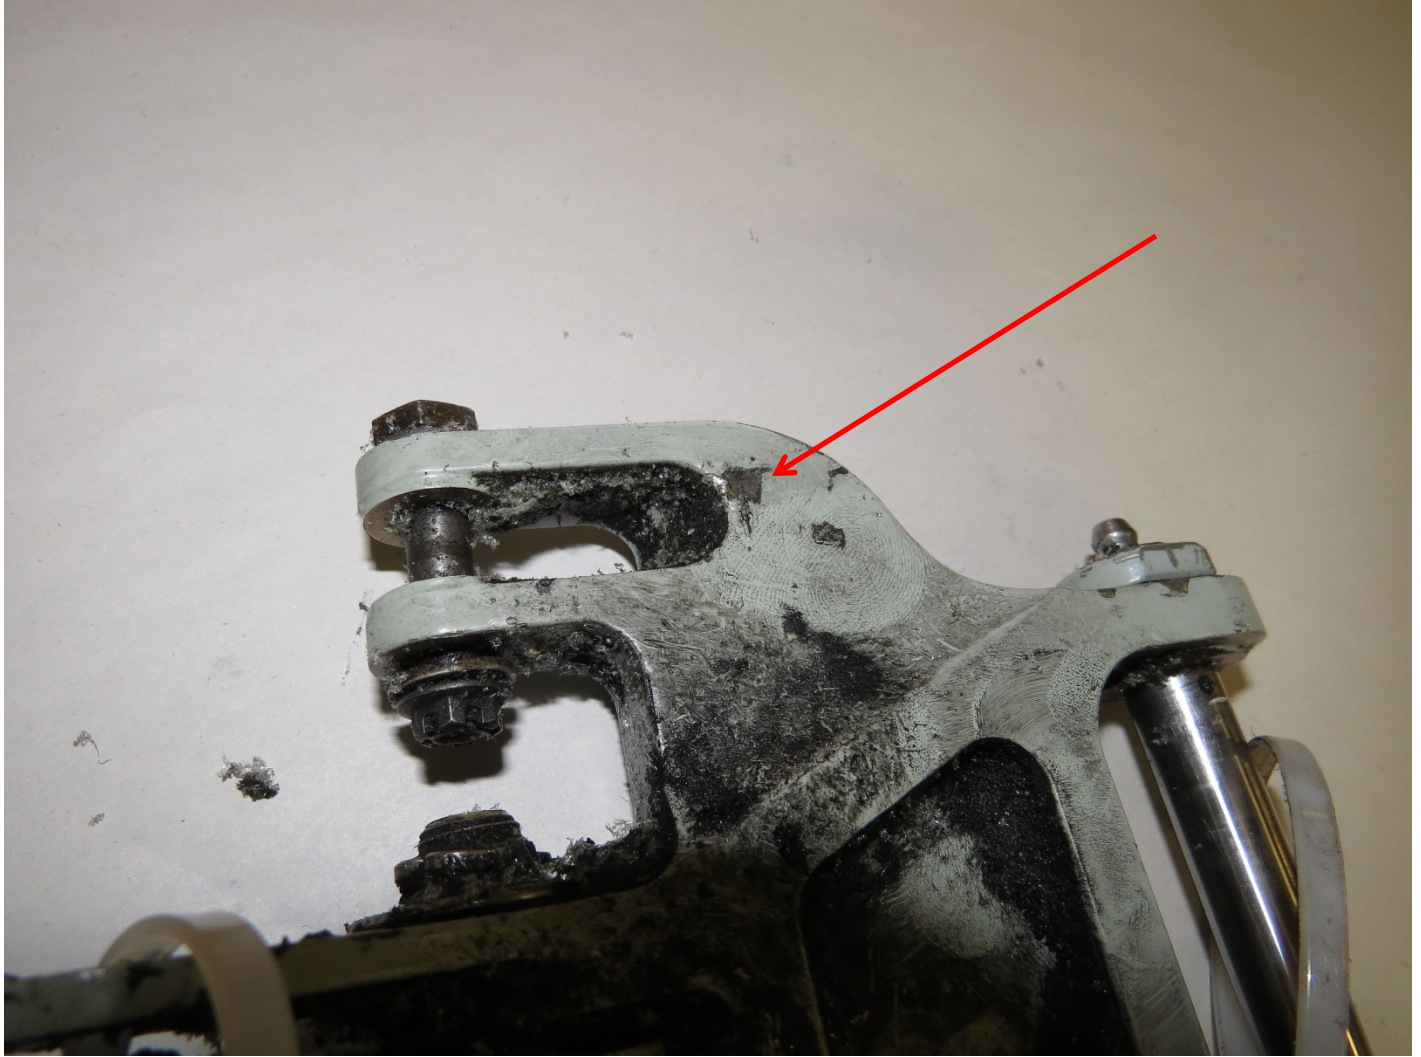
Figure 6
Area of missing paint on lower link

There was a contact area noted between the lower link and the grease nipple area of the upper link. There was an area of missing paint noted in the area of the drive link rod end attachment to the lower link (see figure 6).

The missing paint area was identified for further identification by the UTAS M&P laboratory to determine if the dimensions of the missing paint area were consistent with the dimensions of the drive link.

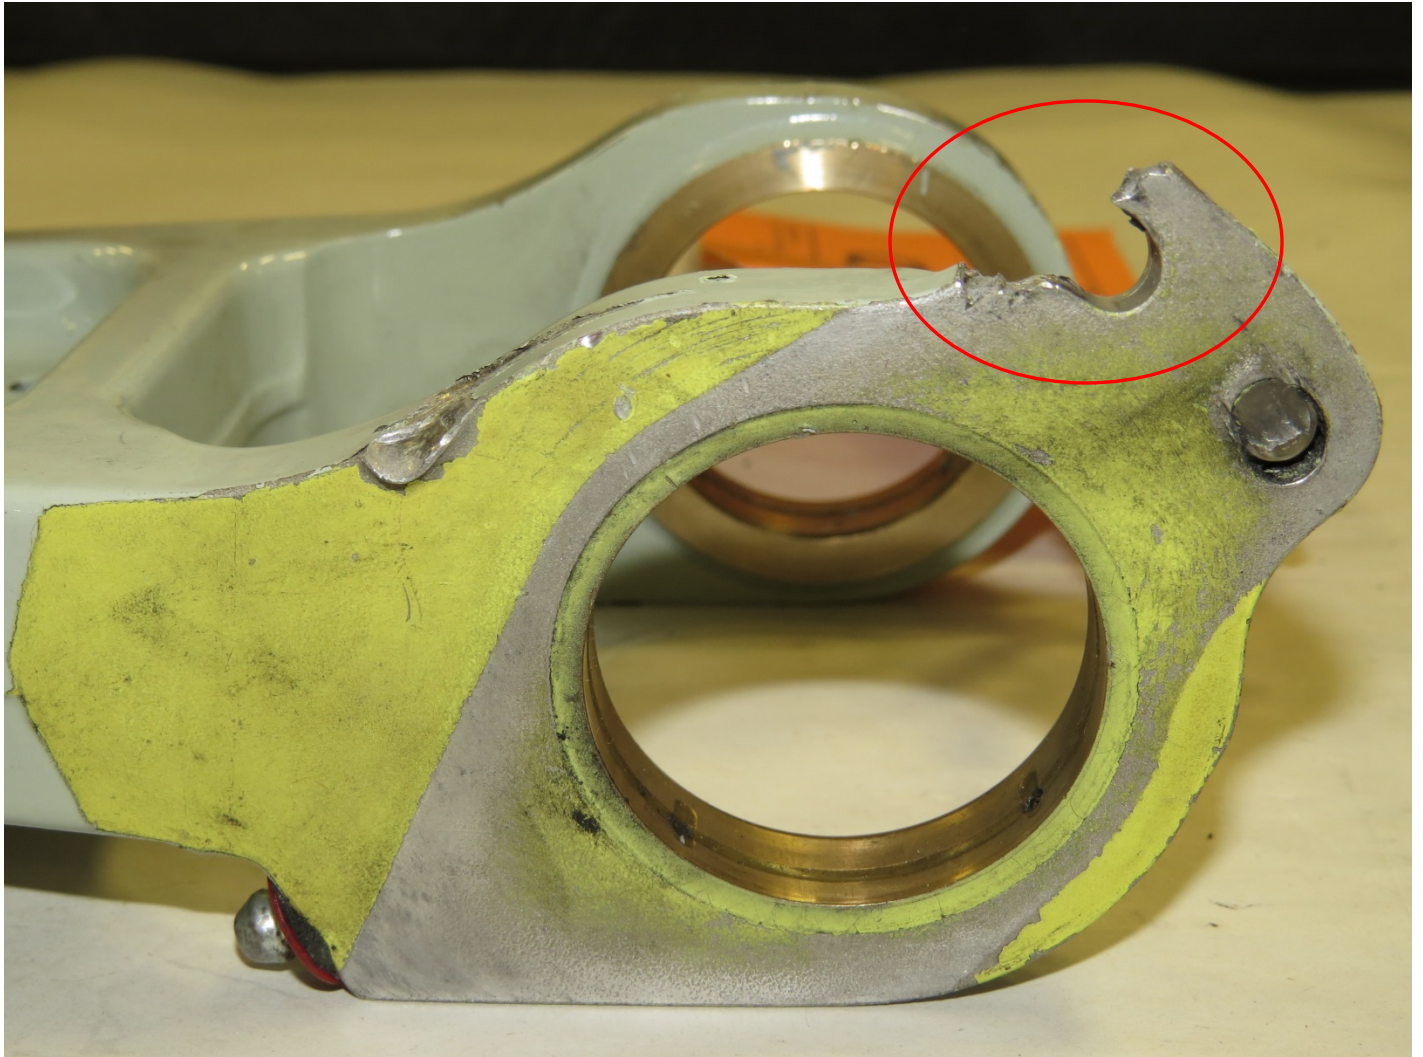
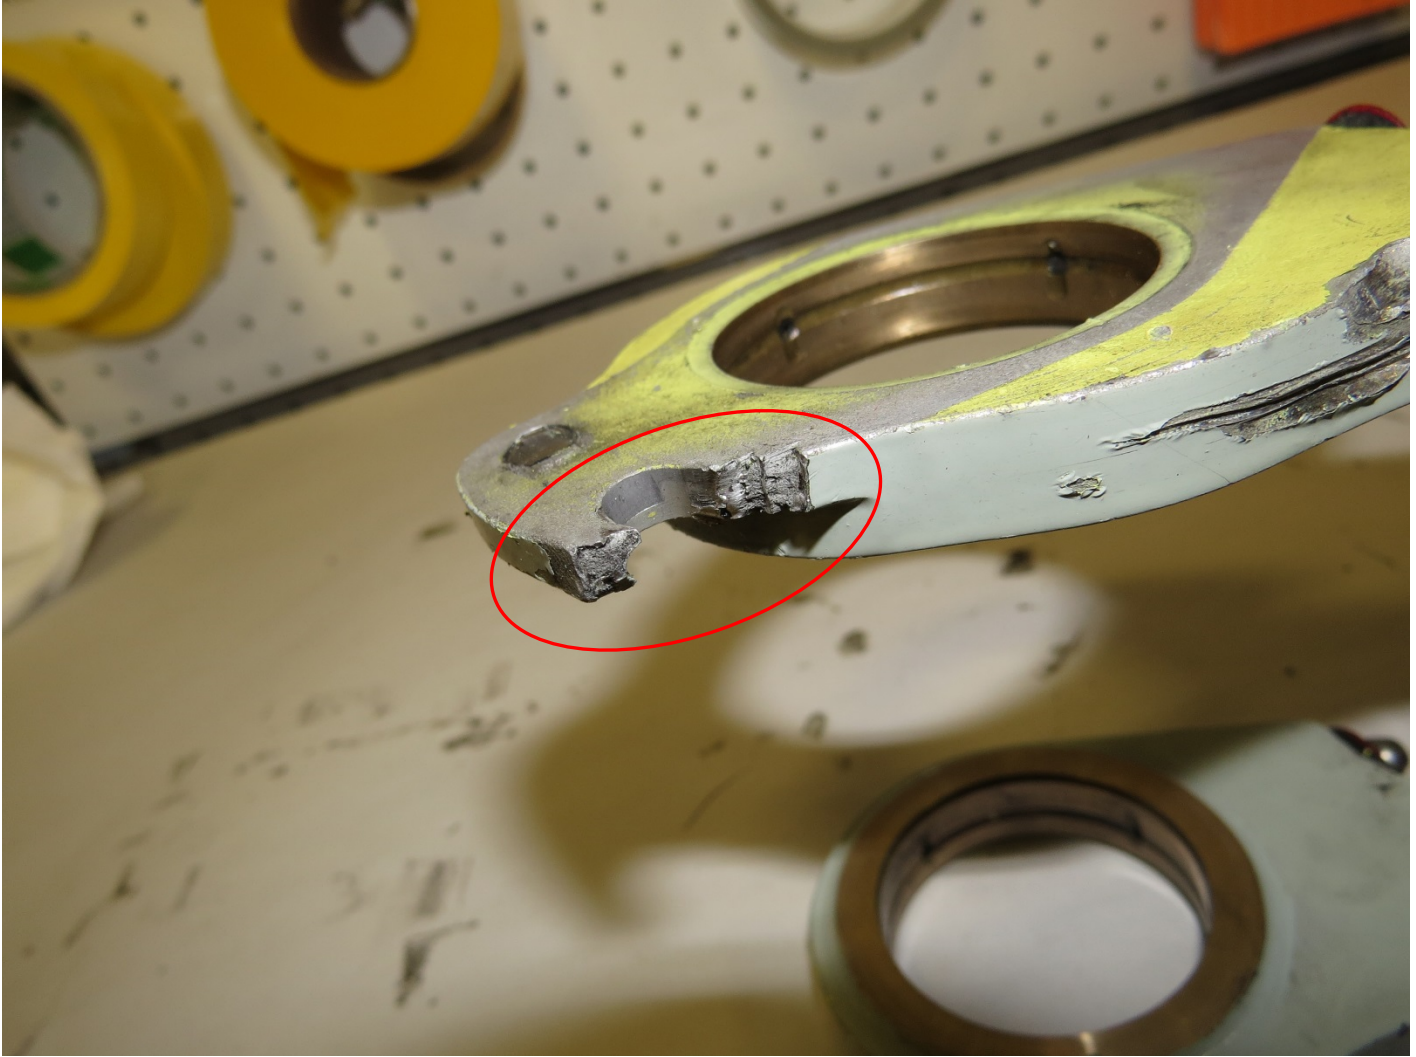
The upper bolt hole on the attachment lug between the lower lock link and the drive arm was noted to have a broken out area where the material from the bolt hole extending to the edge of the lug was missing. The anti-rotation bolt from this hole was found to be deformed and was still present in the drive arm assembly (see figures 8 and 9).

Figure 8
Lower lock link assembly showing upper bolt hole with missing edge material

Close up view of the lower lock link assembly showing upper bolt hole with missing edge material

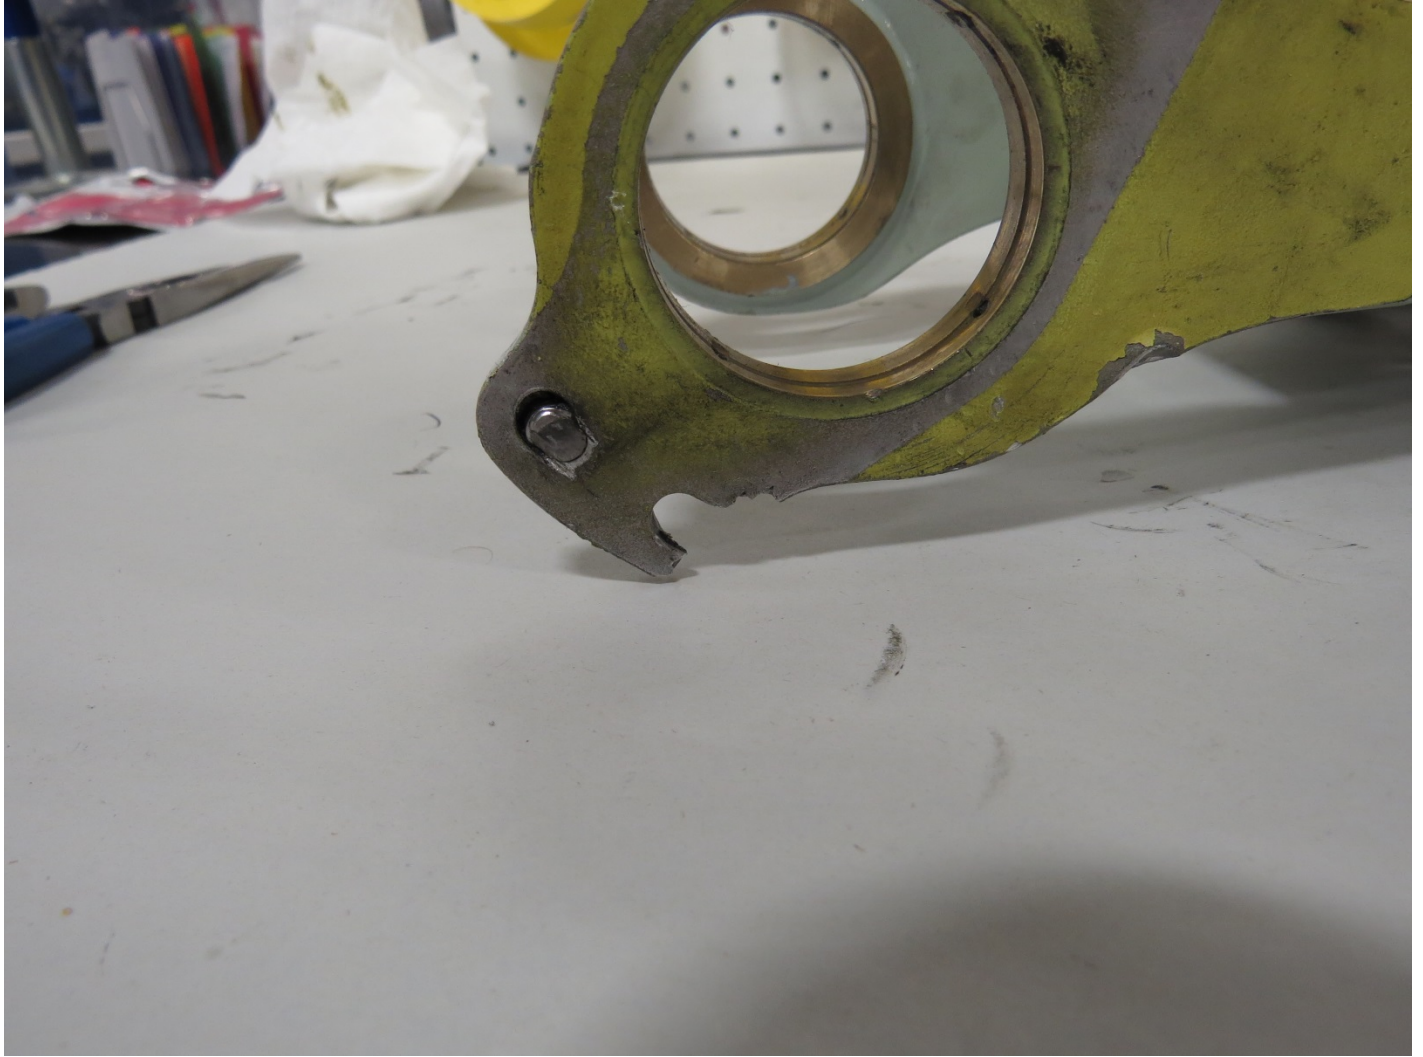
The anti-rotation bolt in the lower bolt hole was found to be sheared off at the level of the flange surface, and material consistent with the bolt was found to be smeared across the flange surface in the direction of the upper bolt hole. The “D” shaped head portion of this bolt was shipped separately in a bag. The end of the bolt, which remained in the lower lock link, did not have a nut attached. The nut from this bolt has not been located. According to UTAS, the nut used in this location was a self-locking nut (see figures 10-12).

Figure 10
Sheared off anti-rotation bolt in lower bolt hole

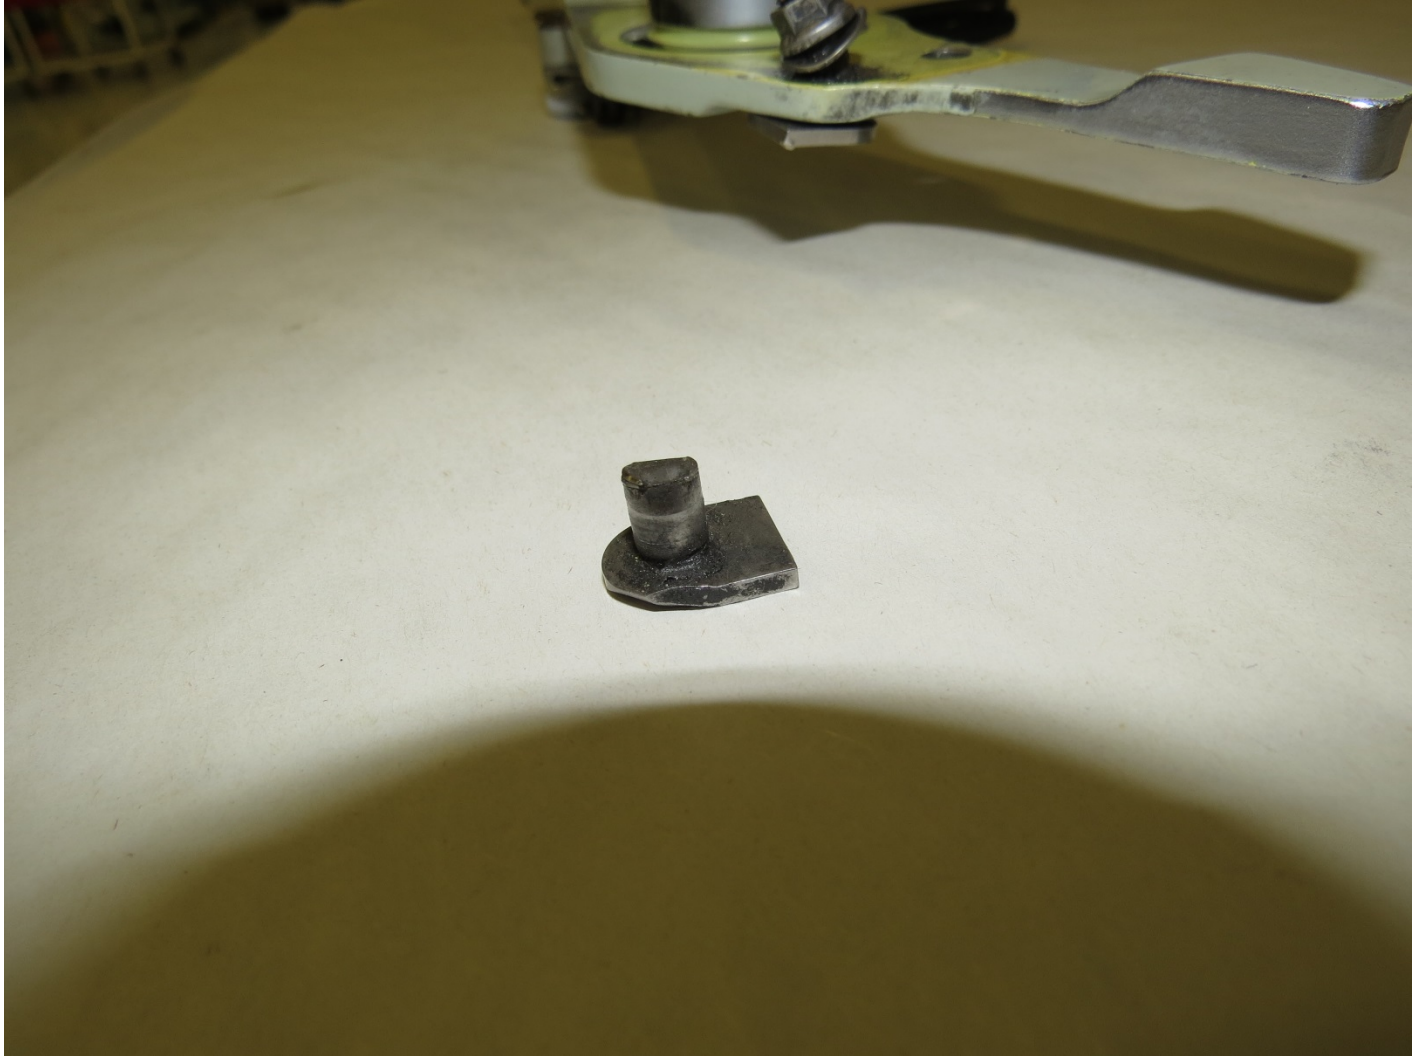
Figure 11
D-shaped portion of sheared off bolt from lower bolt hole

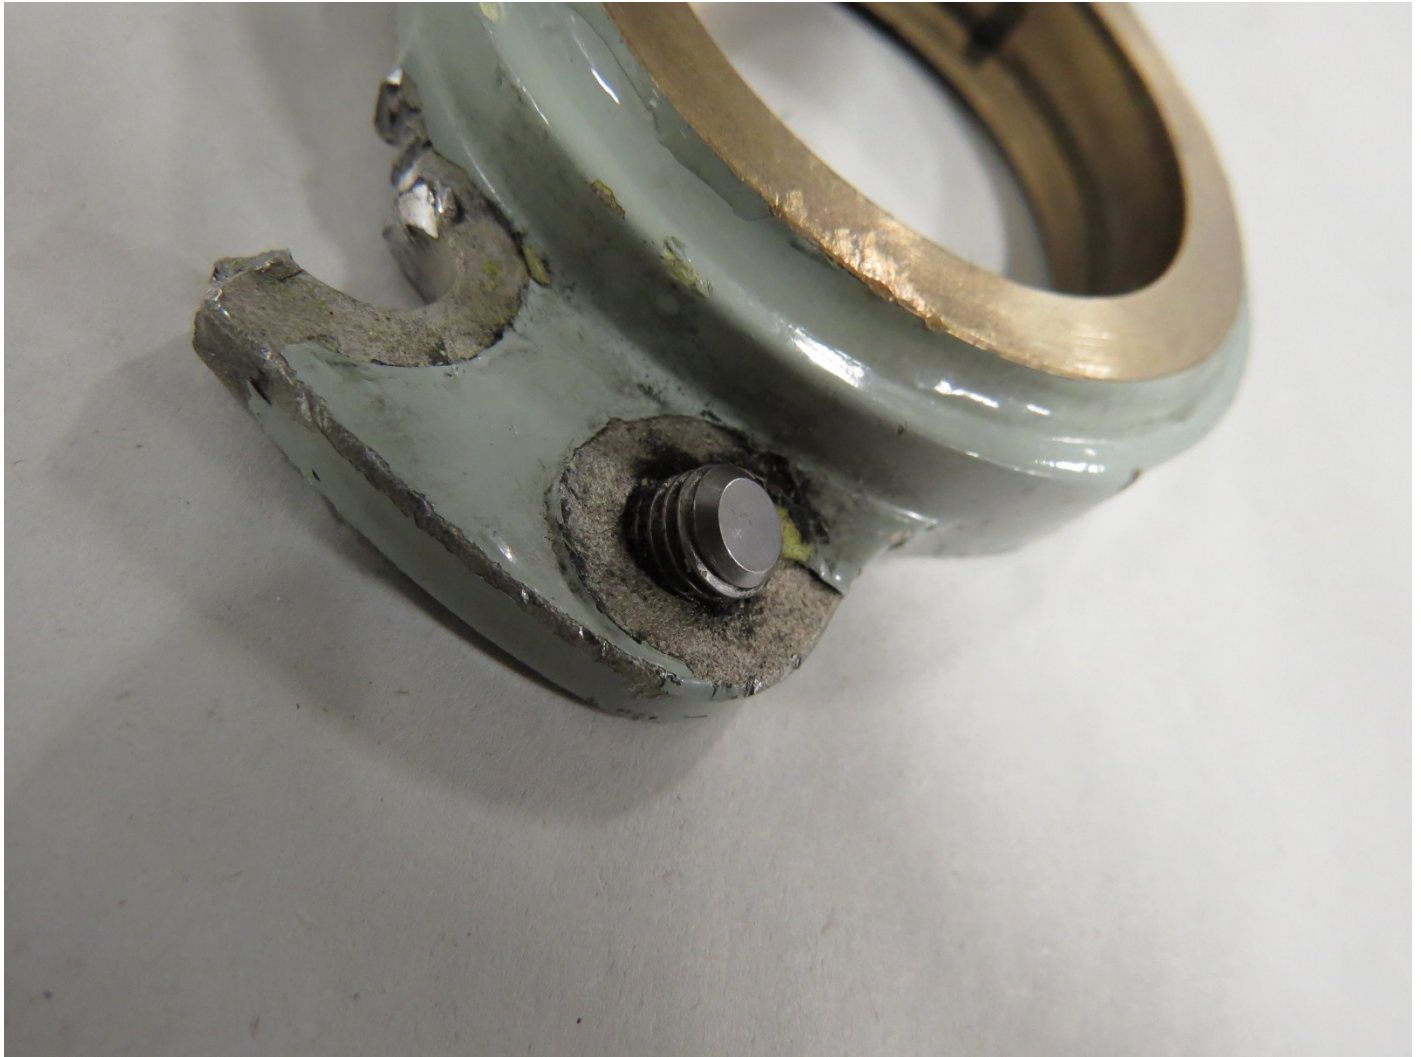
Figure 12
Nut end of anti-rotation bolt in lower bolt hole

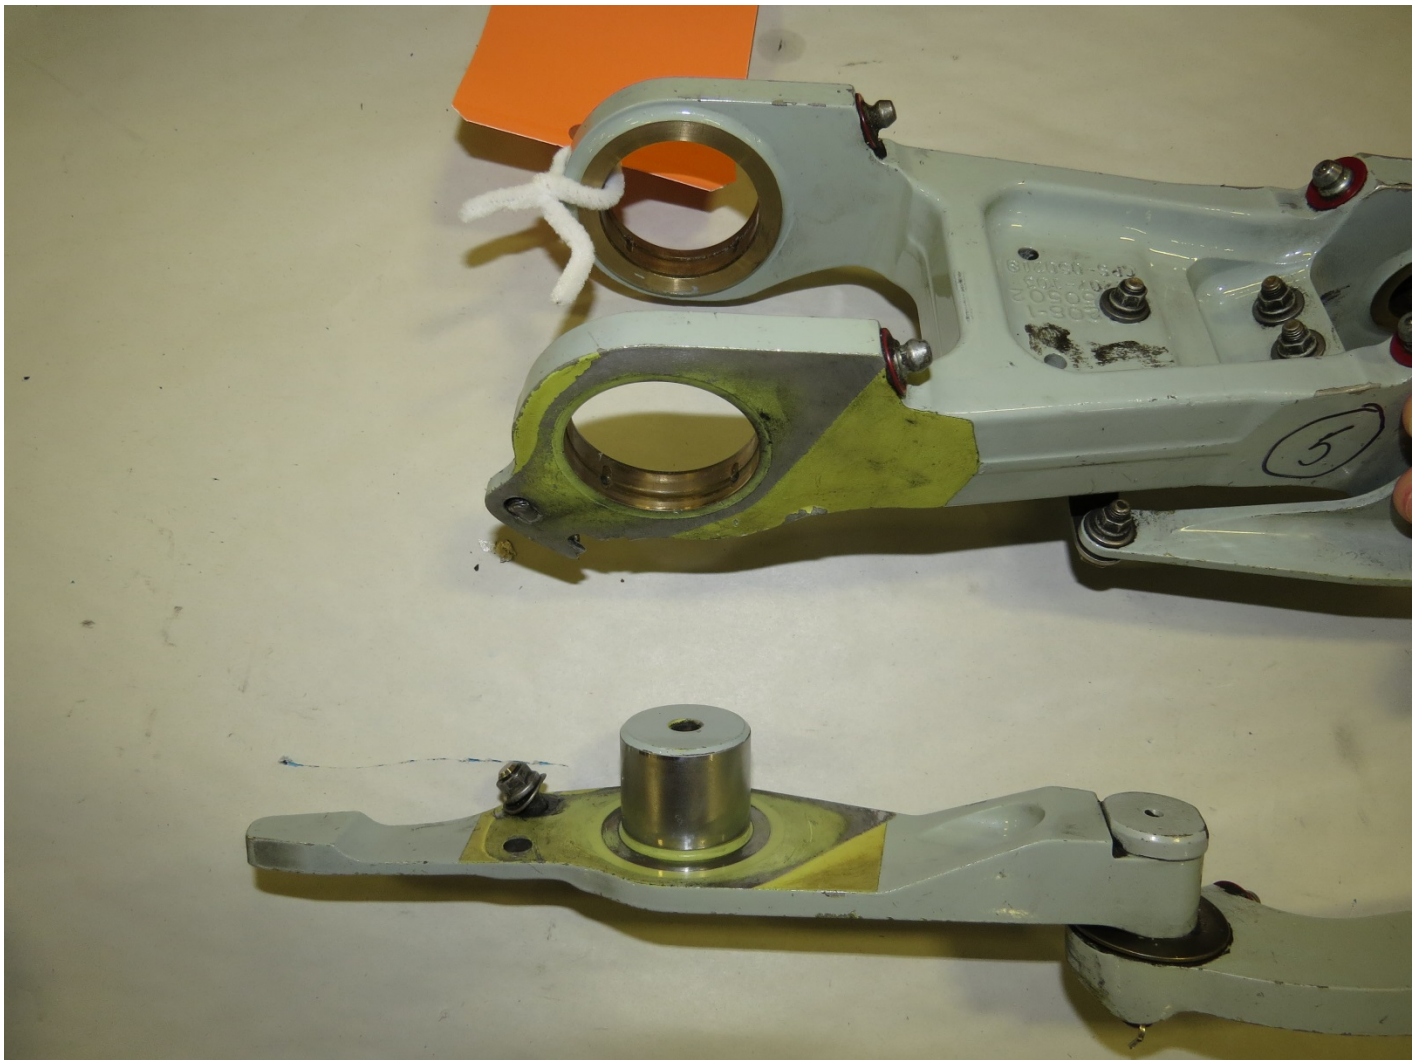
Variations in primer paint density were noted throughout the portion of the lower lock link assembly that was not painted with top coat paint. These variations ranged from areas where the primer paint was completely absent to areas where the primer paint appeared to be scuffed. The areas of missing/scuffed primer paint matched those areas of

missing/scuffed primer paint on the mating drive arm assembly surface (see figure 13).

Lower lock link assembly and drive arm assembly with mating surfaces roughly aligned showing primer wear on both surfaces

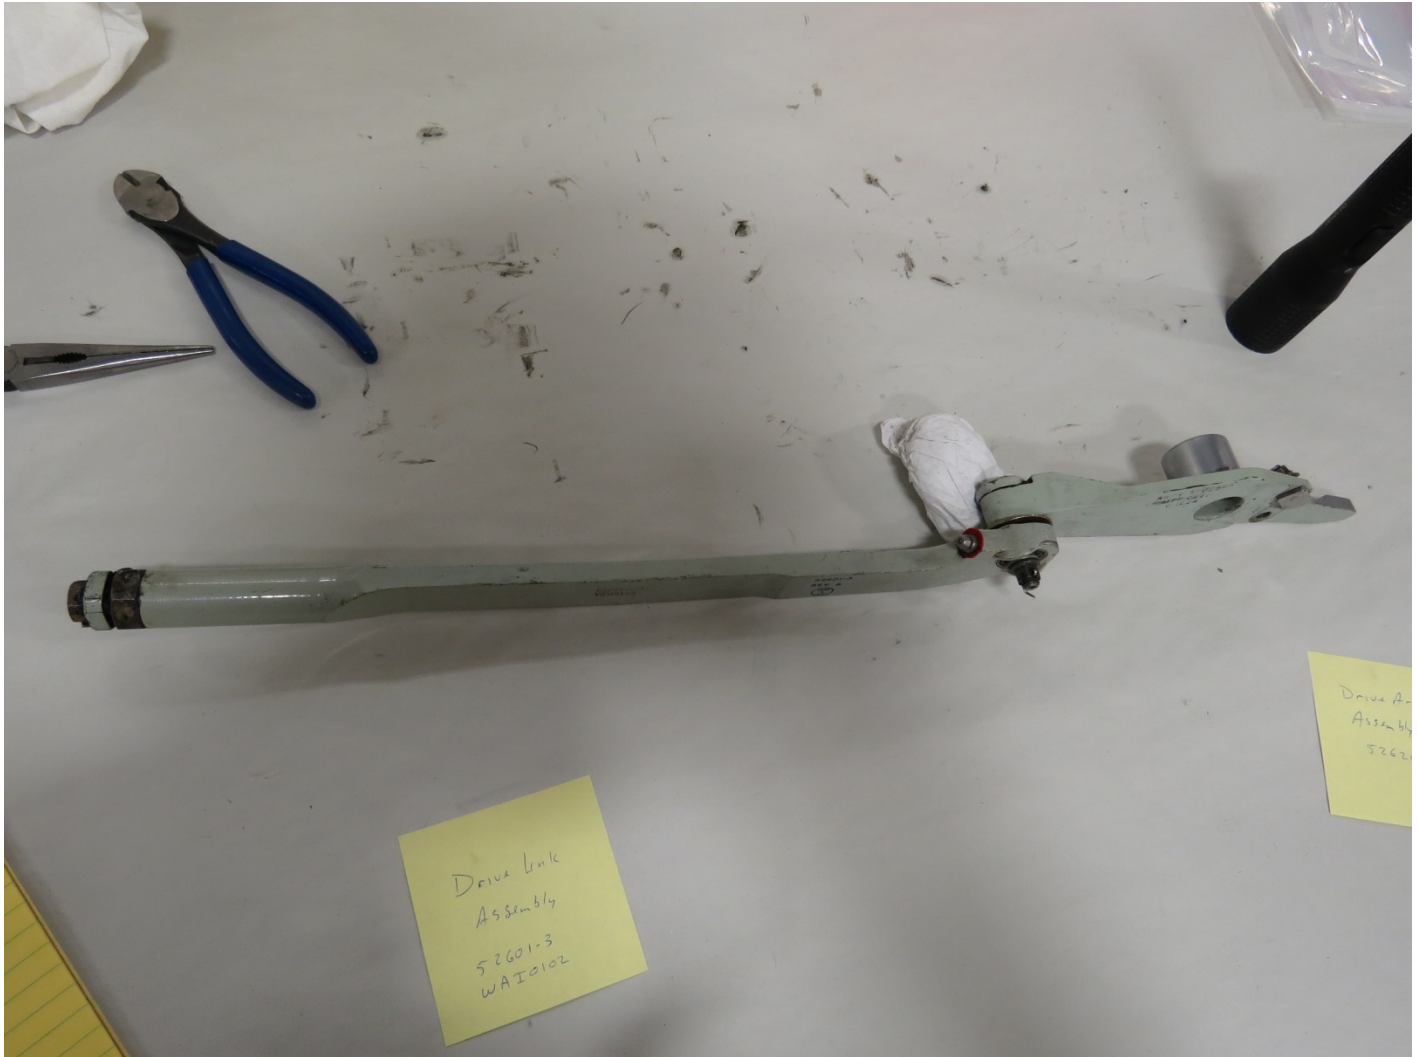
Figure 15
Drive Link Assembly

The drive link assembly was noted to be still attached to the drive arm assembly. The rod end was noted to be broken off of the drive link assembly. The rod end was identified for further investigation in the UTAS M&P laboratory.

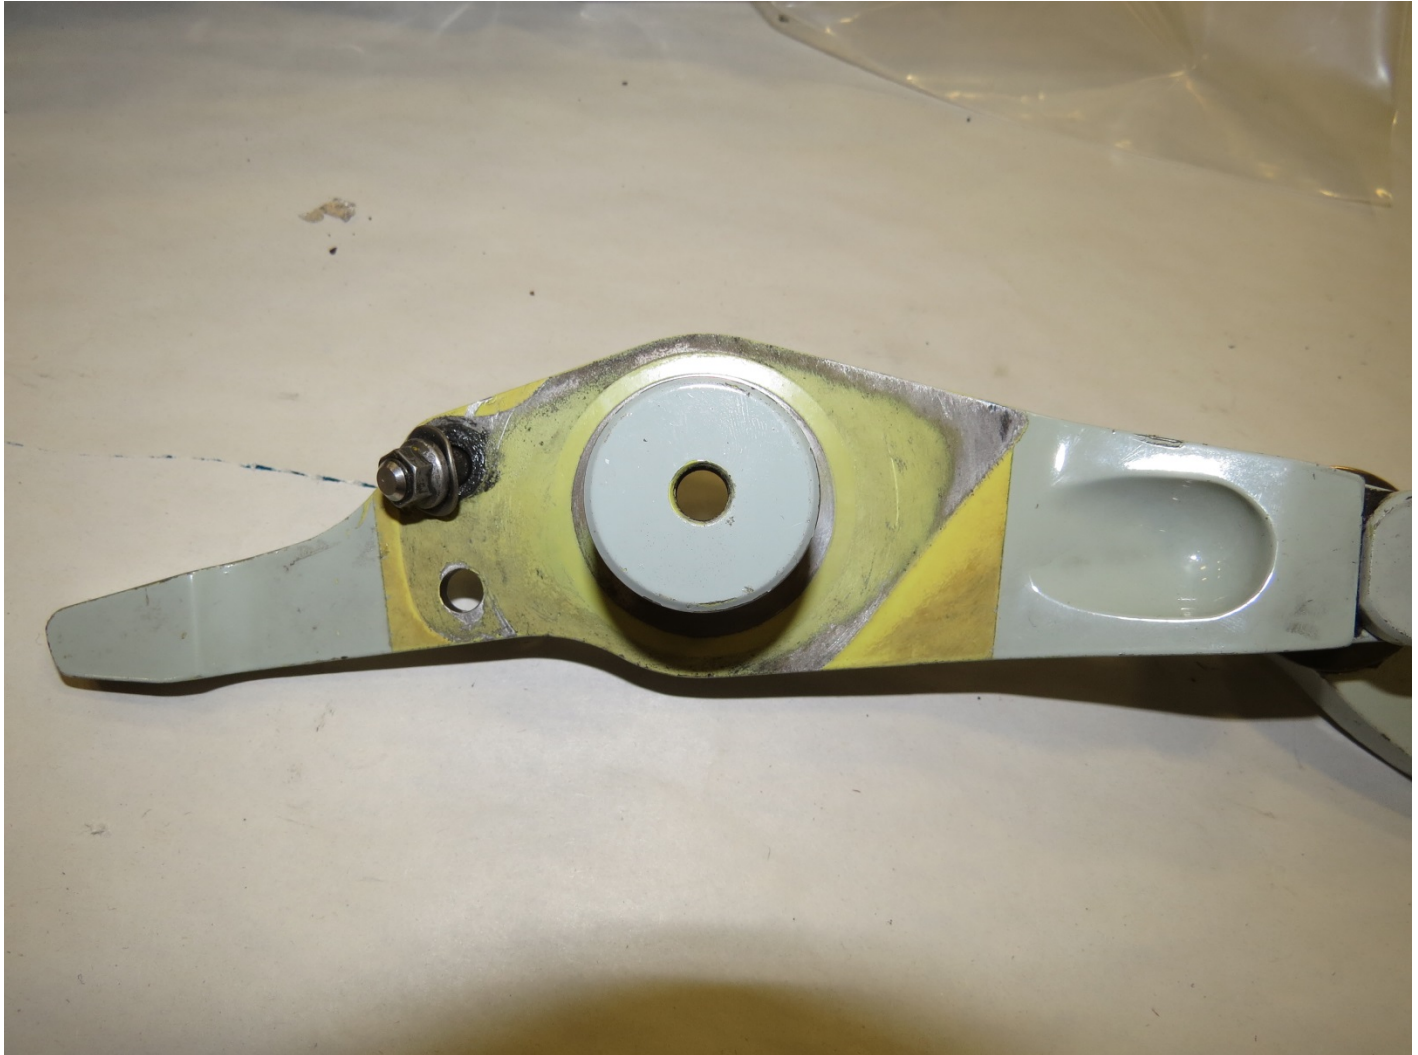
Figure 16
Drive Arm Assembly

One of the anti-rotation bolts used in the joint with the lower lock link assembly was noted to be in the upper bolt hole, but it was deformed. The other anti-rotation bolt from the lower bolt

hole was noted to be in two pieces – the head of the bolt was bagged separately, and the nut end of the bolt was located in the lower lock link assembly (sheared off with material smeared across the lug) with no nut attached.

Variations in primer paint density were noted throughout the portion of the drive arm assembly that was not painted with top coat paint. These variations ranged from areas where the primer paint was completely absent to areas where the primer paint appeared to be scuffed. The areas of missing/scuffed primer paint matched those areas of missing/scuffed primer paint on the mating lower lock link assembly surface.

The surface of the chrome plated outer diameter was noted to have burnished areas that had a different surface finish from the original surface finish. These areas were at the base of this area and approximately 180 deg apart.

The nose landing gear manufacturer (Goodrich) published service bulletin 52200-32-88 on September 11, 2015. This service bulletin directed operators to remove and replace the drive arm pin nuts and replace them with nuts with

a new part number and install them with Loctite at a higher torque value. The reason given for the service bulletin was that, “Operators have reported loose drive arm pins PN 52621-1. Loose drive arm pin nuts could lead to damage of the drag brace jury strut attachment flange.”

The aircraft manufacturer (Bombardier) published service bulletin 670BA-32-055 on October 2, 2015. This service bulletin provided operators with the instructions to do Goodrich service bulletin 52200-32-88. The reason given for the service bulletin was that, “It is possible for the drive arm of the NLG drag brace to be disconnected from the lower lock-link assembly, if one or both nuts for the attachment pins come off. This can cause the NLG to not extend.” Bombardier recommended that the operator accomplish the service bulletin within no more than 1,320 flight hours from the service bulletin release date, unless otherwise directed by the airworthiness authority of the operator.

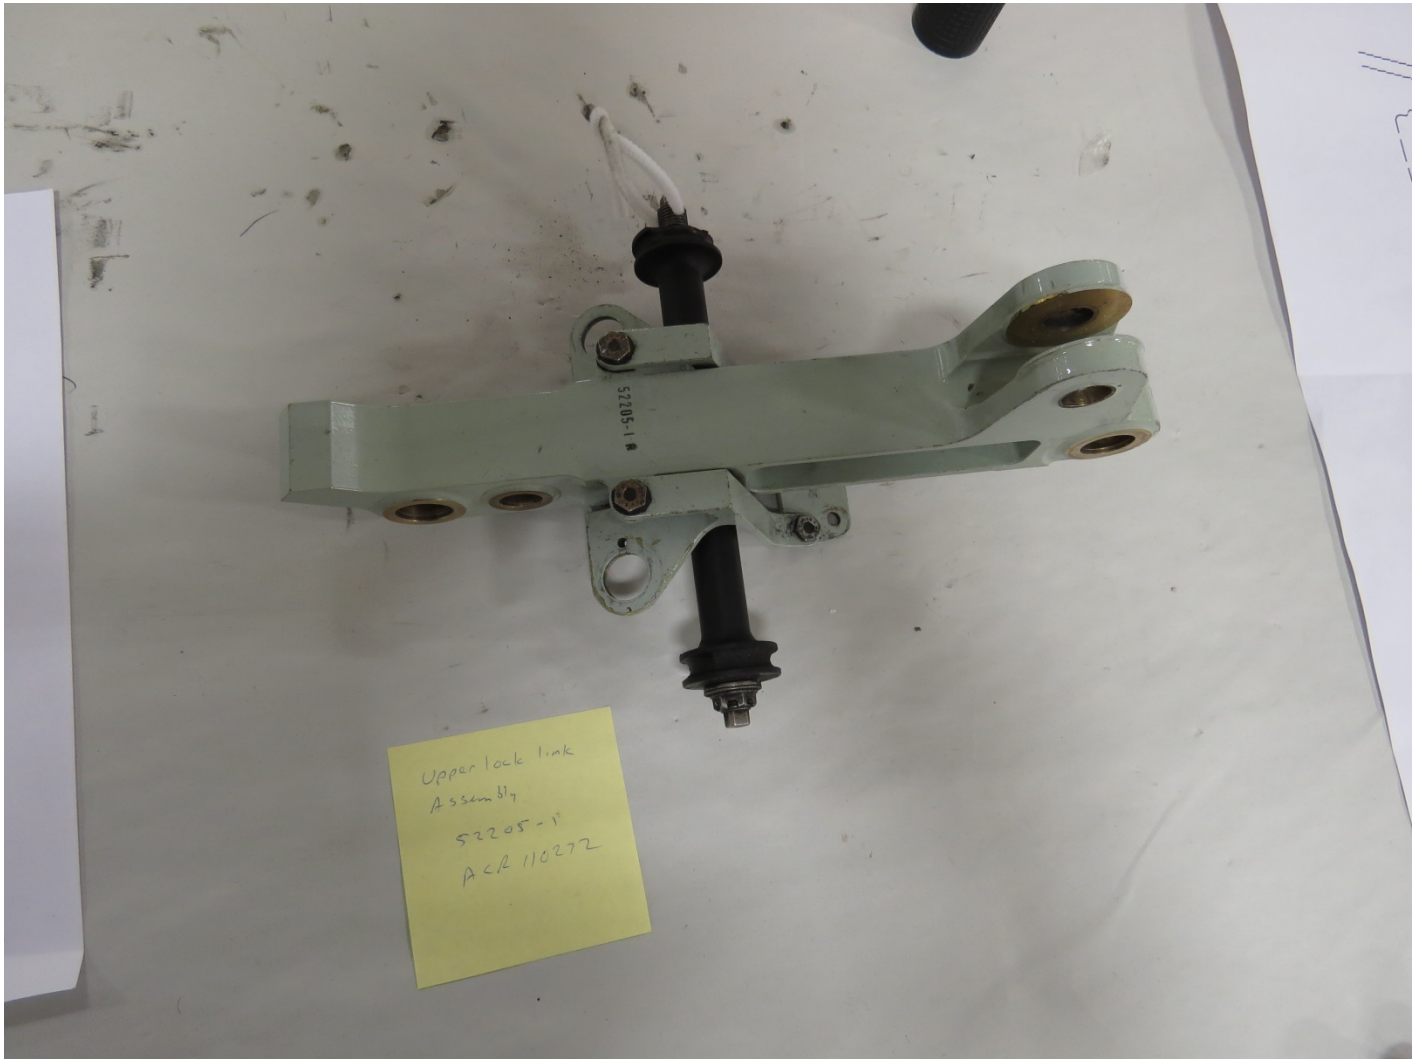
Figure 17
Upper Lock Link Assembly

A nut was noted to be missing from the right hand tension spring attachment spool. The right hand tension spring attachment spool had a broken guide surface. There were several areas of scuffed paint (down to bare metal) noted on the right hand side of the assembly in the area of the ground lock pin hole.

The broken guide surface was identified for further investigation at the UTAS M&P laboratory.

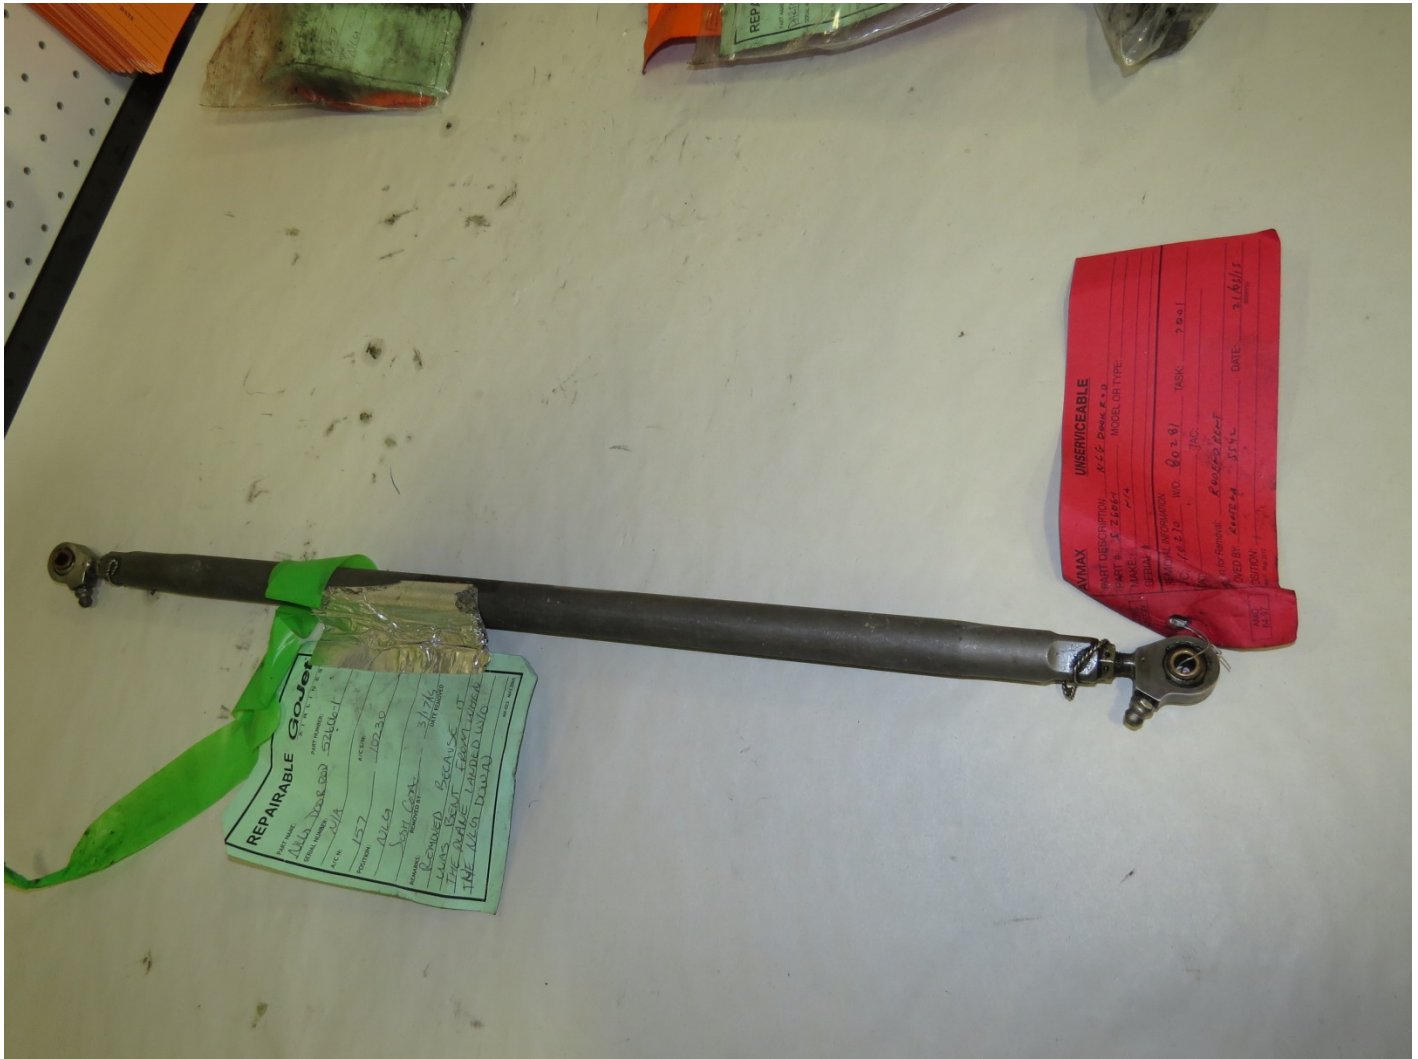
Figure 21
Door Rod (with red tag)

The rod was received with a red tag attached to one rod end. This rod end was able to rotate freely using hand pressure. The lock nut safety wire was noted to be intact. The opposite rod end was noted to be bent.

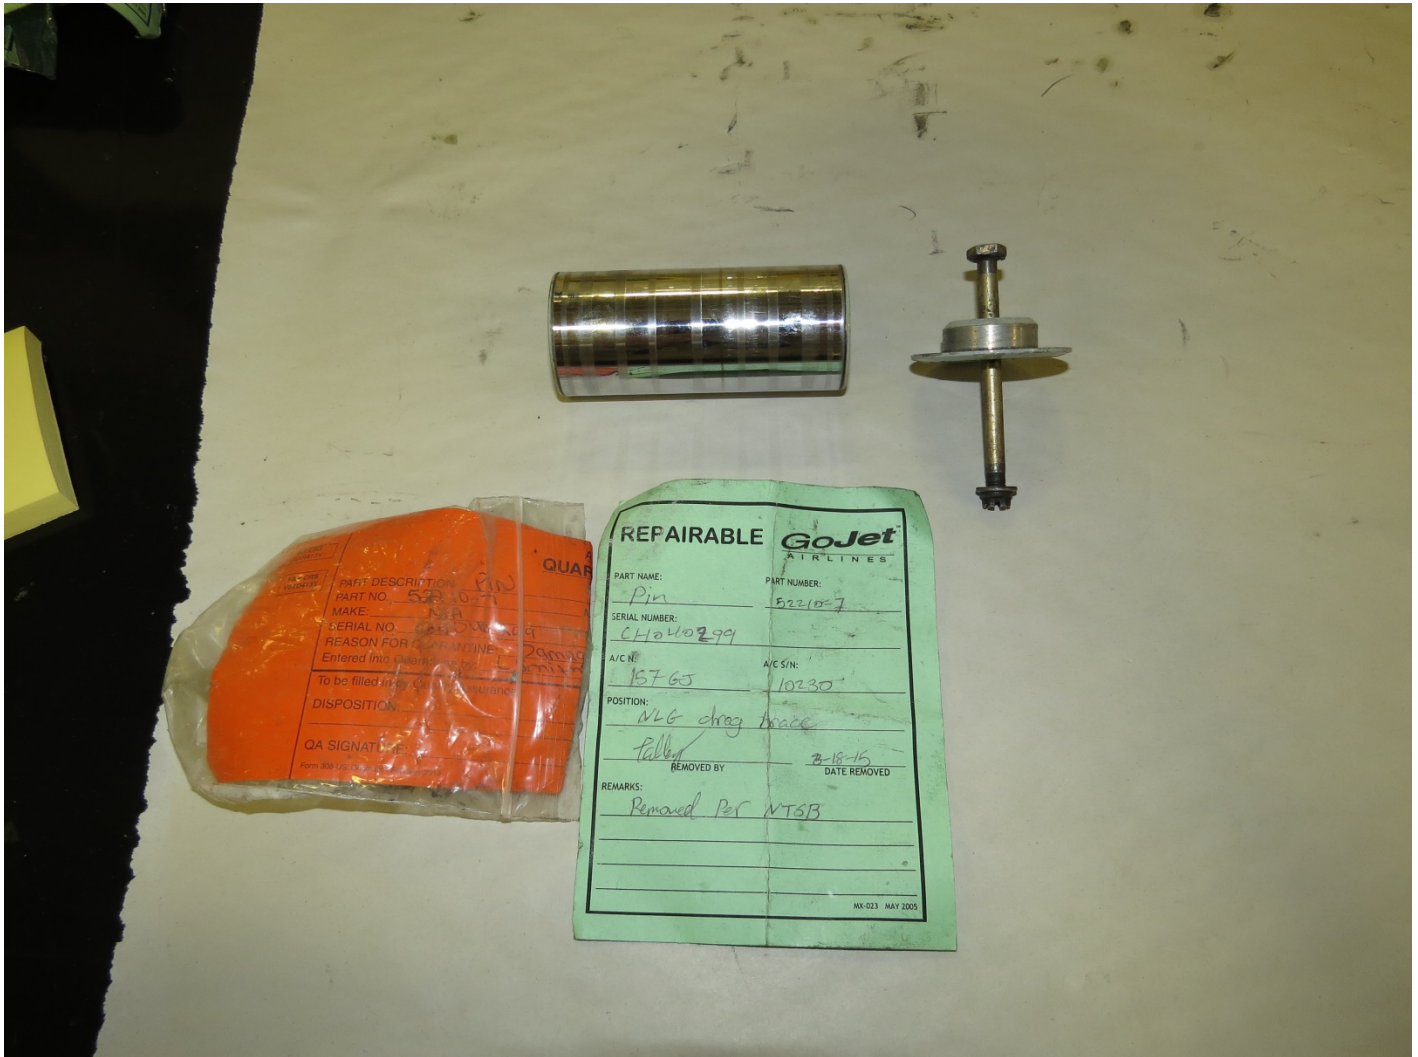
Figure 22
Pin

Wear was noted on the pin surface adjacent to the drive arm. There was also wear noted on the inner pin surface that would be in contact with the drive arm chromed surface outer diameter.

The documentation of the extent of the inner surface wear was identified for further investigation by the UTAS M&P laboratory.

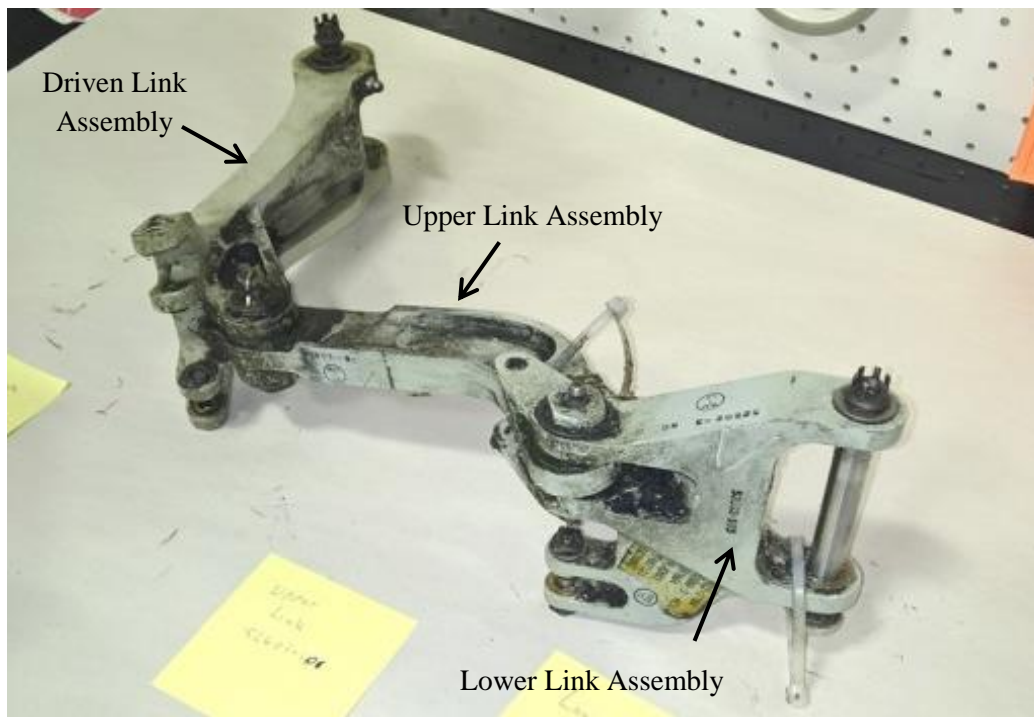
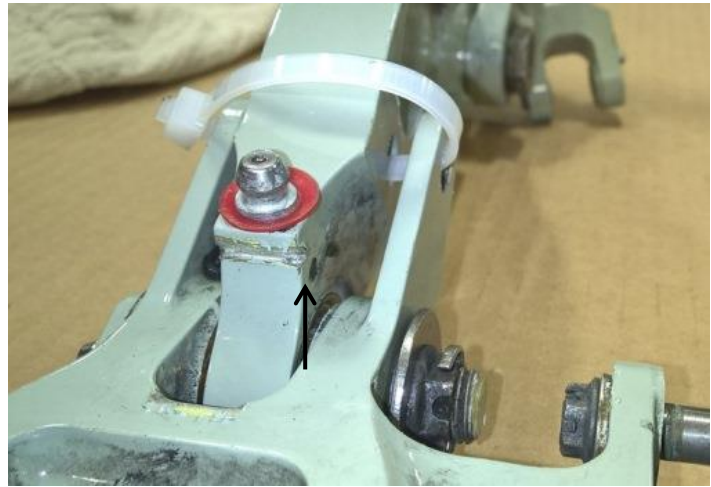
After cleaning the surfaces using a vapor degreaser, the Upper Link Assembly was re-examined. Inspection revealed impact damage across a flat surface adjacent to the grease nipple on the upper link assembly, as highlighted on figures 5 and 6. Although the damage resulted in the primer and paint to be scraped away to the base metal, no discoloration or corrosion was found on the exposed surface indicating that the damage occurred recently. Inspection of the adjacent corner on the lower link assembly revealed matching contact damage.

Figure 5
Impact Damage at End
Of Upper Link

Figure 6
Higher Magnification of
Impact Damage

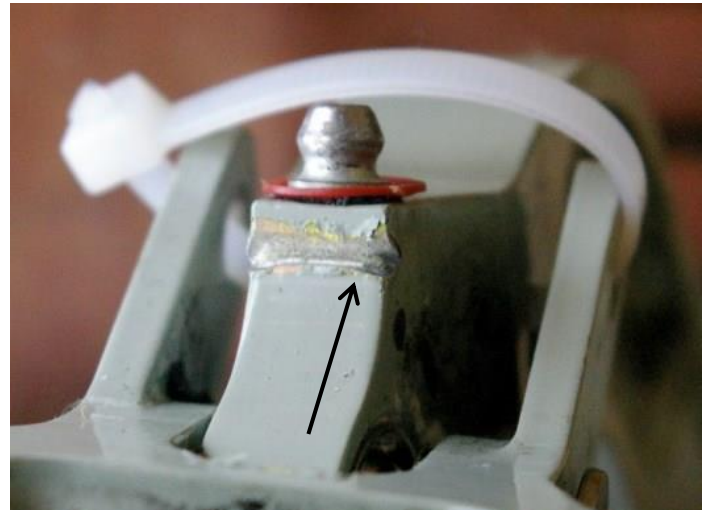
To characterize the depth of the damage, a replica of the impression at the contact damage on the upper link was obtained using RepliSet F5™ and is displayed in figure 7. This method of obtaining a replica is considered to render high level of accuracy (better than 1 μm accuracy). The obtained replica was analyzed using a digital microscope using a line-profile, see figure 7. The depth of the impression at the center was determined to be approximately 0.021 inches (547 microns).

Figure 7
Impression of Impact Area
on the Link, Line Scan with
Depths is shown at Bottom.
