NATIONAL TRANSPORTATION SAFETY BOARD

Systems Group Chairman's Factual Report

DCA-15-IA-089

Operator: Gojet Airlines
Location: Chicago O'Hare International Airport (ORD), Chicago, Illinois
Date: March 14, 2015
Time: 1521 central daylight time
Airplane: CRJ 700, registration N157GJ

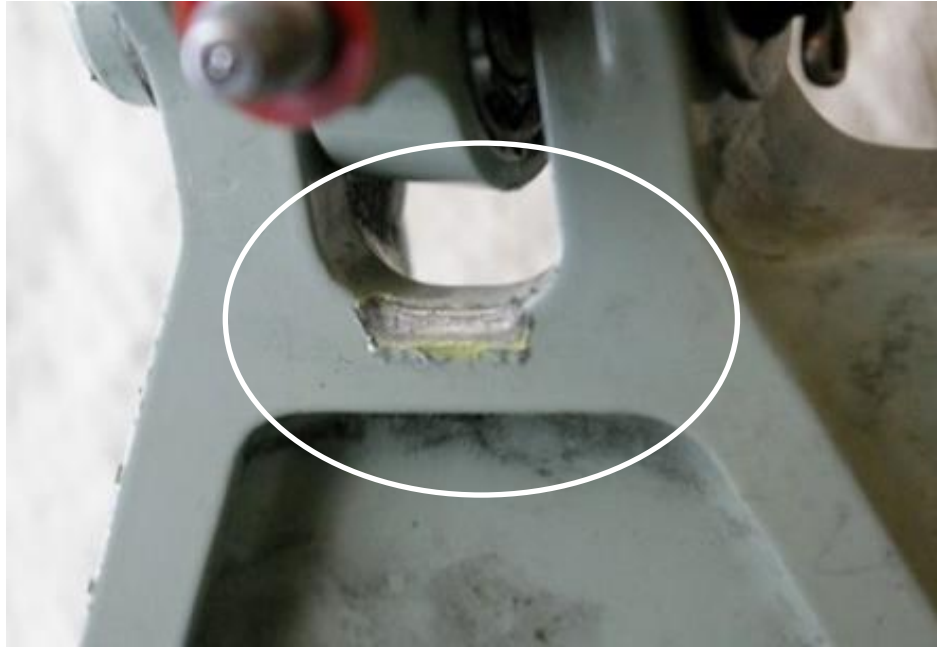
After cleaning the part, the surfaces were visually re-examined. Inspection of the corner at the base of the upper link assembly attachment lugs revealed contact damage from impacting the flat surface adjacent to the grease nipple on the upper link assembly (figure 9). The damaged area displayed parallel scrapes that removed the paint and primer, exposing the surface of the base metal. The exposed 4340 steel did not reveal any discoloration or corrosion, indicating that the contact damage had occurred recently.

Figure 9
Impact Damage from Contact with the Upper Link Assembly

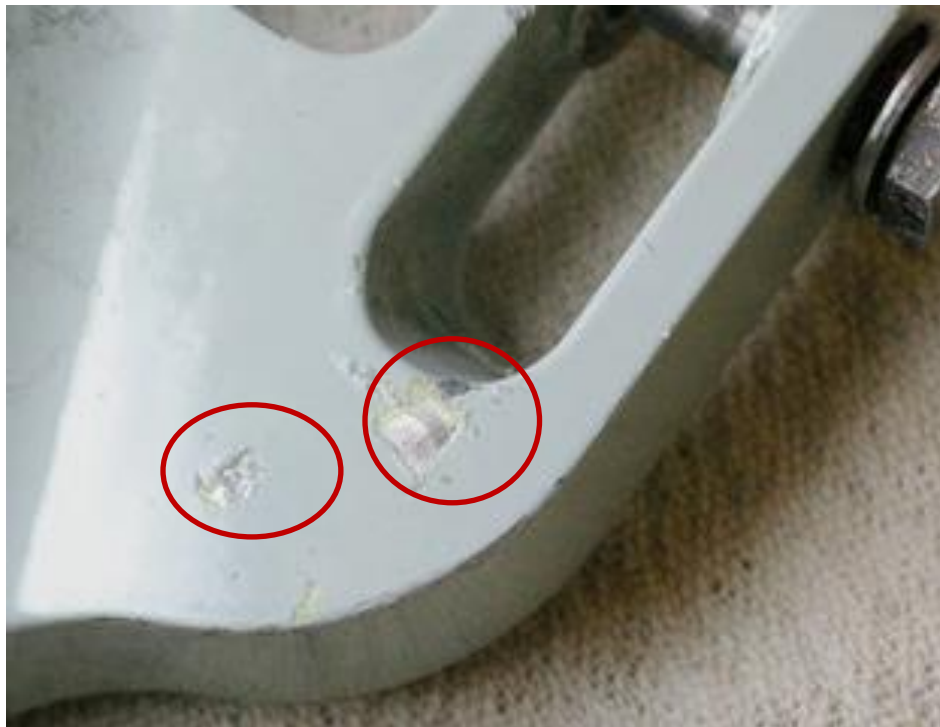
Two other contact damage areas, highlighted in figure 10, were found on the flat surface adjacent to the base of the lugs that connects to the drive link assembly. The damaged areas coincide with the location the end of the rod end nuts on the end of the drive link assembly indicating that the upper linkage had traversed over center during retraction. The contact damage found on the two regions suggests that the upper and lower link assemblies would have had to articulate beyond the expected retract design path.

Since the exposed base metal regions were free of discoloration and corrosion, it’s likely that this occurred within the same timeframe as the damage to the adjacent links.

Figure 10
Contact Damage from Contact with the end of the Drive Arm Assembly

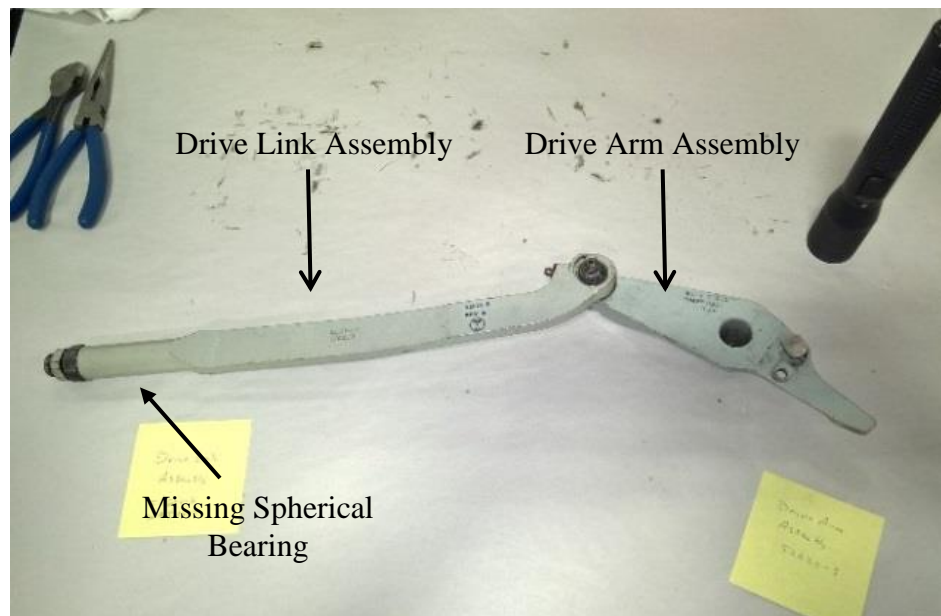
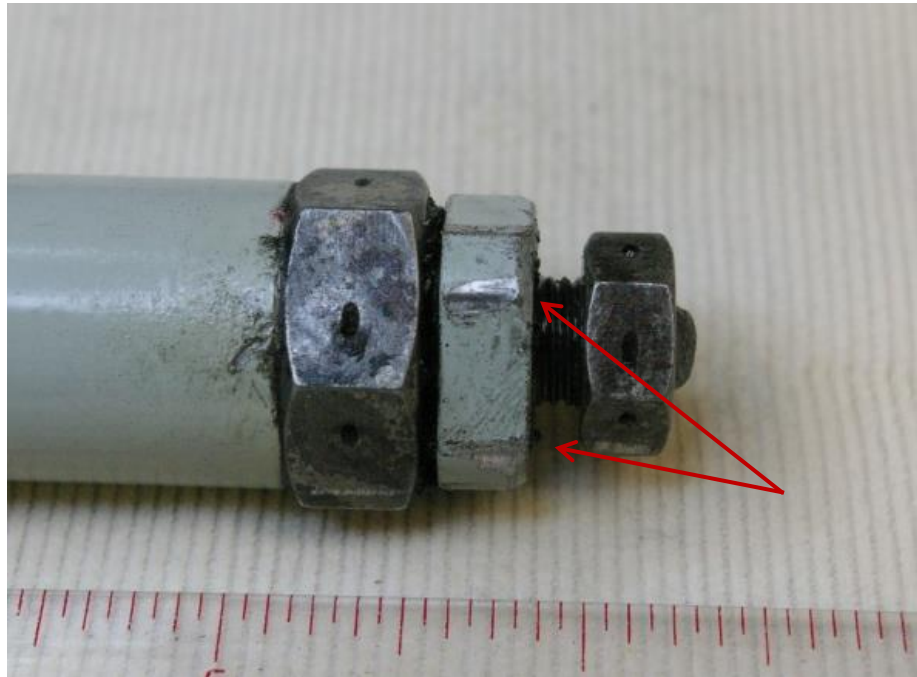
The Drive Link Assembly was received with the threaded spherical bearing rod end fractured away as showed in figure 11. Examination of the corners of the adjustment associated with the fractured spherical bearing end, displayed recent contact damage as presented in figure 12. The location of the damage coincides with the scraped paint and primer found on the lower link assembly (ref figure 10), when the attached linkage traversed over center.

Figure 11
 Drive Link Assembly Attached to the Drive Arm Assembly

Figure 12
Damage to the Corner of the Spherical Bearing
Adjustment Nuts

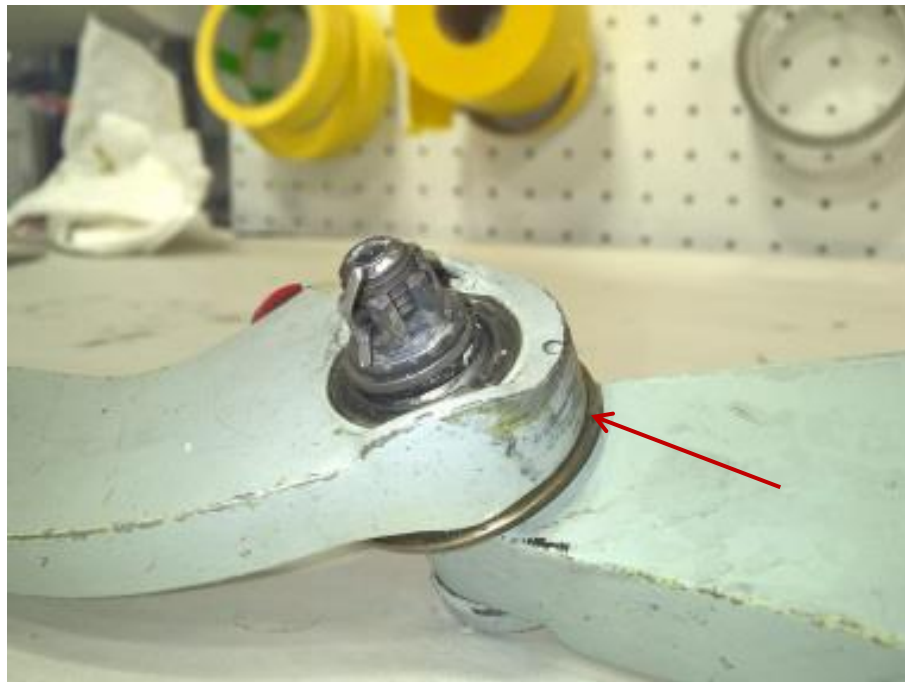
Figure 13
Circumferential Paint and Primer Scrapes on end of Drive Arm Link

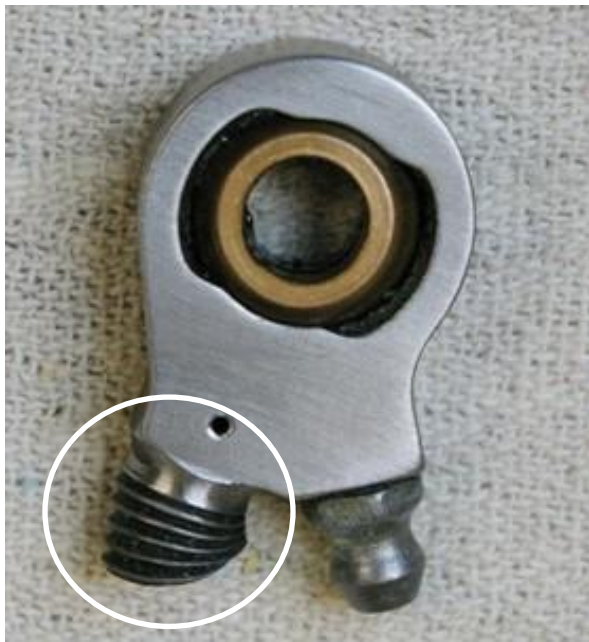
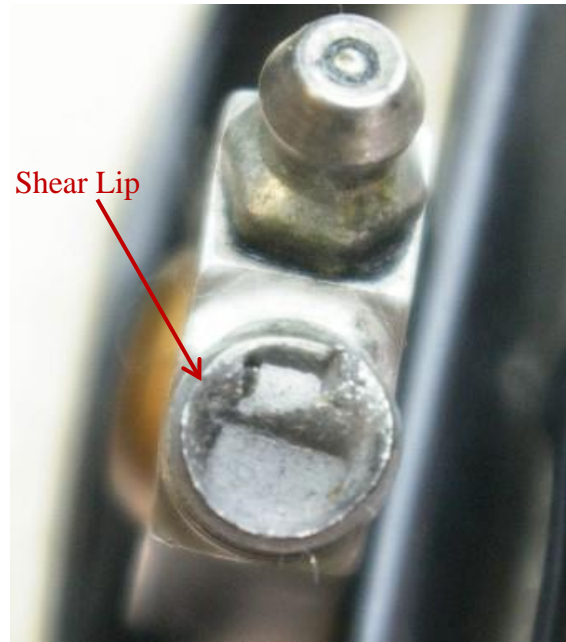
The spherical bearing attached to the Drive Link Assembly was discovered fractured across the bearings thread as shown on figure 14. As it can be seen in Figure 14, the thread pitch was compressed on one side and slightly elongated on the opposite side. The surface morphology of the fracture face displayed a cup cone feature across the majority of the outside edge as highlighted on figure 15. This fracture morphology is consistent with components subjected to tensile overload conditions.

Figure 14
Fractured Spherical Bearing

Figure 15
Spherical Bearing Fracture Face

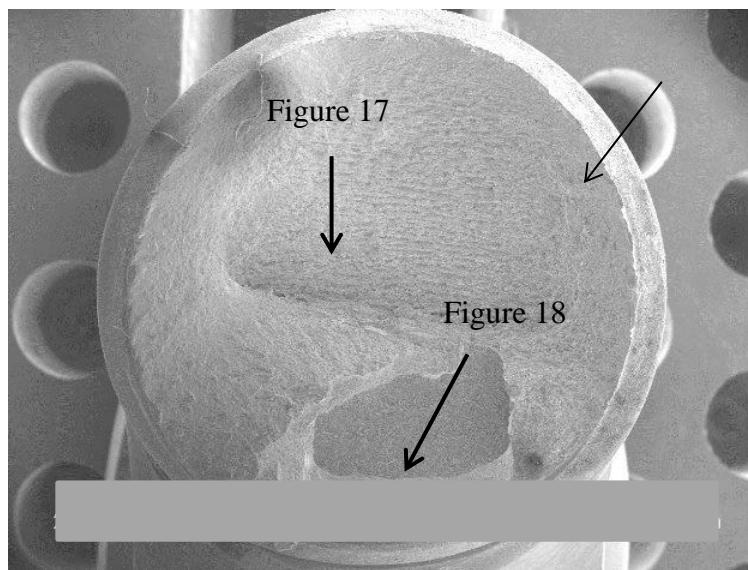
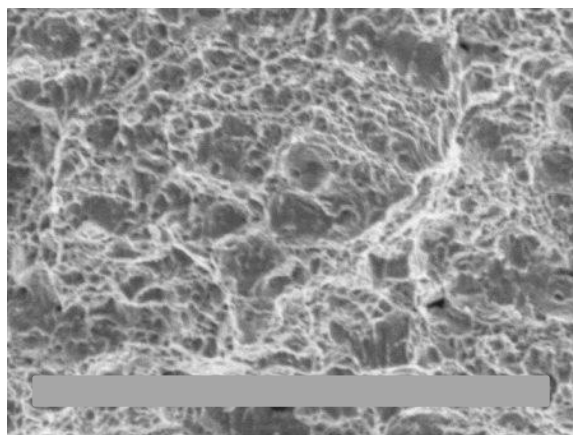
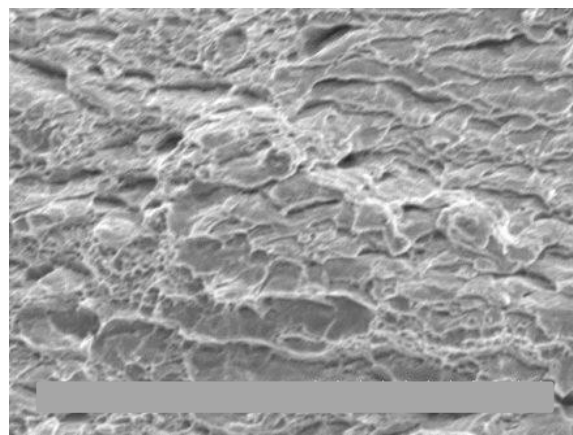
After ultrasonic cleaning of the bearing using isopropyl alcohol, the fracture face was inspected using the scanning electron microscope. The fracture face exhibited two flat surface features surrounded by shear lips as highlighted in figure 16. The flat surfaces represented in Figure 17 at 950X magnification photo displaying ductile dimple fracture morphology. These two flat features suggest that the fracture occurred in two cycles. One cycle created a large crack with its accompanying shear lip but arrested, the second crack was created after a second high load event which lead to the final fracture.

The surfaces of the shear lip displayed on figure 18 at 1000X magnification was also examined, exhibited elongated dimple ductile shear morphology. These images confirmed that the spherical bearing fractured by tensile overload in bending.

Figure 16
Spherical Bearing Fracture Face

Figure 17
Dimple Ductile Morphology

Figure 18
Elongated Dimple Ductile/Shear Surface

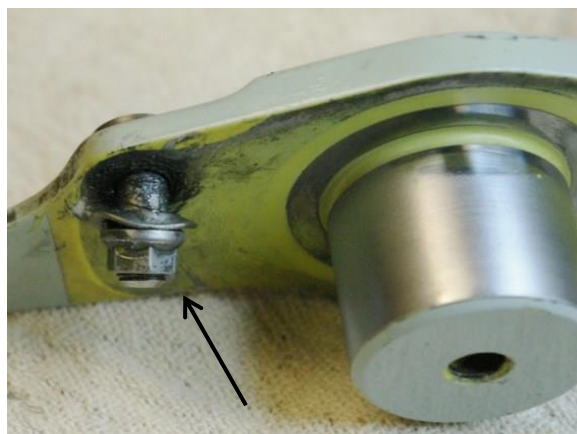
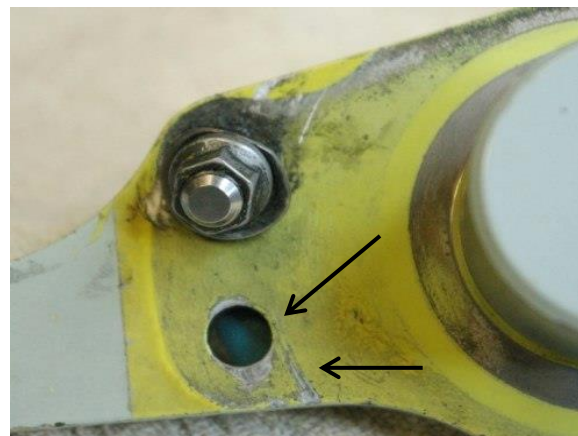
Figures 19 and 20 are photos of the as-received drive arm assembly. One of the two “D” headed pin used to secure the Drive Arm was found completely bent, as displayed in figure 21. The primed surface adjacent to the lower pin hole displayed scrapes to the base metal indicating relative motion between the two components prior to separation as highlighted on figure 22.

Figure 21
Distorted “D” headed Pin and Nut

Figure 22
Scratches Adjacent to Pin Hole

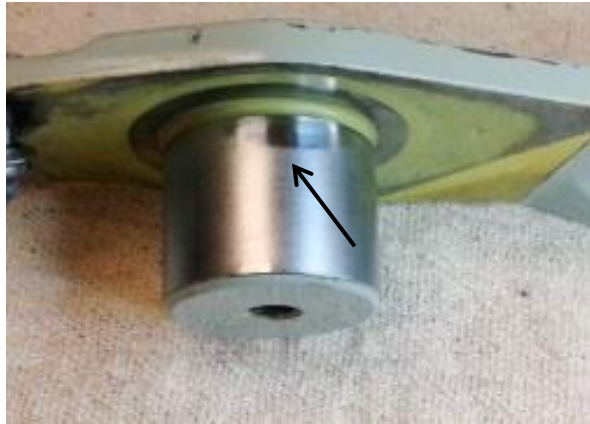
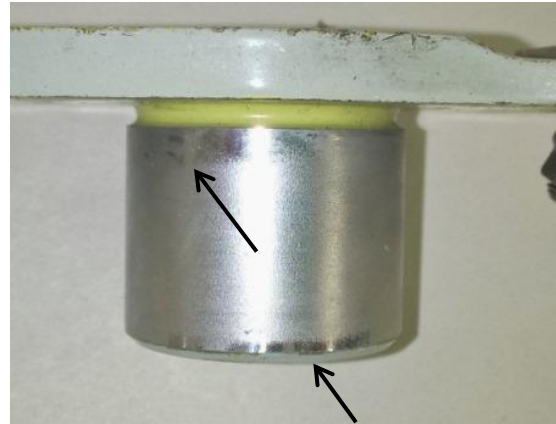
The “as chrome plated” OD feature of the drive arm were worn preferentially 180 degrees apart, adjacent to the chamfer as highlighted in figures 23 and 24, indicating non-uniform wear pattern and asymmetric loading of the joint.

Wear on Upper Face of OD Feature

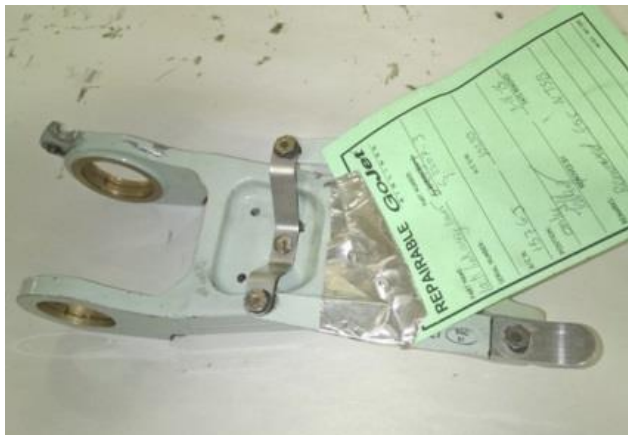
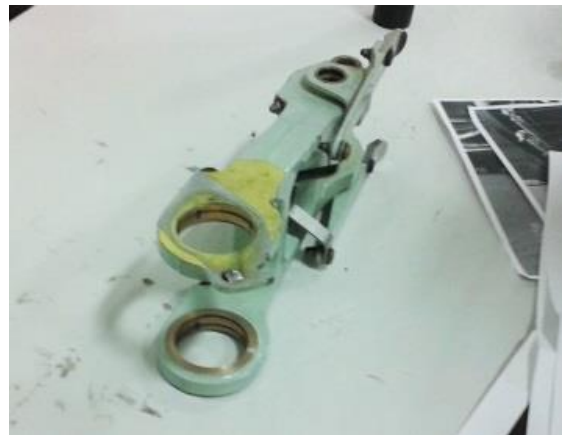
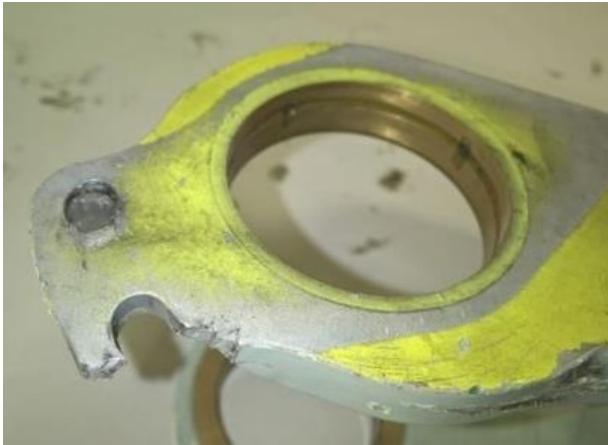
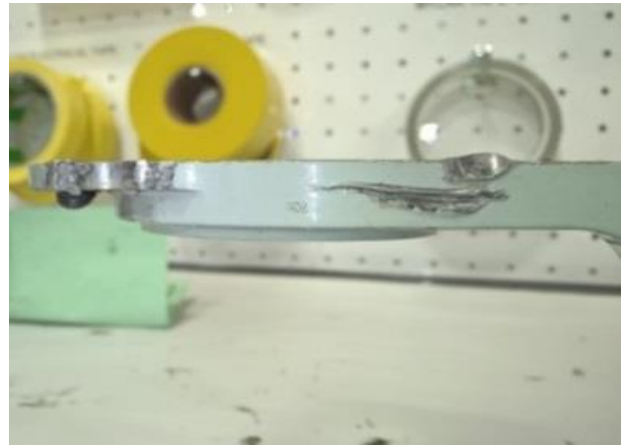
The Lower Lock Link was received as shown in figures 26 and 27. The outside surface of lug displayed 'V' shaped indentations, a circumferential gouge, and an impact impression as highlighted in figures 28 and 29. The lug hole and impressions of the surface damage are consistent with impact from the nut head and washer after shearing the lug hole. The "D" headed pin and nut that occupied the sheared lug hole was found deformed and still present on the mating drive arm assembly.

Figure 28
Fractured Lug Hole and Adjacent Damage

Figure 29
Gouging and Impact Damage

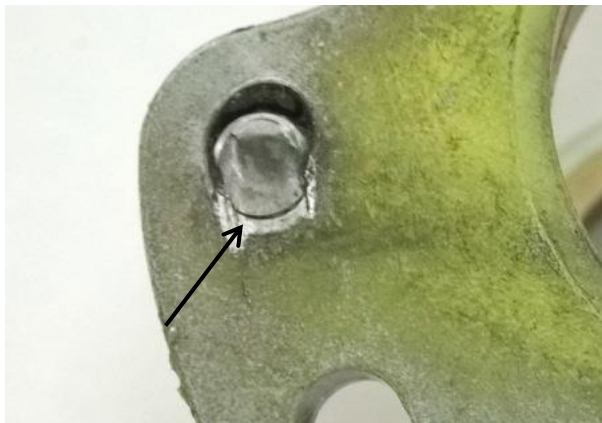
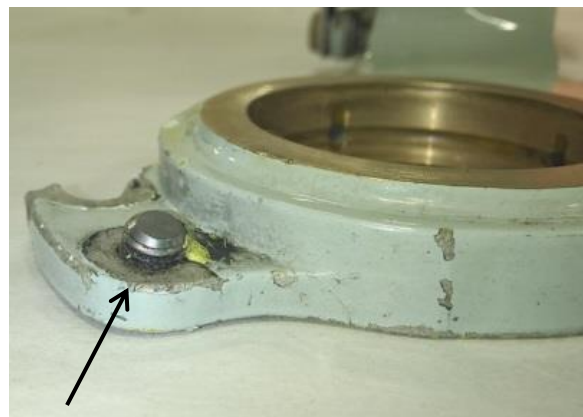
Inspection of the lower “D” headed pin highlighted in figures 30 and 31 revealed that the pin had sheared at the interface of the two assemblies. Viewed from the opposite side, (Figure 31), the sheared “D” headed pin was seen to protrude exposing 4 threads. Aside from the obvious bend, the surface of the exposed threads and lug hole surface did not reveal any mechanical damage. This could suggest that the nut may have failed or backed off and escape the pin during the cycling of the gear.

Figure 30
Pin Sheared at Drive Arm/
Lower Lock Link Interface

Figure 31
Exposed Threads from Sheared Pin

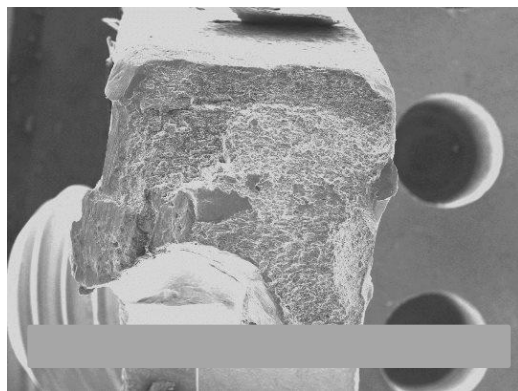
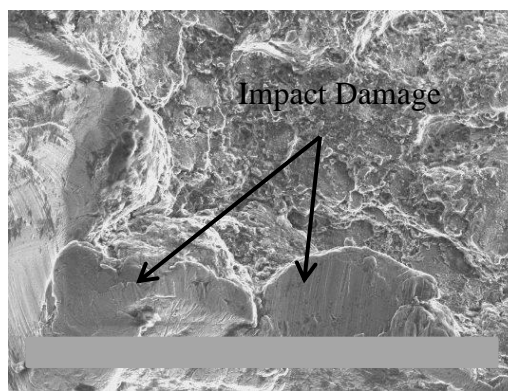
Inspection of the fracture face and adjacent edges of the lug revealed a dimple ductile rupture morphology, typical of tensile overload, as well as mechanical impact damage as displayed in figures 32 and 33. This damage is consistent with the bolt shearing across the lug.

Figure 32
Fracture Face

Figure 33
Fracture Face/Edge Interface

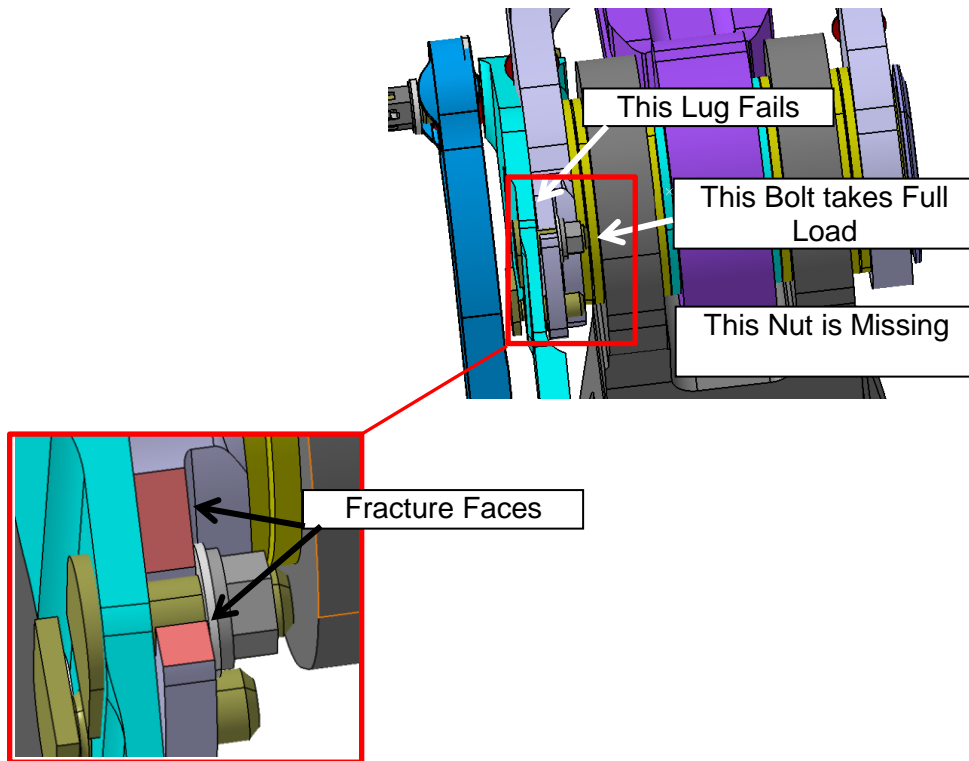
Figure 37

The opening and closing of the landing gear doors is choreographed through the Driven Link, Lower Link, and Upper Link Assemblies, articulated by the Drive Link Assembly attached to the Drive Arm Assembly. The absence of the nut and the gap between the adjacent components causes the loads to be transferred to the upper 'D' headed bolt, in turn causing the aluminum lug to fail in tensile overload, as highlighted on figure 37.

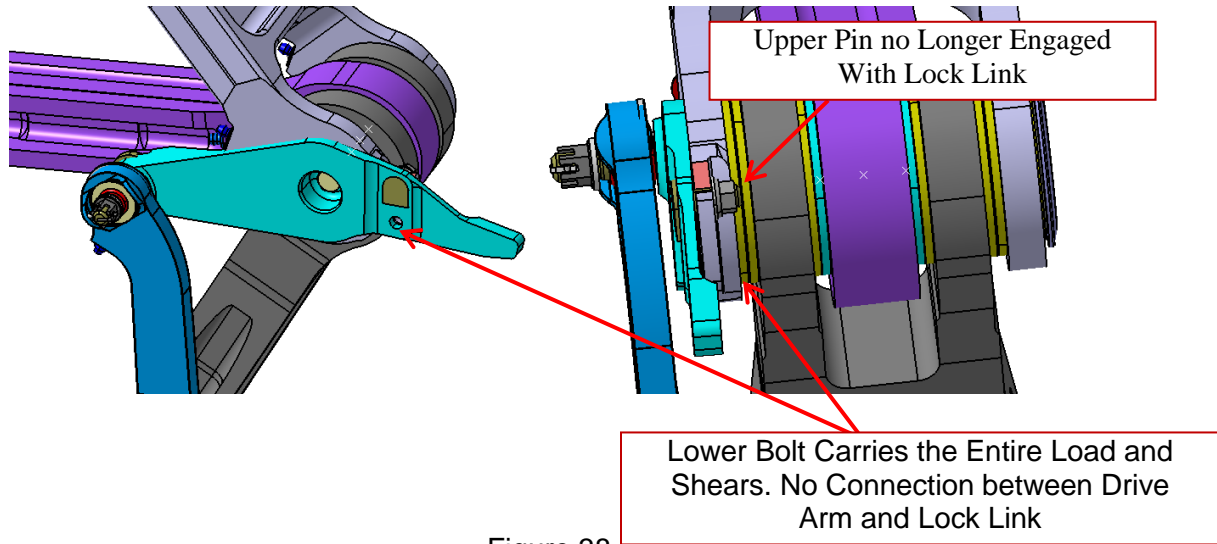
- With the upper D head pin no longer attached, the entire load is transferred through the lower D head pin. The subsequent loads applied during the articulation path circumscribed by the link assemblies resulted in fracture of the lower pin in shear, as displayed in figure 38. Since the drive arm is no longer tethered to the lock link, the drive arm is free to rotate about the apex joint.

Figure 38
Unrestricted Drive Arm

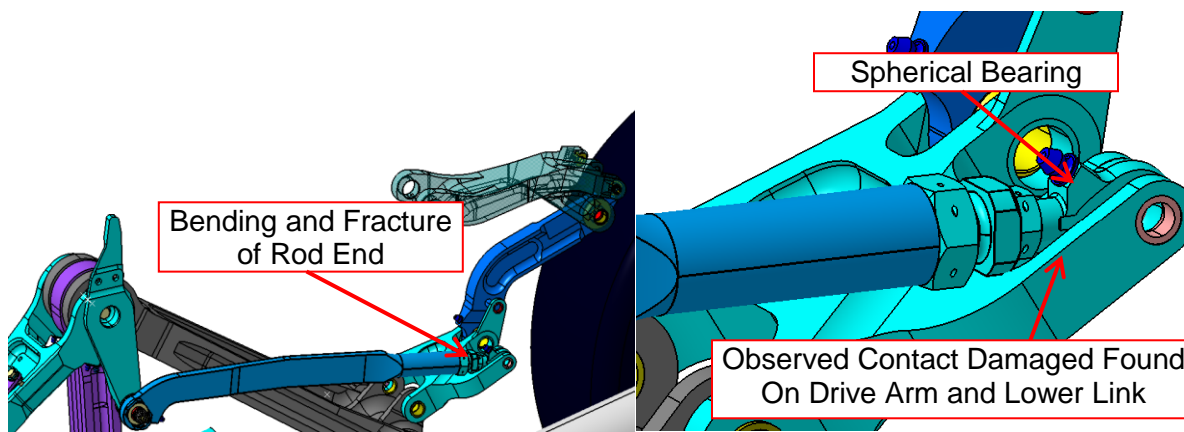
Figure 39

- With the drive arm free to rotate about the apex joint, the door links were able to go overcenter, further than designed, allowing the drive rod to contact the lower link, as shown in figure 39.
