National Transportation Safety Board

RRD23FR015

ROADWAY MAINTENANCE MACHINE SPEED ESTIMATION

February 7, 2024

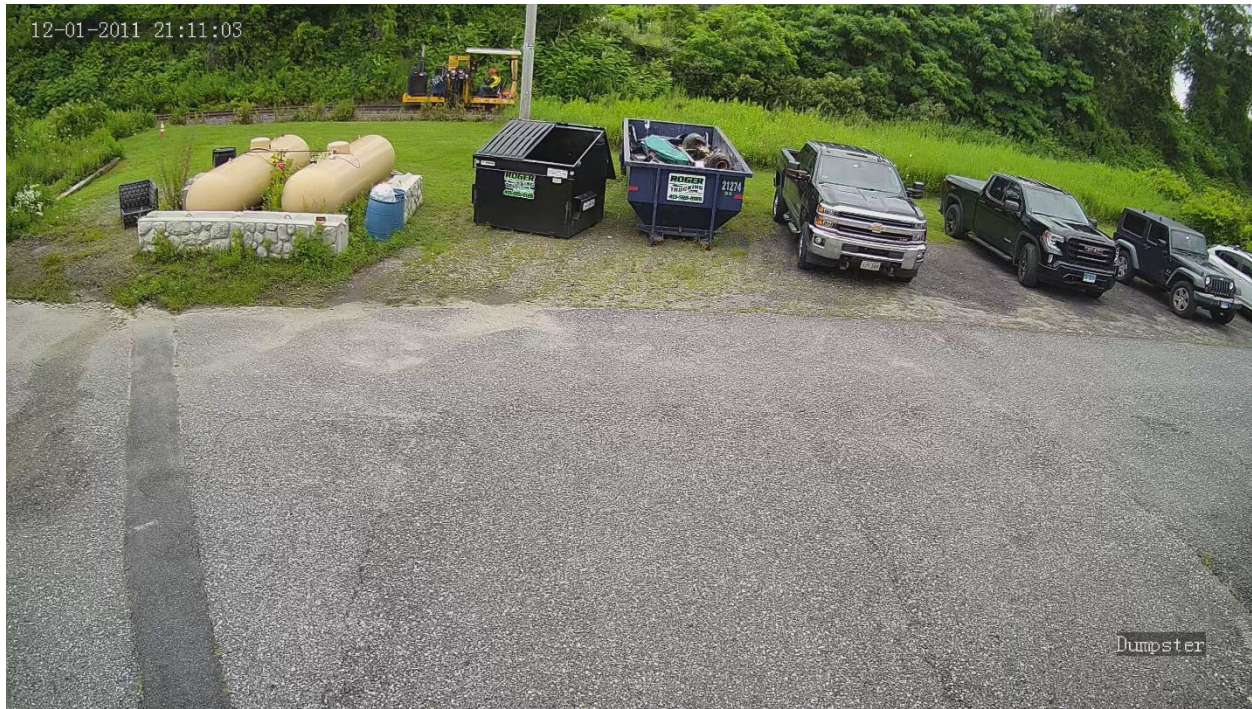
Figure 1. Video frame No. 10907

Speed was estimated based on the time it took the driller to travel the distance equal to its length. Figure 1 shows the driller as seen in video frame No. 10907. In this frame, the yellow part of the rear bumper is aligned with the left side of the gray pole. Figure 2 shows the driller as seen in video frame No. 10932. In this frame, the yellow part of the front bumper is aligned with the left side of the gray pole.

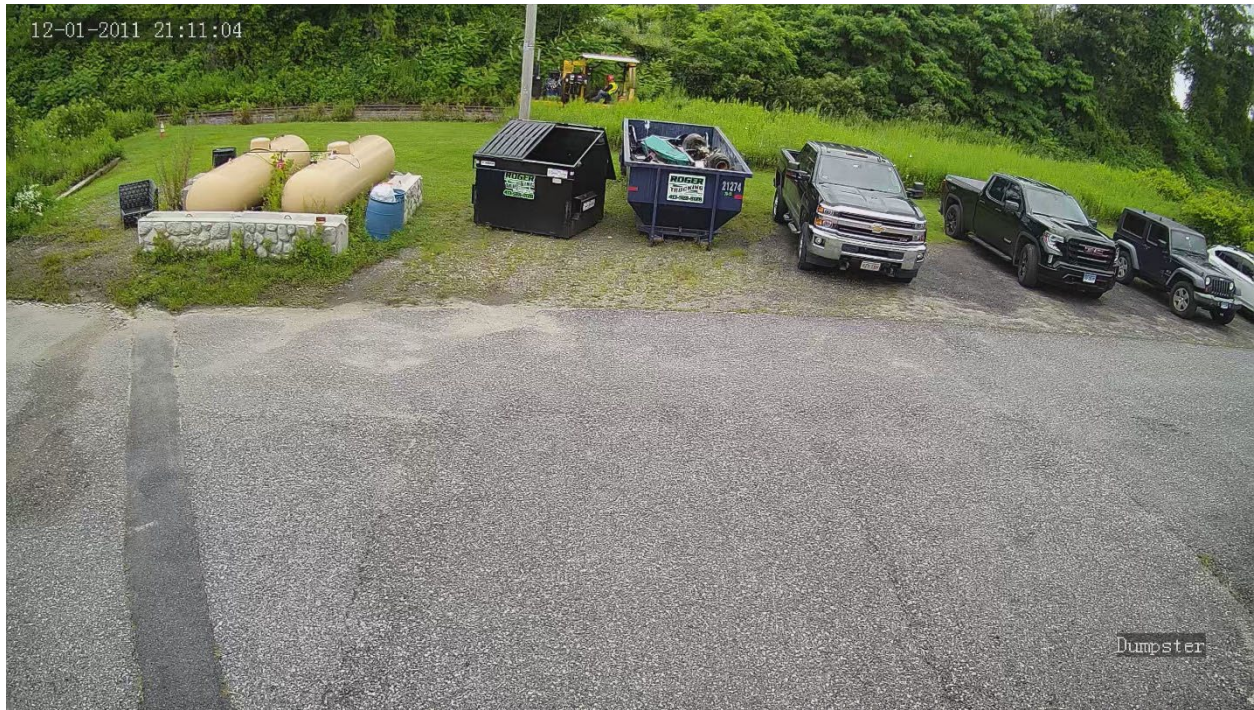
Figure 2. Video Frame No. 10932

The elapsed time between the two video frames is $(10932-10907)/30=0.833$ seconds where the number 30 is the frame rate of the video in frames per second. The length of the driller frame was measured as 183 inches. Each bumper is 8 inches long but its yellow segment that is visible in the video is only about 5 inches long. Adding

Consequently, the nominal estimated speed of the driller is $193/12/0.833=19.3$ feet/second = 13.2 mph. Assuming that there is a possible timing error of one frame spacing of $1/30=0.033$ seconds, the speed estimate becomes $193/12/0.80=20.1$ feet/second = 13.7 mph. The speed error due to timing relative to the nominal speed estimate is $13.7-13.2=0.5$ mph. The error due to timing could be either positive or negative, resulting in a driller speed estimate of 13.2 ± 0.5 mph.
