RRD21FR015
Massachusetts Bay Transportation Authority
Green Line Trolley Collision
July 30, 2021
Boston,
Massachusetts

National Transportation Safety Board

Operations Group Factual Report

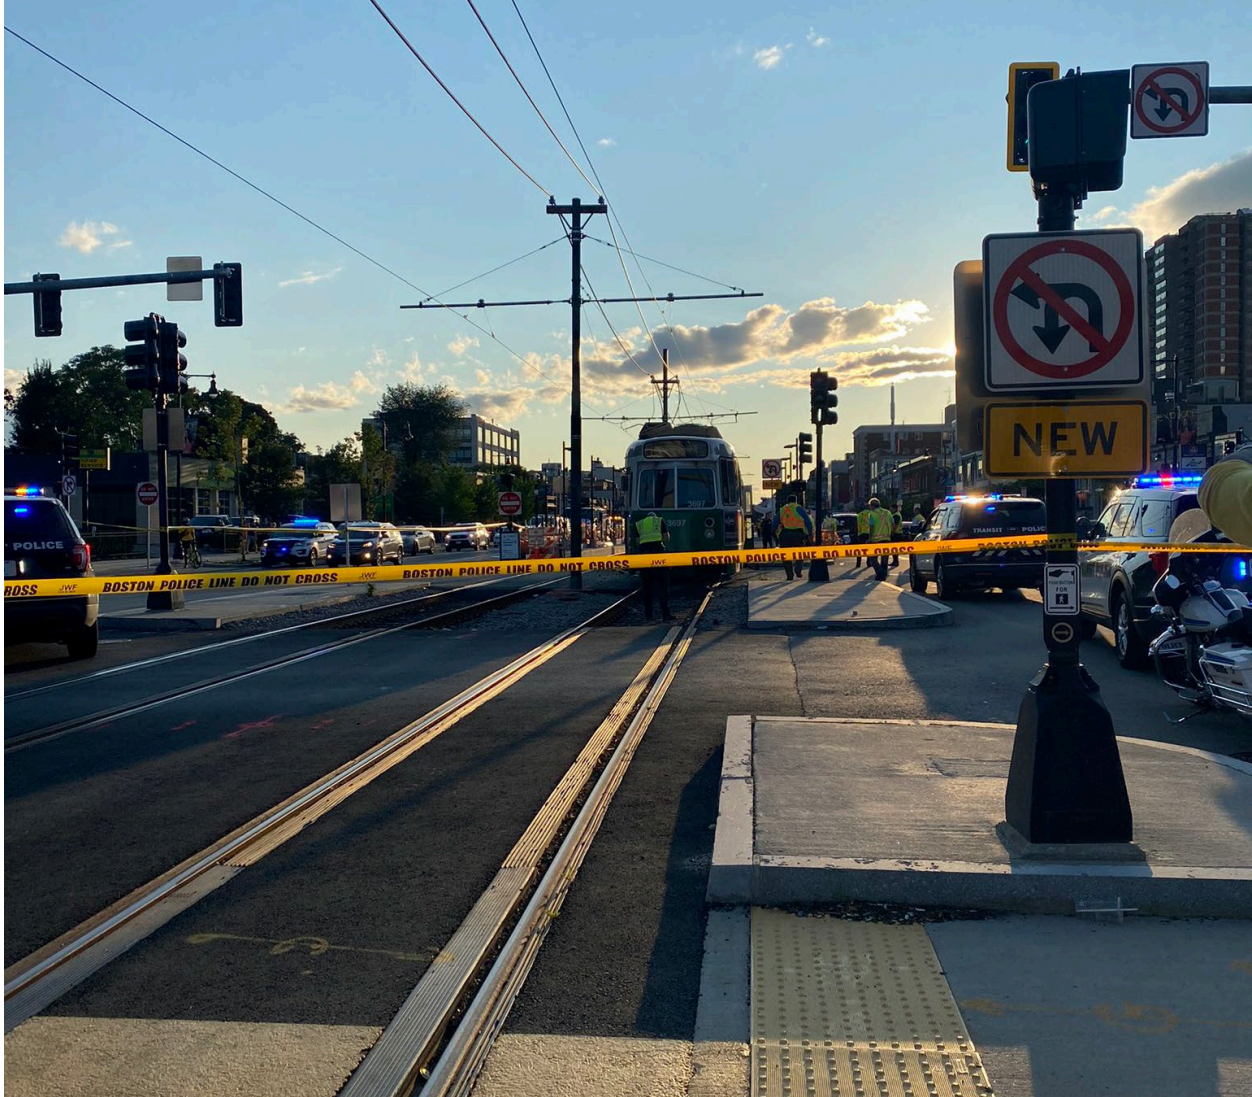
Preliminary evidence indicates that the operator of the striking train placed the master controller in a full power position after the last station stop, accelerating the equipment up a 3% grade at 31 mph for approximately ¼ mile before striking a moving trolley ahead on the same line. It appears that the operator did not attempt to stop the trolley before striking the train in front, the emergency brake was not activated until impact and the operator released the master controller. Estimated impact speed is 31 mph. The struck train was moving at approximately 10

mph at the time of the collision. The operator told responding investigators from MBTA transit police and System Safety that he did not recall what had happened and could not remember if there was another train in front of him. There was no indication from the operator that there was a mechanical failure. Investigators on sight observed that there is approximately ½ mile sight distance from the center of the bridge on Commonwealth Ave. to the accident location.

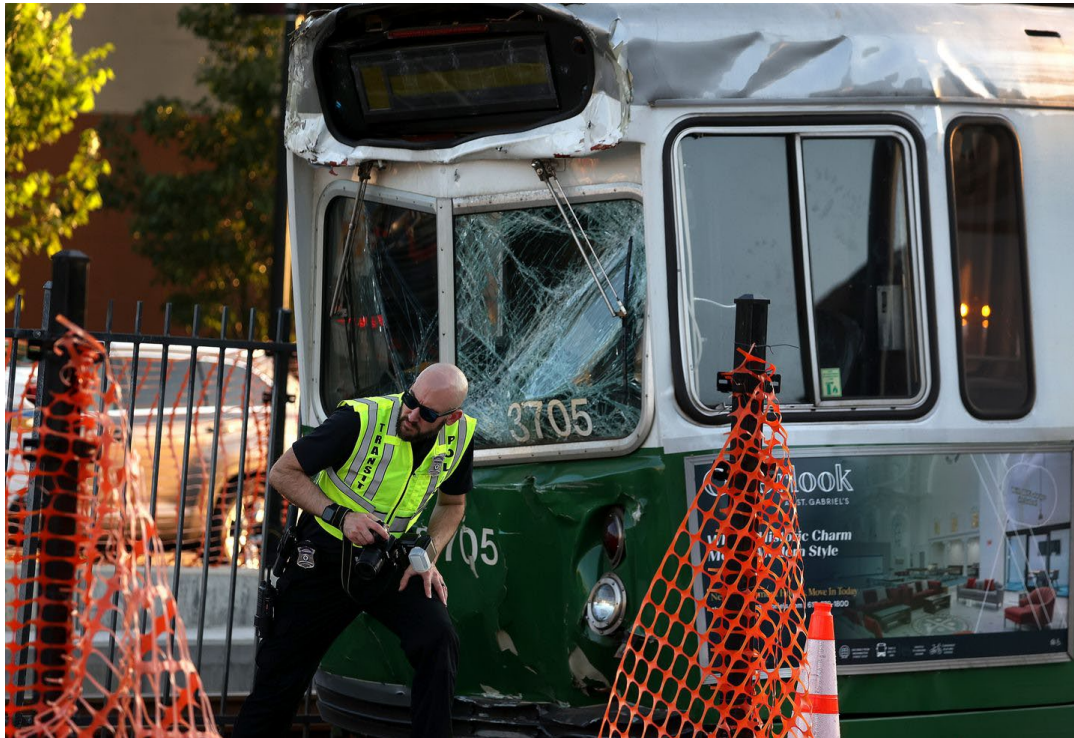
Figure 2: Image of struck trolley car. Deformation to the car is present. Source: Boston Globe

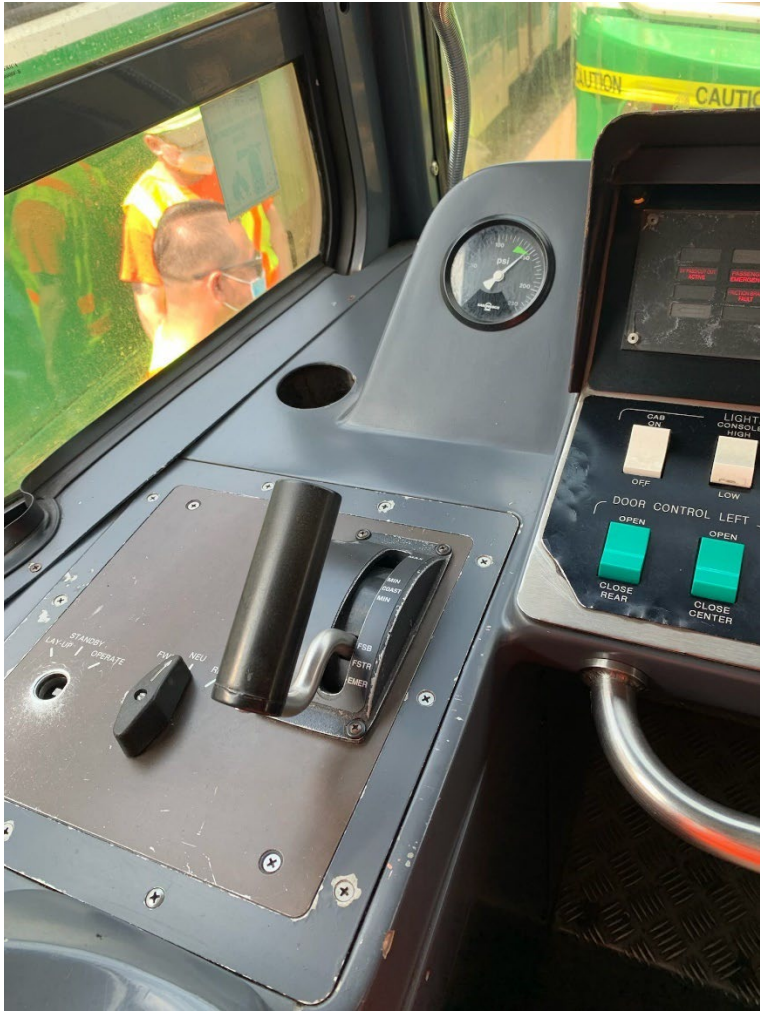
Figure 4: Photo of master controller inactive, “deadman” switch not engaged. Source: NTSB

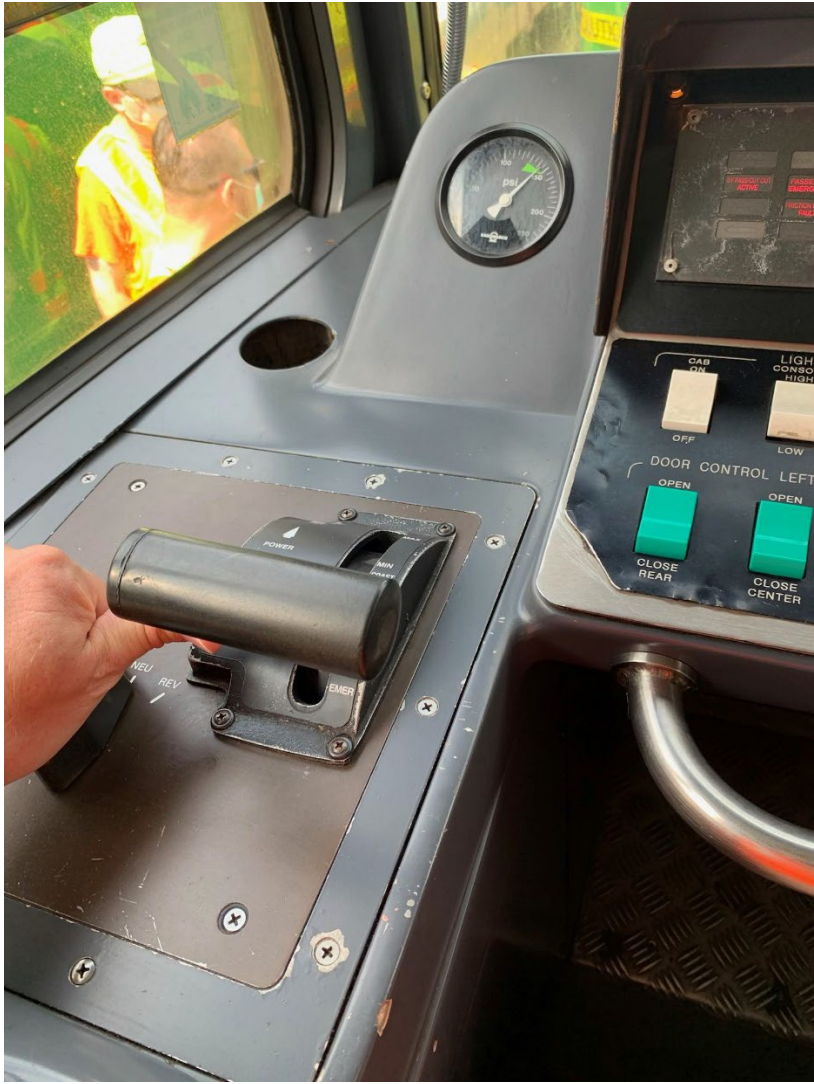
Figure 5: Master Controller in operating position, power and brake can be engaged, “deadman” switch engaged. Source: NTSB
