NATIONAL TRANSPORTATION SAFETY BOARD
Investigative Hearing

Norfolk Southern Railway general merchandise freight train 32N
derailment with subsequent hazardous material release and fires,
in East Palestine, Ohio, on February 3, 2023

Materials Laboratory Factual Report 23-039

RRD23MR005

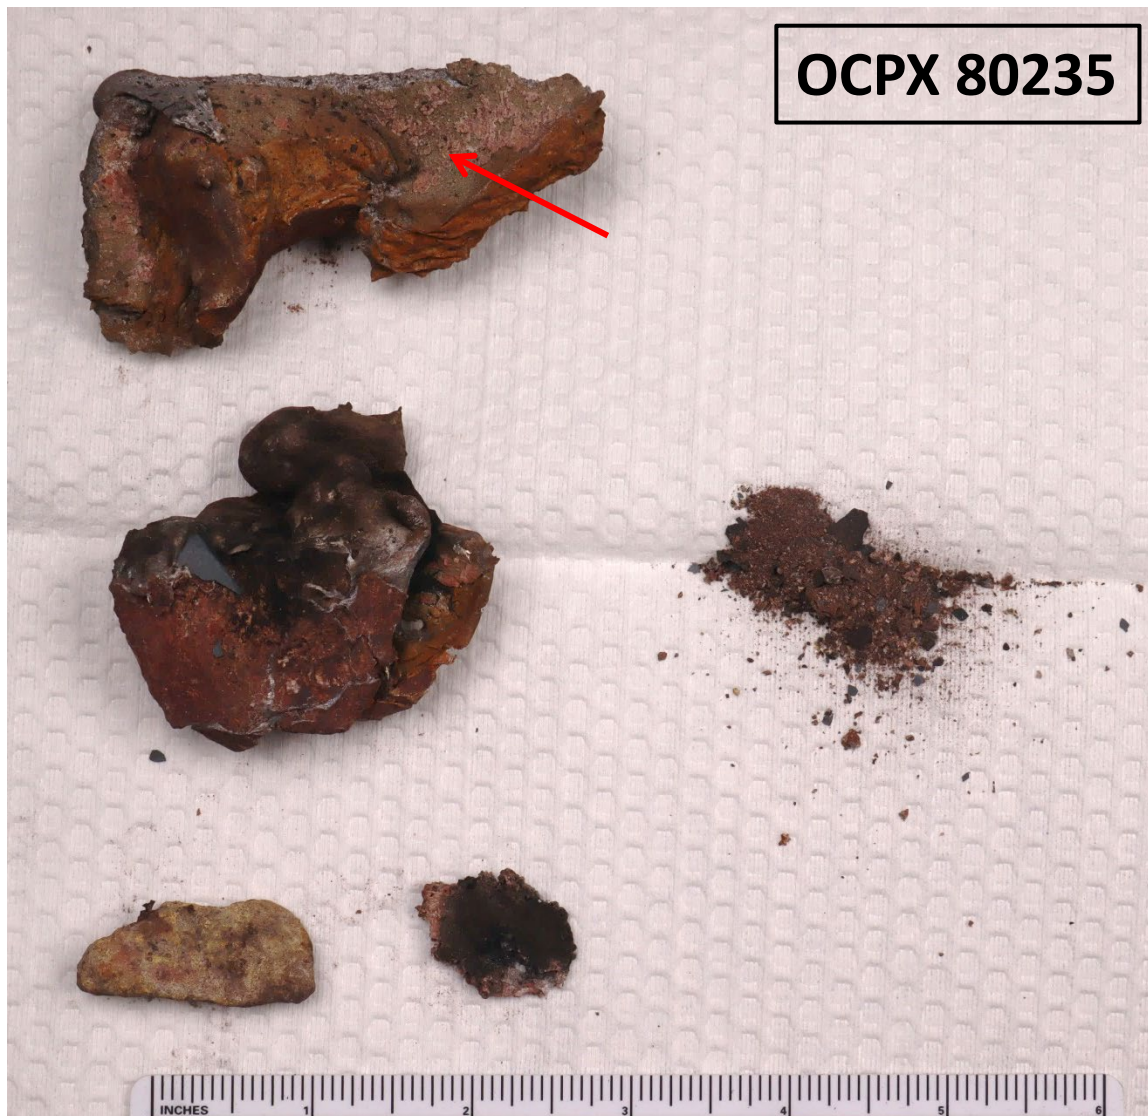
Figure 1. Macro photo showing the sample collected from rail car OCPX 80235 while on-scene. The red arrow points to the approximate location XRF measurements were taken on the piece of debris chosen for analysis.

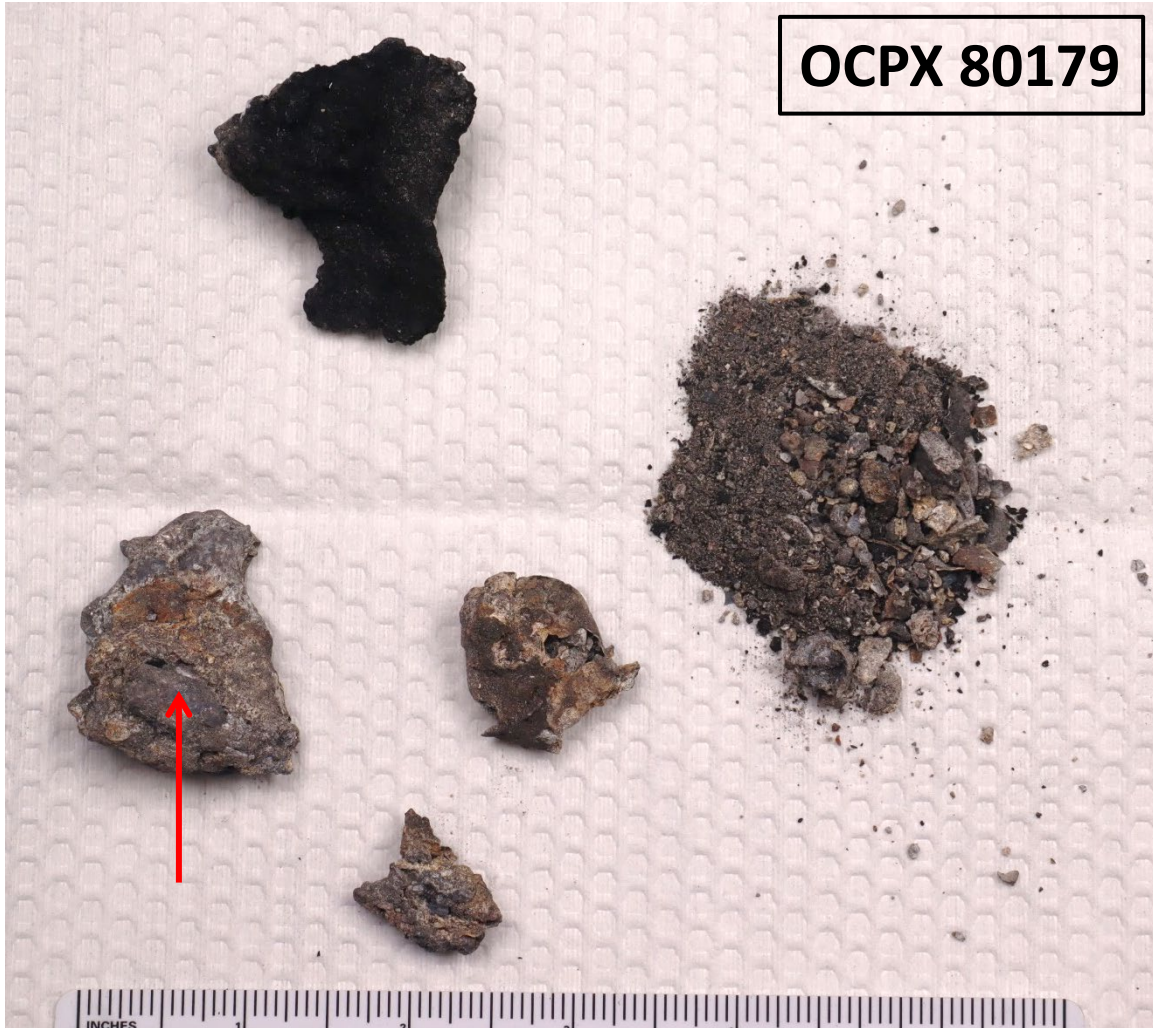
Figure 2. Macro photo showing the sample collected from rail car OCPX 80179 while on-scene. The red arrow points to the approximate location XRF measurements were taken on the piece of debris chosen for analysis.

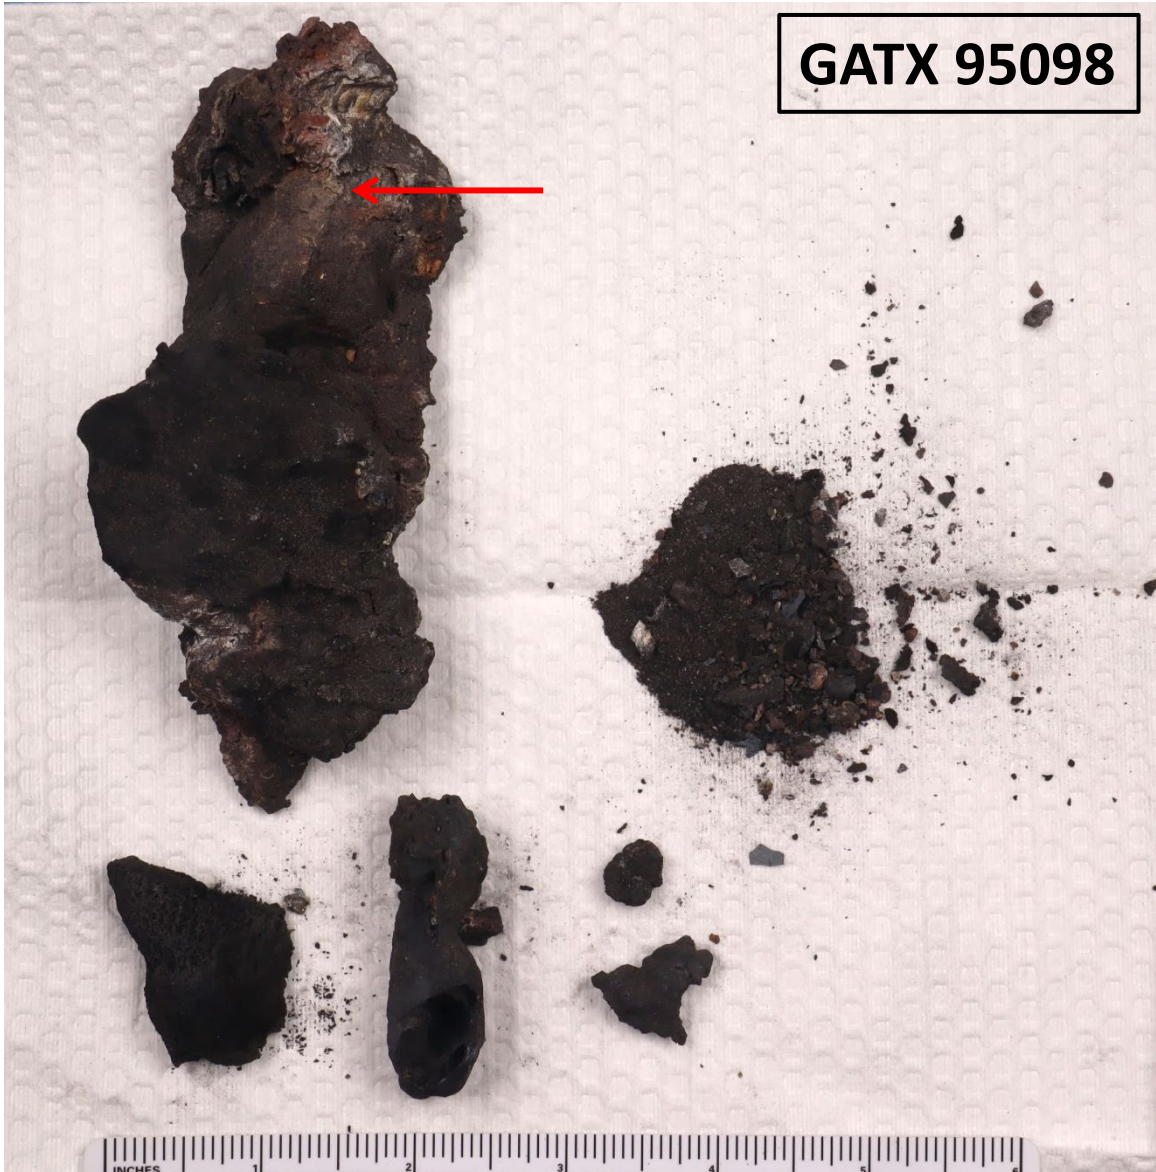
All the analyzed specimens had more than half their weight percent measured as aluminum. Along with the major element of aluminum, two specimens had a minor element of iron – the GATX 95098 specimen collected on-scene and the OCPX 80235 specimen collected during testing. Trace amounts of numerous additional elements made up the balance of each specimen.

Figure 3. Macro photo showing the sample collected from rail car GATX 95098 while on-scene. The red arrow points to the approximate location XRF measurements were taken on the piece of debris chosen for analysis.

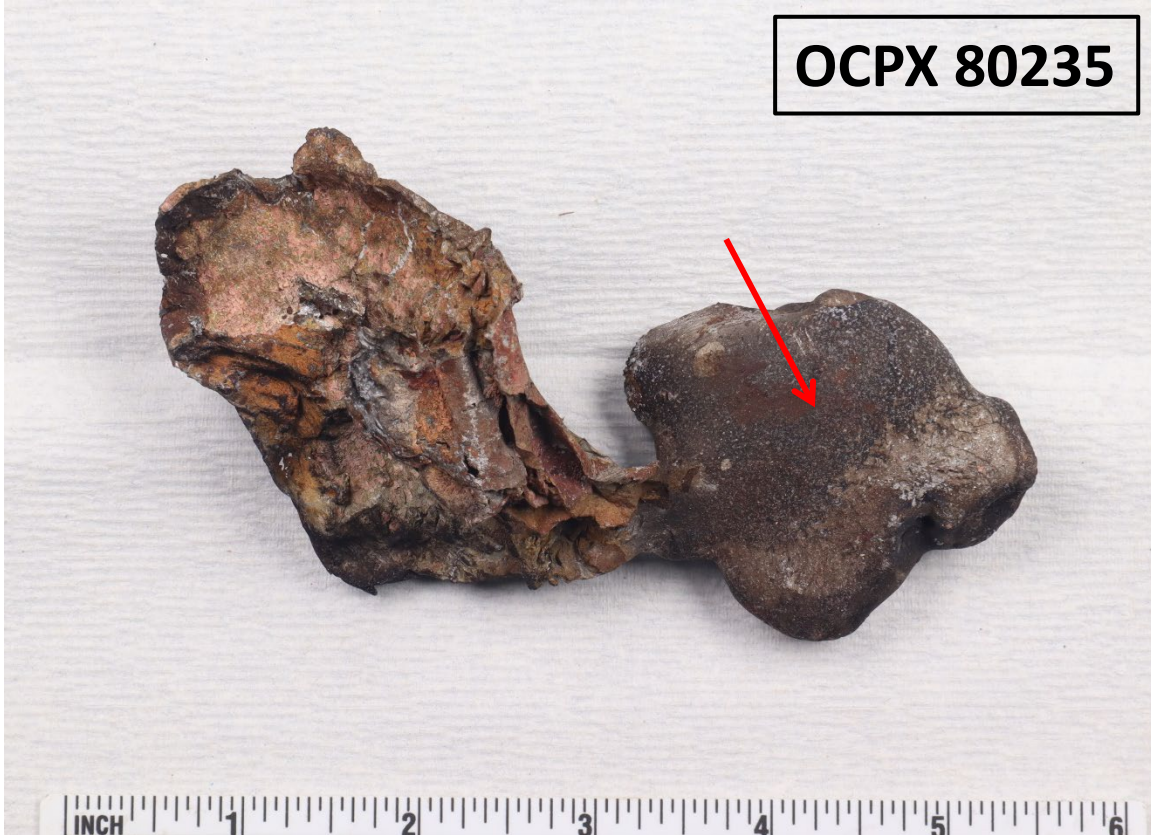
Figure 4. Macro photo showing the sample collected from rail car OCPX 80235 during PRD testing. The red arrow points to the approximate location XRF measurements were taken on the piece of debris chosen for analysis.

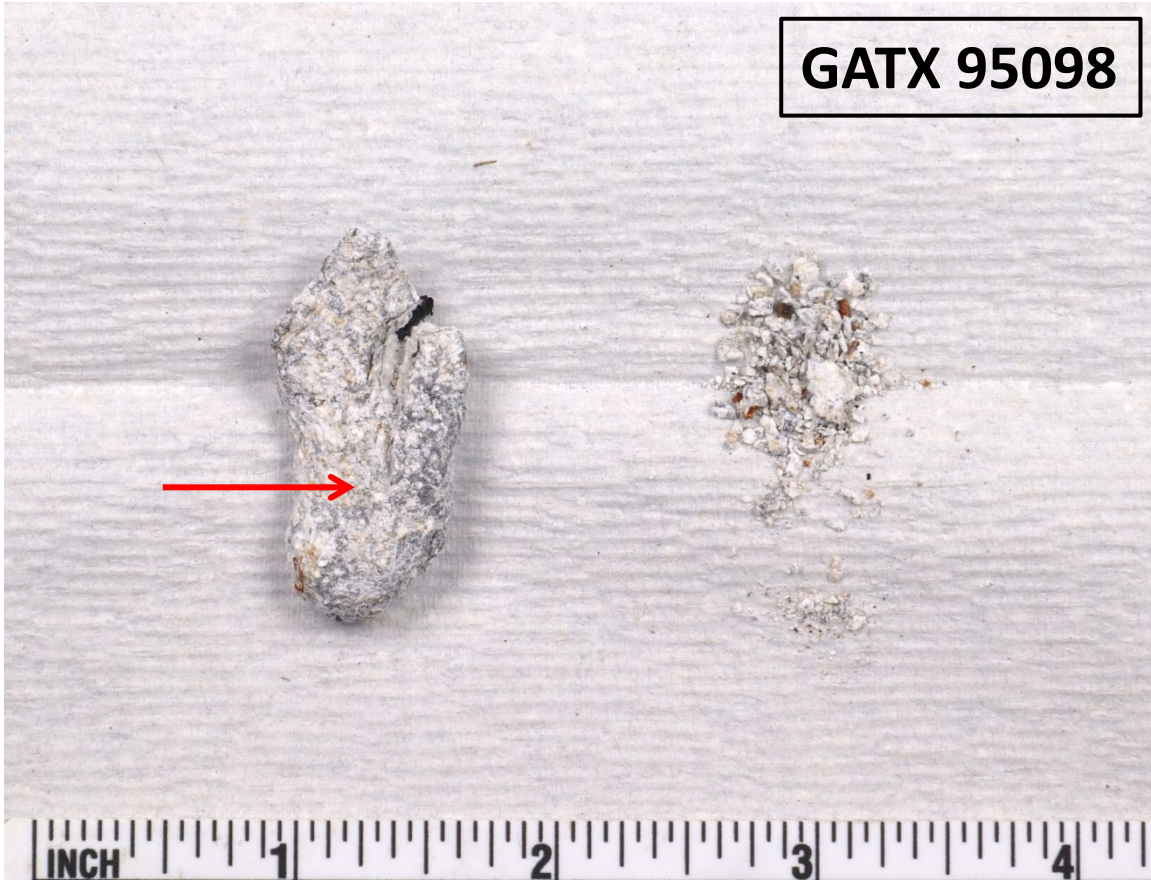
Figure 5. Macro photo showing the sample collected from rail car GATX 95098 during PRD testing. The red arrow points to the approximate location XRF measurements were taken on the piece of debris chosen for analysis.
