Norfolk Southern Railway general merchandise freight train 32N  
derailment with subsequent hazardous material release and fires,  
in East Palestine, Ohio, on February 3, 2023

# **Materials Laboratory Factual Report 23-040**

RRD23MR005

May 4, 2023

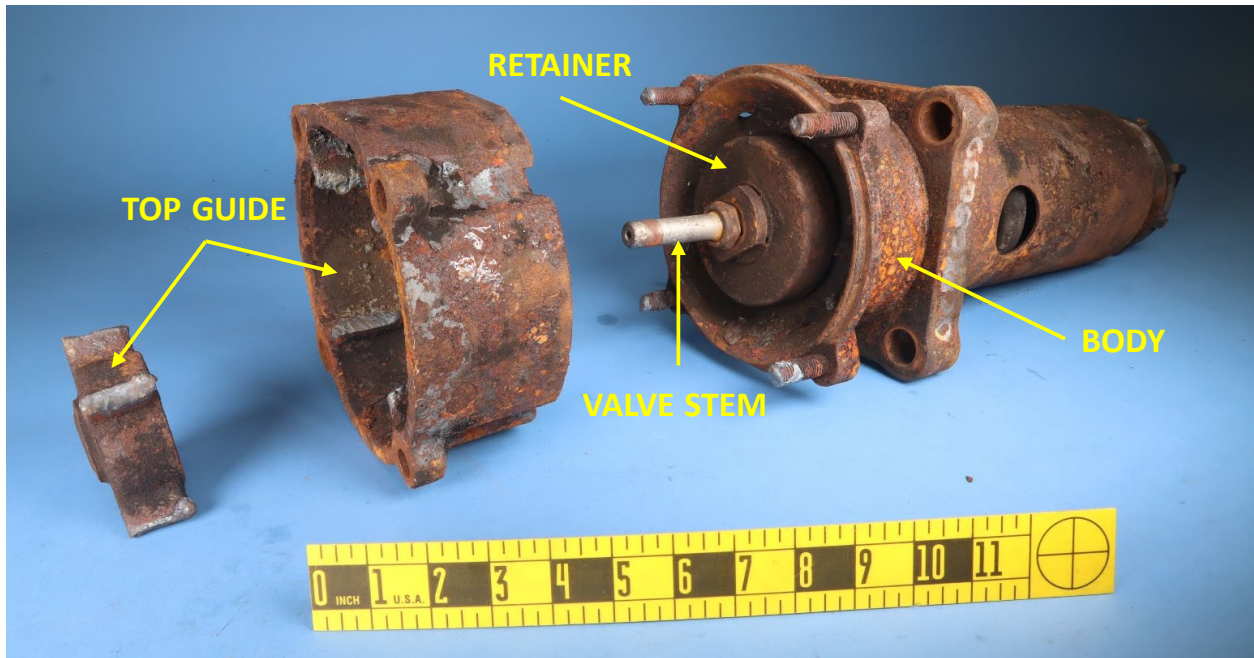
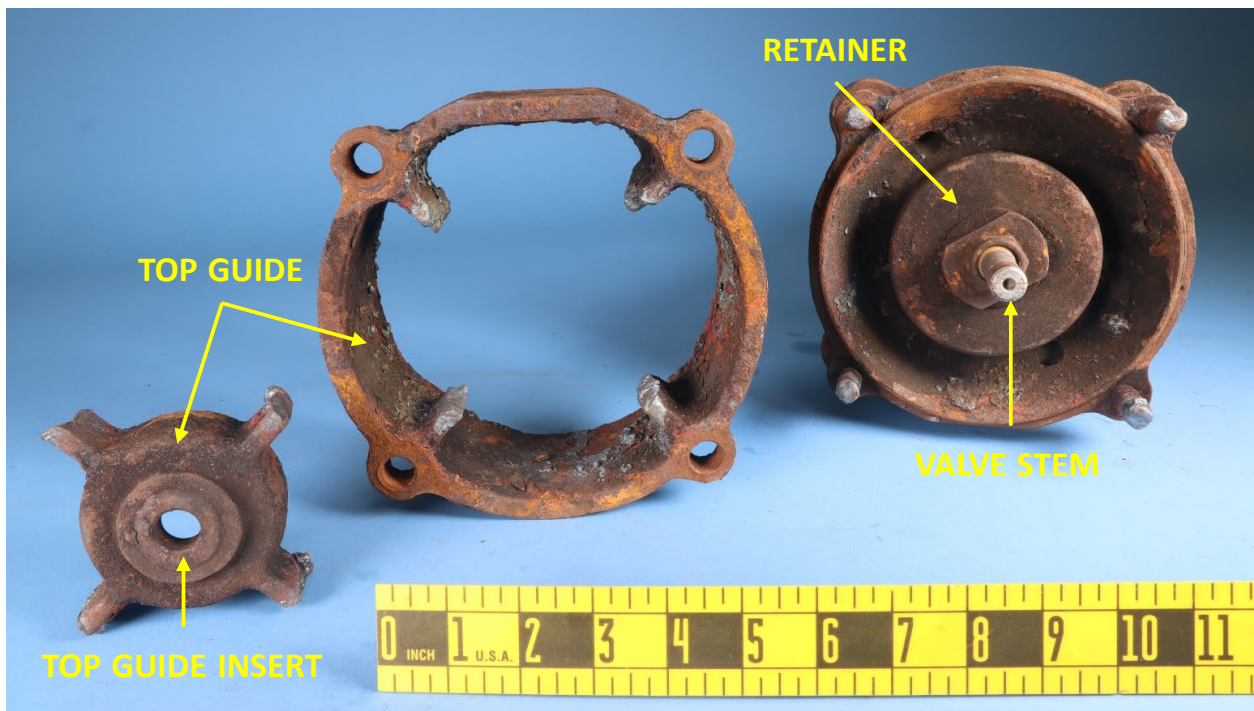
**Figure 1.** Macro photos showing the disassembled PRD from tank car OCPX 80370.

The disassembled PRD was then shipped to the NTSB Materials Laboratory in Washington DC for further examination. The disassembled pieces of the PRD are shown in Figure 1.

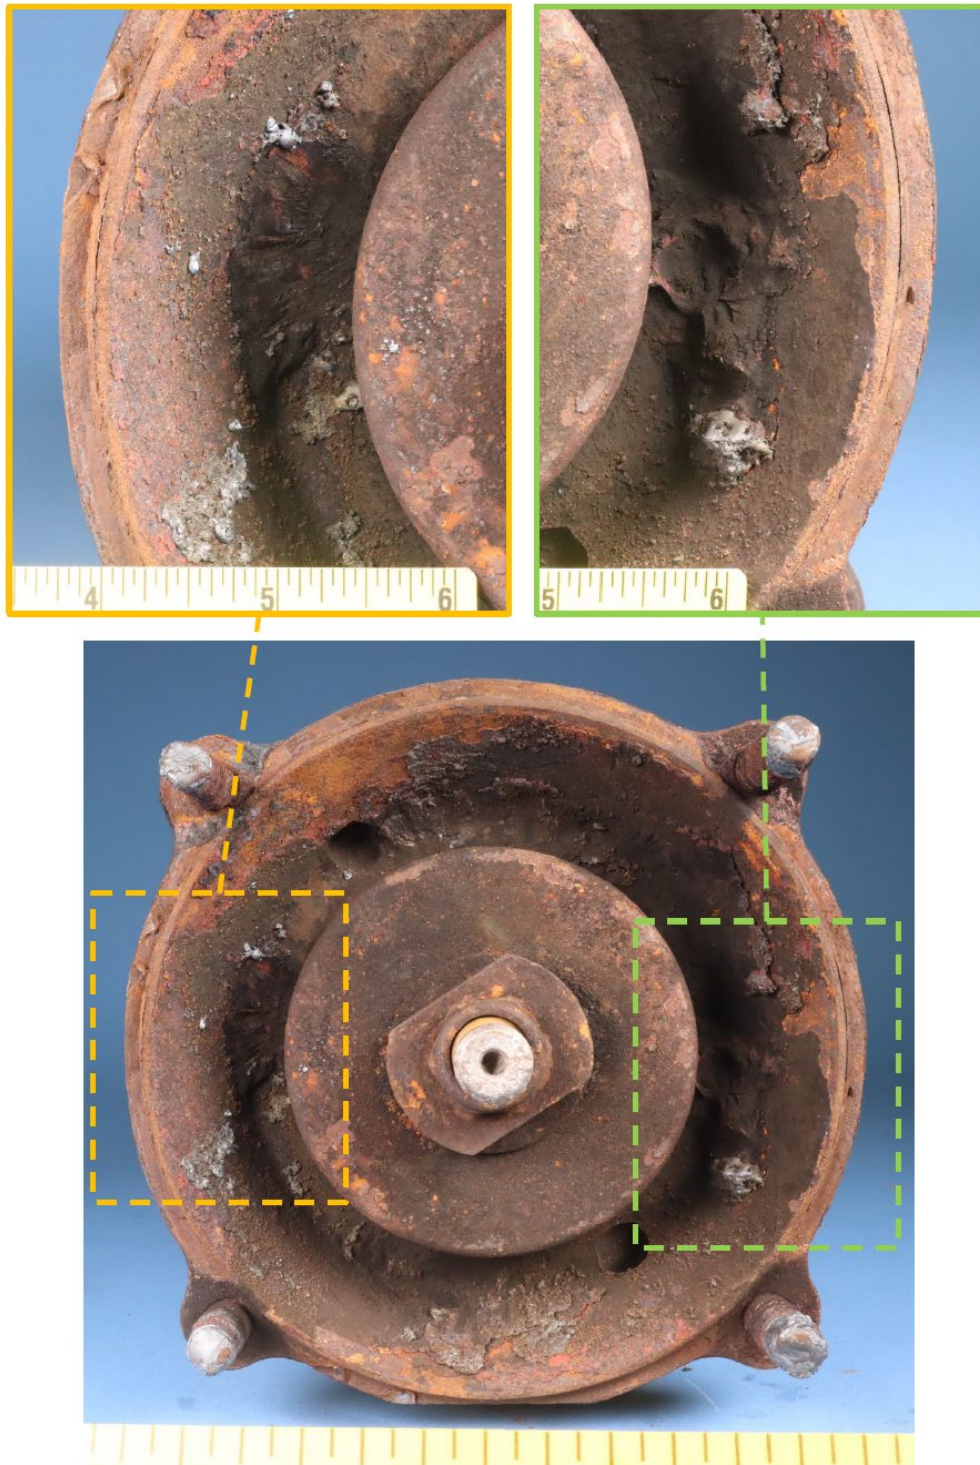
**Figure 2.** Overall (bottom) and close-up (top) photos of the inner surface on the body of the PRD.

The retainer was still assembled to the remainder of the PRD, as shown in Figure 2. Thick layers of soot and reddish-brown-colored burned deposits were visible on the inner surface of the body. Spots of wrinkled, silver-colored debris were fused on top of the deposits in several areas. Similar debris was collected from other PRDs and are documented in NTSB Materials Laboratory Factual Report 23-039.

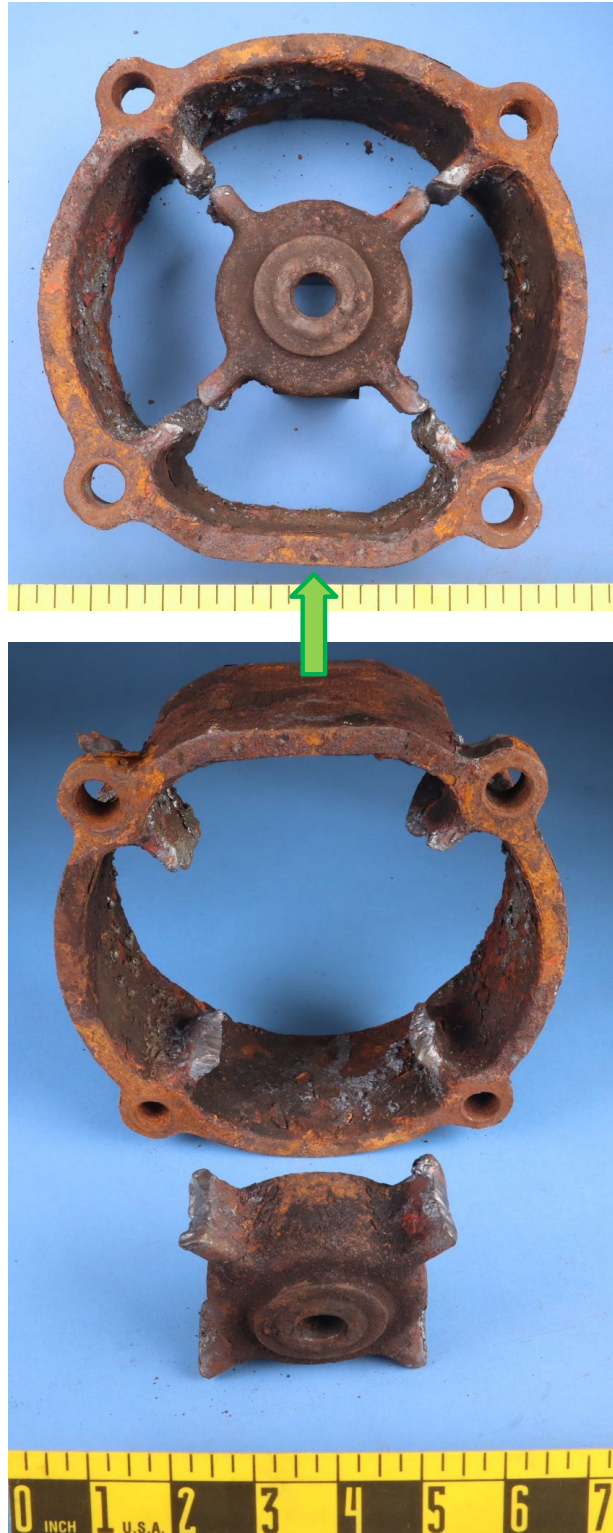
**Figure 3.** Macro photos showing the top guide pieces of the PRD as viewed from the outboard side.

Photos of the top guide pieces as viewed from the outboard side are shown in Figures 3 and 4, while photos of the top guide pieces as viewed from the inboard side are shown in Figures 5 and 6. Thick layers of soot and reddish-brown-colored burned deposits were visible on the inner diameter of the guide rim. Some areas where the deposits had flaked off were exposed and orange-colored rust was visible on the surface. Silver-colored splatter resulting from the torch cutting of the spokes was observed on top of the burned debris in some areas.

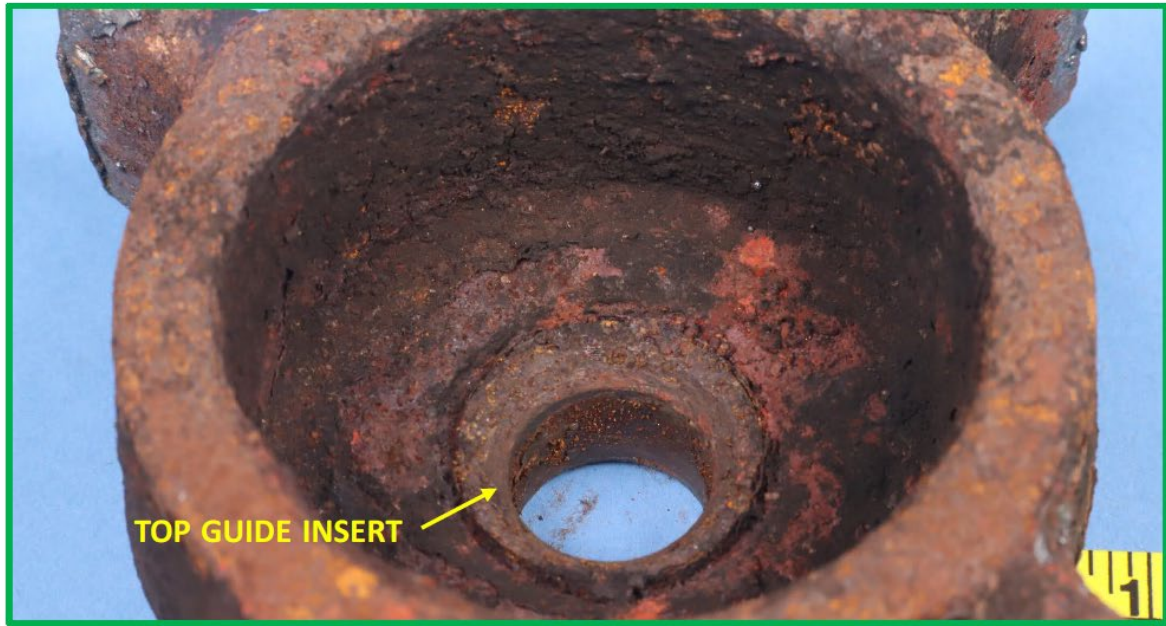
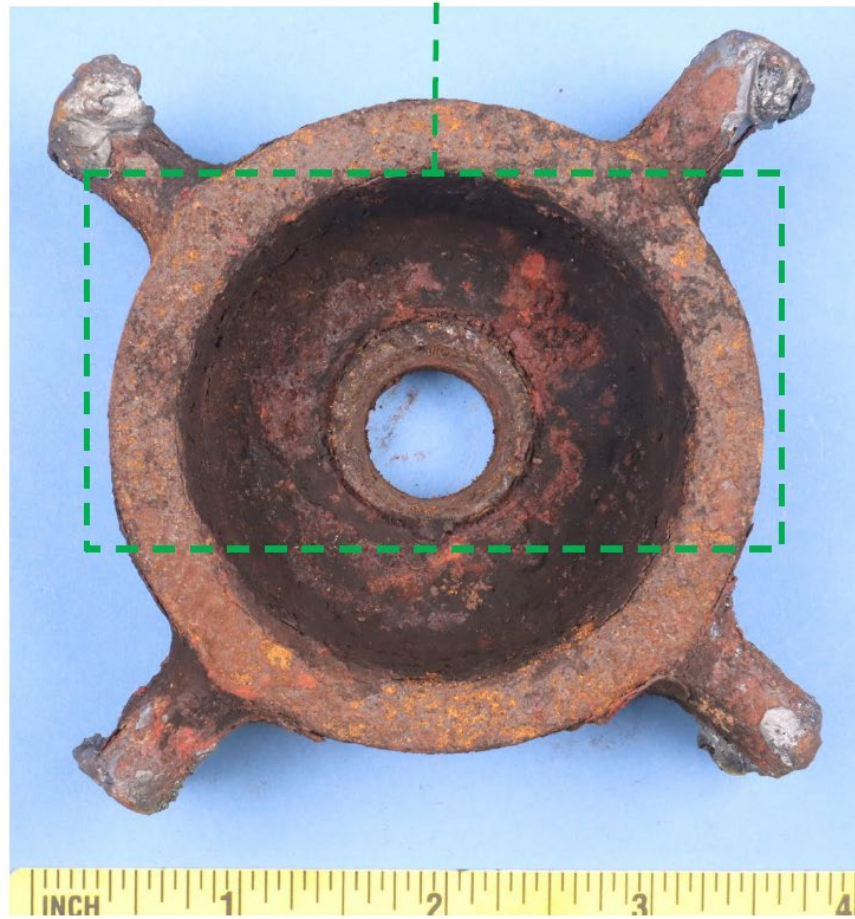
**Figure 7.** Macro (bottom) and close-up (top) photos showing the center portion of the PRD top guide as viewed from the inboard side.

Figure 7 shows the inboard surface on the center portion of the top guide. Thick layers of soot and reddish-brown-colored burned deposits coated the entirety of the inboard surface. The inner diameter of the top guide insert also had evidence of burned deposits adhering to the surface.

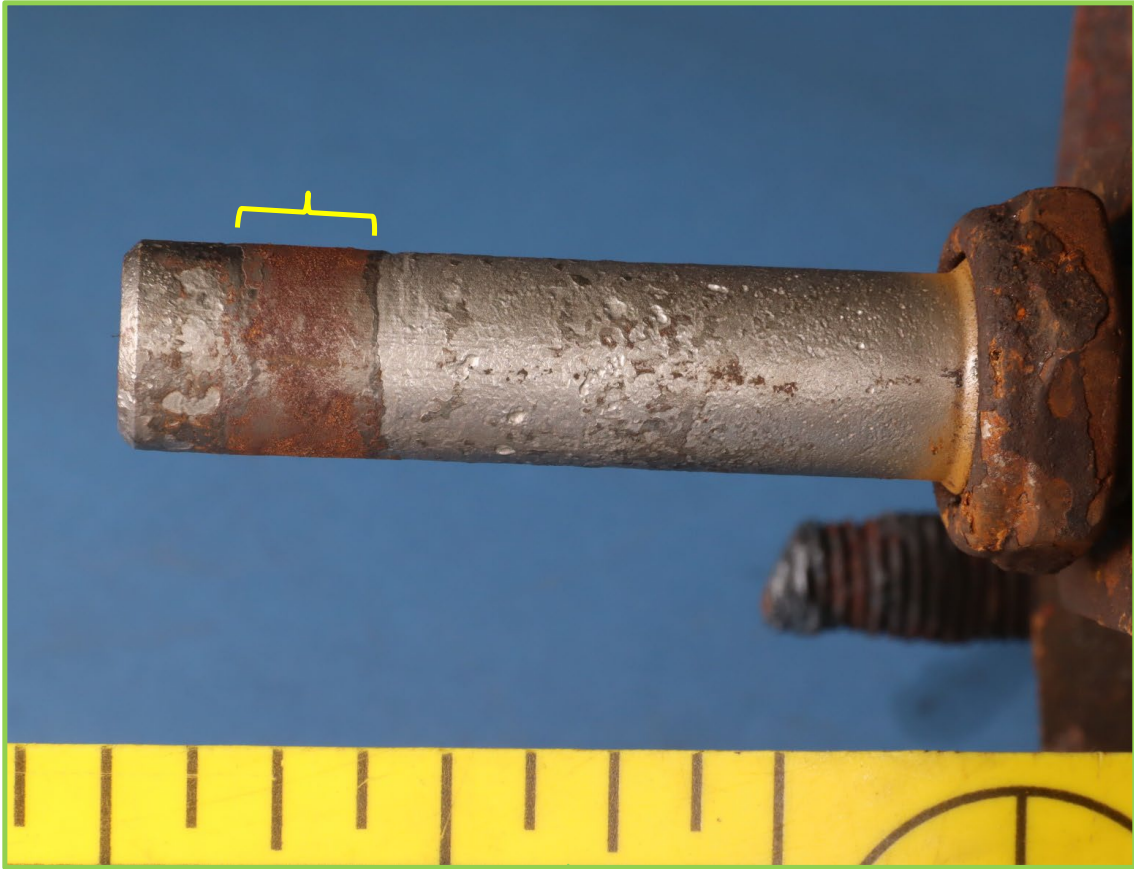
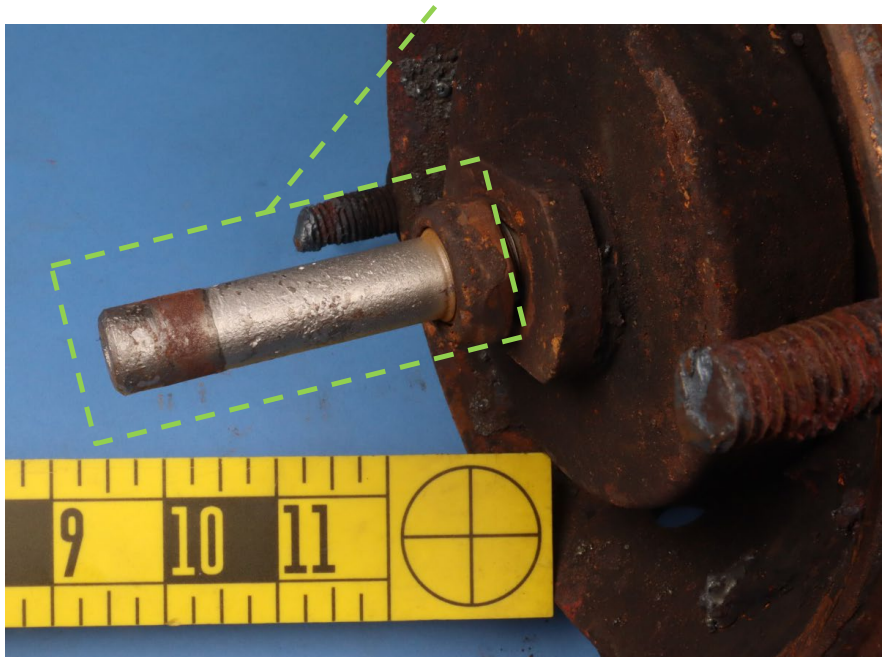
Similar reddish-brown deposits were observed in a band on the outer diameter of the mating valve stem, indicated by the yellow bracket in Figure 8. Recall that the valve stem had been bead-blasted, and these deposits persisted even though the remainder of the valve stem was relatively clean and appeared silver. This band was thus the likely position of the mating top guide insert during the event and prior to disassembly, with the bottom of the band located approximately 0.75 inches from the valve stem end. Evidence of deposits also still adhered to the cleaned valve stem, while the removal of other deposits left divots in the valve stem surface.

**Figure 8.** Close-up photos of the valve stem of the PRD with a band of reddish-brown deposits indicated by the yellow bracket.
