Norfolk Southern Railway general merchandise freight train 32N
derailment with subsequent hazardous material release and fires,
in East Palestine, Ohio, on February 3, 2023

GROUP	B
EXHIBIT	
14

Materials Laboratory Factual Report 23-041

RRD23MR005

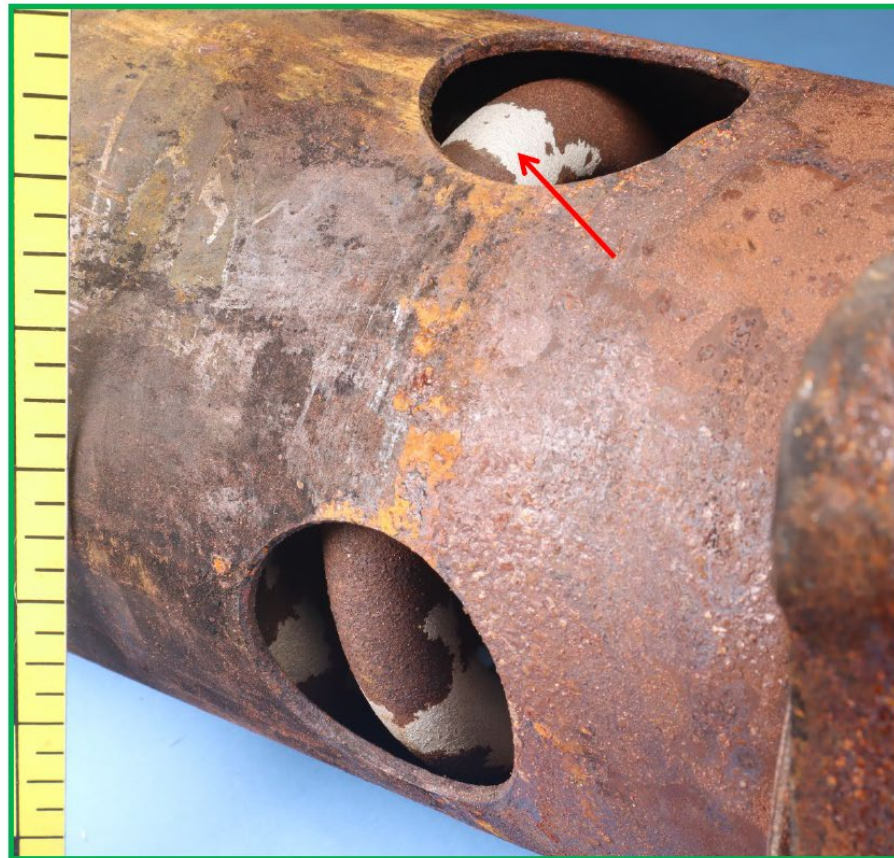
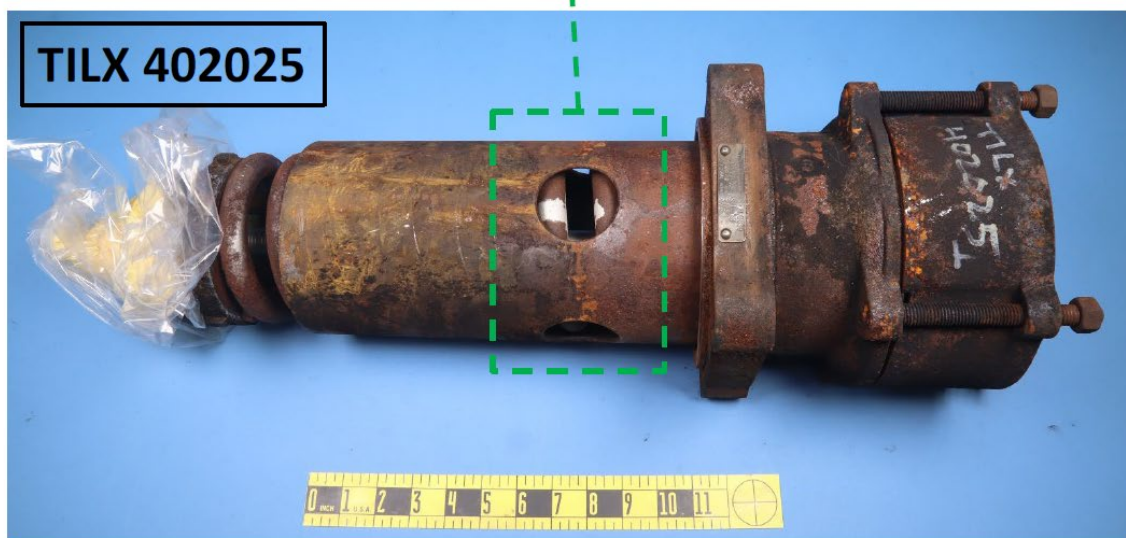
The exposed silver-colored areas on the spring were analyzed using an Olympus Vanta x-ray fluorescence (XRF) alloy analyzer. The XRF results showed a majority weight percent of iron from the underlying base metal steel alloy, with the second highest weight percent present identified as aluminum. Consequently, aluminum coating was confirmed as present on the surface of the valve spring.

Figure 1. Overall and close-up photos showing the PRD from tank car TILX 402025. The red arrow points to the approximate location XRF measurements were taken in a silver-colored area exposed after bead-blasting removed the dark colored soot and debris on the valve spring.
