Norfolk Southern Railway general merchandise freight train 32N
derailment with subsequent hazardous material release and fires,
in East Palestine, Ohio, on February 3, 2023

**Unmanned Aircraft System Aerial Imagery
Group Chair's Factual Report**

RRD23MR005

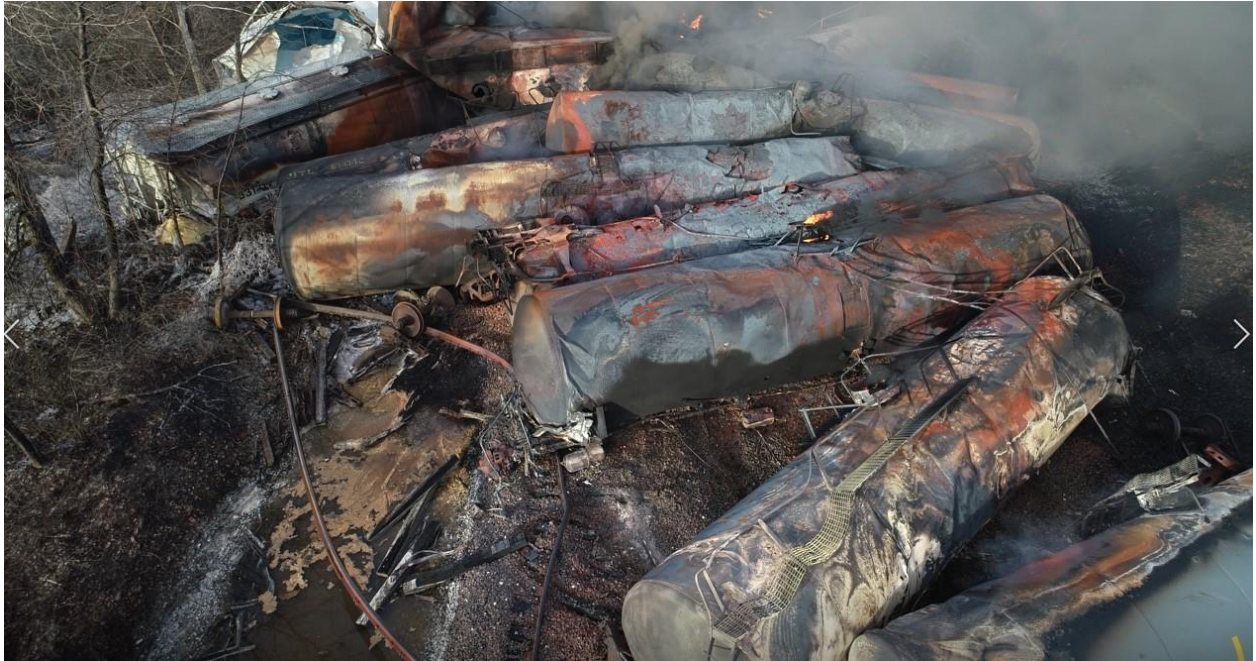
Figure 2. Image from video flight showing the resting positions of several tank cars.

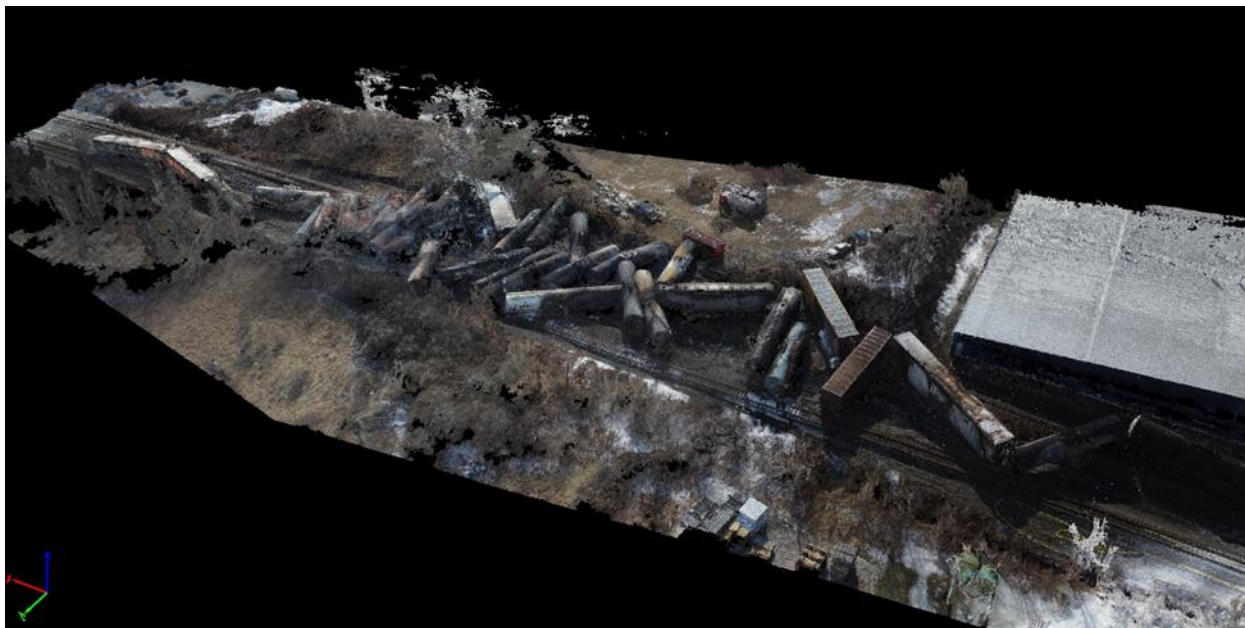
Figure 4. Generated Point Cloud of the main derailment site.

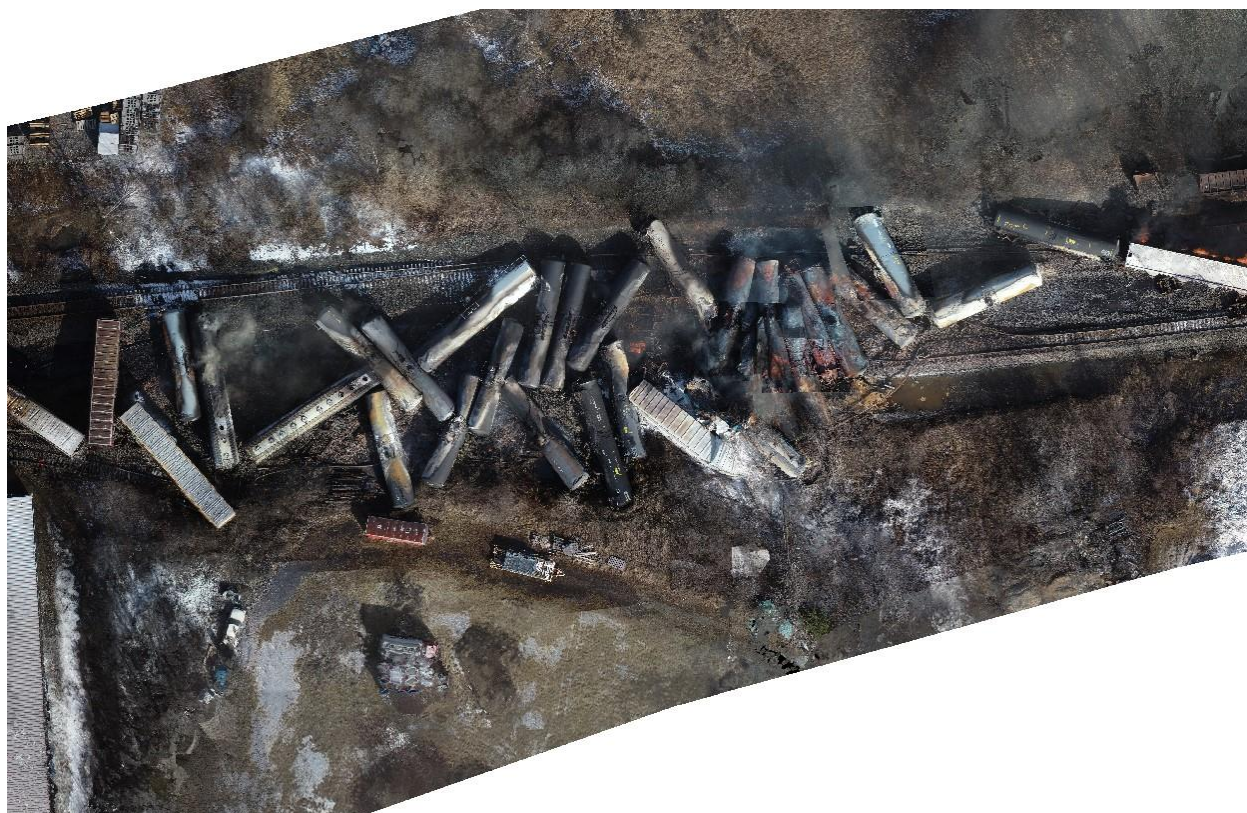
Figure 3. Generated Orthomosaic Image of the main derailment site.

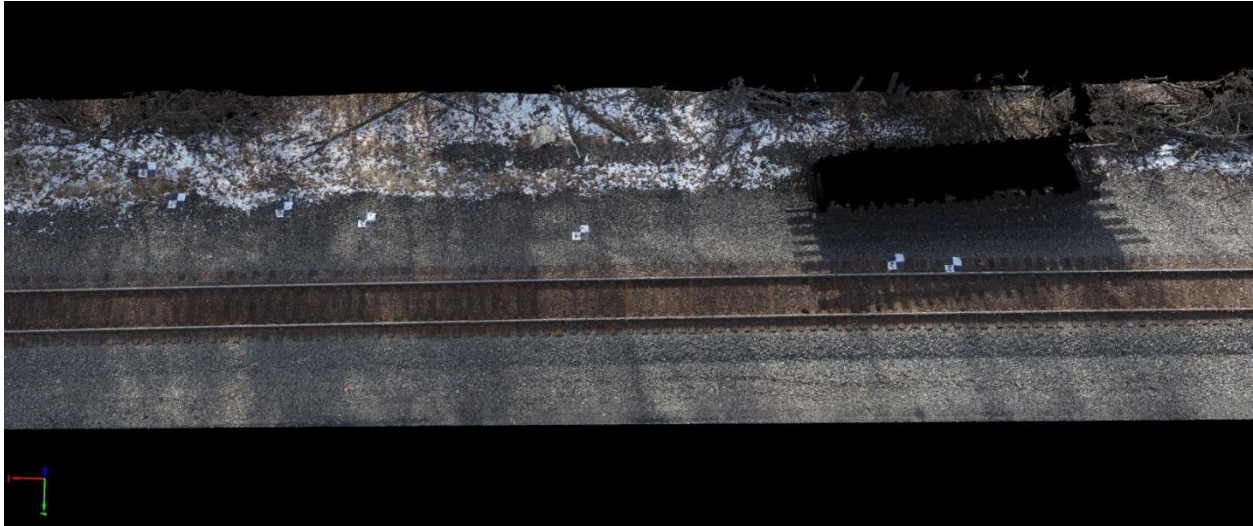
The area where the derailment began was identified by NTSB investigators and the sUAS team was requested to document the area. The same process as above was utilized for processing in the Pix4d photogrammetry software. The resulting point cloud of the rail section can be seen in **Figure 6**.

Figure 6. Generated Point Cloud of the section of rail where the derailment started.
