NATIONAL TRANSPORTATION SAFETY BOARD  
**Investigative Hearing**

Norfolk Southern Railway general merchandise freight train 32N  
derailment with subsequent hazardous material release and fires,  
in East Palestine, Ohio, on February 3, 2023

**Hazard Communications and  
Emergency Responder Preparedness  
For The Initial Emergency Response  
Group Factual Report**

RRD23MR005

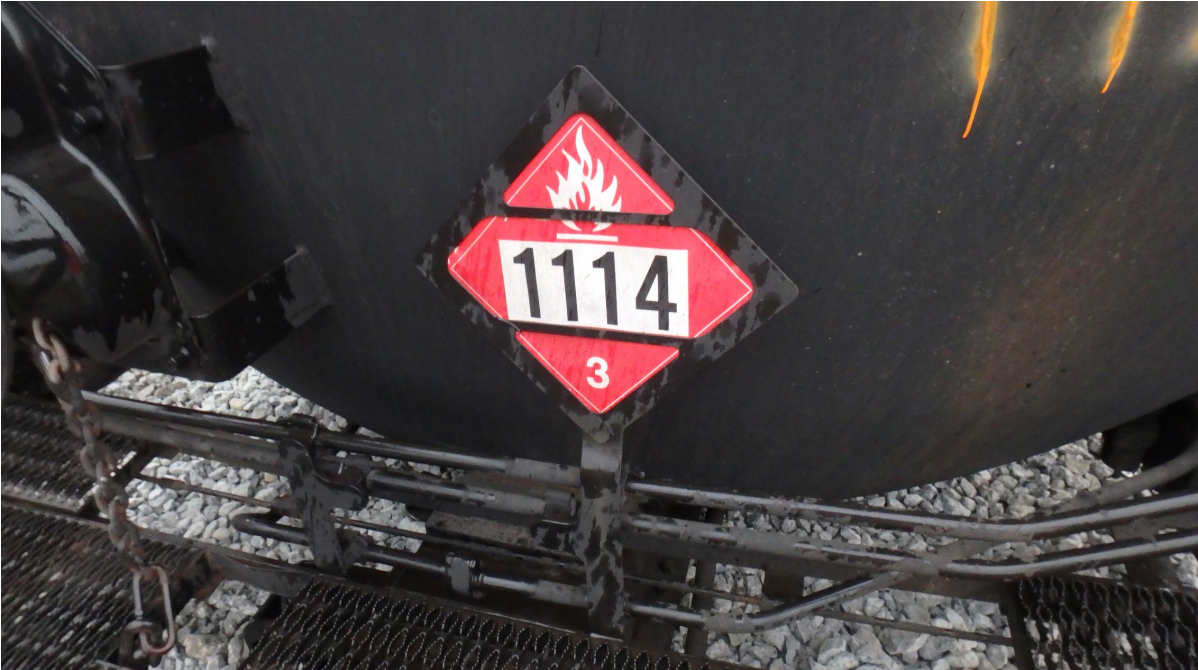
The above photo was taken by an NTSB investigator at the accident site. It shows a railcar with a placard indicating that benzene (a flammable liquid) is contained therein.

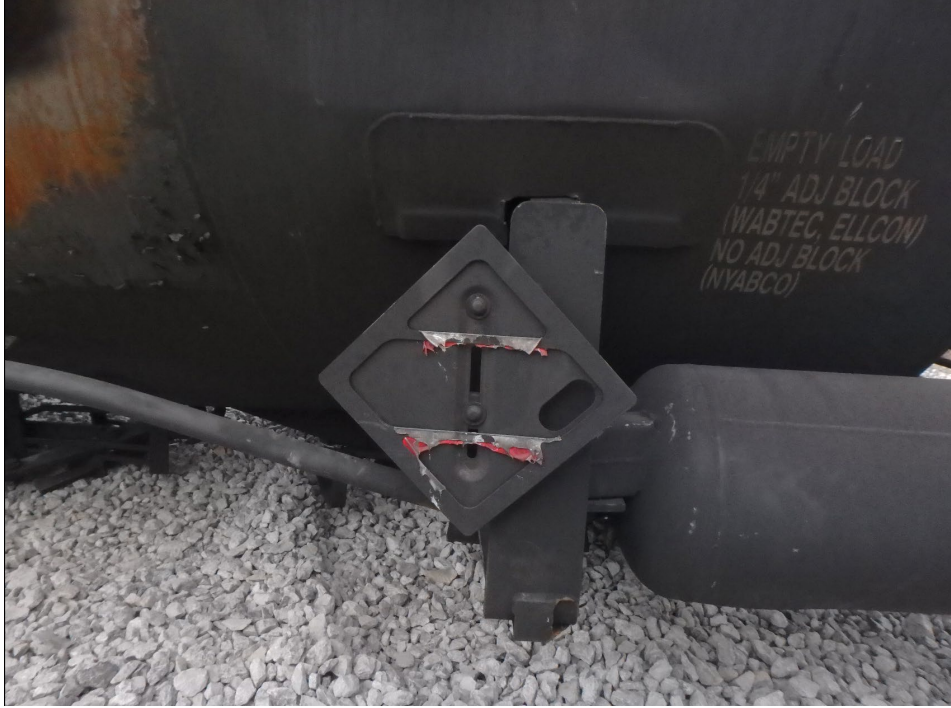
Responding firefighter interview testimony indicated that placards affixed to a number of the railcars had been subjected to heat from fires and sustained damage.

As depicted in the photo-images, some of the placards were damaged to the extent that they were no longer functional (i.e., the information was not visible, or missing).

The above photo was taken by an NTSB investigator at the accident site. At the center of the photo is a placard holder. A charred red material is wrapped around the crossbars of the placard. No placard text is visible.

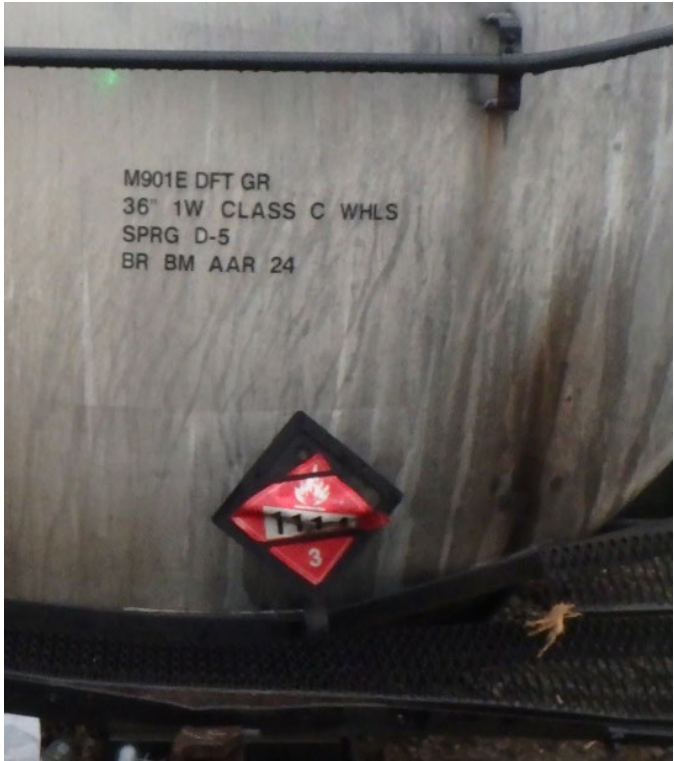
The above photo was taken by an NTSB investigator at the accident site. It was cropped to only show the placard, which is warped.

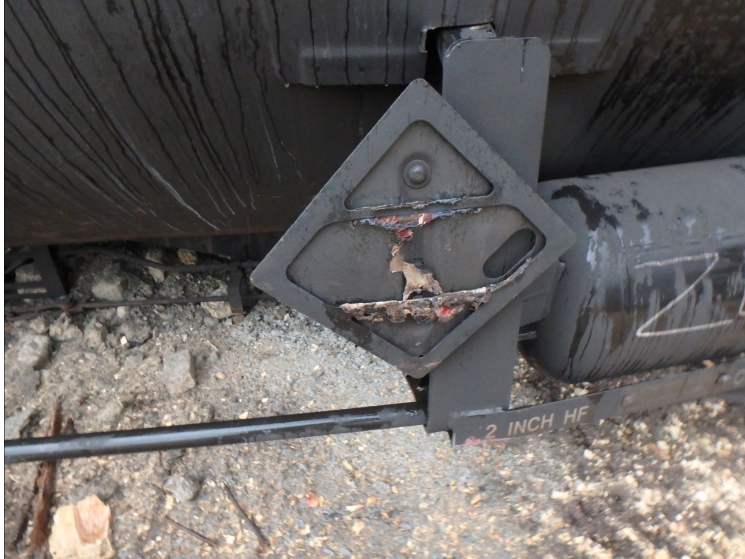
The above photo was taken by an NTSB investigator at the accident site, depicting a placard that was totally destroyed, apparently by heat exposure.
