NATIONAL TRANSPORTATION SAFETY BOARD
Investigative Hearing

Norfolk Southern Railway general merchandise freight train 32N
derailment with subsequent hazardous material release and fires,
in East Palestine, Ohio, on February 3, 2023

GROUP	D
EXHIBIT	
18

**Oxy Vinyls Tank Car Residue Sampling and
Analysis Report**

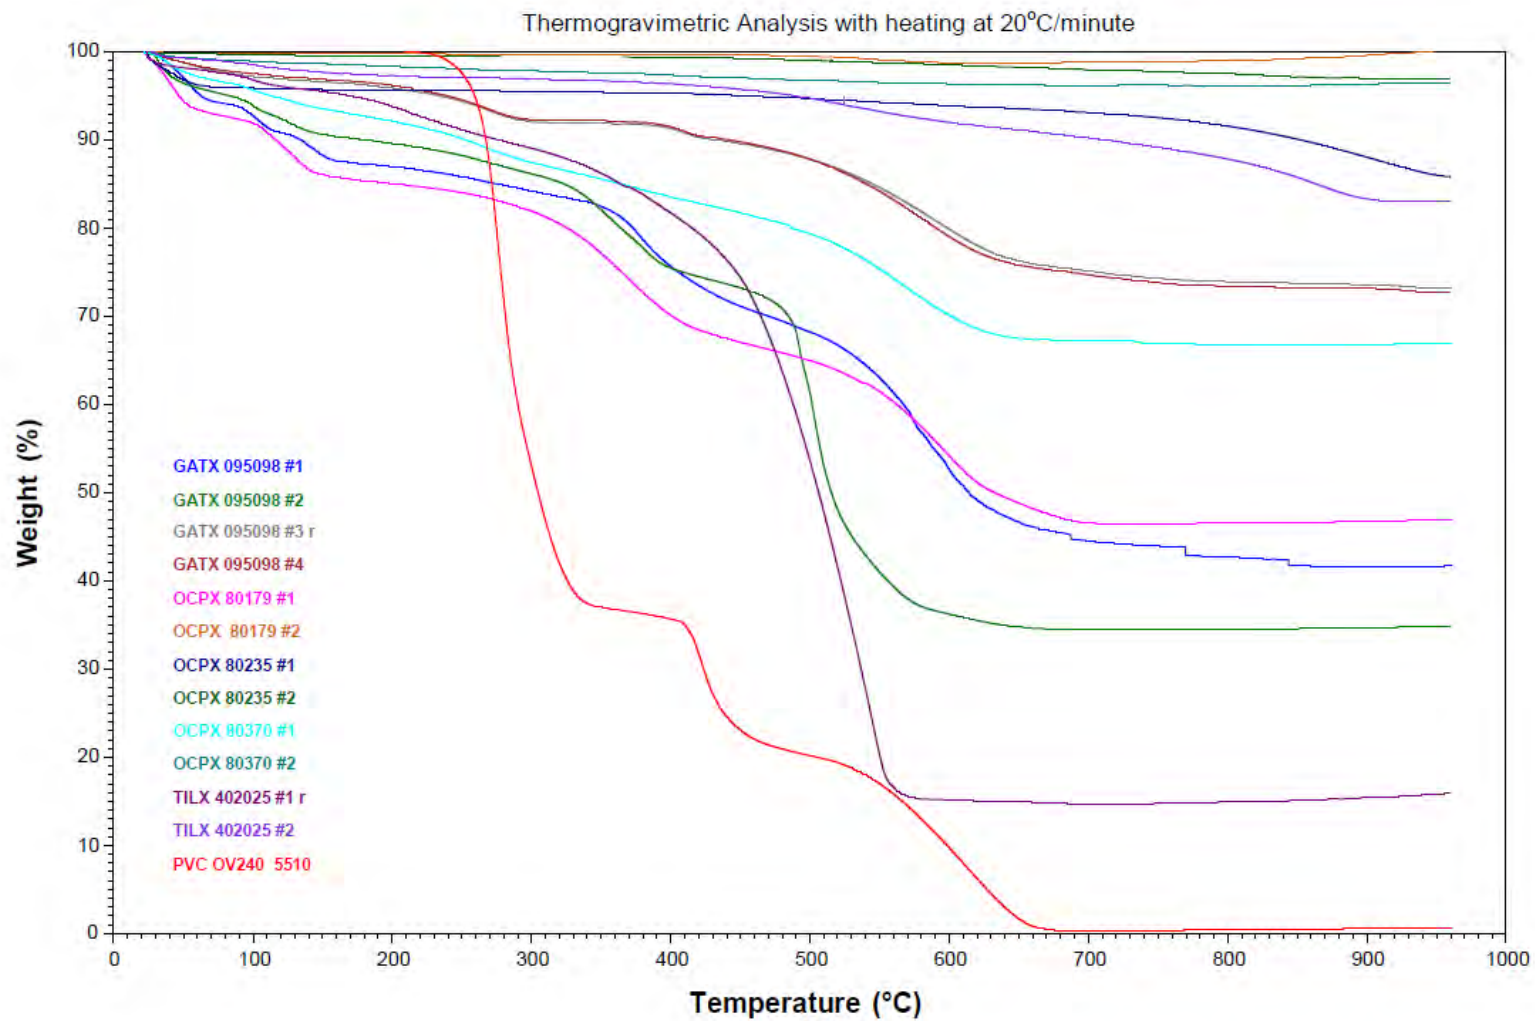
Figure 13. Weight loss of samples upon heating compared to PVC (red).

PVC weight loss by TGA is shown in comparison with weight loss curves for the railcar samples. PVC undergoes weight loss at visibly different temperatures than all railcar samples.

Based on these analyses, PVC was not present in any of the railcar samples.

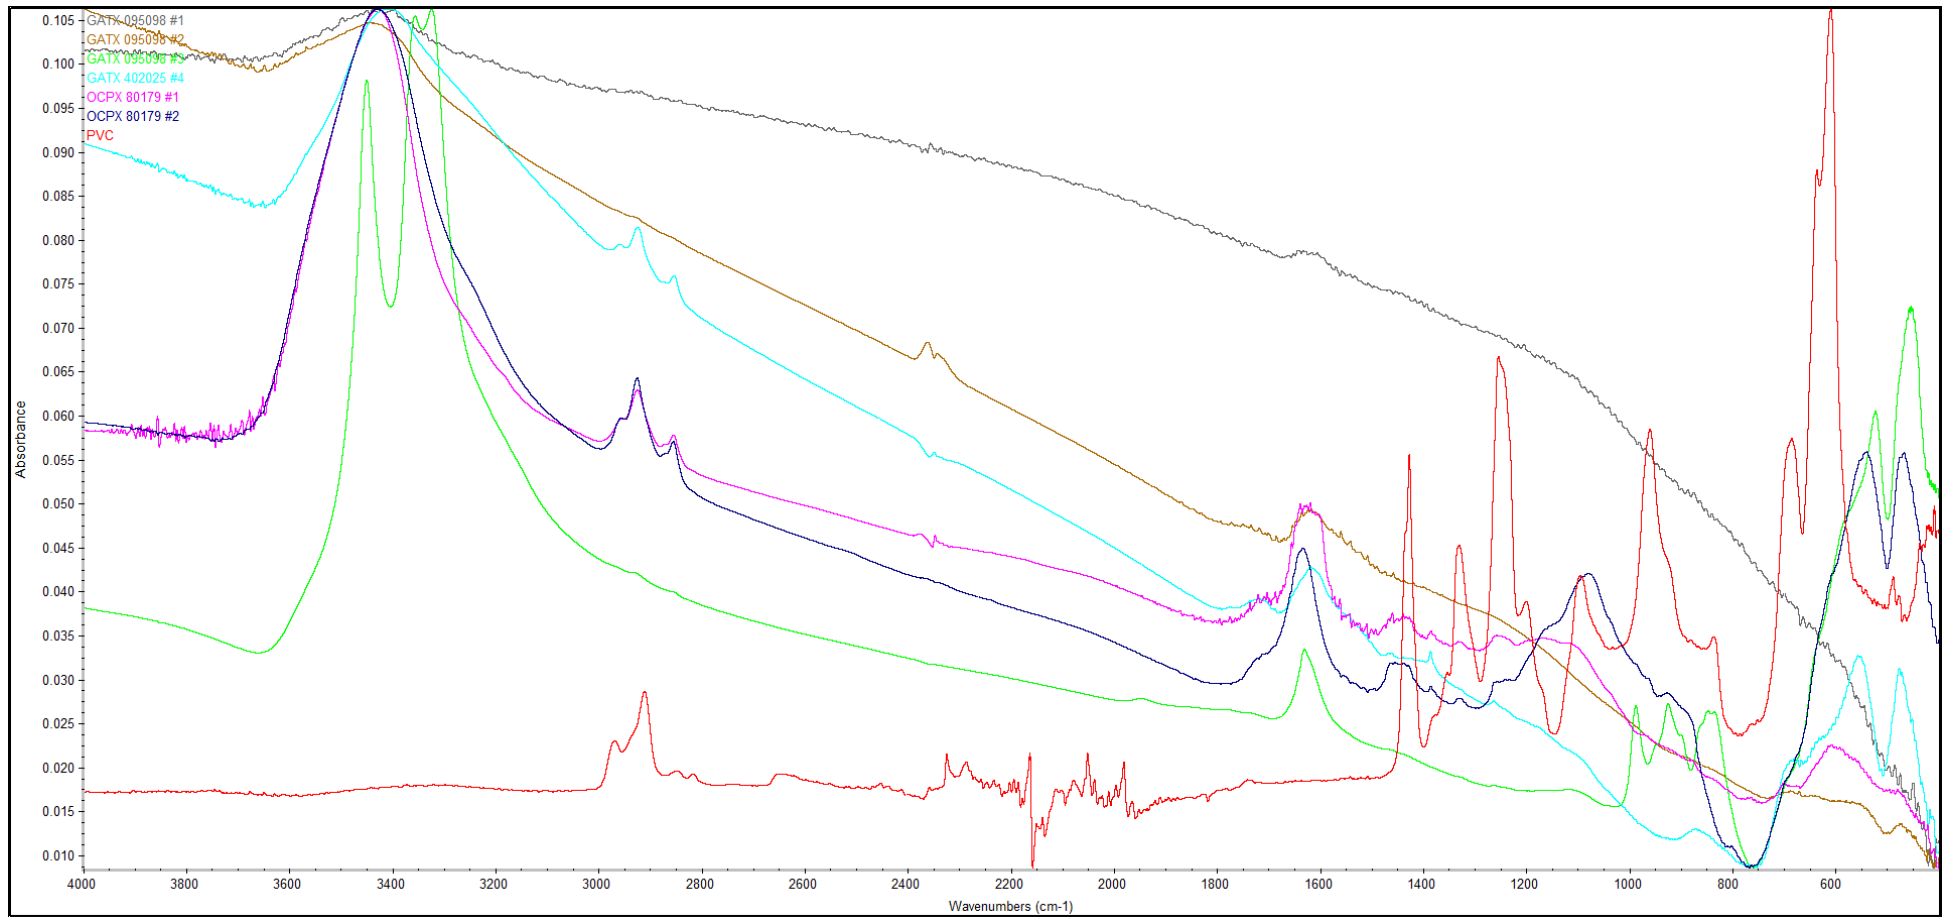
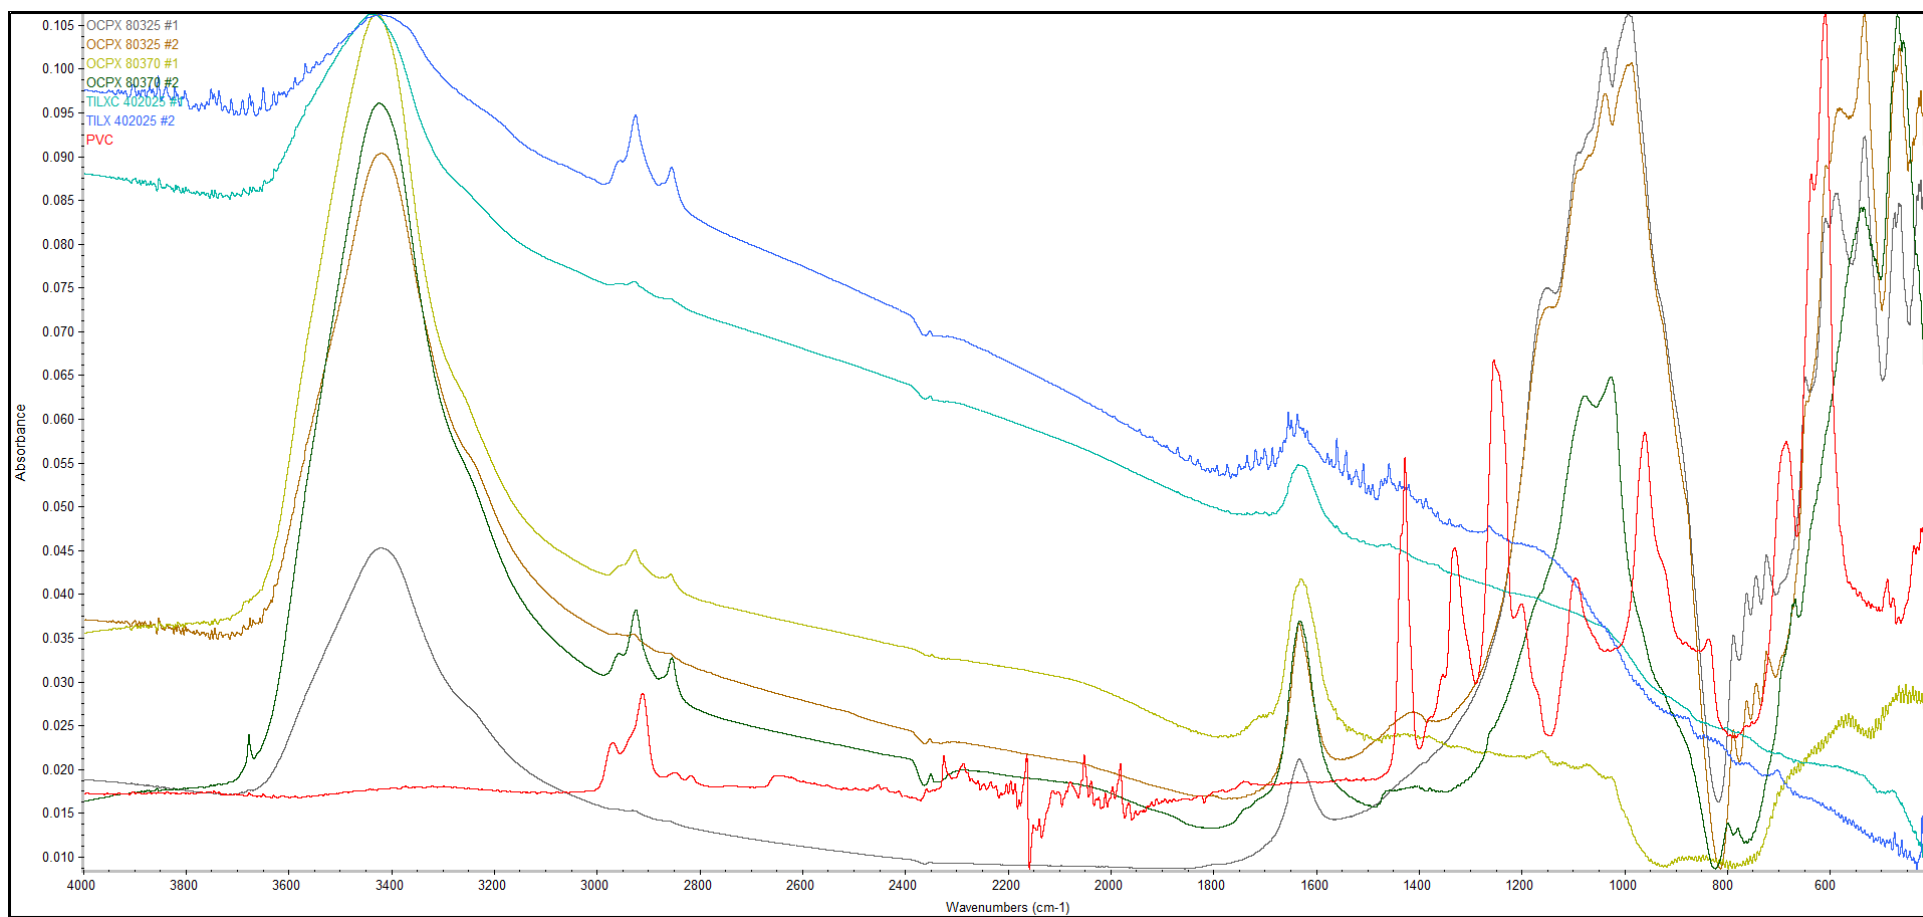
Figure 14. FTIR spectrum of railcars compared to PVC (red).

The FTIR peaks from 3700 to 3000 cm^{-1} for both PVC and railcar samples we believe to be associated with stretching energy of O-H bonds suggesting there may be moisture in the samples. The EDS analysis will not confirm presence of hydrogen. The peaks between 3000 and 2700 cm^{-1} are typical of energy absorbed from C-H bonds stretching some of the carbon could be aliphatic in nature. The red peaks between 1400 and 1150 cm^{-1} and between 750 and 550 cm^{-1} , we believe are C-Cl bond stretching energies as expected from PVC.
