**RRD23FR011 New Castle PA Derailment Preliminary Report**

Preliminary Report RRD23FR011

# Norfolk Southern Railway Derailment

New Castle, Pennsylvania

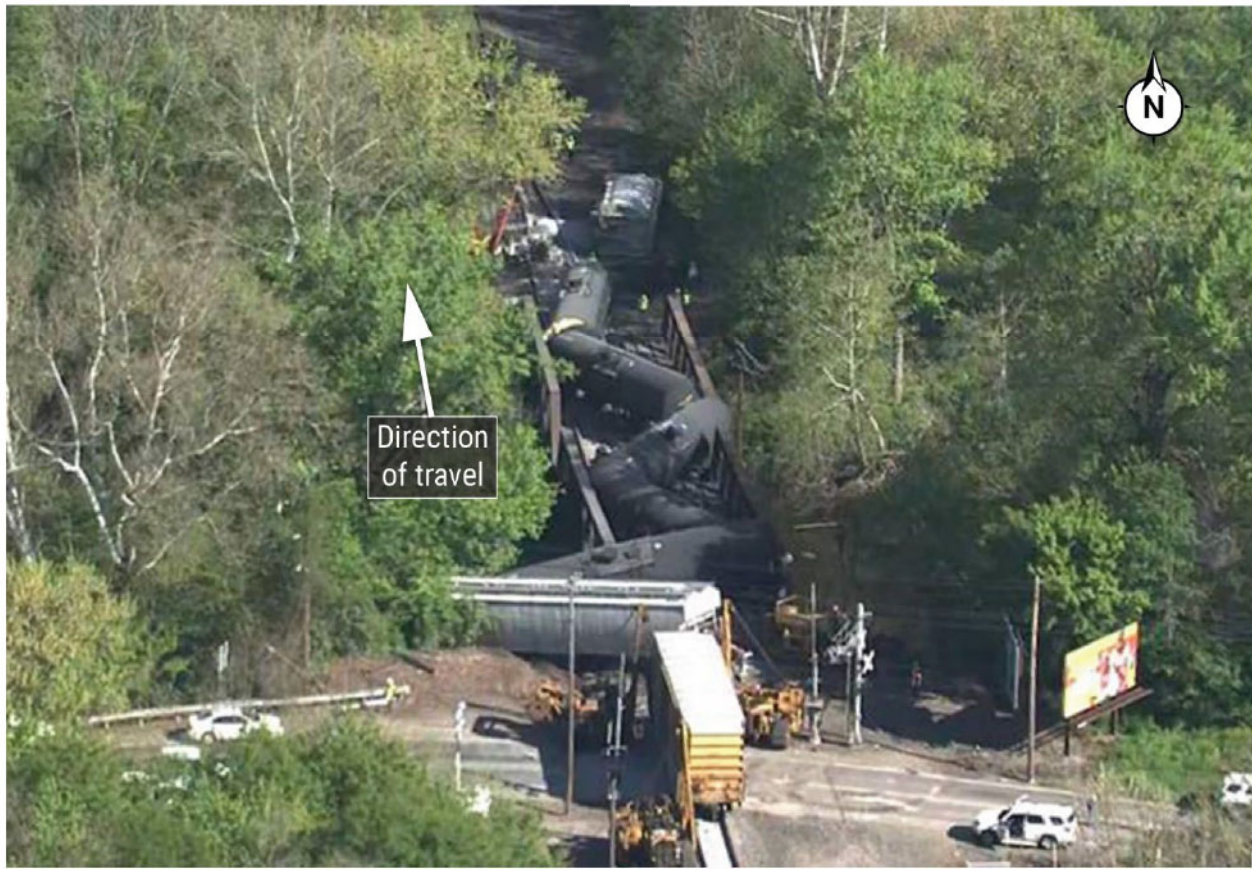
On May 10, 2023, about 10:57 p.m., northbound Norfolk Southern Railway (NS) general merchandise freight train 14M derailed nine mixed-freight railcars on the Youngstown Line at milepost (MP) 76.56 in New Castle, Pennsylvania.<sup>1</sup> (See figure 1.) The derailed equipment included one hazardous material tank car, which was not breached, that contained paraffin.<sup>2</sup> There were no reported fatalities or injuries. NS estimated damages to equipment and track infrastructure to be about \$6.1 million. At the time of the accident, visibility conditions were dark and clear; the weather was 52°F with no precipitation.

**Figure 1.** Aerial photograph of derailment site. (Source: WPXI Pittsburgh.)

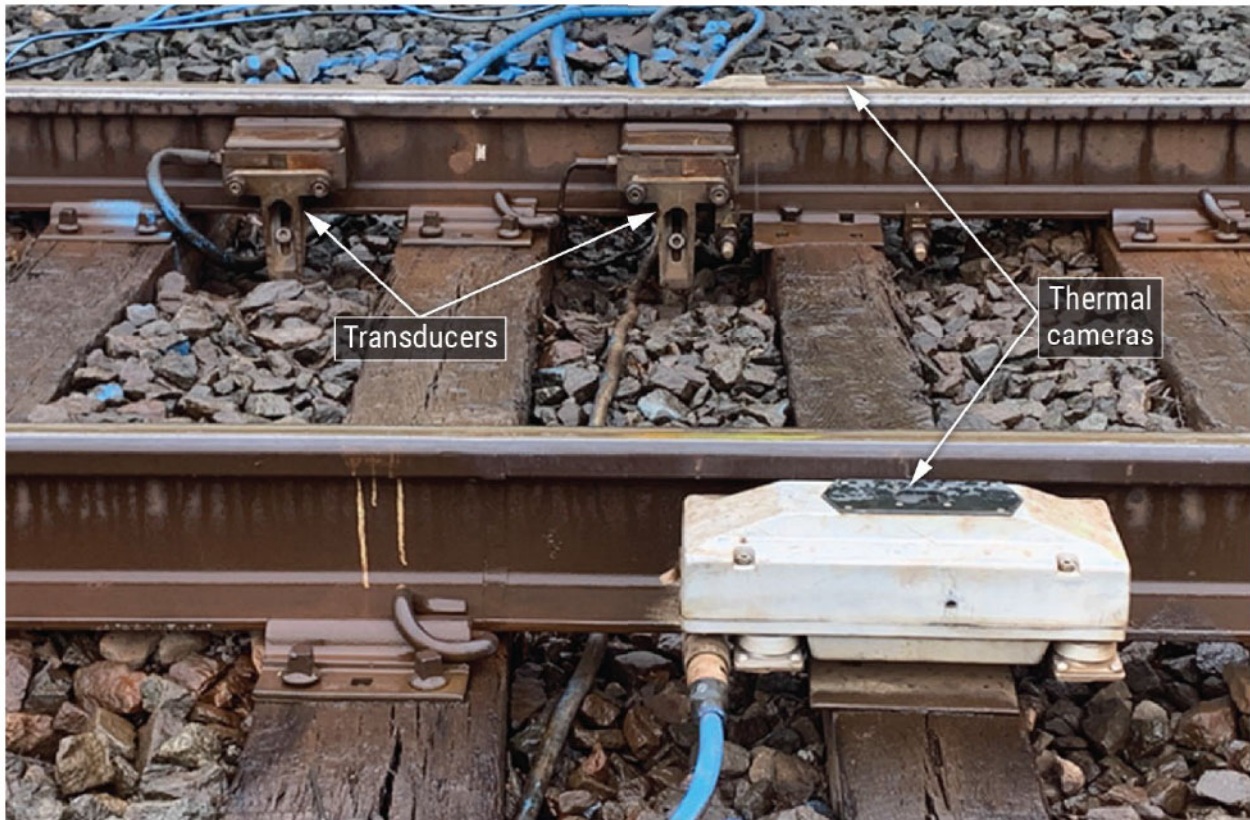
During review of signal data logs, NTSB investigators found that signal maintainers had performed maintenance on the Youngstown Line between Conway Yard and New Castle, Pennsylvania, on May 8, 2023. Maintenance activity included detaching and re-attaching track-mounted components of the HBD at MP 91.9.<sup>10</sup> Postaccident on-scene testing showed that the HBD's transducers were attached incorrectly and reporting reversed train travel directions (that is, a northbound train would be reported as southbound).<sup>11</sup> (See figure 2.) NS's ATC system requires an accurate report of train travel direction to interpret HBD data. Under NTSB investigators' direction, signal maintainers corrected the transducers' positions. In subsequent tests, NS technicians at the ATC desk in Atlanta confirmed that they had received usable HBD data.

**Figure 2.** Photo of the HBD at MP 91.9 on rail track.

Postaccident examinations did not identify conditions that would have prevented the HBD from transmitting an alarm message. However, NTSB investigators reviewed the inward-facing image recorder and audio data from the head-end locomotive of train 14M and did not find evidence of an audible alarm being broadcast over the locomotive radio.
