National Transportation Safety Board

Highway Accident Brief

Fatal Pedestrian Collision with Sport Utility Vehicle Upper Marlboro, Maryland, June 24, 2016

Accident Number: HWY16SH016

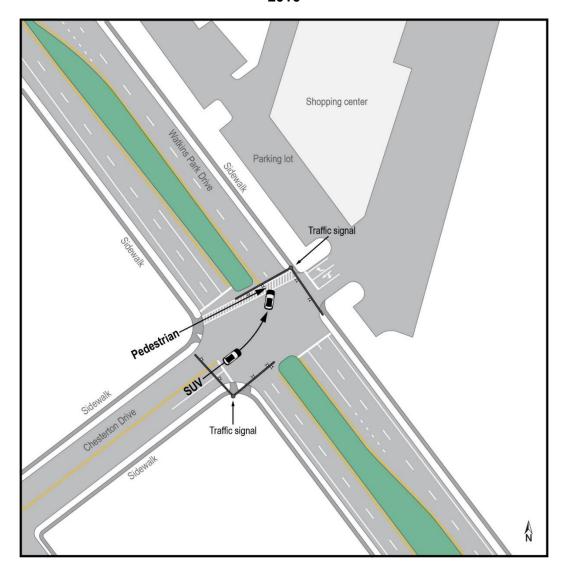
About 12:30 p.m. on Friday, June 24, 2016, a 2010 Cadillac Escalade sport utility vehicle (SUV) operated by a 69-year-old male was stopped for a red traffic signal in the northeastbound travel lane of Chesterton Drive at Watkins Park Drive (State Route 193) in Upper Marlboro, Prince George's County, Maryland. Meanwhile, a 76-year-old male pedestrian was standing on the opposite side of Chesterton Drive, near a pedestrian crosswalk, waiting to cross Watkins Park Drive. When the traffic signal on Chesterton Drive cycled to green and the pedestrian signal cycled to WALK, the driver entered the intersection and the pedestrian entered the crosswalk (figure 1). As the driver made a left turn into the left northwestbound lane of Watkins Park Drive and the pedestrian reached the same lane, the SUV struck the pedestrian while he was in the crosswalk, causing him to fall to the roadway. On colliding with the pedestrian, the driver sharply applied the brakes, stopping the SUV in the left northwestbound lane.

Figure 1. Diagram of crash scene showing path of SUV and pedestrian's path on crosswalk, with exit from parking lot near crash site.

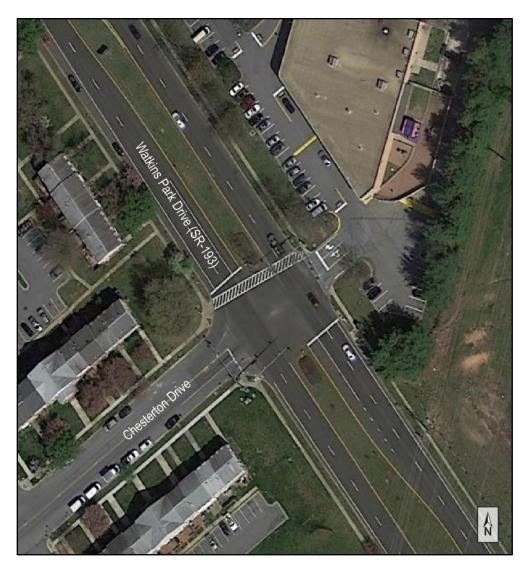
The crash occurred on Watkins Park Drive at its intersection with Chesterton Drive, near the exit from a parking lot (figure 2). Watkins Park Drive is a main traffic artery in the suburban unincorporated community of Upper Marlboro. The area near the crash is mostly residential. The roadway is asphalt and consists of two northwestbound and two southeastbound through lanes. Each through lane is about 11 feet wide. The through lanes in both directions have a left-turn lane

Figure 2. Aerial view of intersection of Watkins Park Drive and Chesterton Drive in Upper Marlboro, also showing parking lot and exit (upper right) near crash site. (Base photo by Google Earth)

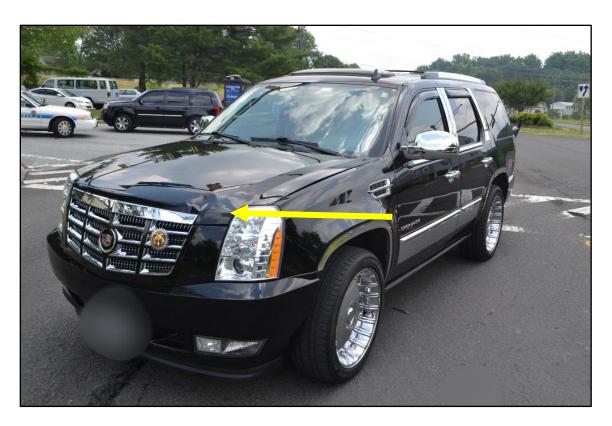
The SUV was examined at the crash scene. It had contact damage on the left leading edge of the hood (figure 3). The grill was cracked, and ornamental trim around the wheel well on the front left fender was bent. No other crash-related damage was noted.

Figure 3. Photograph of front of SUV showing damage to hood (arrow).
