# National Transportation Safety Board

## Highway Accident Brief

### Rear-End Collision Between a Car Operating with Advanced Driver Assistance Systems and a Stationary Fire Truck, Culver City, California, January 22, 2018

| <b>Accident Number:</b> | HWY18FH004 |

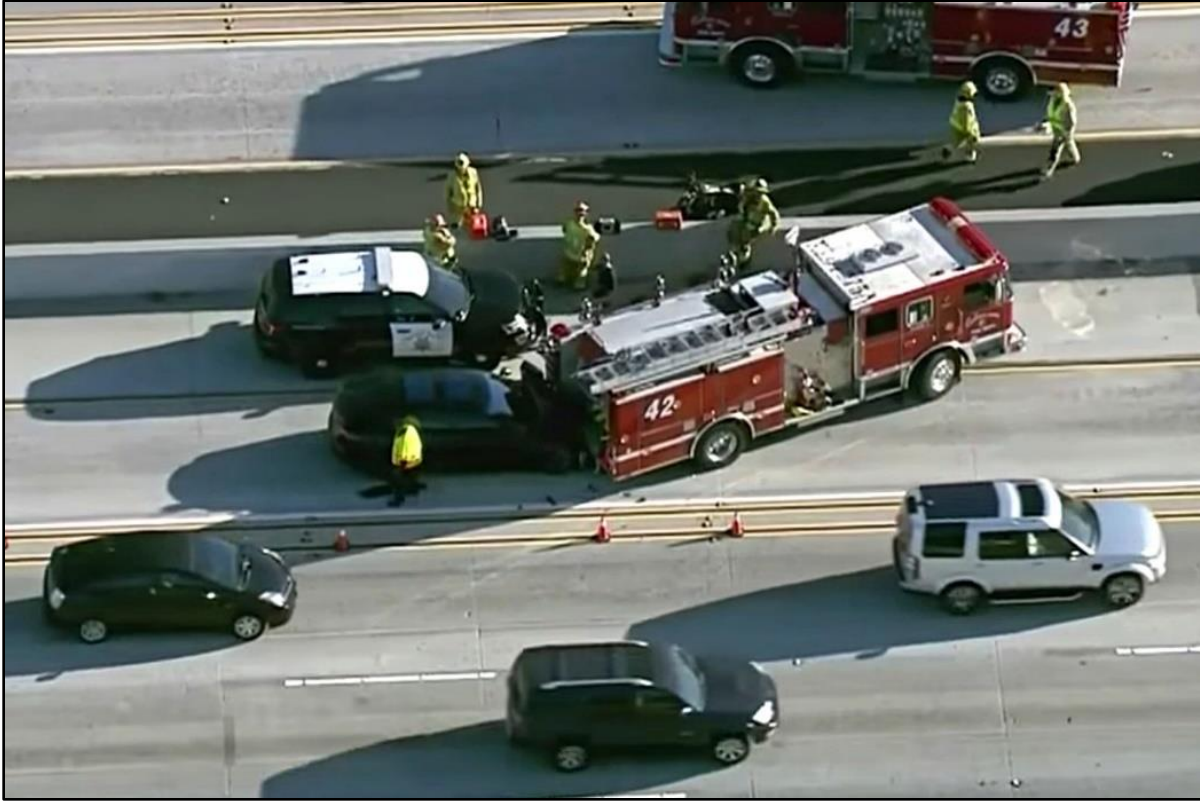
The crash occurred in the southbound HOV lane of I-405, about 350 feet north of Washington Boulevard in Culver City (figure 2). A concrete barrier divides the northbound and southbound lanes.

**Figure 2.** Overhead view of crash scene showing Tesla and fire truck at final rest on southbound I-405. (Source: CHP)

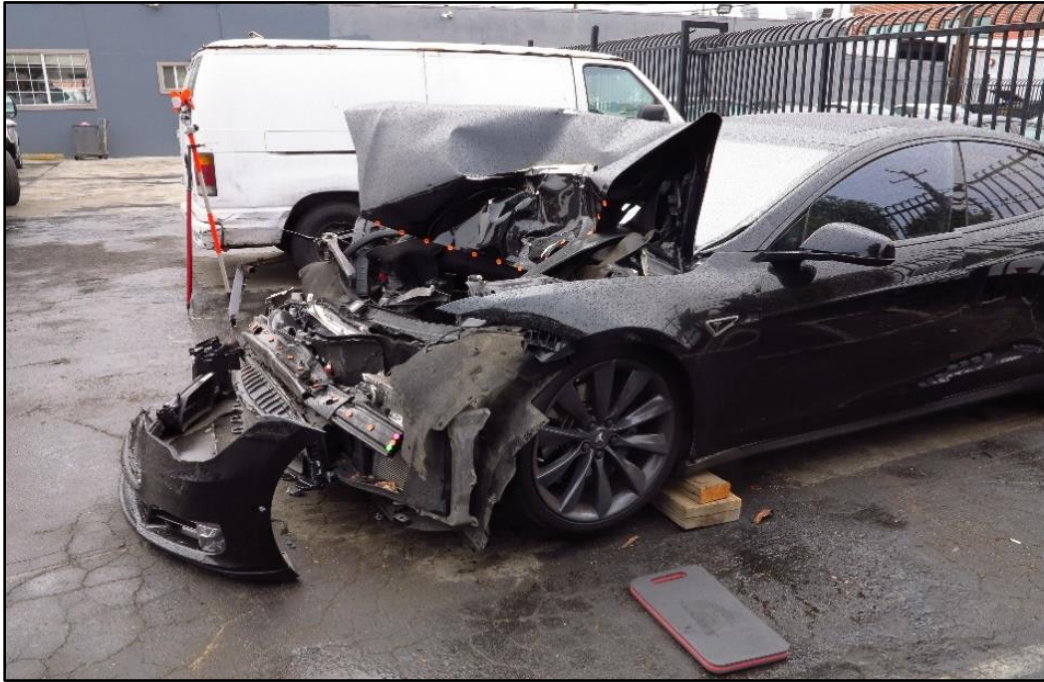
The car sustained front-end damage that extended back from the front bumper to the firewall/dashboard area and was concentrated on the left (driver’s) side (figure 3). The center of the front bumper was rotated upward about 90 degrees from its original mounting position, and a red transfer mark was visible to the right of the centerline. The lower part of the cowl at the

front of the car had separated from the vehicle, and the upper part was imprinted with a pattern that matched the fire truck's rear deck. The hood was crushed back and to the left, compromising the windshield and shattering the glass. The left side of the hood displayed red transfer marks. The left side of the firewall was displaced to the rear, which then displaced the dashboard and instrument panel into the passenger compartment. The left side of the dashboard was touching the top of the steering wheel.

**Figure 3.** Front-end crash damage to Tesla.

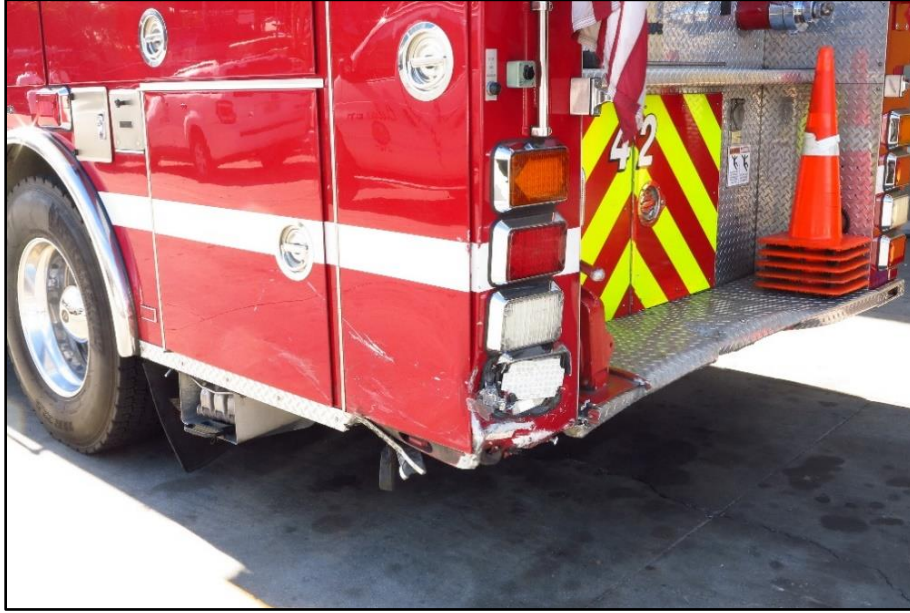
The fire truck sustained damage to the rear deck and the left rear corner (figure 4). The lower part of the left rear corner had crush damage. Gouges, scrapes, and black transfer marks originating at the left rear corner extended forward about 40 inches along the two equipment

compartment doors on that side. The lower part of the compartment door and the left part of the rear deck sustained impact damage. The lens of the lowest red emergency light on the left rear was crushed, but the light was functional.<sup>5</sup> The left side of the rear deck was distorted upward, which prevented the rear compartment doors from opening.

**Figure 4.** Crash damage to rear deck and left rear corner of fire truck.

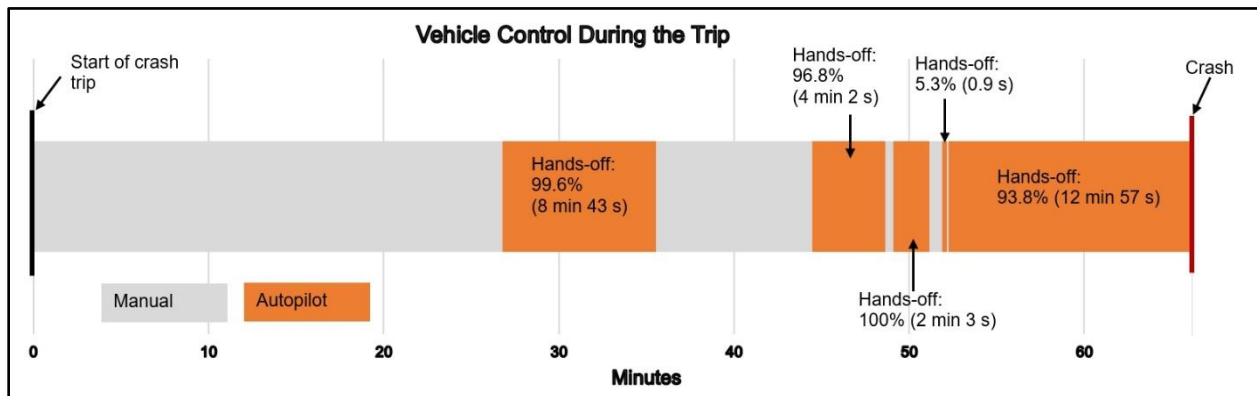
The crash trip lasted about 66 minutes and covered about 30 miles. During the trip, the Autopilot system was engaged for a total of 29 minutes 4 seconds (figure 5). For most of that time, the system did not detect driver-applied steering wheel torque. Hands were detected on the steering wheel for only 78 seconds.

**Figure 5.** Periods of manual and Autopilot control during crash trip, with callouts showing percentage and duration of time driver had hands off steering wheel while Autopilot was engaged.

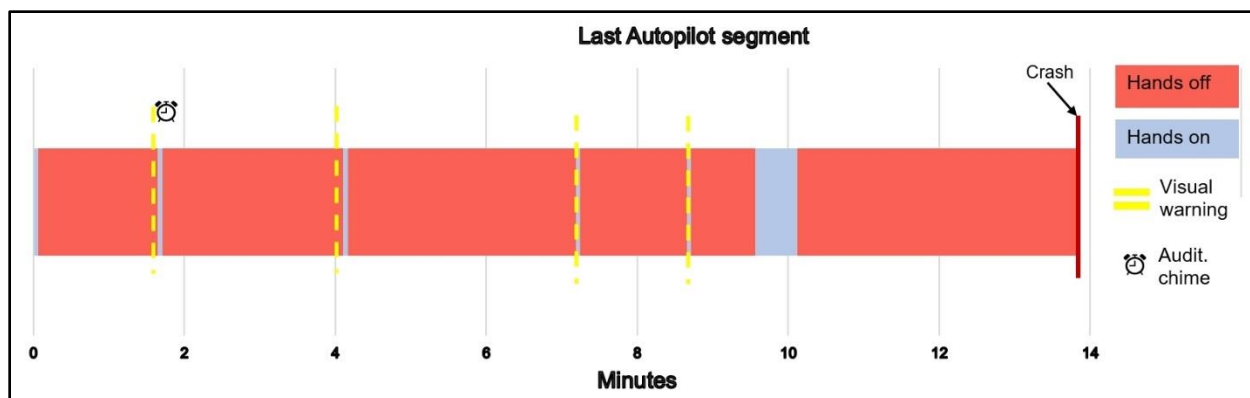
The Autopilot system was engaged continuously in the final minutes of the crash trip. During the last segment, the Autopilot system issued several hands-off alerts. As shown in figure 6, in the last 13 minutes 48 seconds before the crash:

- The system detected driver-applied steering wheel torque for a total of 51 seconds.
- The system displayed a visual PLACE HANDS ON THE WHEEL alert four times.
- The system sounded a first-level audible warning once—after the first visual alert.
- In the last 3 minutes 41 seconds before the crash, the system did not detect driver-applied steering wheel torque. During that time, while following a lead vehicle, the Tesla's speed went below 25 mph. According to the logic outlined above, the system would produce a warning after 10 minutes of hands-off operation when the car was traveling at between 8 mph and 25 mph.<sup>10</sup>

**Figure 6.** Last Autopilot segment of crash trip, showing hands-off warnings and brief periods when driver's hands were detected on steering wheel.

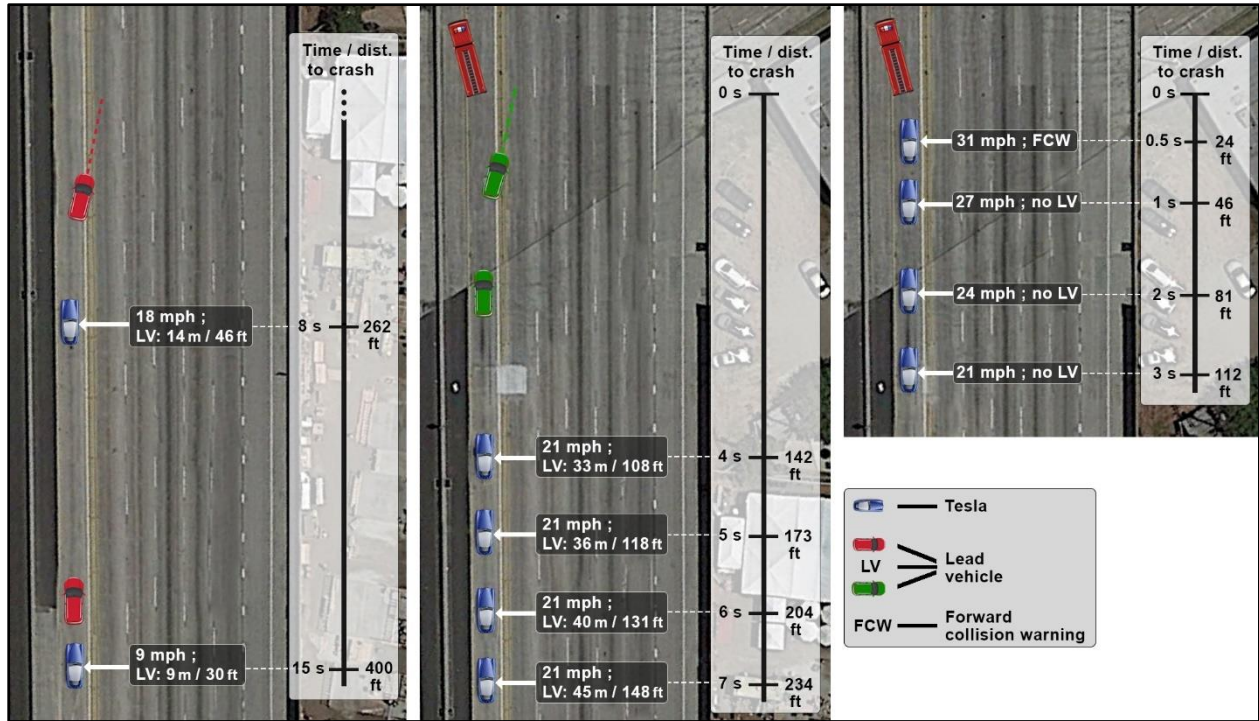
Figure 7 depicts the movement of the Tesla and the two lead vehicles in the last 15 seconds before the crash. In the left panel—covering 15 to 8 seconds before impact—the Tesla is accelerating from 9 to 18 mph while following a lead vehicle (red car) at 30 to 46 feet. In the middle panel—covering 7 to 4 seconds before impact—the Tesla is traveling at a constant 21 mph while following a lead vehicle (green car) at a distance decreasing from 148 to 108 feet. In the right panel—covering the last 3 seconds before impact—the Tesla is accelerating from 21 to 31 mph, with no lead vehicle and a forward collision warning half a second before impact.

**Figure 7.** Illustration of movement of Tesla (blue car) and vehicles traveling ahead in same lane (red and green cars). Time before crash is 15 to 8 seconds (left image), 7 to 4 seconds (middle image), and 3 to 0 seconds (right image). Shown are approximate vehicle positions and Tesla's speed and distance to closest lead vehicle (LV). Red fire truck is shown at top of middle and right panels.

AEB did not activate during the event, and data show no driver-applied braking or steering before the crash. Tesla's AEB is a radar/camera fusion system that is designed for front-to-rear collision mitigation or avoidance. According to the company, the system requires agreement from both the radar and the camera to initiate AEB; complex or unusual vehicle shapes can delay or prevent the system from classifying vehicles as targets or threats.
