Stretch Limousine Run-Off-Road Crash
Near Schoharie, New York
October 6, 2018

NTSB/HAR-20/03
PB2020-101008

Highway Accident Report

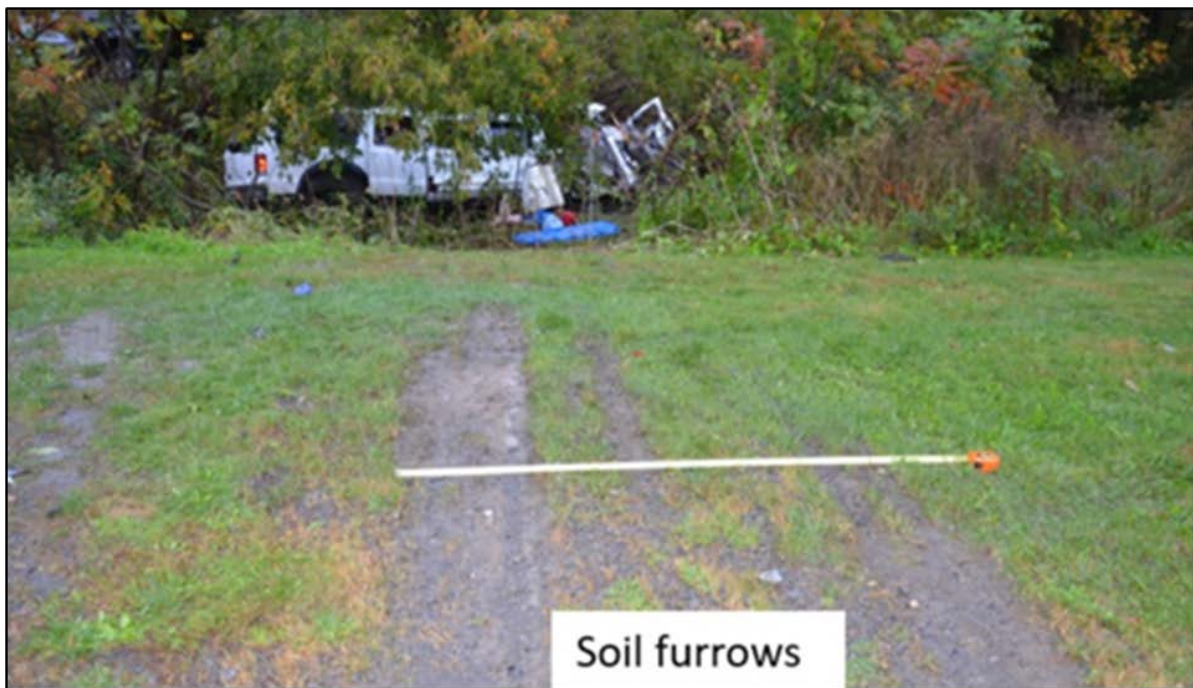
Store restaurant. The initial area of impact was identified by linear soil furrows beginning about 38 feet south of the highway edge.⁹ (See figure 6.)

Figure 6. Southbound view of soil furrows leading to limousine area of rest.

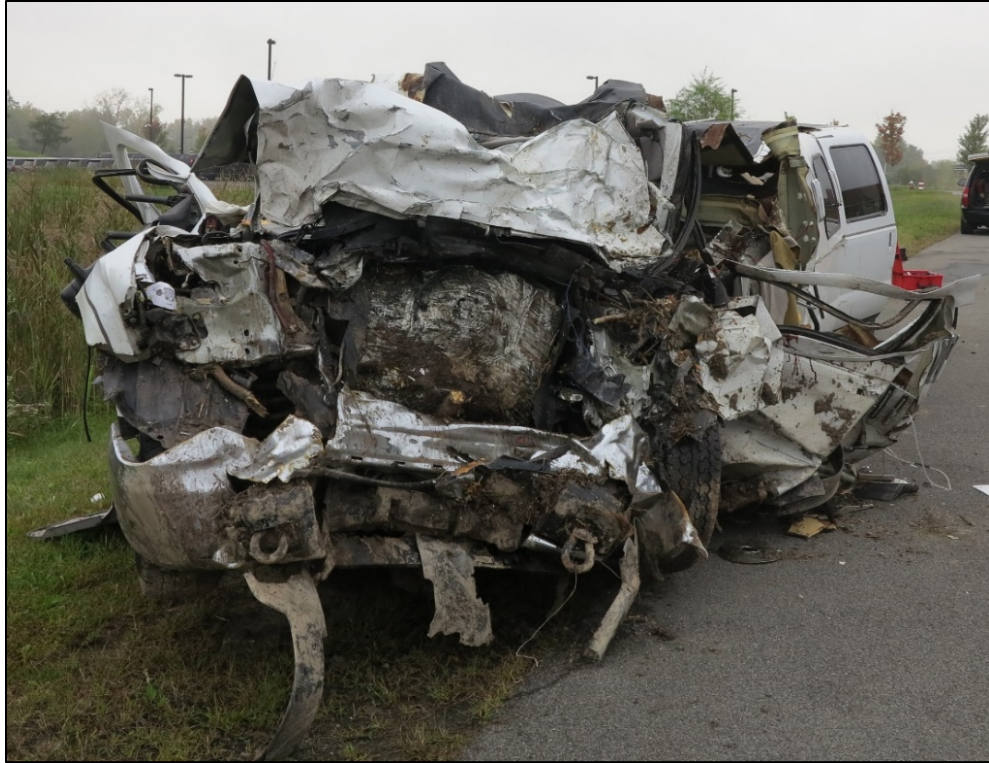
Figure 9. Postcrash front view of limousine (not in final rest position).

There was a complete loss of occupant survival space for the driver and front passenger seating positions, and partial intrusion into the left front corner of the rear passenger compartment. Figure 11 shows a driver-side and overhead view of the limousine created by 3D scans of the vehicle. Portions of both views have a yellow outline that roughly represents the original structure of the limousine before the crash. The red-shaded areas represent the approximate regions of intrusion and compromised survival space. The green-shaded areas highlight the portions of the limousine that remained relatively intact and where survival space was maintained in the vehicle structure.

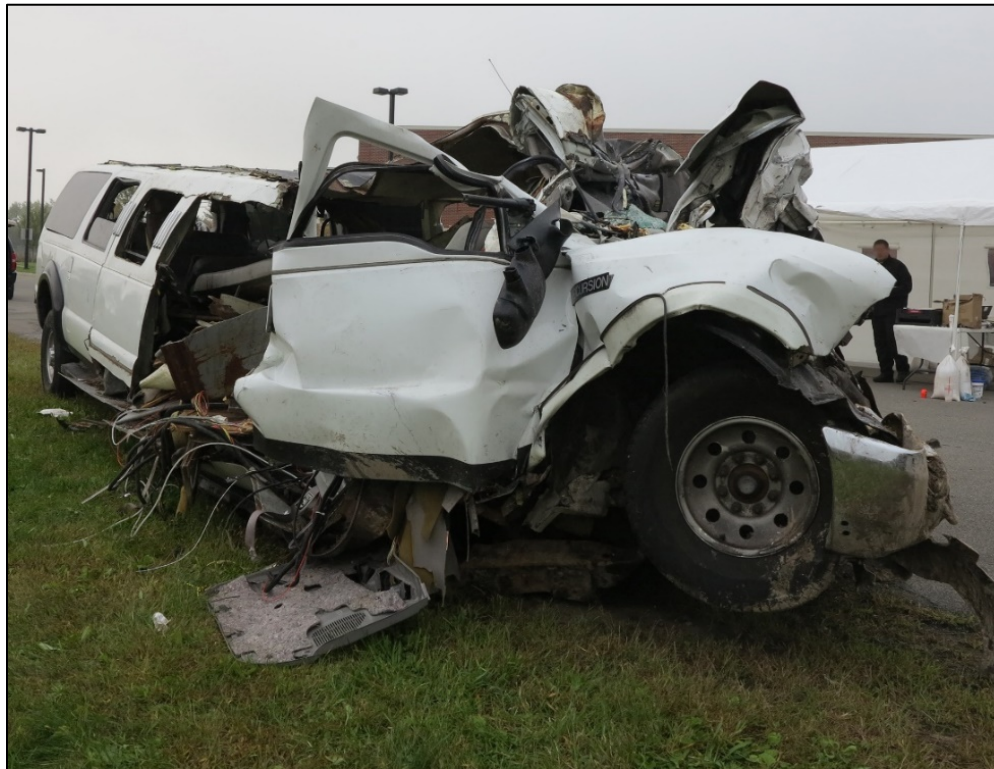
Figure 10. Postcrash passenger side view of limousine (not in the crash final rest position).

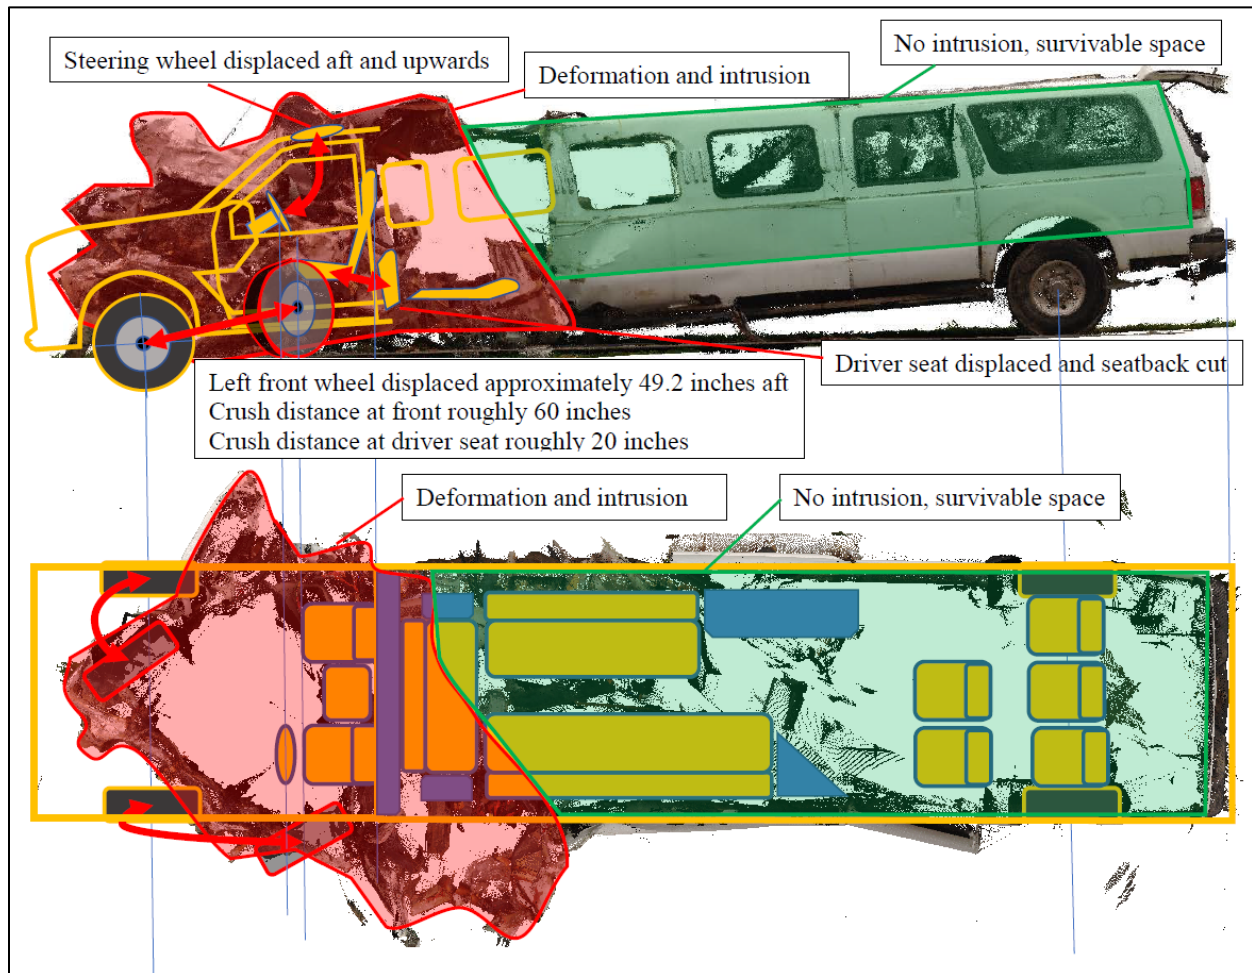
Figure 11. Diagrams of limousine crash damage. Top image shows side view postcrash 3D image of limousine with overlaid reconstruction of vehicle's precrash structure. Bottom image shows overhead view of postcrash 3D image of limousine with overlaid reconstruction of vehicle's precrash structure.

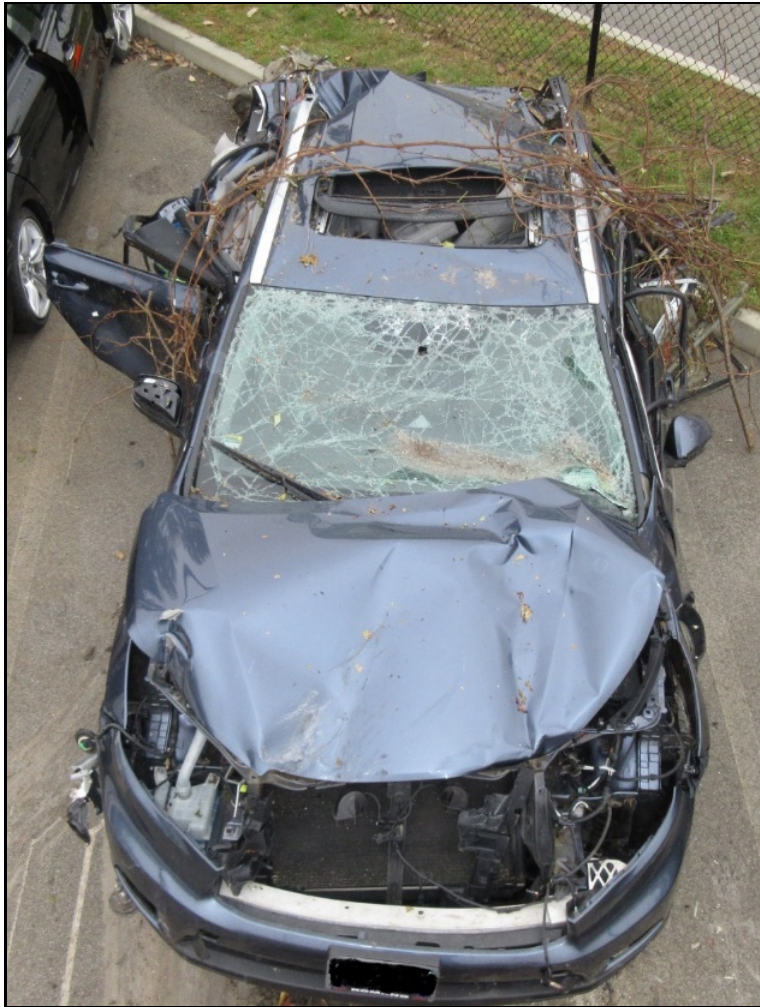
1.5.1.2 Toyota Highlander SUV. The unoccupied, parked SUV sustained extensive rear-end impact damage. The rear axle and body structure were pushed forward, decreasing the vehicle's length by about 48 inches.¹⁵ Additional contact damage and rearward displacement was observed to the SUV's hood (see figure 12). The leading edge and upper surface of the hood showed distinct areas of direct contact. The upper radiator support and surrounding features also showed rearward displacement. The front windshield was fractured, with the cracks showing characteristics of direct contact damage.

Figure 12. Front overhead view of Toyota SUV depicting damage to hood, windshield, and roof. (Windshield shows evidence of impact with the ground during crash event.)

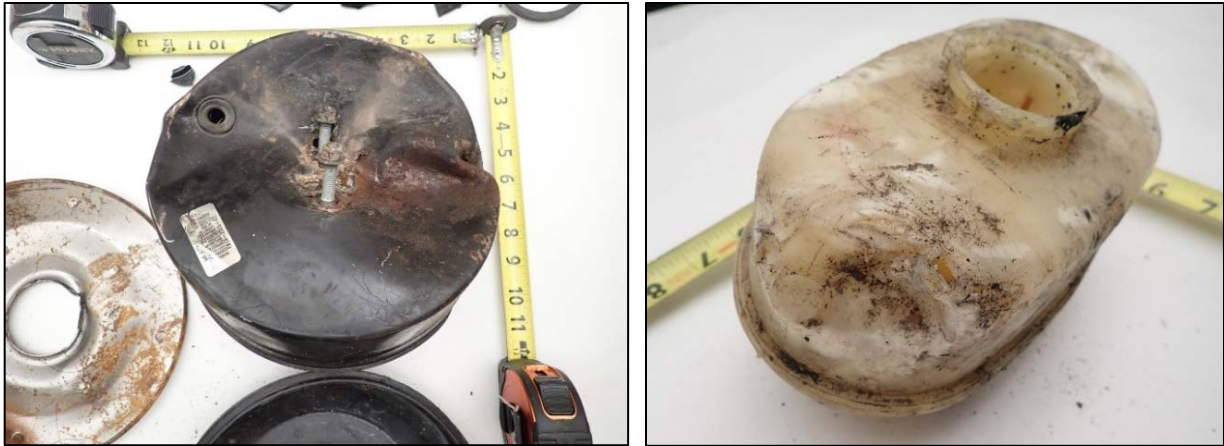
Figure 18. Photographs of brake components, postcrash. Left photo shows damaged power brake vacuum booster. Right photo shows damaged plastic brake fluid reservoir. (Source: NYSP)

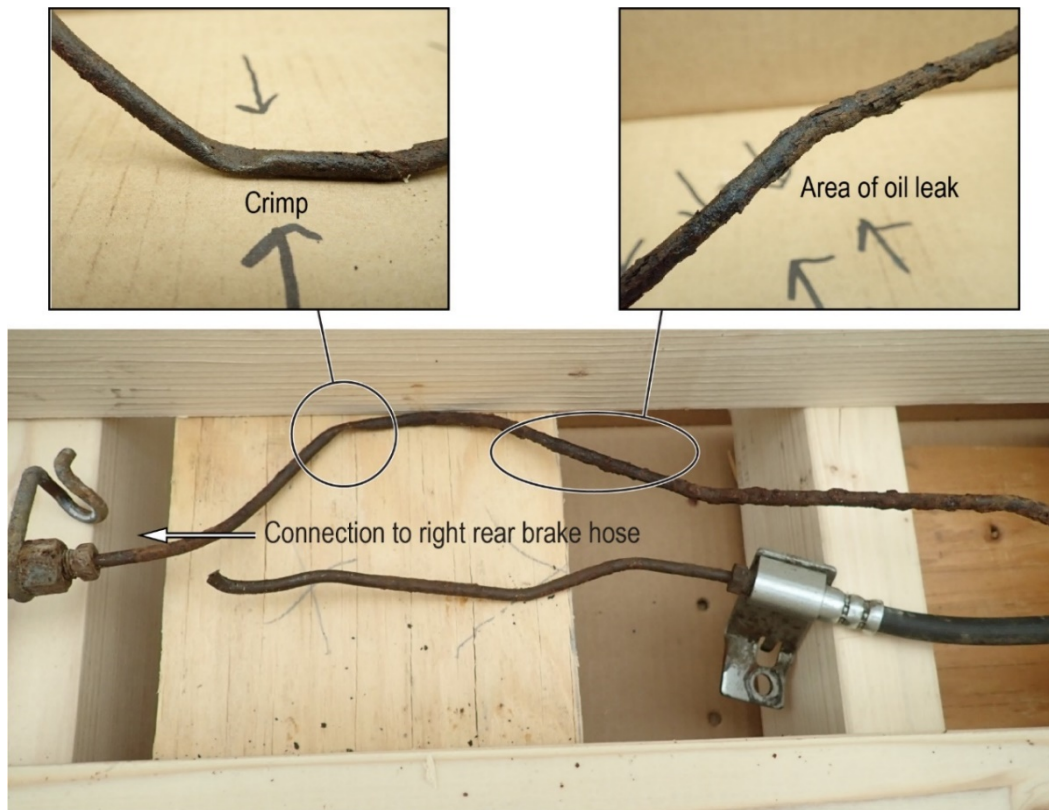
- Steel brake line.** The steel brake line (tubing) attached to the right of the rear differential housing was corroded, as evidenced by spalling and flaking of the surface corrosion scaling.⁴¹ The brake tubing was coated in oil consistent with brake fluid, which indicated that, at some point, this area of the brake line experienced a leak. Although NTSB investigators did not have the opportunity to conduct a laboratory examination of the brake line, they observed more fluid near the section of the line with the greatest corrosion damage. On this basis, it appeared likely that the leak from the brake line was a preexisting condition rather than crash damage.⁴² In addition to the corrosion, the tubing exhibited a crimp near the connection to the right rear flexible rubber brake hose.⁴³ The crimp was downstream of the oil flow, which would have reduced the amount of brake fluid that could flow to the rear brakes, potentially affecting braking performance (see figure 19). No service records or vehicle inspection notes indicated a crimp; however, the uniform corrosion on the crimped region is consistent with the crimp having been present before the corrosion occurred—a preexisting condition.

Figure 19. Photographs of brake line segments, postcrash. Left top photo shows crimp in brake line (downstream of oil flow) that was attached near right rear brake assembly. Right top photo shows corroded steel brake tubing with an area of brake fluid coating. Bottom photograph shows locations of both brake line segments. (Source: NYSP, with NTSB labels added)

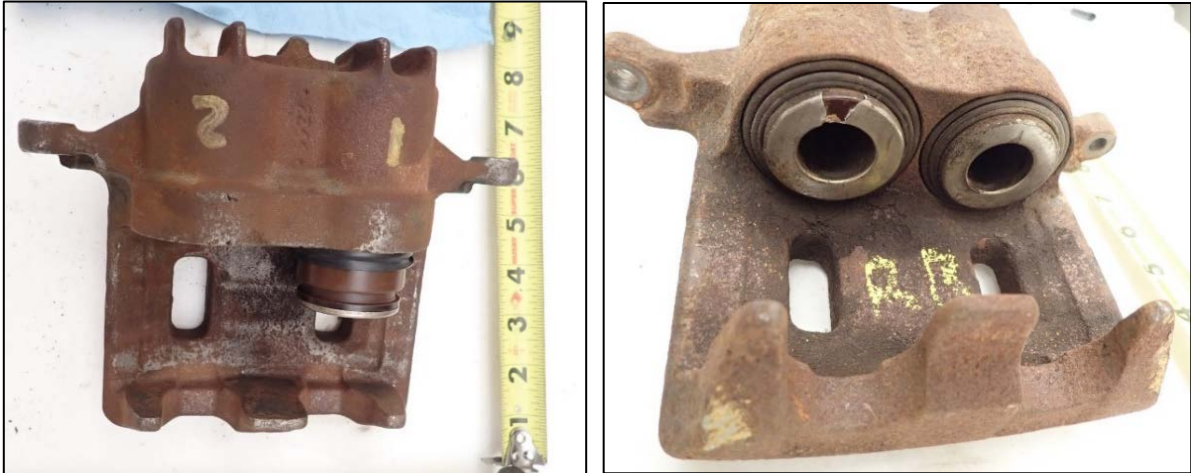
- Rear brakes.** Both the right and left rear brake calipers and slide pins showed evidence of corrosion across all surfaces. The two pistons on the right rear caliper appeared to be seized (frozen) in place.⁴⁴ One of the pistons on the left rear caliper was extruding from the piston bore and appeared to be binding within the bore (see figure 20). NTSB investigators did not have the opportunity to examine the brake components further to determine whether the corrosion resulted in the seized pistons or whether the pistons seized due to lack of the movement from a loss of brake fluid. The thicknesses of the rear brake pads and rotors were within federal commercial vehicle regulatory specifications. Both rear rotors were corroded and had scoring to the inner and outer swept brake rotor surfaces. The left rear disc brake pads, both inner and outer, were in good condition, with little to no evident wear. The right rear disc pads were corroded, and the friction material showed uneven wear.

⁴⁴ The right rear caliper was of an older design, and its pistons were composed of steel rather than having the phenolic (plastic) composition of the pistons in the left rear, right front, and left front calipers. Assuming that both pistons for the right rear caliper were seized in place before the crash, there would have been no braking at the right rear brake assembly. Functional testing would be required to determine the extent to which the pistons were seized in place.

Figure 20. Photographs of brake calipers, postcrash. Left photo shows left rear brake caliper with one piston extruding from piston bore. Right photograph shows right rear brake caliper with both pistons seated within piston bores.

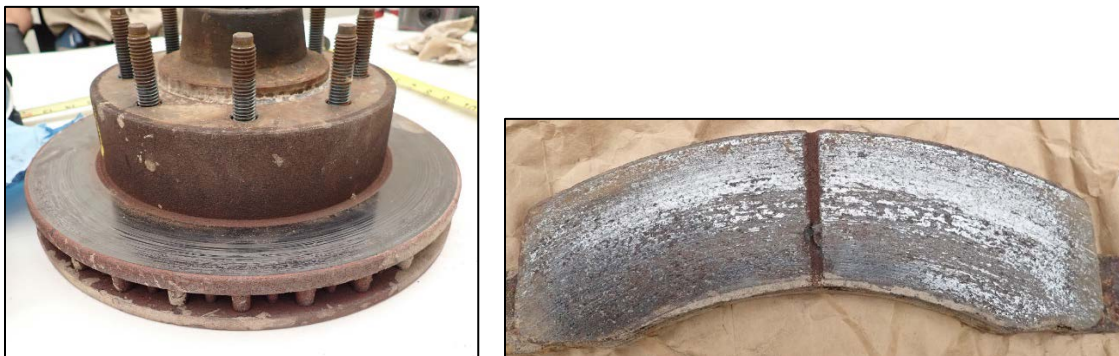
- Front brakes.** When examining both the left and right front brake components, NTSB investigators detected an odor of burned materials.⁴⁵ The brake pads were corroded and displayed uneven wear patterns, glazing, and deterioration of the friction surfaces (see figure 21). The brake rotors were corroded across all areas except the swept surfaces, which appeared to contain embedded friction material from the pads. All brake component measurements (pads and rotors) were within commercial vehicle regulatory specifications.

Figure 21. Photographs of right front disk brake rotor and inner right front brake pad surface. Left photo shows right front disc brake rotor with corrosion and swept surfaces. Right photo shows the inner right front brake pad surface with corrosion and uneven wear patterns, glazing, and deterioration.

⁴⁵ The NYSP troopers who responded to the crash told NTSB investigators (recorded in investigators' field notes) that they had detected a strong odor of overheated brakes at the crash scene.
