Multivehicle Work Zone Crash on Interstate 95
Cranbury, New Jersey
June 7, 2014

Accident Report

NTSB/HAR-15/02
PB2015-105186

**National
Transportation
Safety Board**

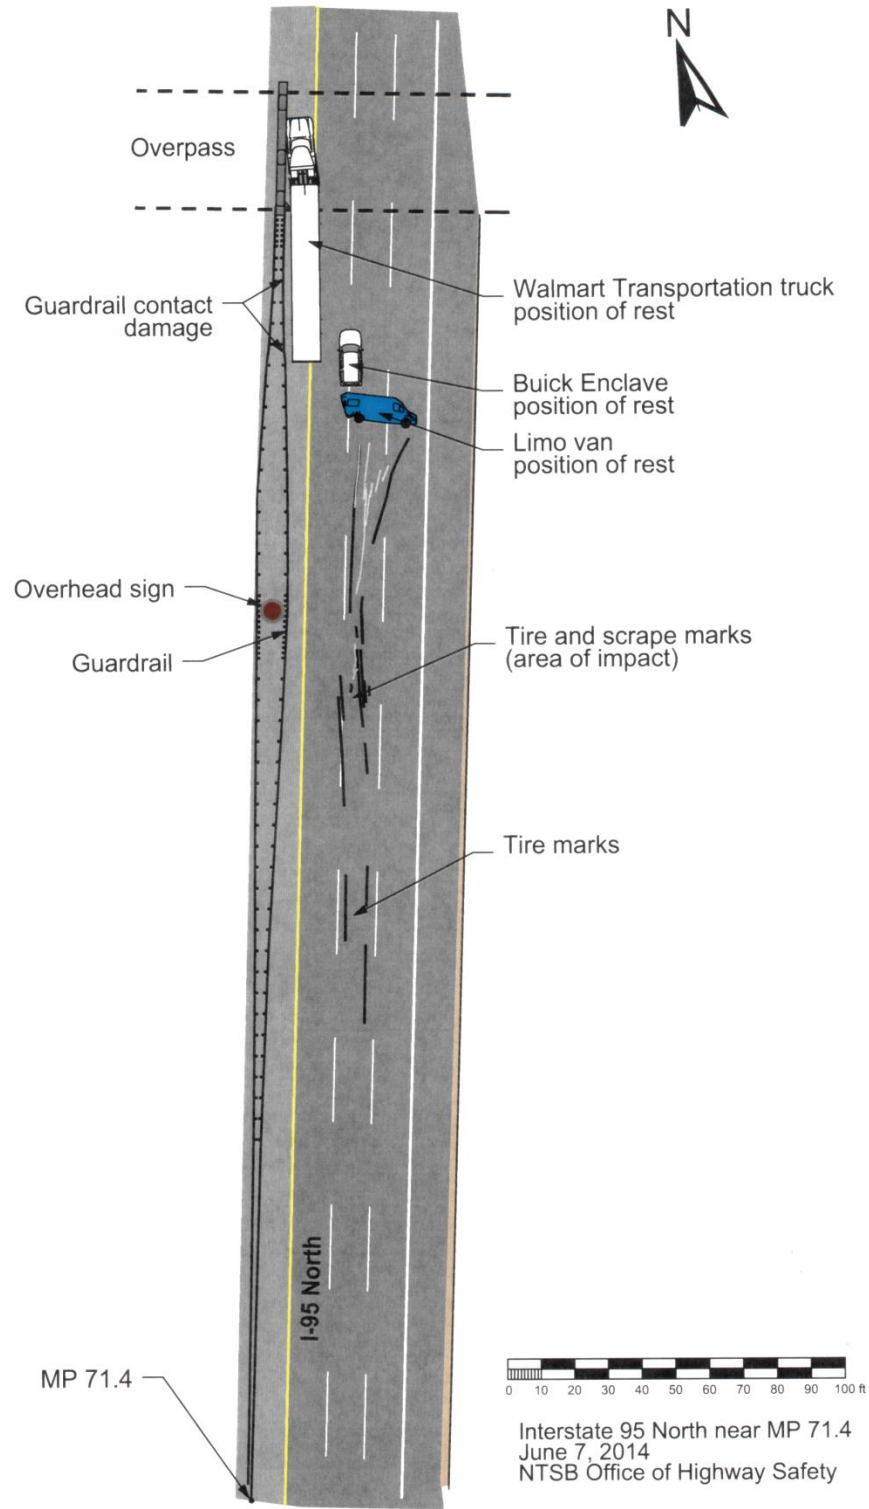
Figure 2. Crash area diagram showing final at-rest positions of the limo van, Buick Enclave, and Walmart Transportation truck. (The Freightliner truck, Ford F-150 pickup truck, and Nissan Altima all came to controlled stops farther north of the crash site, and they are not included in the diagram.)

The crash event consisted of a rapid succession of five impacts, involving six motor vehicles, concluding with the Walmart Transportation truck's running into a fixed concrete barrier. The primary impact occurred when the Walmart Transportation truck struck the limo van. The impact from the Walmart Transportation truck accelerated the limo van forward and rotated its front into the right lane, where it collided with the left side of a 2006 Freightliner tractor-trailer.⁷ Contact damage indicated that the limo van was upright at the time of initial contact with the Freightliner. The presence of undercarriage gouging ahead of the right front wheel indicates some degree of sustained contact between the two vehicles, and the forward movement of the Freightliner at the time of impact contributed to the limo van's rolling over. During the limo van's rotation, its left front end struck the rear of a white 2011 Buick Enclave, which struck the outboard edge of the rear bumper of a white 2011 Ford F-150 XLT crew cab pickup truck; both of these vehicles were traveling in the center lane. The limo van rolled over onto its left (driver) side before coming to rest across the center lane. After striking the limo van, the Walmart Transportation truck continued into the left lane and struck a gray 2005 Nissan Altima in the left rear before colliding with a guardrail to the left of the travel lanes and coming to rest. Figure 1 shows the location of the crash. Figure 2 provides a diagram of the crash location and the at-rest positions of the Walmart Transportation truck, Buick Enclave, and limo van.

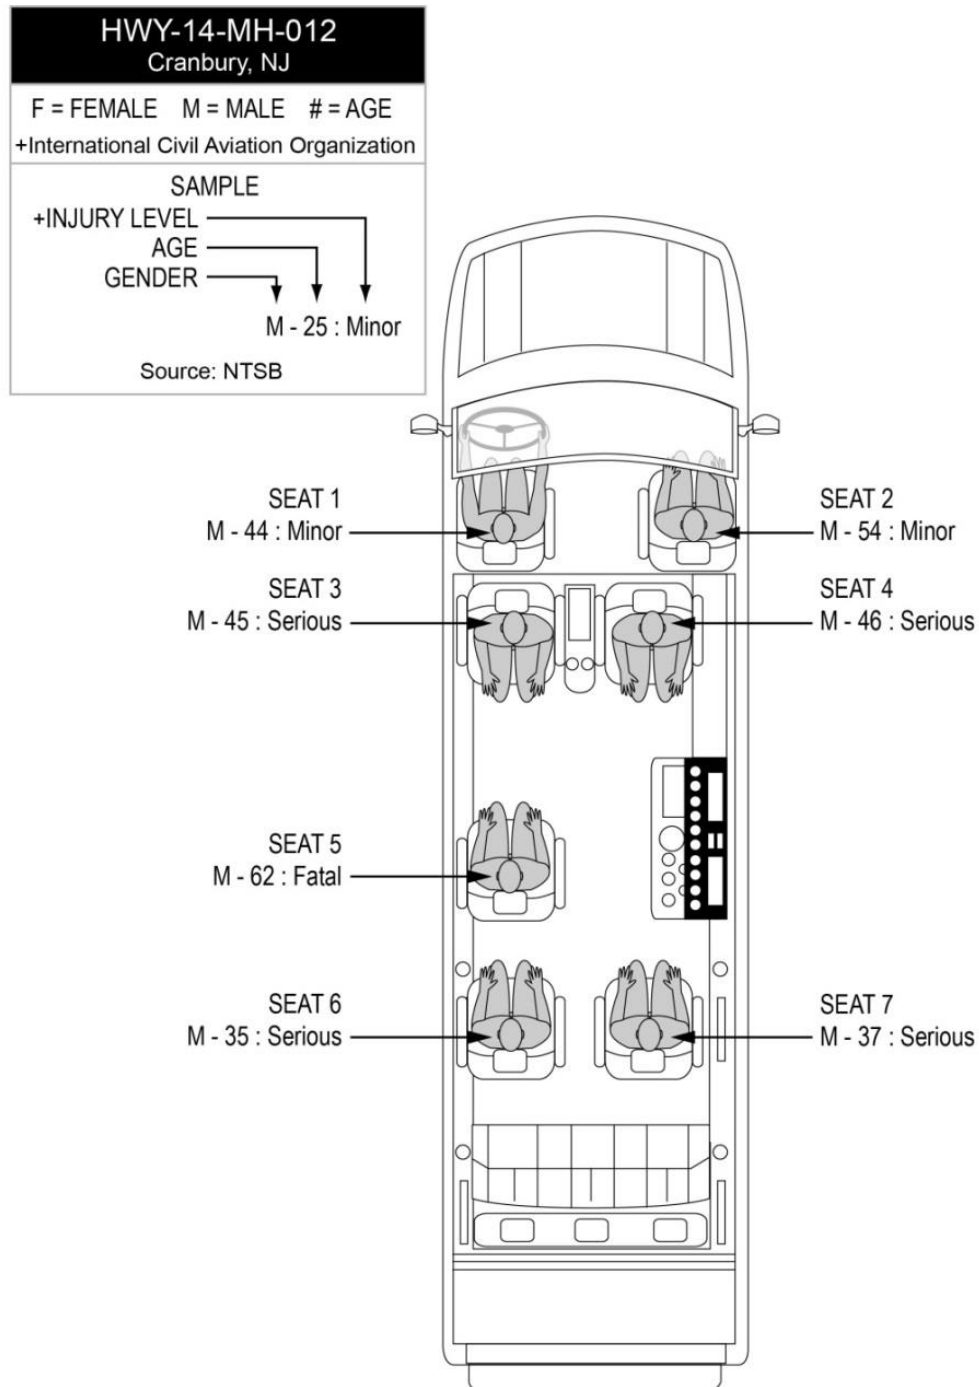
Figure 3. Interior of the limo van, showing the occupant locations and injury information.

The seating positions of the passengers in the separate passenger compartment in the back of the limo van were established based on physical evidence and interviews with the limo van driver and the passenger who occupied seat 7. The agencies that provided care or transport to the limo van occupants are detailed in table 2.

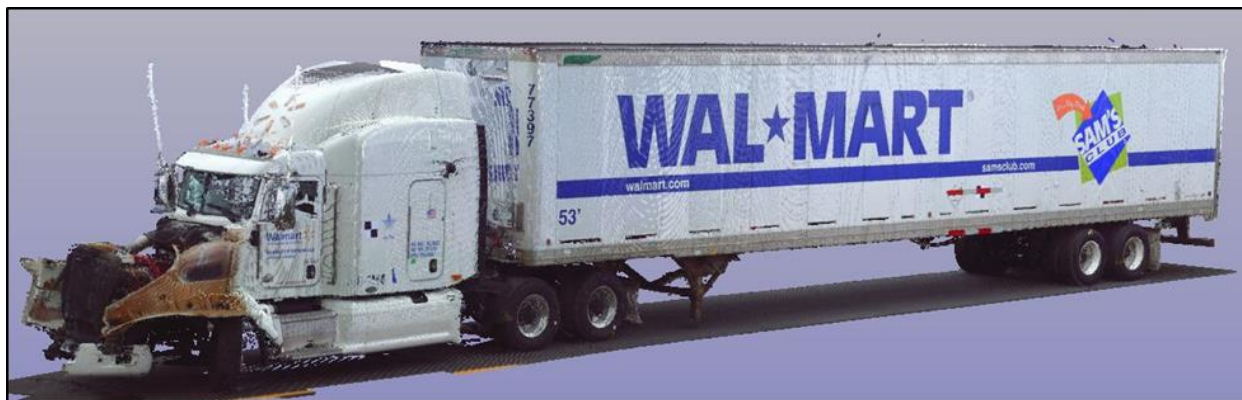
Figure 4. Three-dimensional scan image showing damage to the Walmart Transportation truck from the driver side.

Damage. The Peterbilt truck-tractor sustained extensive front end damage, which displaced the hood and fenders. The semitrailer experienced relatively little damage. (See figure 4 for an image of the postcollision condition of the Walmart Transportation truck.)

The wheel assembly of the left front steer axle was rotated to the left, outward, about 60 degrees and displaced rearward about 10–11 inches. The right front wheel was at an angle approximately 45 degrees inward from the right side of the truck-tractor. Postaccident rotation of the steering wheel did not move the front axle wheels, due to damage at the connection of the steering input shaft to the steering gear box. Examination of the damage to the steering gear box determined that the front wheels were 8.3 degrees to the left when the Walmart Transportation truck struck the limo van.

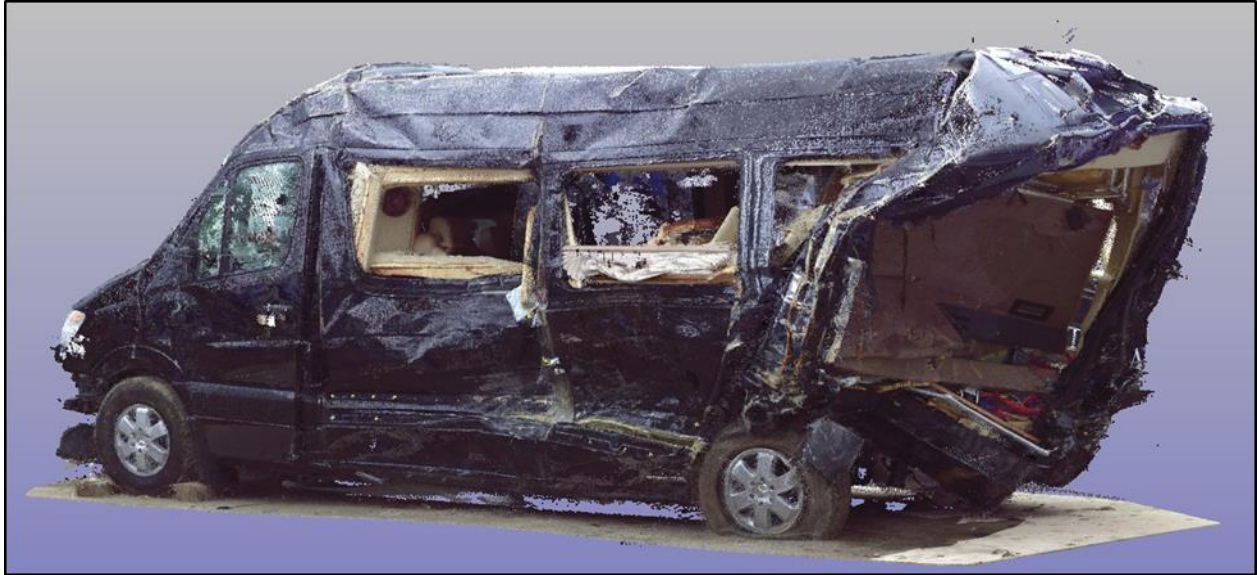
Figure 7. Three-dimensional scan image showing damage to the limo van from the driver side.

Damage. The vehicle exterior had three distinct areas of damage—to the rear, the left (driver) side, and the right front. Severe impact damage crushed the rear of the van. The rear doors were crushed and found with the center latch closed; the hinges showed signs of being cut. The rear door windows were broken out. In addition to the forward displacement of the structure, the vehicle body exhibited a lateral shift toward the left.

The driver side of the limo van was crushed inward along its entire length, with heavy scraping, and all the windows were broken out. The right (passenger) side front fender was crushed inward, and the right front door was dented. The sliding door on the right side had damage and dents and was not operational. The windshield was missing, and the windshield frame was distorted.²⁴ (See figure 7.)

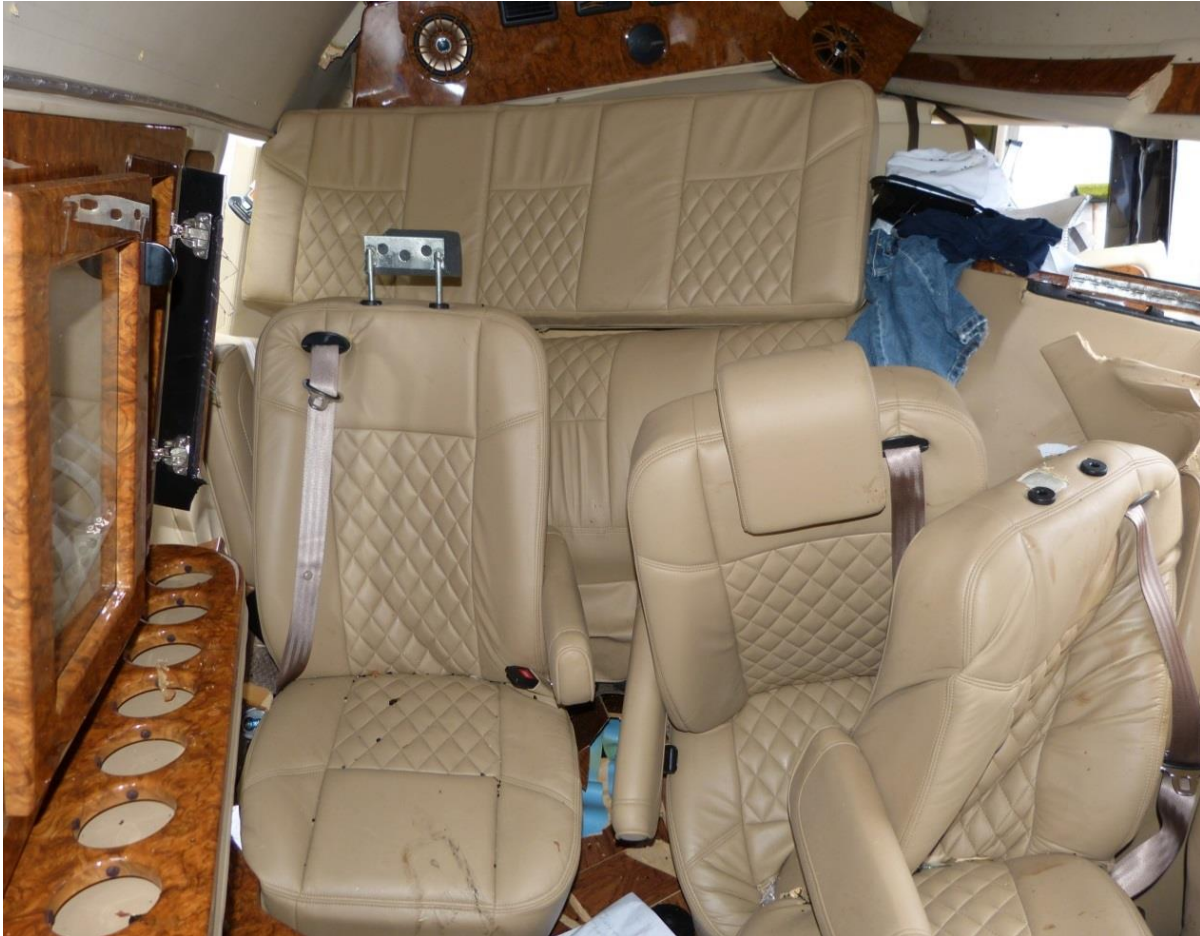
Figure 8. Postaccident view of the interior of the limo van, looking back into the passenger seating area.

In the passenger compartment, the left front (seat 3) captain's chair in row 1 was deformed on the outboard side and in contact with the intruding left sidewall. (Refer to figure 3 to view the seating diagram.) The right-side seat in row 1 (seat 4) was intact, and the mounting attachments for both row 1 seats were intact. The single forward-facing seat in row 2 (seat 5) was displaced inward by the intruding side panel, and the seat and mounting points sustained significant damage. The two forward-facing row 3 seats (seats 6 and 7) were heavily damaged and displaced. The three-position bench seat at the rear of the compartment was displaced upward and into the row 3 seats, with its cushion and backrest flattened. (See figure 8 for a photo of the interior.) In the cab, the driver and front passenger seats showed little damage.
