Medium-Size Bus Roadway Departure,  
Return, and Rollover  
Bryce Canyon City, Utah  
September 20, 2019

NTSB/HAR-21/01  
PB2021-100917

# Highway Accident Report

**Abstract:** On September 20, 2019, a medium-size bus was traveling east on Utah State Route 12, a two-lane highway, near Bryce Canyon City, Utah. The bus was occupied by a 60-year-old driver and 30 passengers. Near mile marker 10.4, at a vehicle-recorded speed of about 64 mph, the bus's right wheels departed the right edge of the roadway. The driver steered left to return the bus to the roadway, a maneuver that redirected the bus into the westbound travel lane. The driver then steered sharply to the right, causing the bus to become unstable. It rolled 90 degrees, or a quarter turn, onto its left side. The bus slid on its left side until its roof struck the guardrail end treatment along the side of the westbound roadway and rolled over the guardrail, coming to rest on its wheels. No other vehicles were involved in the crash. Four passengers were fatally injured, 17 sustained serious injuries, and 9 sustained minor injuries. The bus driver was not injured. The safety issues discussed in the report of the crash concern t

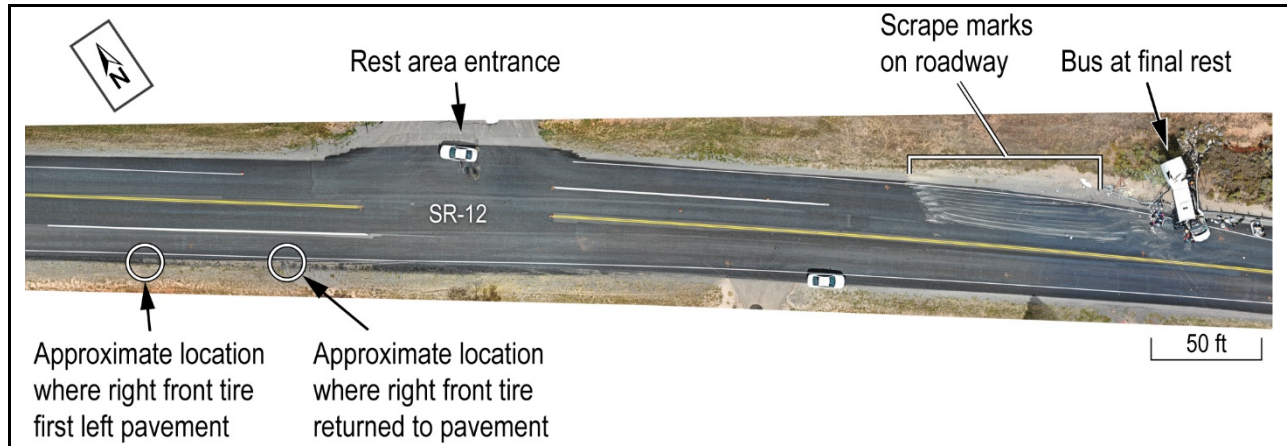
In the area where the bus was traveling, SR-12 is a two-lane undivided roadway with a slight curve to the right for eastbound traffic (see figure 2 for an orthomosaic aerial image of the crash scene).<sup>3</sup> The eastbound lane widens to create a dedicated left-turn lane for traffic entering a rest area to the north of the roadway. The westbound lane widens to create a dedicated right-turn lane for traffic entering the rest area. The posted speed limit in the area is 65 mph.

**Figure 2.** Orthomosaic aerial image of crash scene on SR-12. (Source: Utah Highway Patrol, with labeling added by the NTSB)

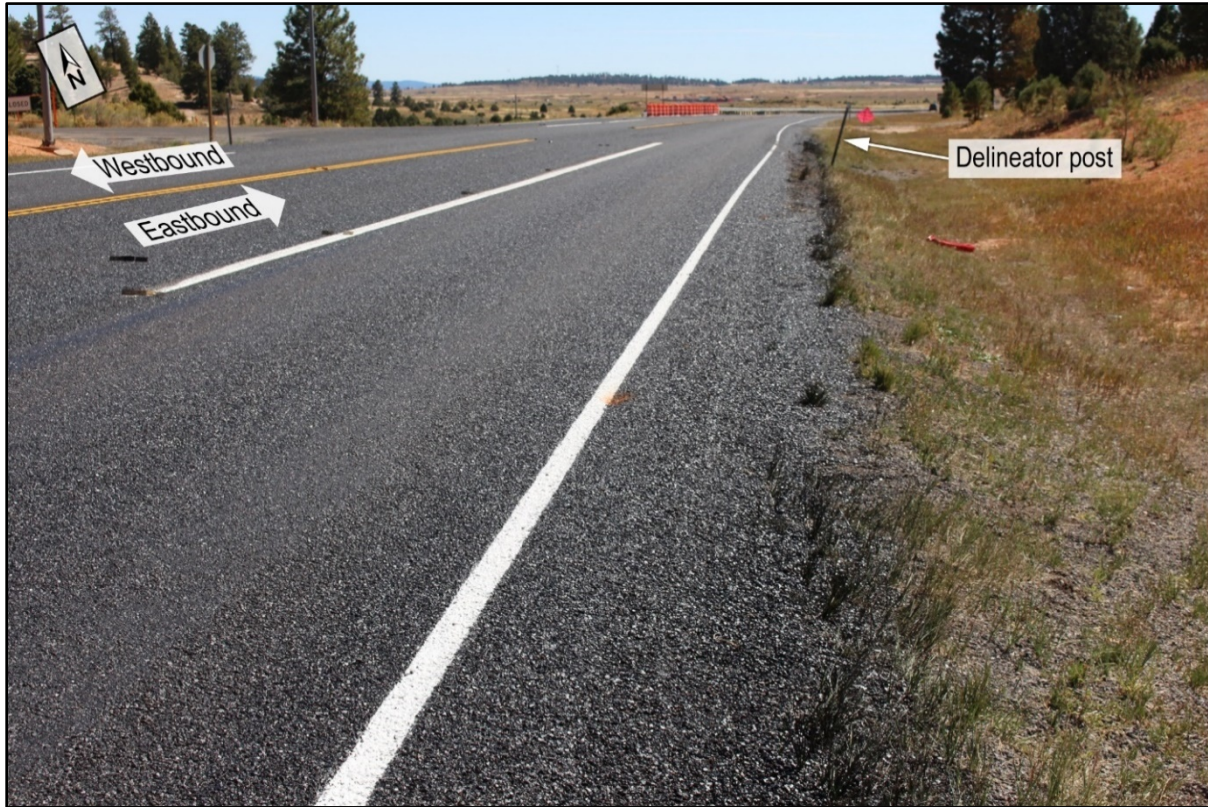
Near mile marker 10.4, at a vehicle-recorded speed of 64 mph, the right-side wheels of the bus departed the right edge of the roadway (see figure 3).<sup>4</sup> The bus driver steered the bus to the left and returned it to the roadway, redirecting the bus into the westbound travel lane. A delineator post that was struck (sideswiped) by the bus as it returned to the roadway is indicated in figure 3.

**Figure 3.** Location where bus left roadway and then returned, with struck delineator post indicated by arrow and label.

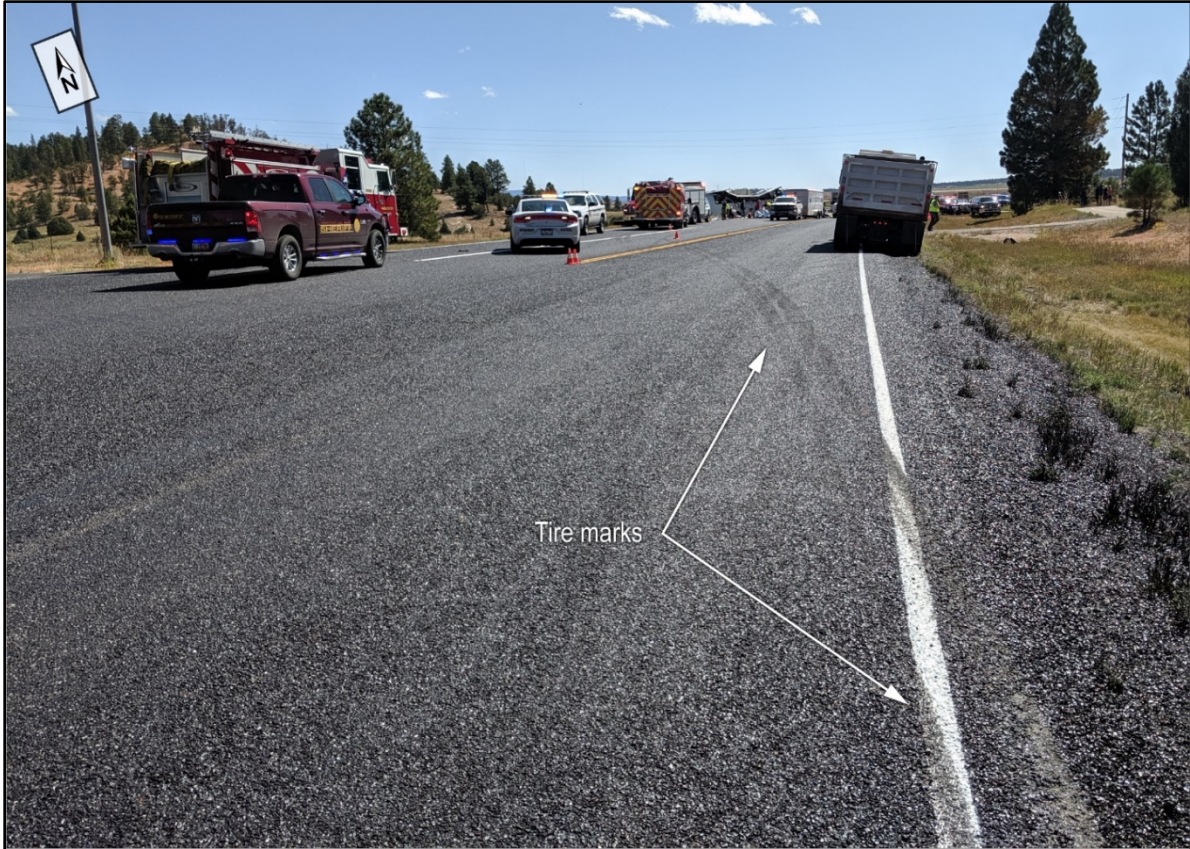
Figure 4 shows tire marks from the bus as it returned to the roadway. The driver then steered sharply to the right, causing the bus to roll 90 degrees (or a quarter turn) onto its left side in the westbound lane. (Figure 5 shows the tire marks from the bus as the driver overcorrected to the right.) The bus slid on its left side for about 85 feet (see figure 6 for gouge marks) until its roof struck the guardrail end treatment next to the westbound travel lane (see figure 7). The bus continued to roll over the guardrail another three-quarters of a turn, landing about 43 feet farther east and coming to rest upright on its tires on top of the guardrail, having completed one full roll during the crash.

**Figure 4.** Tire marks curving across eastbound travel lane after bus departed roadway and was steered back. (Source: Utah Highway Patrol)

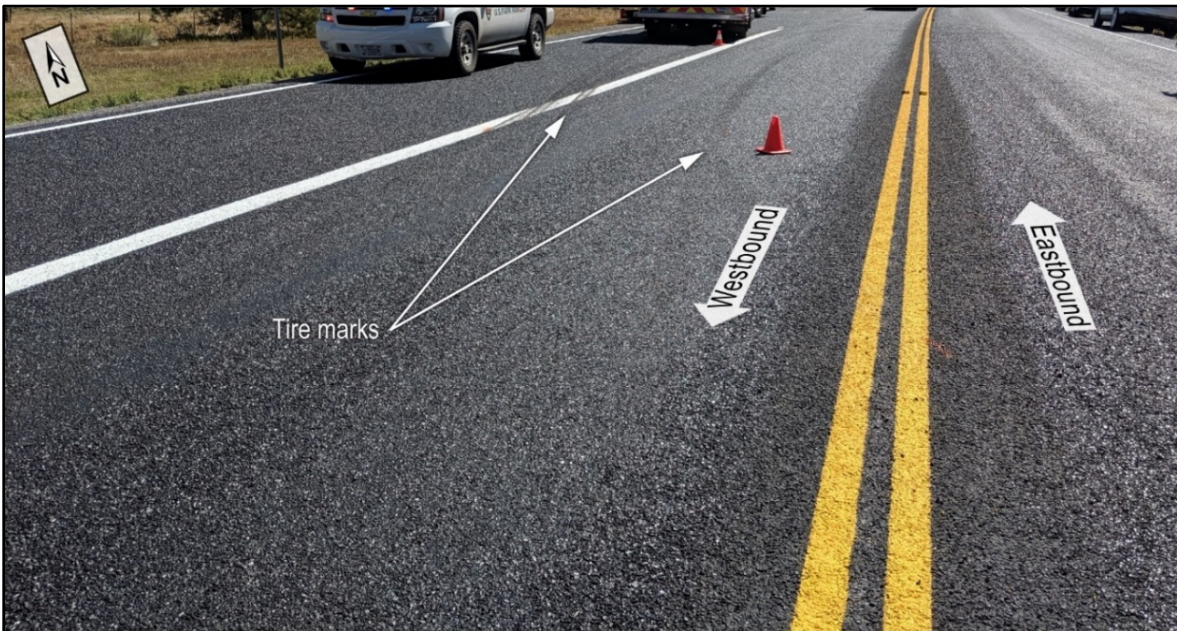
**Figure 5.** Tire marks curving from westbound toward eastbound lane. (Source: Utah Highway Patrol)

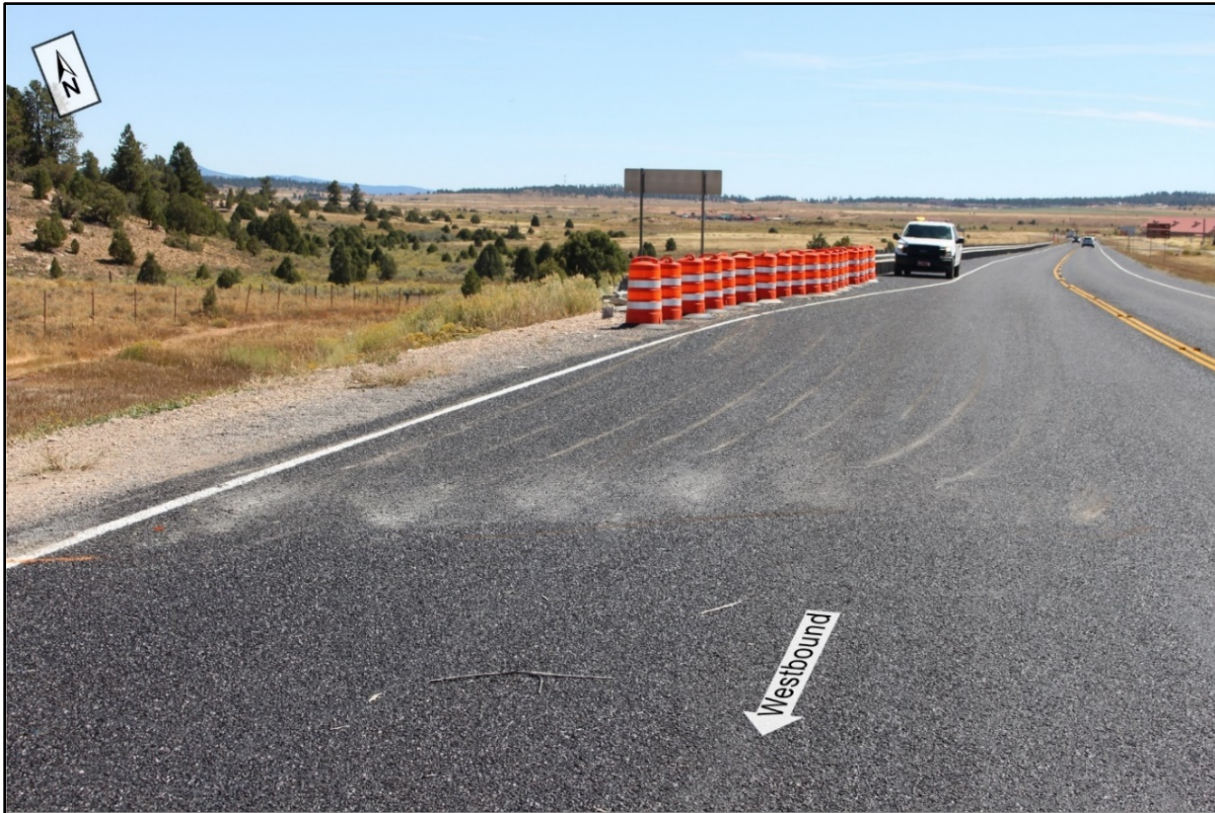
**Figure 6.** Gouge marks on westbound lane pavement left by bus sliding toward guardrail.

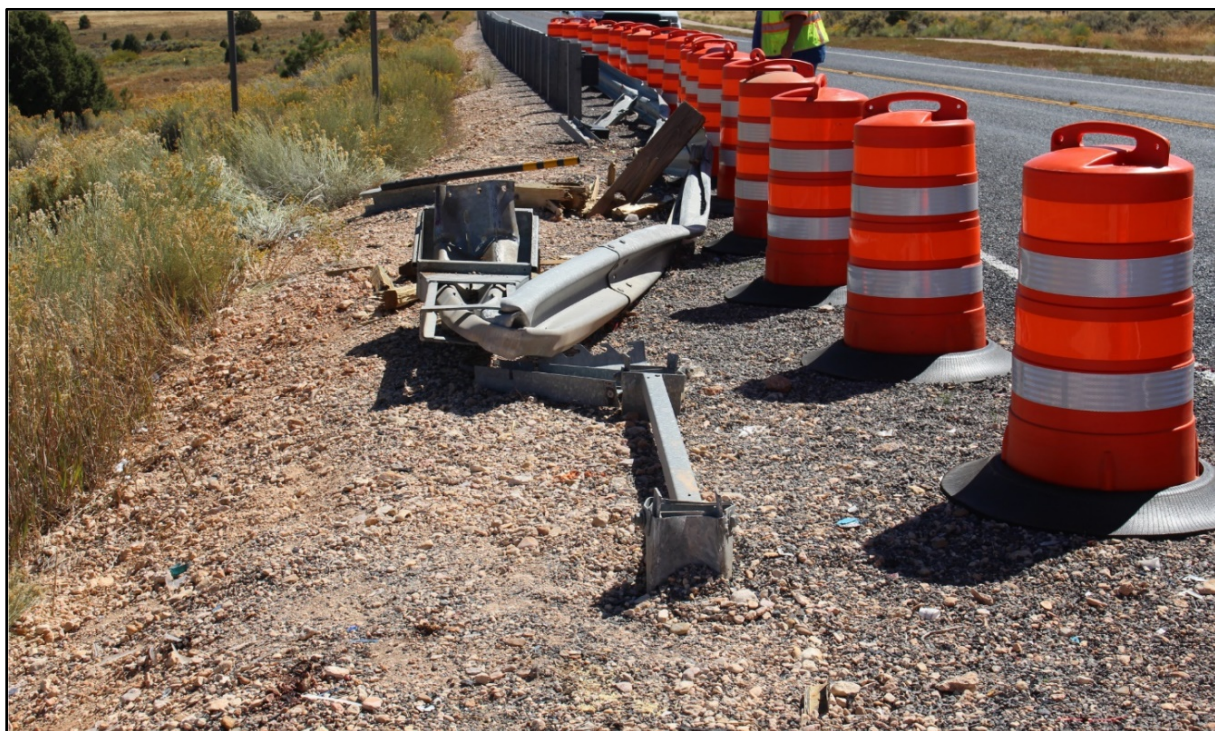
**Figure 7.** Damaged guardrail on westbound side of SR-12. (View is looking east.)

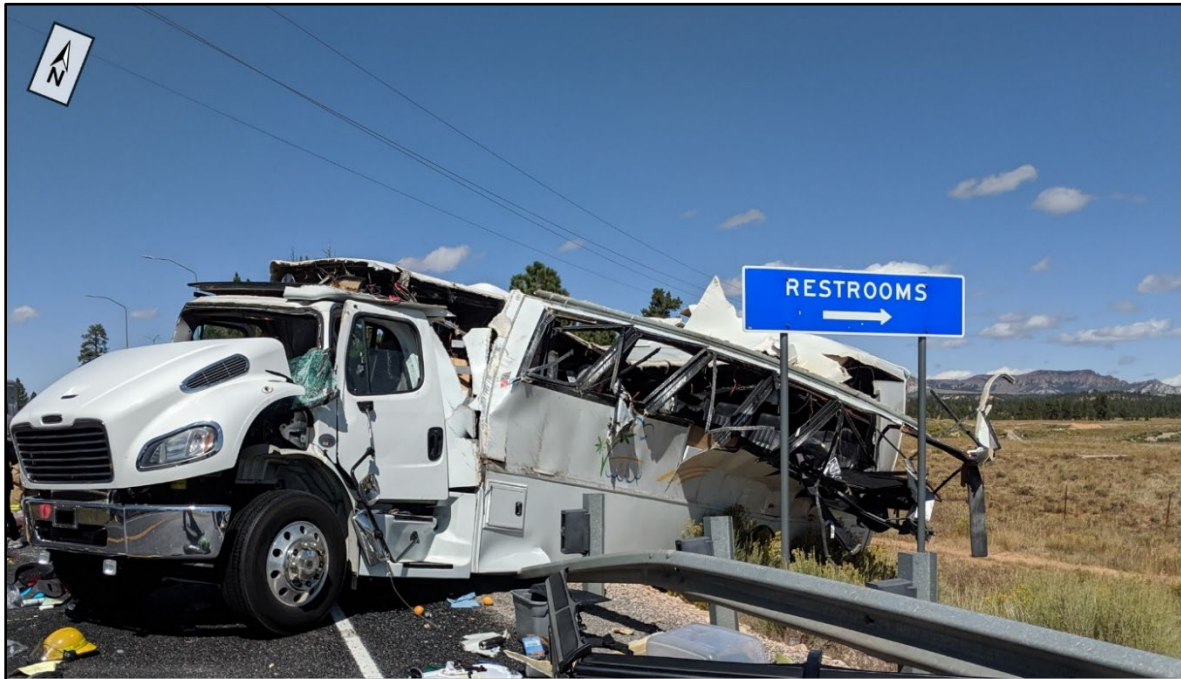
At final rest, the bus straddled the damaged guardrail, with its front end partially blocking the westbound traffic lane of SR-12 (see figure 8). No other vehicles were involved in the crash.

**Figure 8.** Bus at final rest on top of guardrail. (Source: Utah Highway Patrol)

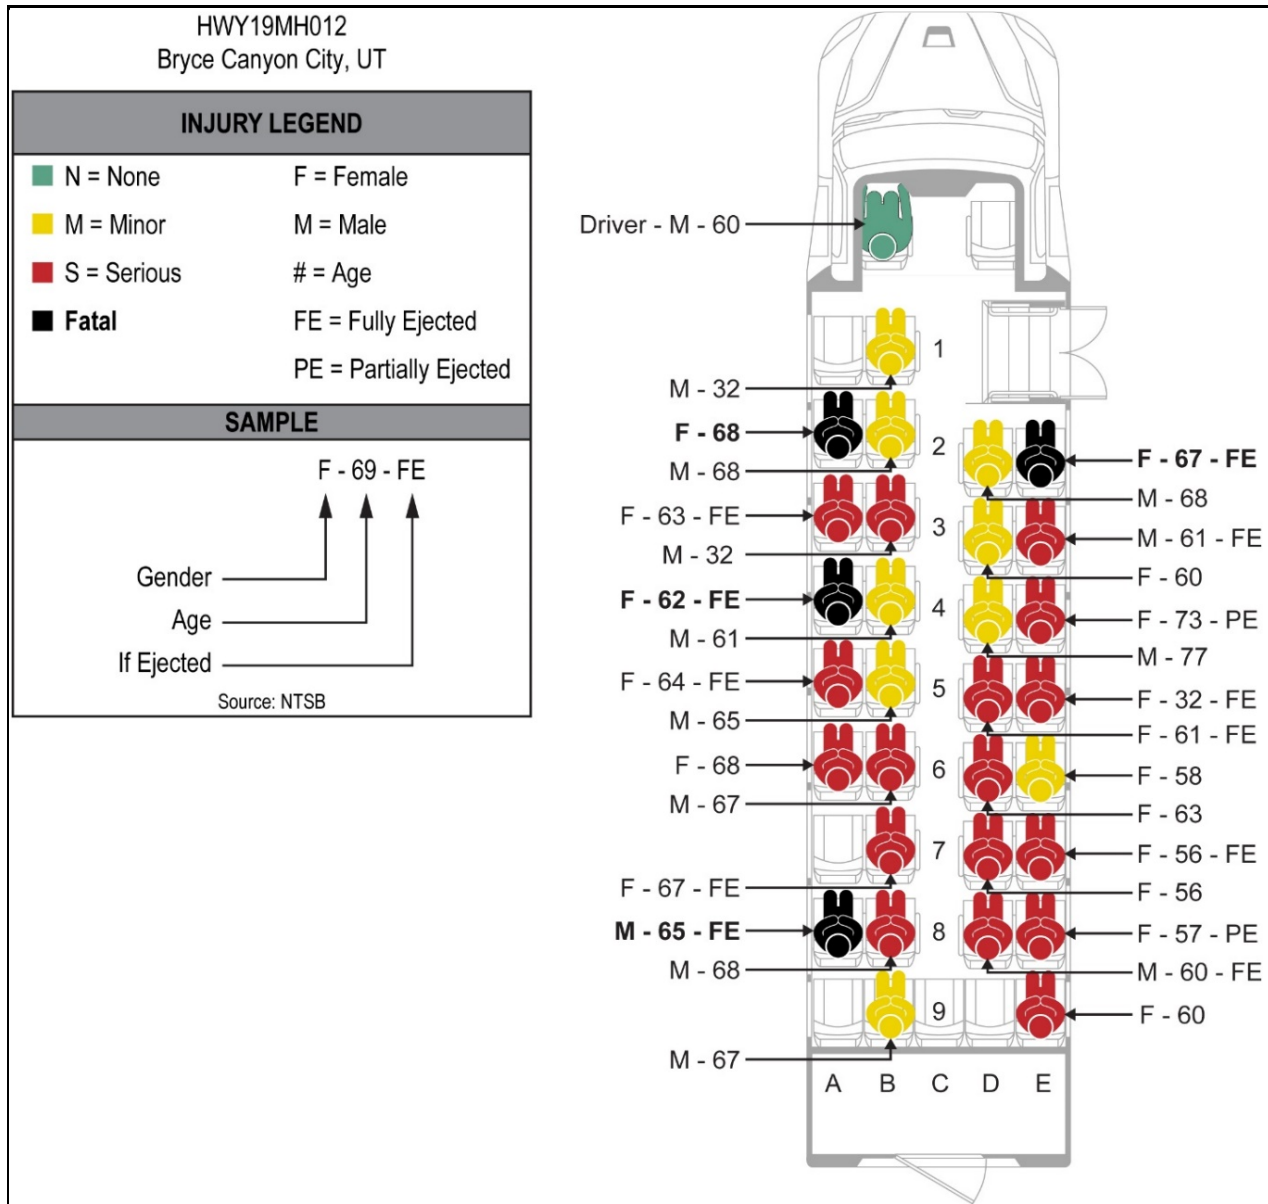
Figure 9 summarizes information on bus occupant seating position, ejection, and injury severity. Appendix C provides detailed information on occupant seat belt use. (According to Utah’s Motor Vehicle Safety Belt Usage Act, anyone age 16 or older who is a passenger in a motor vehicle operated on a highway is required to wear a properly adjusted and fastened safety belt.)

**Figure 9.** Bus seating chart, showing occupants’ seating positions and injury severity.

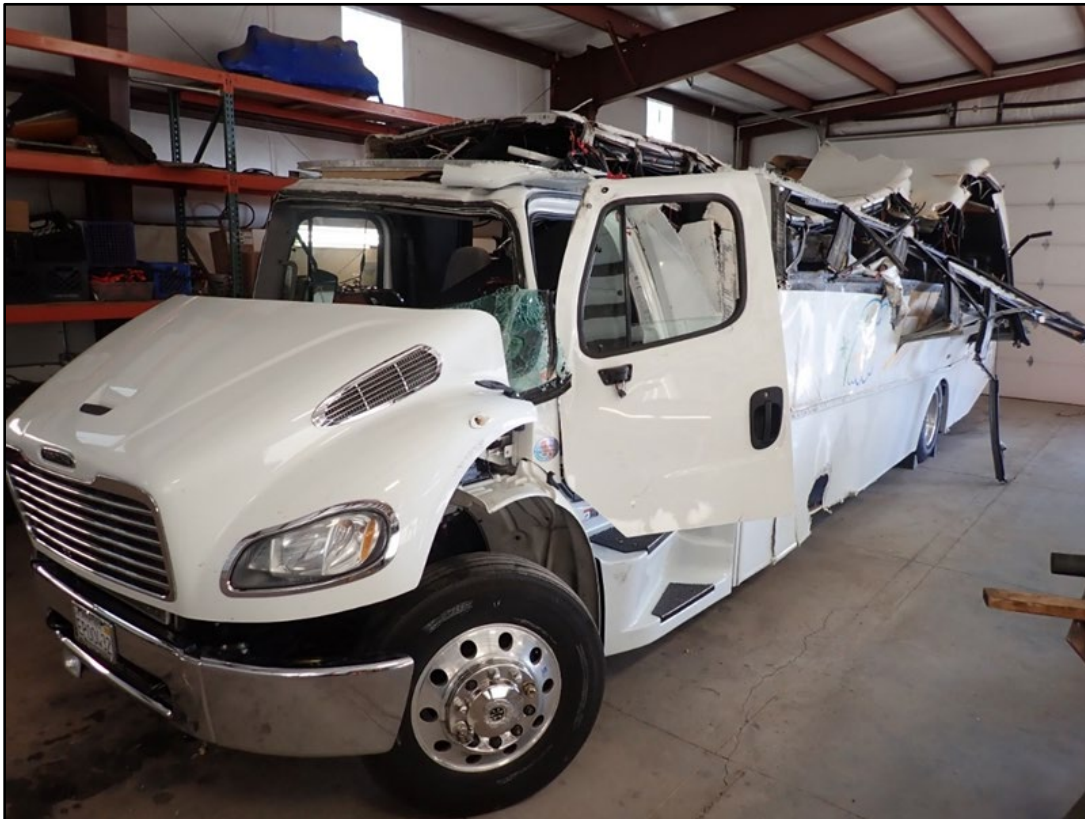
The front of the Freightliner bus had minor damage (see figures 10 and 11). The fiberglass roof of the cab was torn and displaced rearward. The front windshield was shattered and displaced from the frame. The driver's door would not close due to damage to the frame; the passenger cab door was operational.

**Figure 10.** Damage on left side of bus.

As shown in figures 10 and 11, the fiberglass panels on the left and right sides of the bus were damaged and torn.<sup>12</sup> All windows on both sides, including the emergency windows, were displaced and broken. A 6-inch by 8-inch wood guardrail post was embedded in the right side of the bus, at a point about 20 feet back from the front bumper and just beyond the underfloor luggage compartment. The frame of the passenger boarding door (located behind the passenger cab door on the passenger side of the bus) was damaged, and the glass on the left side of the bifold boarding door was missing.

The bus sustained extensive roof damage with significant intrusion into the occupant space. The roof was displaced and shifted to the right about 31 inches. The left side of the roof was crushed downward, exposing the tops of the passenger seats next to the left sidewall. The overhead luggage racks remained attached to the collapsed roof on both sides of the bus. The emergency roof hatch was found closed and damaged; it could not be fully opened. Postcrash, the fiberglass roof and structural metal bows were separated from the metal sidewall frame mounts on both the left and right sides. Examination of the joint welds indicated that they were adequate.

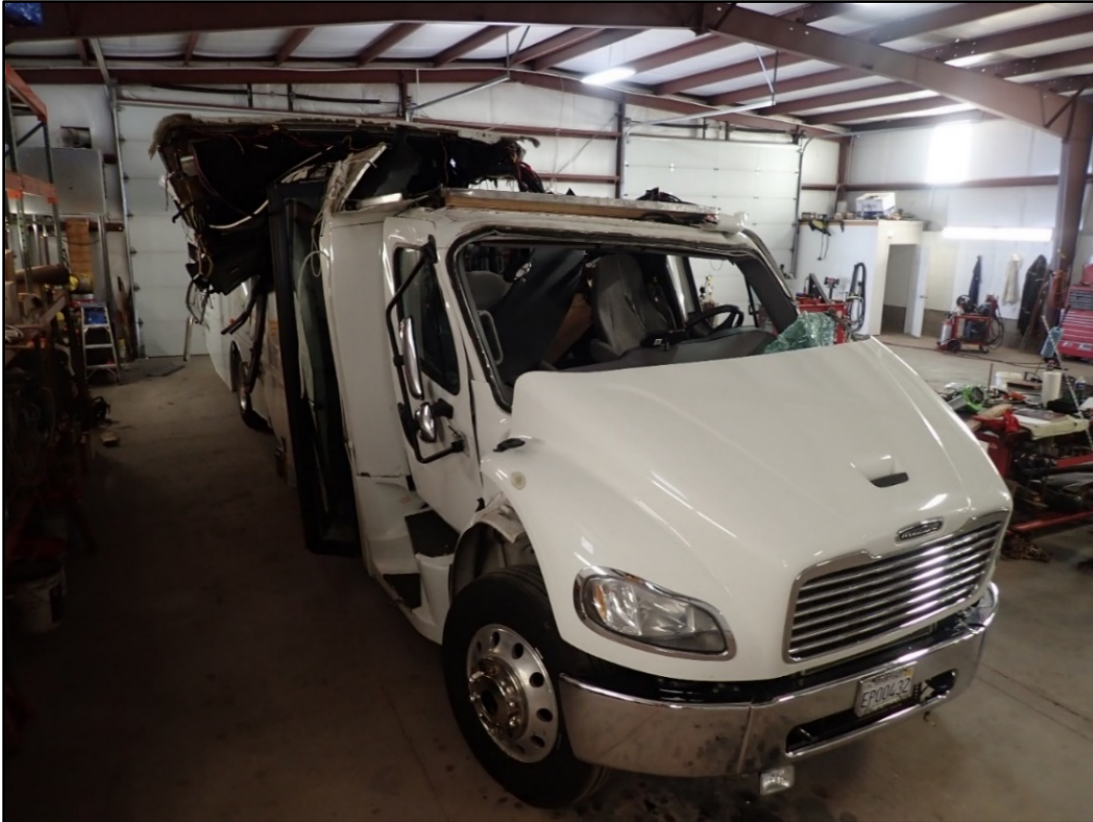
**Figure 11.** Damage on right side of bus.

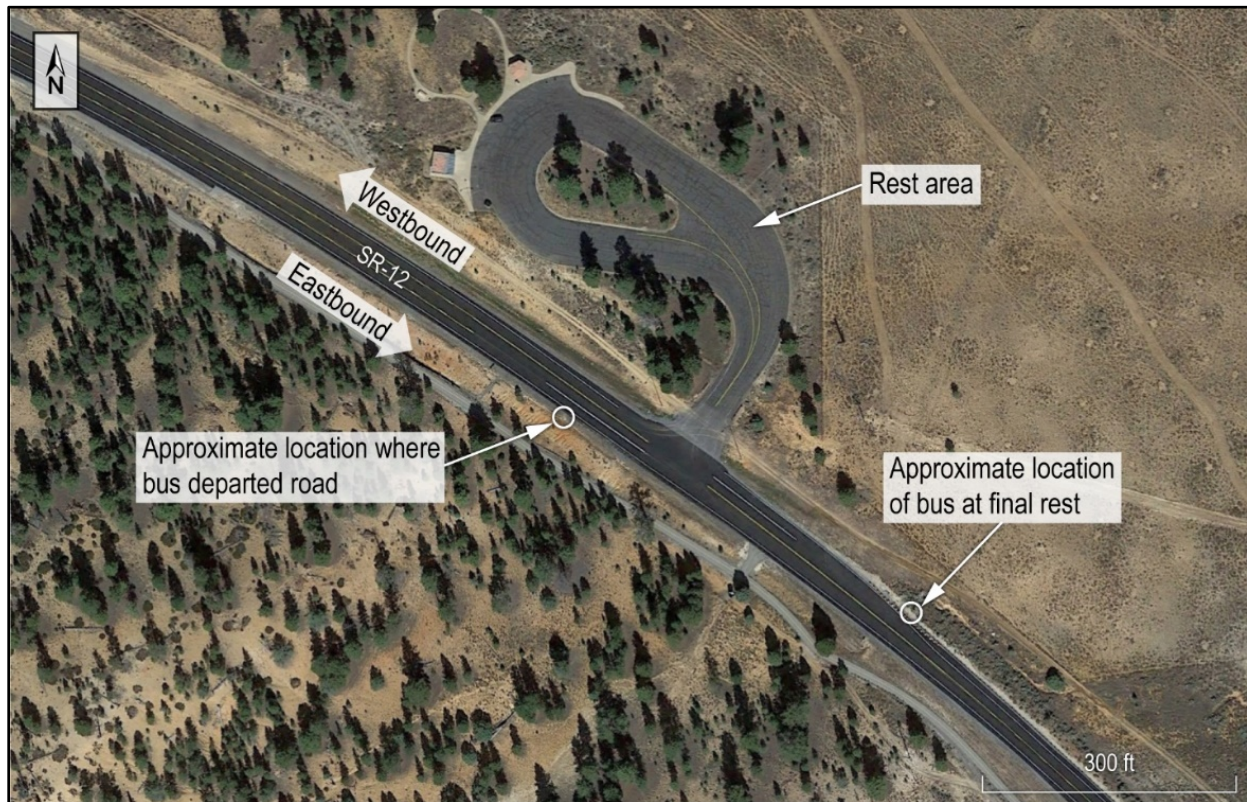
travel lane was 12 feet, 9 inches wide; the asphalt-paved shoulder was 5 feet wide; and the gravel shoulder was 3 feet wide. The yellow solid double lines separating the east- and westbound travel lanes were 4 inches wide. The white solid line separating the eastbound travel lane from the left turn lane was 8 inches wide, and the white solid lines separating the travel lanes from the paved shoulders were 4 inches wide. The regulatory and warning signage conformed to the Federal Highway Administration (FHWA) *Manual on Uniform Traffic Control Devices for Streets and Highways* (MUTCD) guidance (FHWA 2009).

**Figure 12.** Crash location. (Source: Google Earth [labels added by the NTSB])

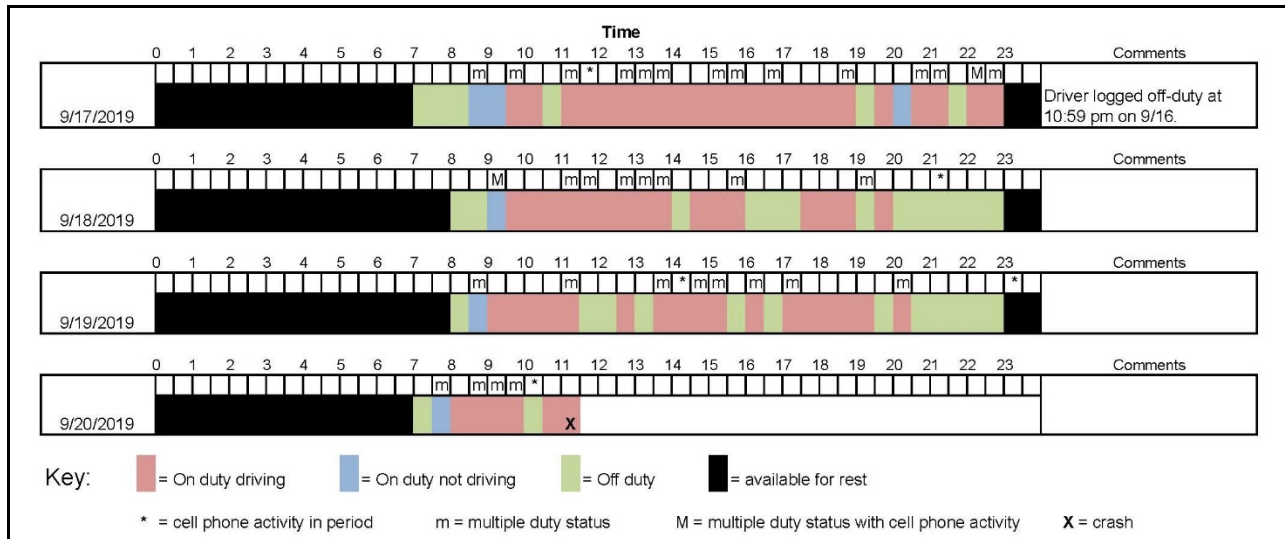
preceding the crash. On the morning of the crash, he had been driving for 3 hours, 16 minutes and had been on duty for 3 hours, 45 minutes. A review of the driver’s hours of service did not show any 10-hour, 15-hour, or 70-hour hours-of-service (HOS) violations.<sup>31</sup>

**Figure 13.** Bus driver sleep and work history.
