Highway Investigation Report HIR-23-01

Multivehicle Crash in Icy Conditions on Interstate 35 West

Fort Worth, Texas
February 11, 2021

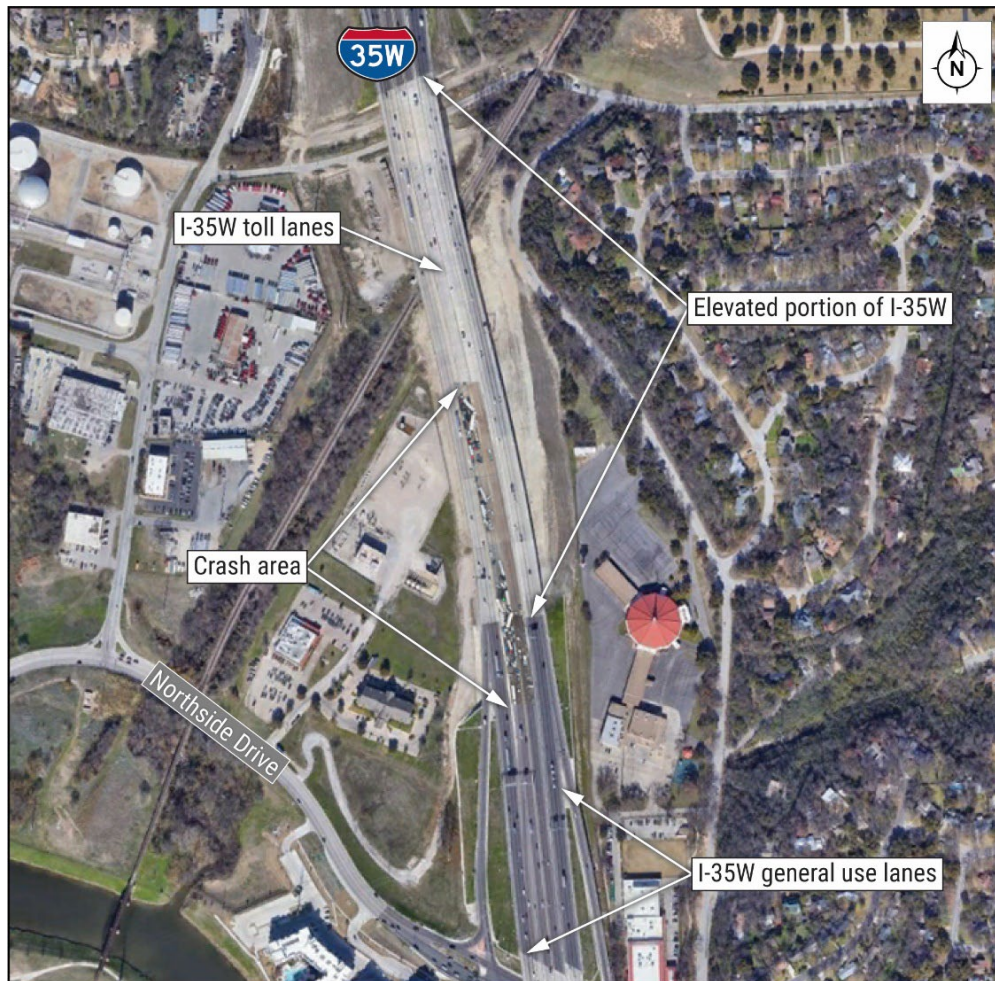
Figure 1. Overhead view of crash scene. (Source: Google Earth image adapted by NTSB.)

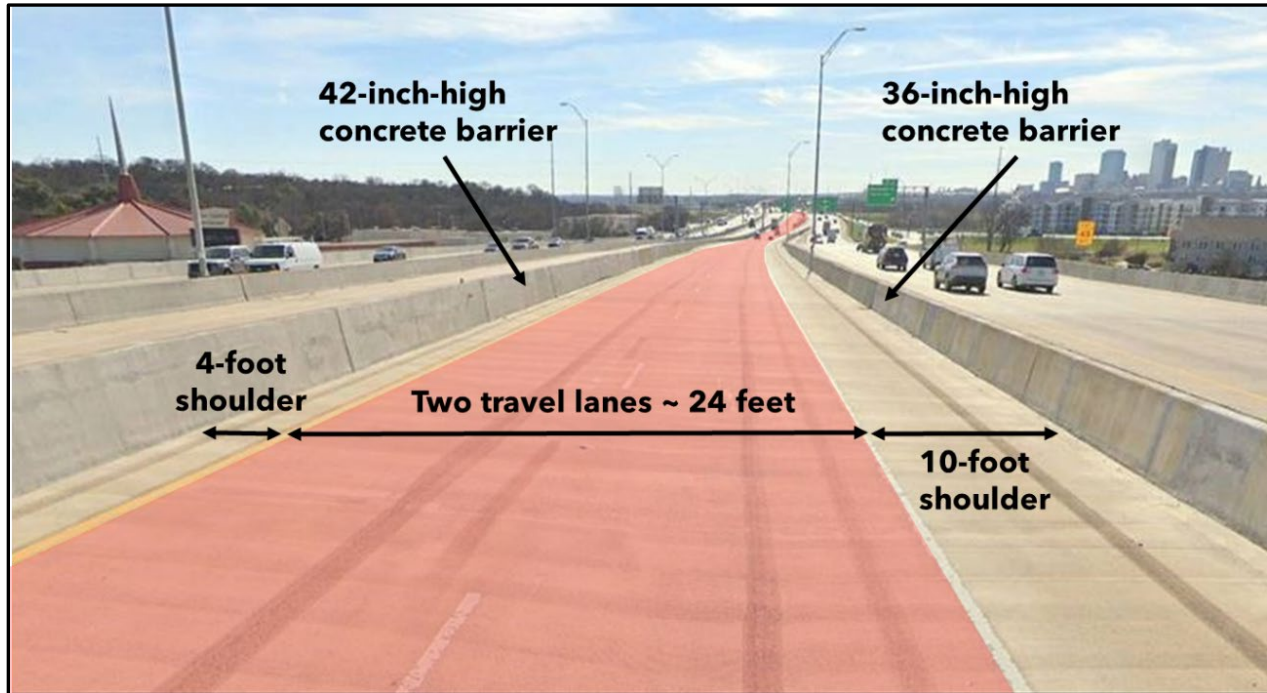
Figure 3. I-35W southbound toll lanes (highlighted in red) in area of crash site, looking south. Southbound general use lanes are on right side of image and northbound toll lanes are left of 42-inch-high concrete barrier. (Source: Google Earth Street view image from January 2020, adapted by NTSB.)

The crash occurred on an elevated portion of the roadway. The elevated structure preceding the crash location consisted of a hill crest with a 3% upgrade slope followed by a 3% downgrade slope.¹³ The February 11, 2021, crashes began occurring about 1,000 feet past the hill crest on the downgrade slope. Based on the vertical alignment, the available sight distances for a passenger car and a truck-tractor traversing the crest of the vertical curve were about 950 and 994 feet, respectively. The American Association of State Highway and Transportation Officials (AASHTO) recommends a stopping sight distance of 866 feet for a 75-mph design speed on a 3% downgrade (AASHTO 2018).

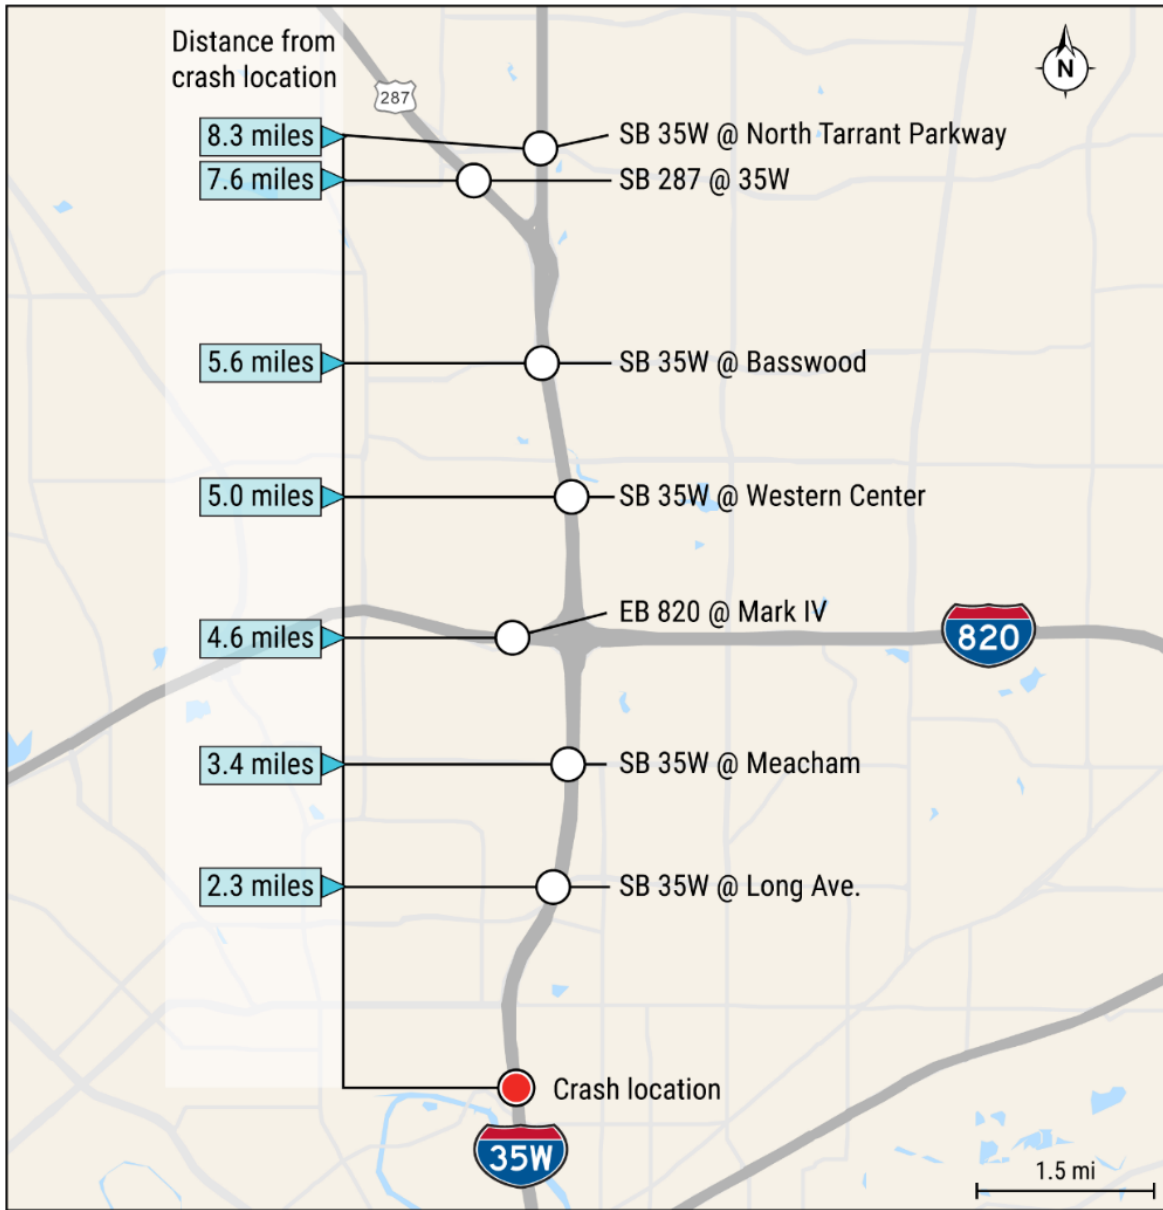
Figure 4. Map showing locations of dynamic message signs along, and on roads leading onto, southbound toll lanes. (“SB” indicates “southbound” and “EB” indicates “eastbound.”)

The nearest dynamic message sign to the crash site was located about 2.3 miles north at the Long Avenue on-ramp. The sign was visible to traffic in both the southbound general use and toll lanes.
