HIR-23-05

Multivehicle Crash and Postcrash Fire on Interstate 65

Greenville, Alabama
June 19, 2021

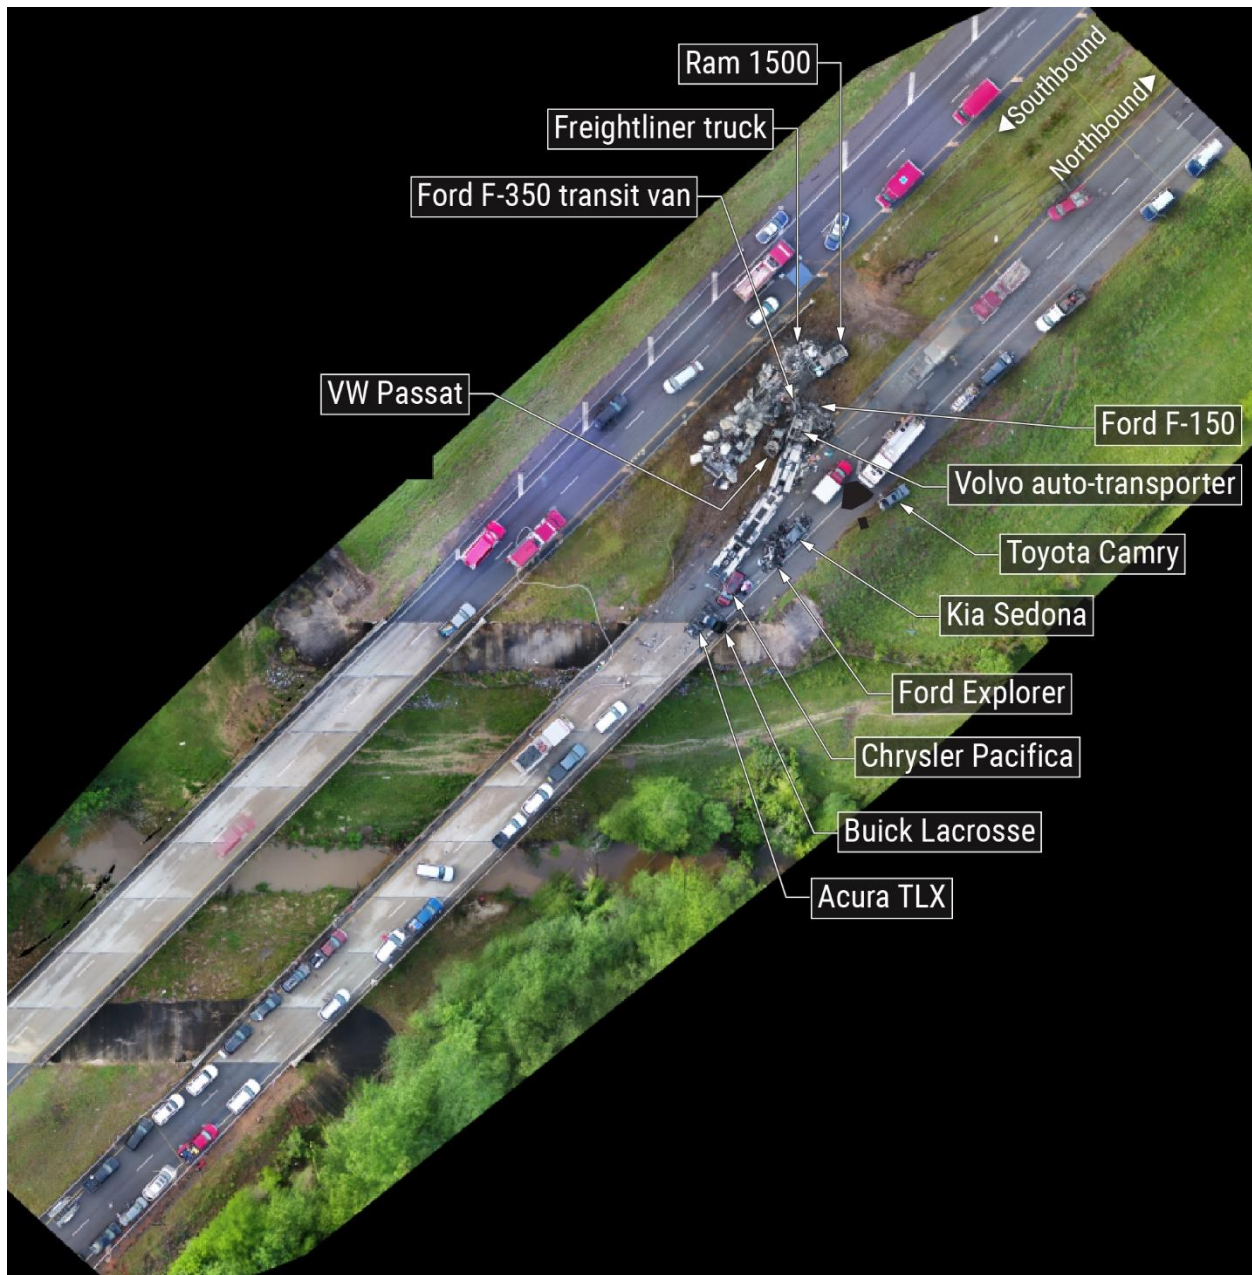
Figure 1. Orthomosaic image of final rest positions of vehicles involved in crash. (Source: Alabama Law Enforcement Agency; labels added by the NTSB)

At final rest (as shown in figure 1), the Ford Explorer, Acura TLX, Chrysler Pacifica, Buick Lacrosse, and Kia Sedona remained on the road in the right lane. The Toyota Camry was off the road beyond the right shoulder. The Volvo auto-transporter's truck-tractor and part of its auto-trailer, the Freightliner and its box trailer, the Ford F-350 transit van, the Ram 1500, the Ford F-150, and the VW Passat were in the earthen median between the north- and southbound lanes at final rest. A portion of the Volvo's (Cottrell) auto-trailer remained in the left lane (see postcrash photograph in figure 5).

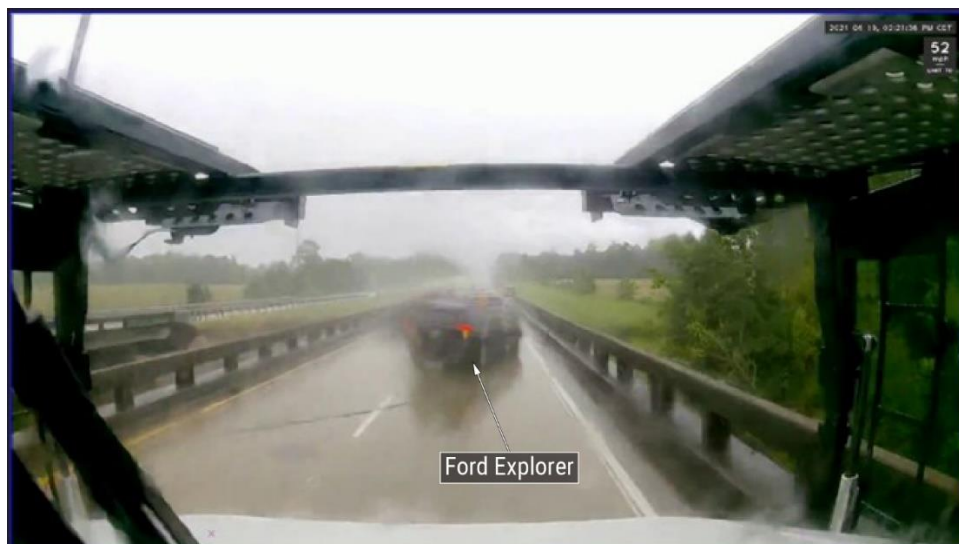
About 1.5 seconds after moving into the right lane, the Ford Explorer struck the Acura TLX at an estimated speed 27-30 mph. When the Ford Explorer collided with the rear of the Acura, the Acura was pushed into the Chrysler Pacifica, which in turn struck the Buick Lacrosse a second time. Figure 4 shows the video footage after the Ford Explorer collided with the Acura TLX but before the Volvo auto-transporter collided with the vehicles. The Volvo auto-transporter's driver braked and steered it toward the left, but it struck the Ford Explorer at the rear corner on the passenger side at a speed of about 51 mph. The Volvo auto-transporter made subsequent contact with the vehicles in the right lane, displacing them as it moved into the left lane.

Figure 4. Capture of the video from Volvo auto-transporter's forward-facing camera about 0.5 seconds before collision between Volvo and Ford Explorer.

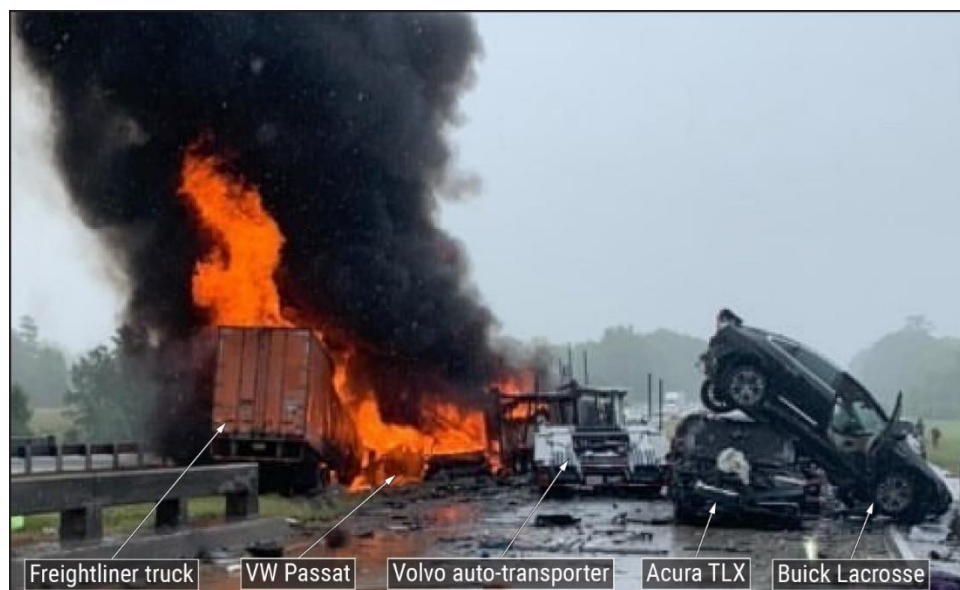
Figure 5. Postcrash witness photograph of crash and fire taken from northbound lanes of I-65 on bridge crossing for Pigeon Creek. (Source: Alabama Law Enforcement Agency [provided to law enforcement by witness], annotated by the NTSB)

Following the multivehicle collision, a postcrash fire engulfed the six vehicles at final rest in the median. The vehicles sustained extensive fire- and heat-related damage. Witness photographs showed the fire initially burning along the right side of the Freightliner truck; however, neither the exact origin of the fire nor the exact ignition source could be determined due to the extent and severity of the fire damage.

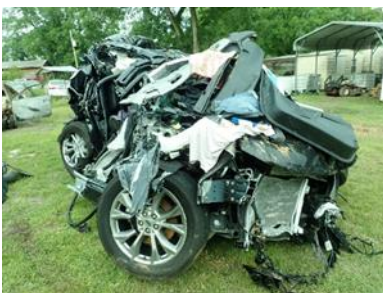
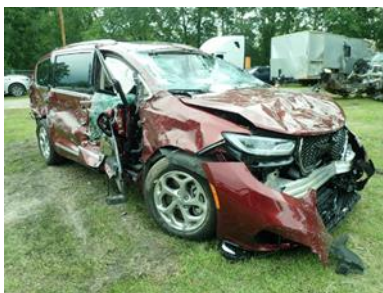
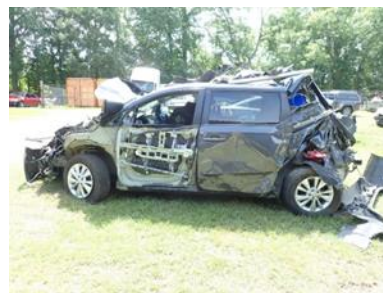
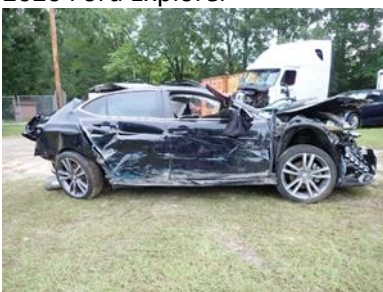
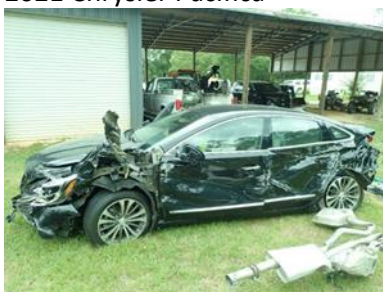
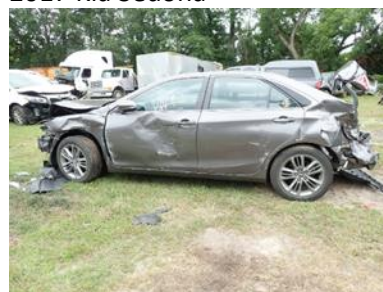
Postcrash examination of the 10 passenger vehicles involved in the crash indicated that the damage was consistent with one or more impacts during the crash sequence (see figure 6 for six passenger vehicles not involved in the postcrash fire).

Figure 6. Passenger vehicles not involved in postcrash fire.

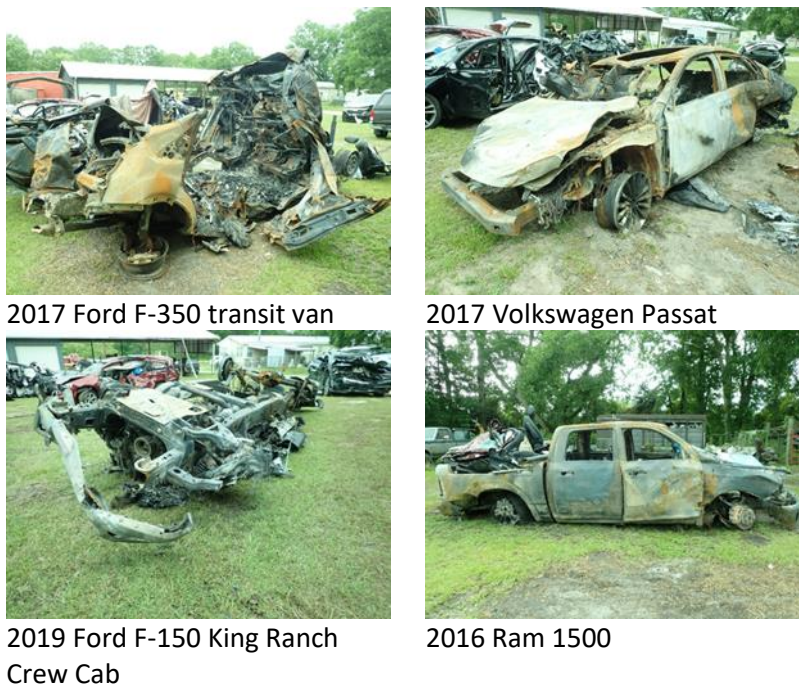
The Ford F-350 transit van, VW Passat, Ford F-150, and Ram 1500 sustained severe fire damage (see figure 7).

Figure 7. Passenger vehicles involved in postcrash fire.

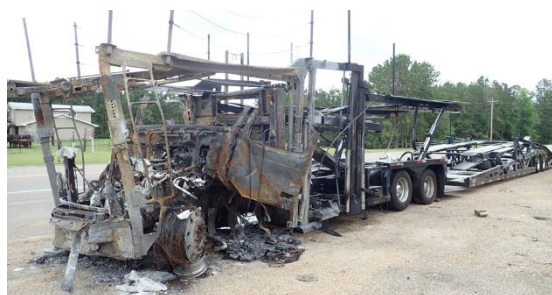
2020 Volvo truck-tractor with 2020 Cottrell auto-trailer

Postcrash examination of the Volvo auto-transporter and the Freightliner truck indicated that the damage to the two trucks was consistent with frontal impacts and the postcrash fire (see figure 8). Investigators examined all major mechanical systems on the two commercial trucks, including the steering, braking, and suspension systems. They found no evidence that there had been any precrash mechanical problems with either truck.⁹ There were no recalls on the trucks that had not been addressed by the carriers.

Figure 8. Commercial trucks involved in postcrash fire.

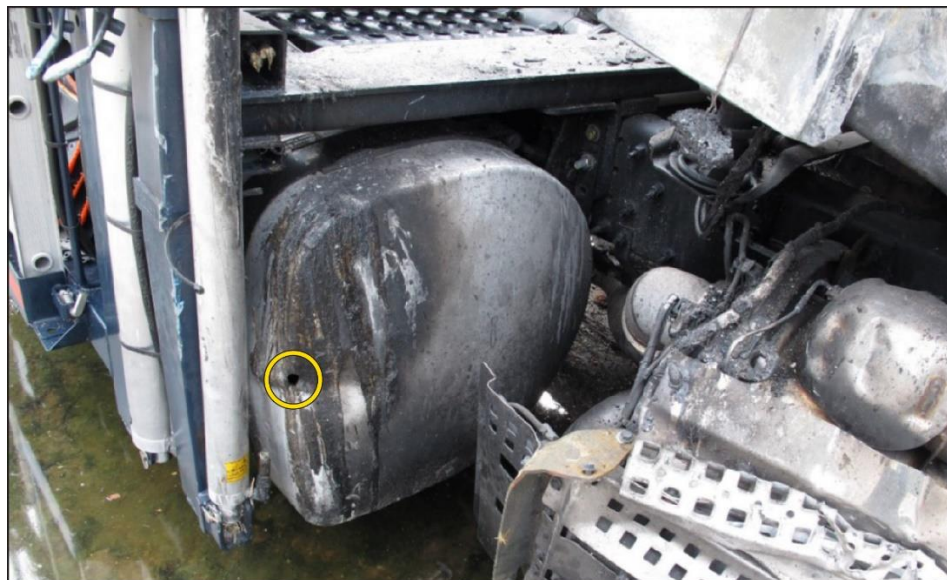
An aluminum fuel tank from the passenger (right) side of the truck-tractor of the Volvo auto-transporter was found still attached to the vehicle. The tank had a hole in it measuring about 3 inches by 3 inches (location of hole is circled in yellow in figure 9).¹⁰ The left fuel tank was missing, presumably destroyed in the fire. The fuel tanks from the other vehicles involved in the fire were missing and presumed consumed by the fire, including the Freightliner's two fuel tanks.

Figure 9. Fuel tank from passenger side of Volvo auto-transporter's truck-tractor, showing location of hole (circled in yellow) found in it postcrash.

The postcrash fire consumed six vehicles and contributed to the fatal injuries of the eight passengers of the Ford F-350 transit van. The initial source of the fuel for the fire was likely from one of the damaged or destroyed commercial truck fuel tanks, given their vulnerability to rupture during a crash. The NTSB has investigated several crashes where the impact damage to fuel tanks on commercial truck-tractors has led to rupture and fire (NTSB 2011, 2015, and 2017b). The NTSB has issued recommendations to SAE International to work with the FMCSA and NHTSA to improve the crashworthiness of side-mounted fuel tanks on truck-tractors to prevent catastrophic tank ruptures and limit post-collision fuel spillage, as well as to develop and promulgate an updated standard (NTSB 2017b).³⁸

Fuel tanks on commercial trucks involved in crashes are susceptible to high impact forces, resulting in ruptures, postcrash fuel spillage, and fire. The NTSB has previously recommended that federal regulators work to improve vehicle safety standards to improve the crashworthiness of side-mounted fuel tanks on truck-tractors.
